# **Challenges of Testing EB Coated CMC under SPLCF Conditions in Steam Environment at High Temperatures**

**Prepared for Presentation at the 44<sup>th</sup> Annual Conference on  
Composites, Materials, and Structures, Cocoa Beach/Cape  
Canaveral, Florida, January, 2020**

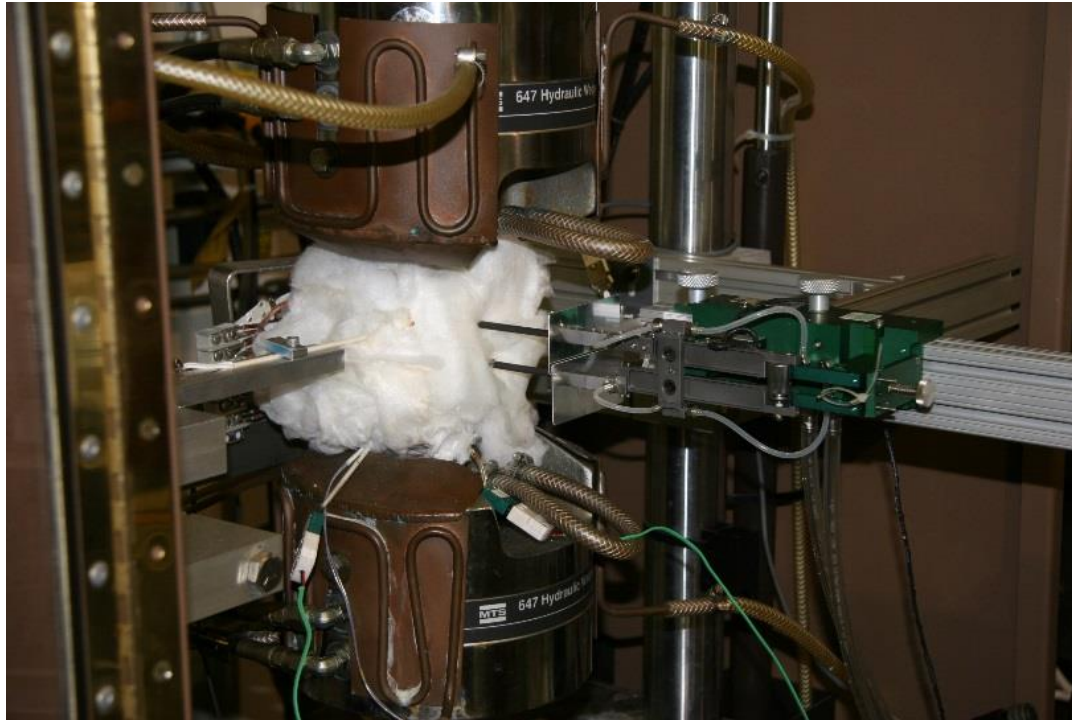
# High Temperature Testing of CMCs in Creep, Fatigue and SPLCF in Steam Environment

- Electromechanical, 50 kN Load Cell
- Three Zone Igniter Element Furnace
- 1.0 in. Gage Length, Water-Cooled Extensometer
- Frequencies up to 1 Hz
- Temperature capability: 1315°C (Current)  
1482°C (Developmental)

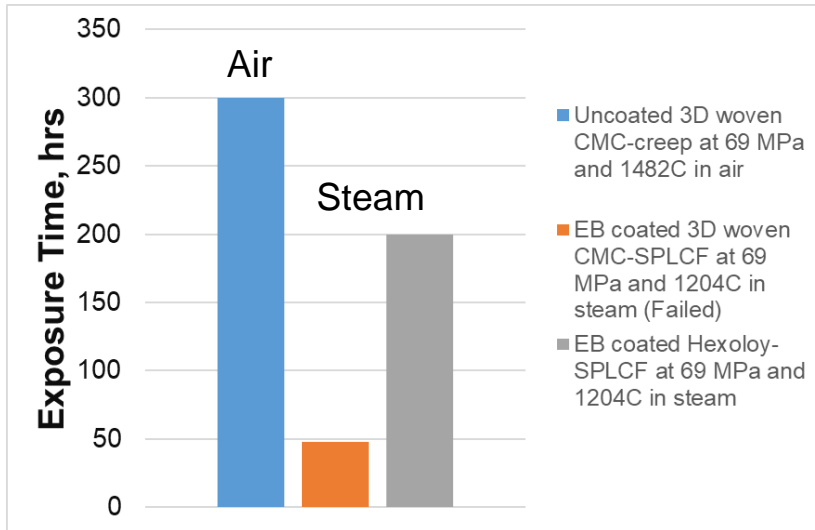
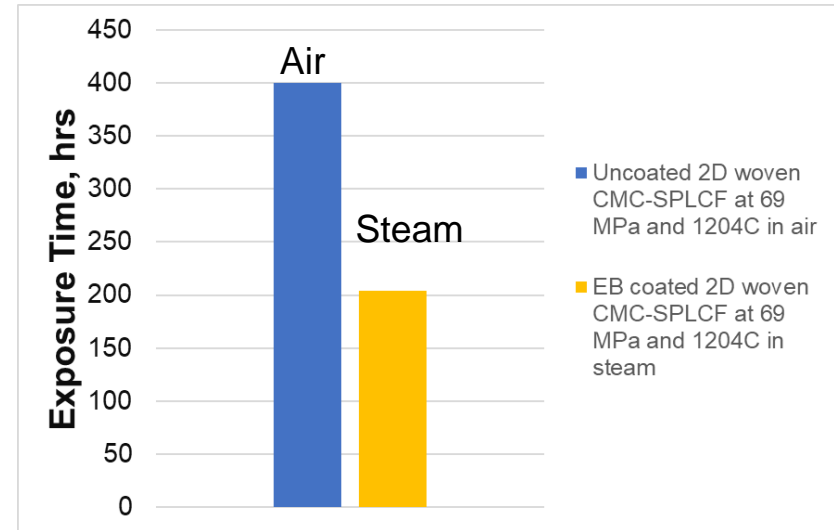
# History of Uncoated and EB Coated CMCs and Hexoloy Specimens Tested in Air and Steam

Note: In steam environment, Type-I EB coating system does not protect 3D woven SiC/SiC CMC from degradation, but Type-II EB coating does protect 2D woven SiC/SiC CMC.
