# **INFRARED THERMOGRAPHY AND X-RAY COMPUTED TOMOGRAPHY AS COMPLEMENTARY TECHNIQUES FOR THE CHARACTERIZATION OF DAMAGE IN COMPOSITE SANDWICH STRUCTURE**

K. Elliott Cramer & Wade C. Jackson

NASA – Langley Research Center

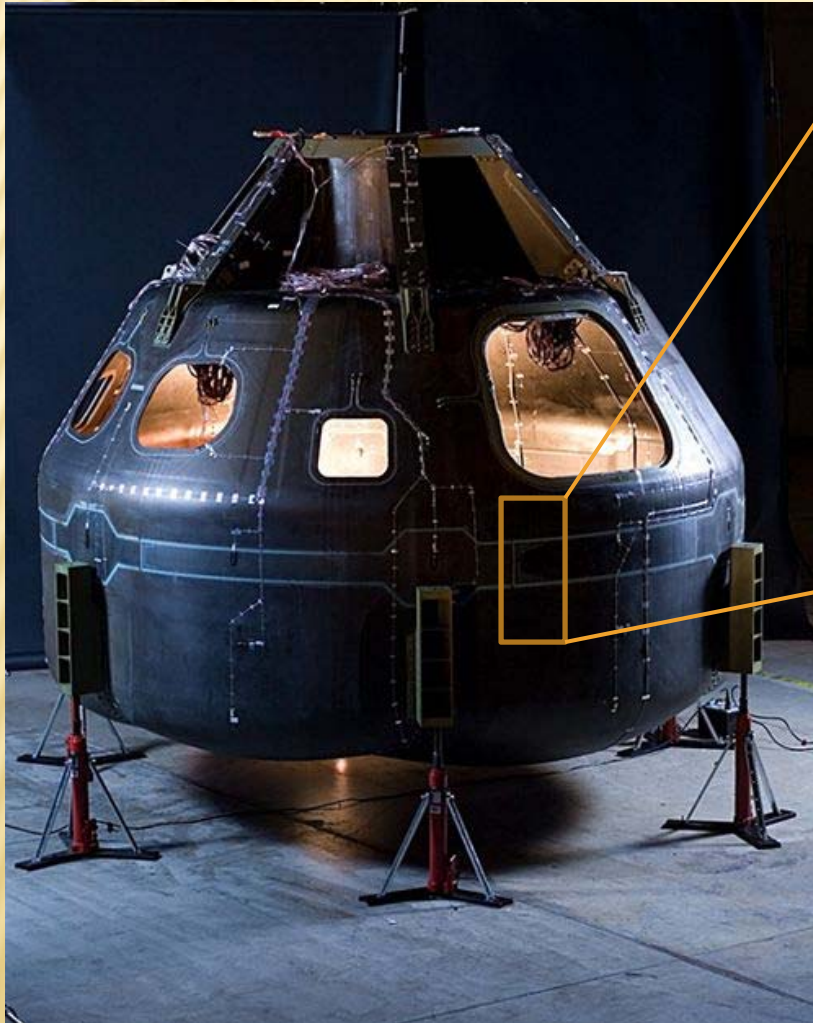
## Splice Region

61.2 cm Overall Length  
7.6 cm Overall Width  
12.7 cm Splice Region Length

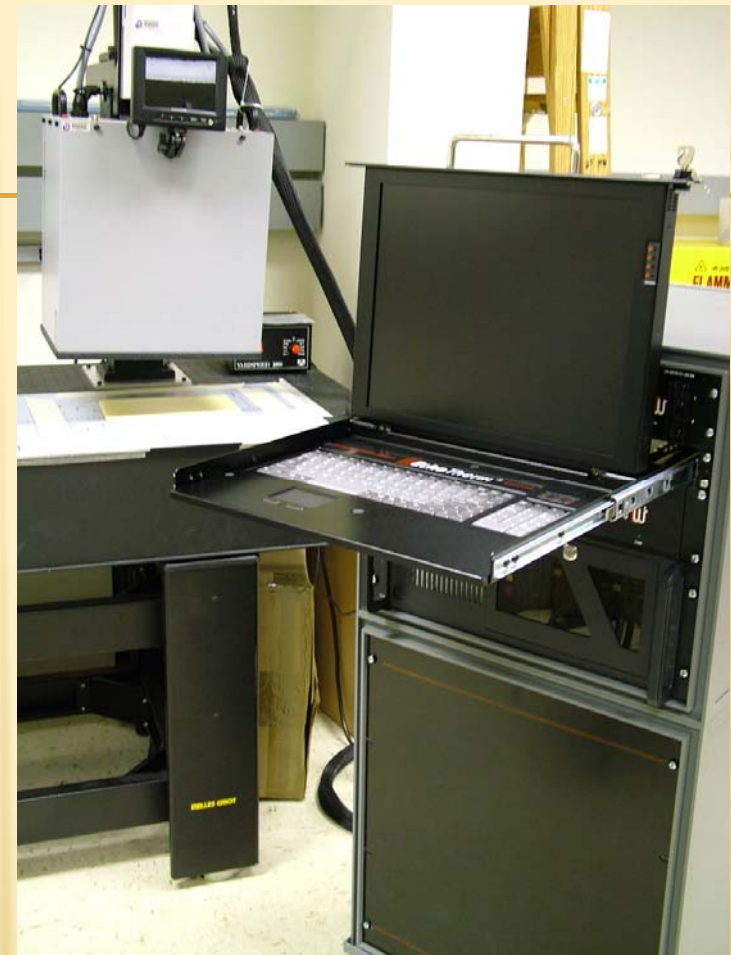
# THERMOGRAPHY HARDWARE

## Data Collection:

TWI Echotherm System

FLIR Phoenix® infrared imager

640 x 512 element array

3-5  $\mu\text{m}$  wavelength range

120 fps acquisition speed

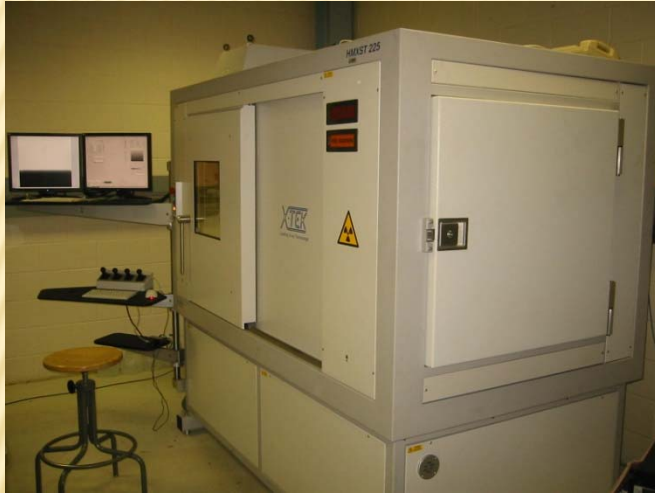
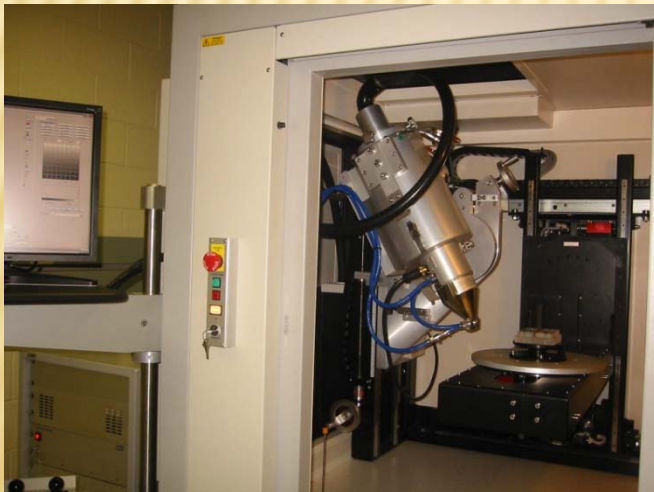
# X-RAY CT

- **5  $\mu\text{m}$  Focal Spot Reflection Target X-Ray Source or 25 to 225 kV**

- **15 or 30kg Capacity 5 axis fully programmable manipulator.**

- **Detector is 2000x2000 pixels with 200 micron pitch**

- **10 micron spatial resolution for specimens 1.5 cm wide**

- **Thin panels 10"x10" – full volume 200 micron spatial resolution**
