# Pulse-Echo Phased Array Ultrasonic Inspection of Pultruded Rod Stitched Efficient Unitized Structure (PRSEUS)

Patrick H. Johnston

NASA Langley Research Center, Hampton, VA

2010 Review of Progress in Quantitative Nondestructive Evaluation

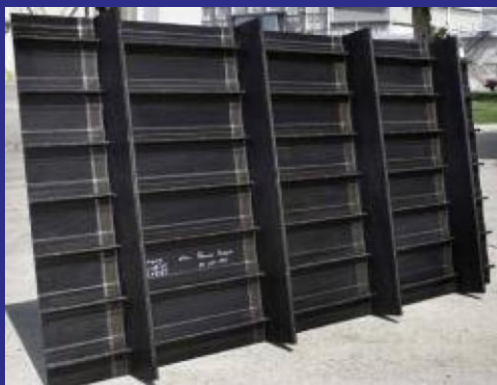
# Pultruded Rod Stitched Efficient Unitized Structure (PRSEUS)

- Rod improves stiffening
- Stitching enables fail-safe design
- Self-supporting pre-form reduces tooling

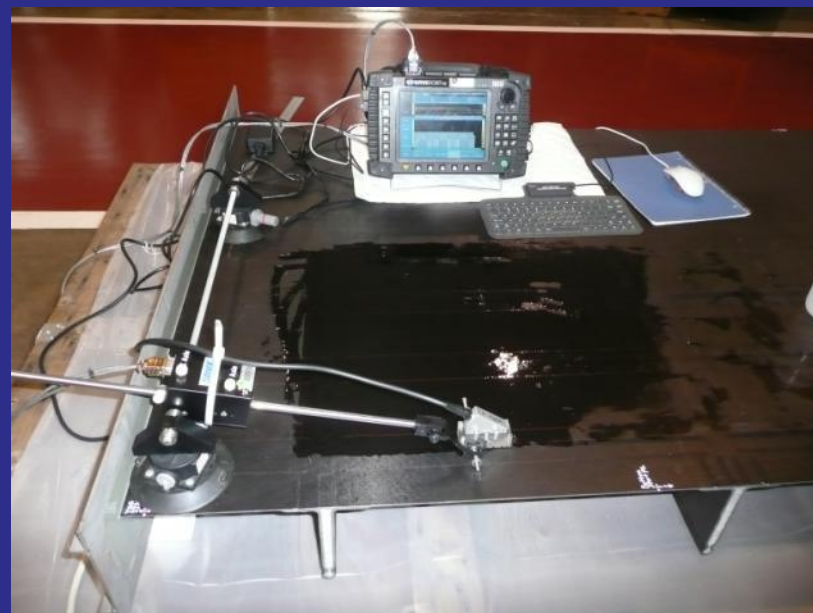
- Linear phased-array probe (10 MHz, 64 elements each 10mm X 1 mm) mounted on plastic delay or captive water probe
- Beam focused just under surface of composite
- 16-element aperture scanned electronically to yield 49 lines per sweep
- Two-dimension manual scanner with encoder output to instrument
