# HIGHLY LOADED COMPOSITE STRUT TEST DEVELOPMENT AND RESULTS

**K. Chauncey Wu and Dawn C. Jegley**

NASA Langley Research Center, Hampton, Virginia

January 11, 2012

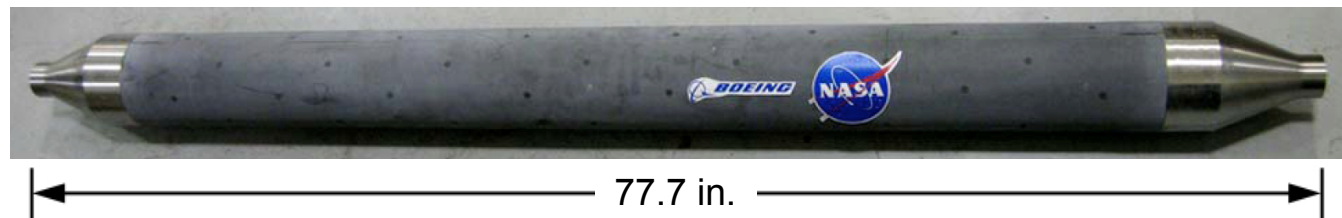
Phase 2  
high-load  
struts

- Ten struts were designed, analyzed and built by Boeing and Northrop Grumman under contract to NASA.
- Strut lengths ranged from 61 to 127 inches, with predicted compressive loads from -2 to -140 klb.
- Strut bodies fabricated from IM7/8552 prepreg tow and tape using hand layup, and then autoclaved or oven-cured.
- Tapered ends of struts incorporated titanium end fittings.

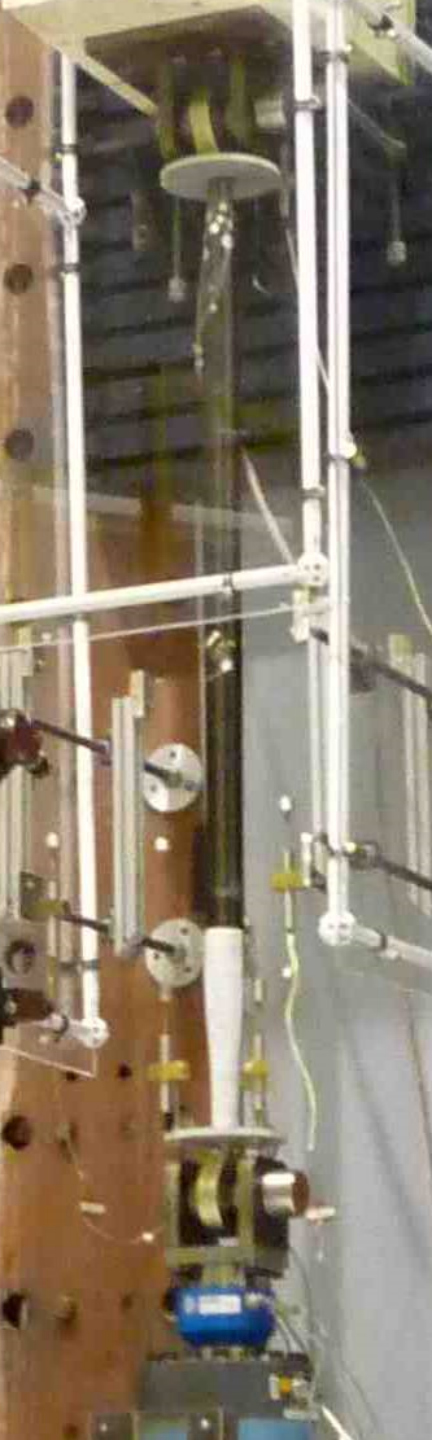
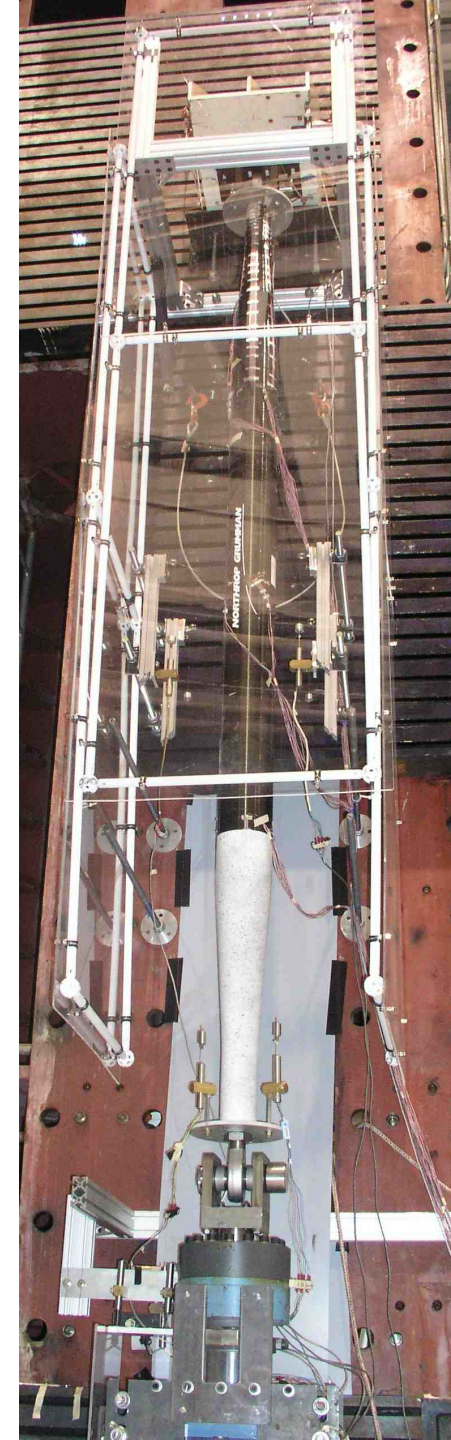
- Final checkout tests were performed using the three composite struts developed as MDUs during the Phase 1 study.
- Two composite struts were 61 in.-long and 2.5 in.-OD. (shown at left), and one strut was 127 in.-long and 6.2 in.-OD (shown at right).
- These composite struts were tested in both tension and compression, but only compression test results are presented here.

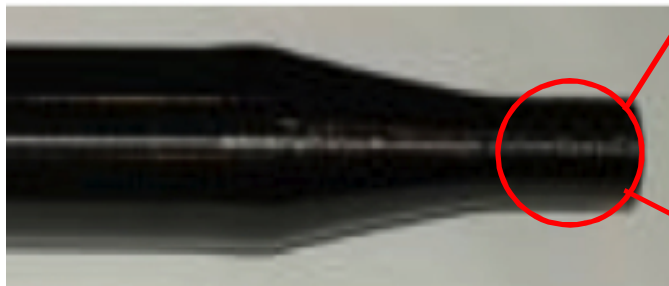
- Patented internal titanium end fittings provided interface between strut and test hardware. They were completely integral with the composite strut ends.
- End fittings were aligned with plaster mandrel axis, and composite material was hand-placed over them.
- Additional hoop tows were wrapped around end fittings to provide a smooth OML. After shrink-wrapping, assembled strut was cured in an oven.
- Mandrel washed out from inside of cured strut.

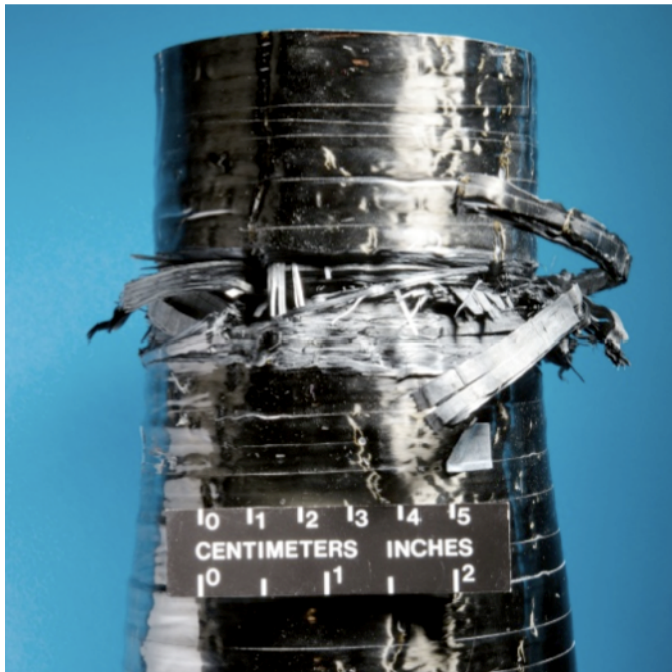
NG-1 strut test stopped after sudden load drop at -119.3 klb.  
NG-2 loaded past -110 klb load drop to collapse at -121.7 klb.

NG-2 failed upper end fitting  
(no visible damage on NG-1)
