# **Failure Analysis of the X-33 Liquid Hydrogen Composite Tank**

**E.H. Glaessgen  
NASA Langley Research Center  
Hampton, Virginia**

**The Symposium for Ed Rybicki  
The University of Tulsa  
Tulsa, OK**

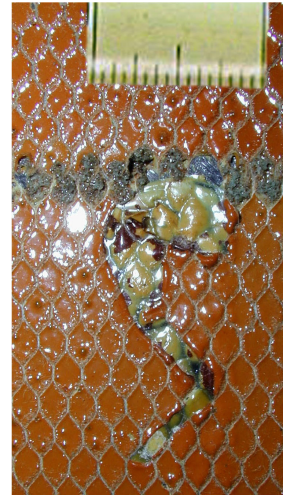
**J-shaped debond**

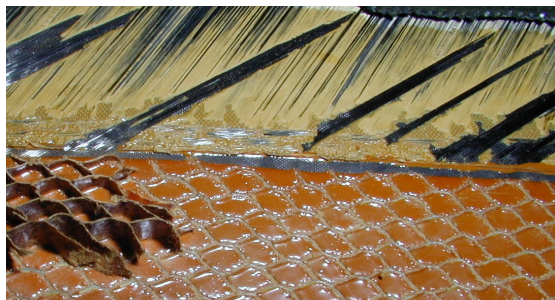
**Coalesced debonds  
at core splice**
