X33 Hydrogen Tank Failure

James Reeder

NASA Langley Research Center
Durability, Damage Tolerance
and Reliability Branch

CMH17 Meeting August 19, 2012

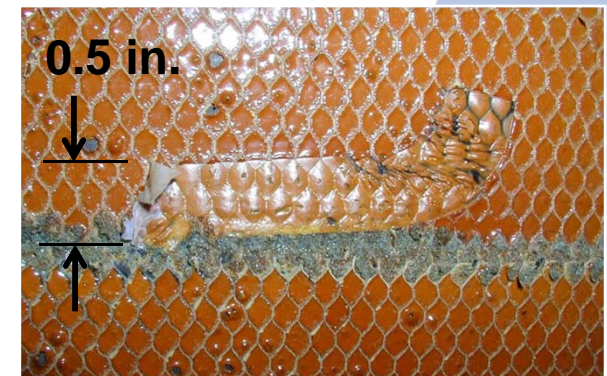
Teflon FOD next to splice

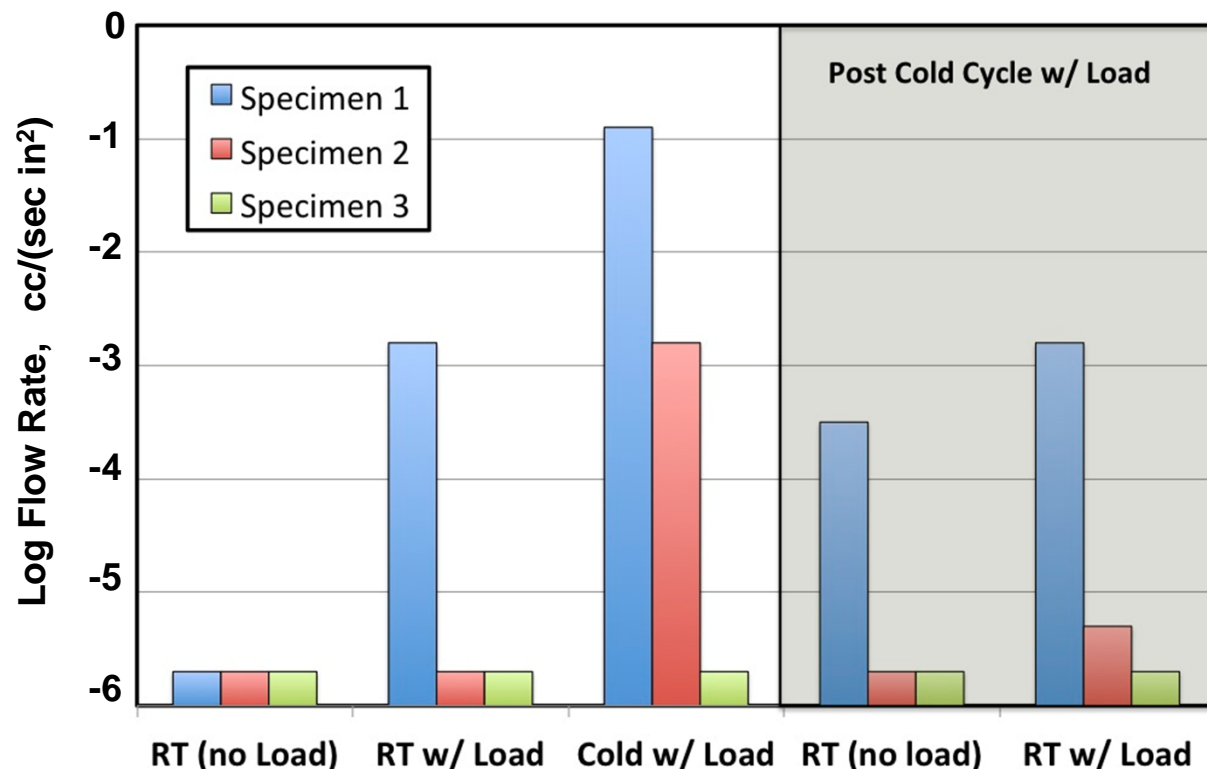
Permeability Testing

- Permeability varied significantly from point to point
- Permeability slowed significantly without both mechanical and thermal strain on inner facesheet
- Outer facesheet low permeability

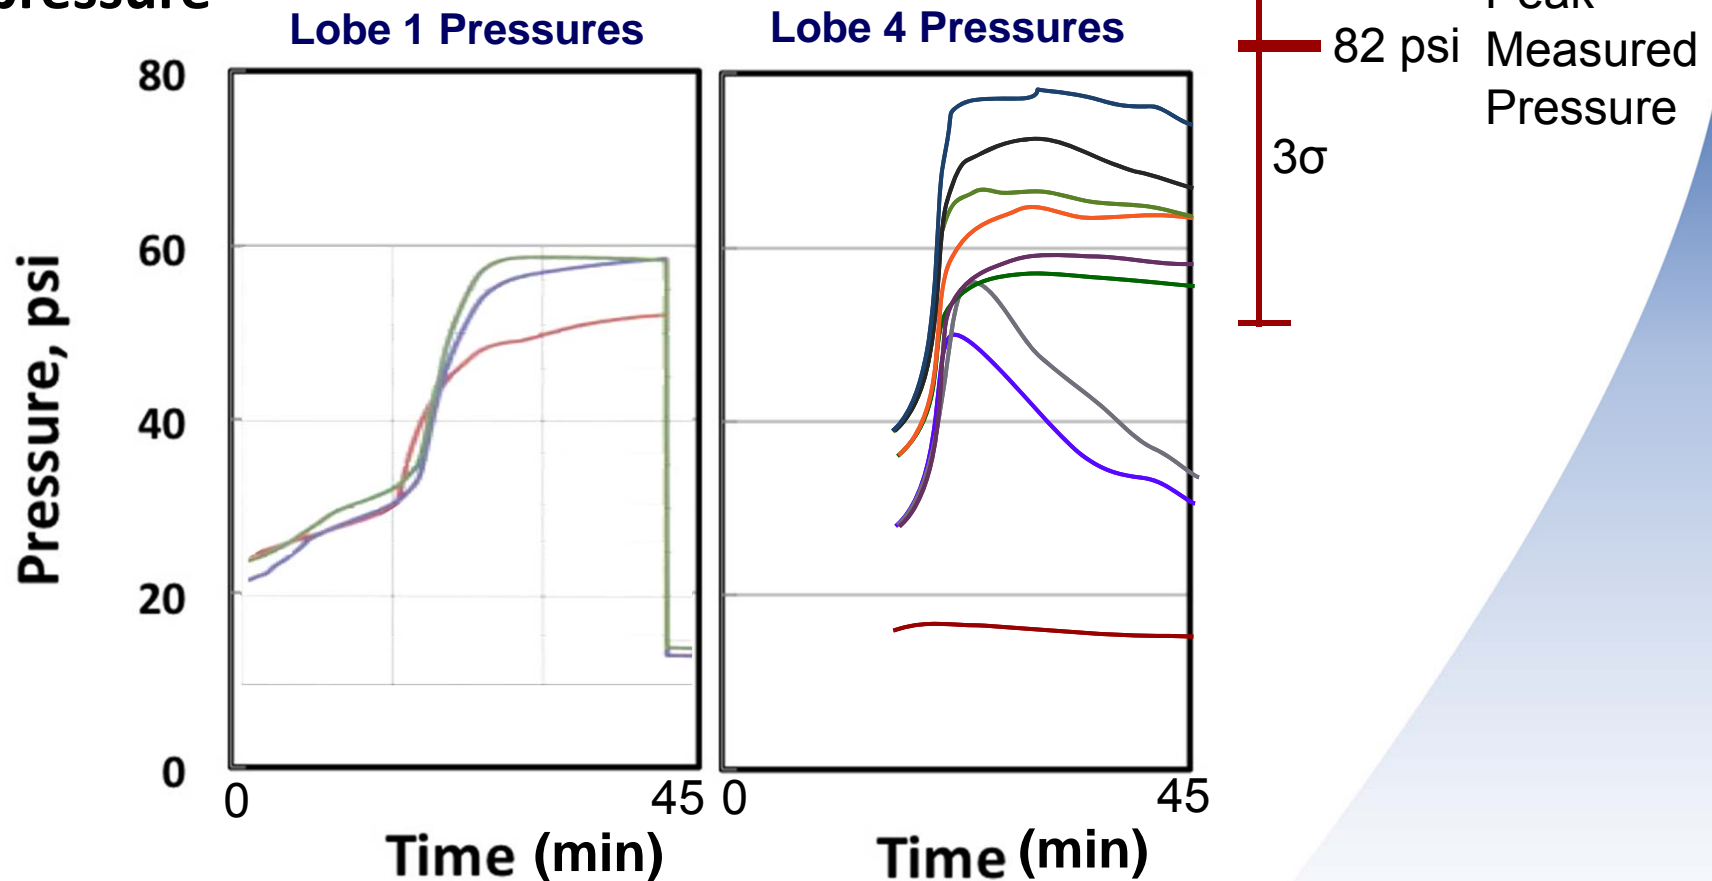
Core Internal Pressure

- Significant variability in measured core pressures
- Evidence of rising core pressure with tank pressure

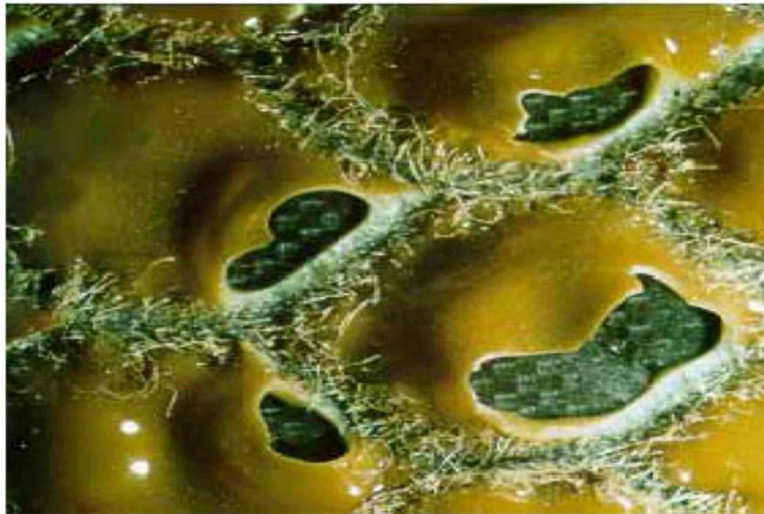
Poor Bondline

Inner Bondline

Facesheet to core bond

- **Poor prep of cut honeycomb**
- **Out time for adhesive**
 - AF-191 Adhesive
- **Cells communicated**
 - (perhaps not between core splice joints)

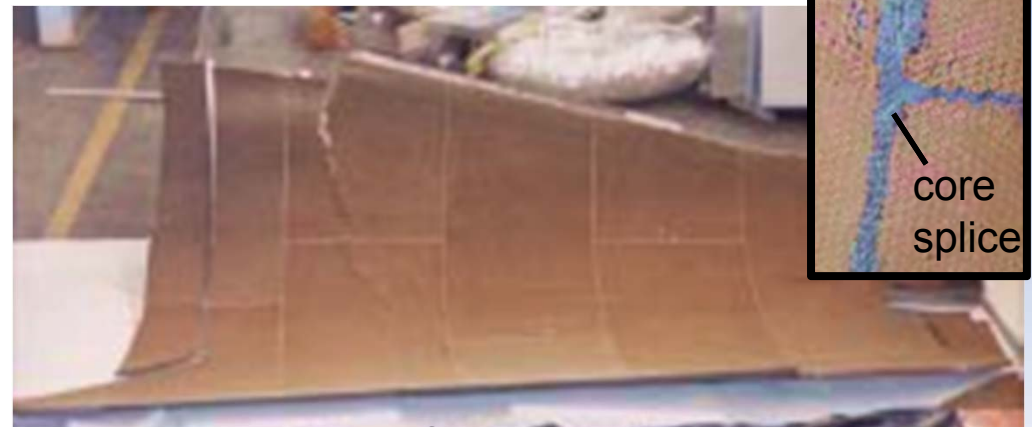
Removed outer facesheet and core (showing core splices)

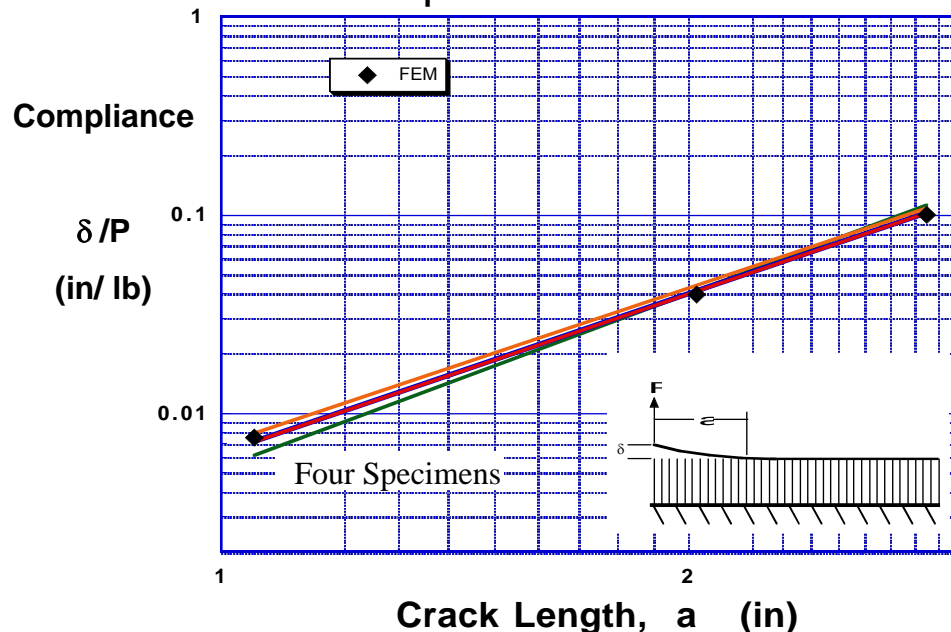
Analysis Calibration

- How to model a facesheet with a single brick elements?
 - Effective Bending Modulus in debonded regions
 - Effective Tension Modulus in bonded regions
- How to model honeycomb core with solid brick element?
 - Shear properties adjusted
- Calibrated to single cantilever beam results
 - Both compliance and G

Inner Facesheet	
	Bending	Tension
E_{11}	2.8	7.09
E_{22}	11.3	11.4
G_{12}	1.93	2.11

Core
$E_{11} \text{ \& } E_{22}$	6E-04
E_{33}	0.02
G_{13}	0.018
G_{23}	0.002

Used to calibrate model

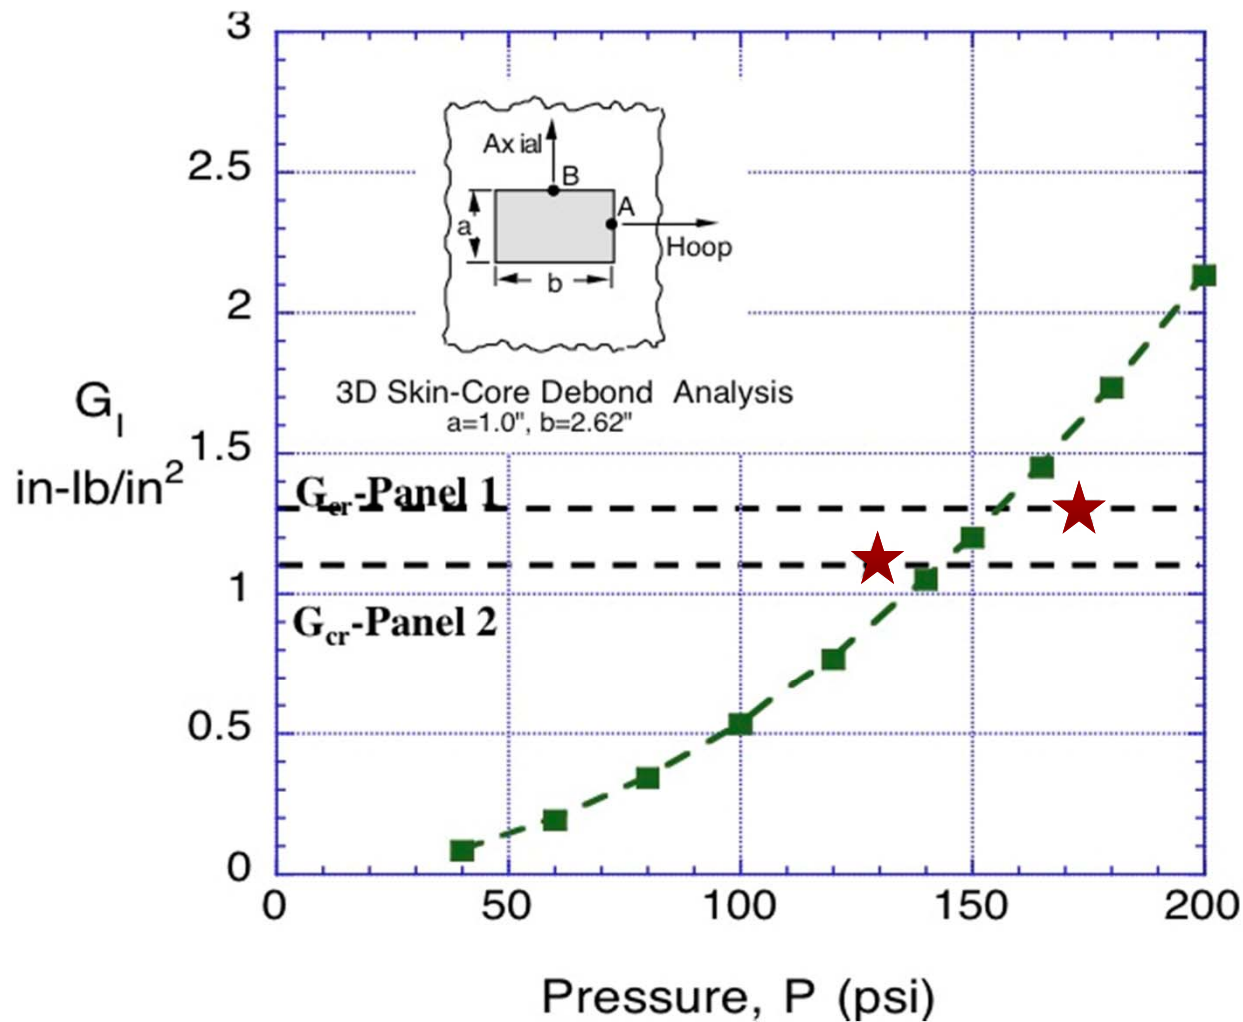
Model Validation with Test Panels

➤ **Two test Panels**

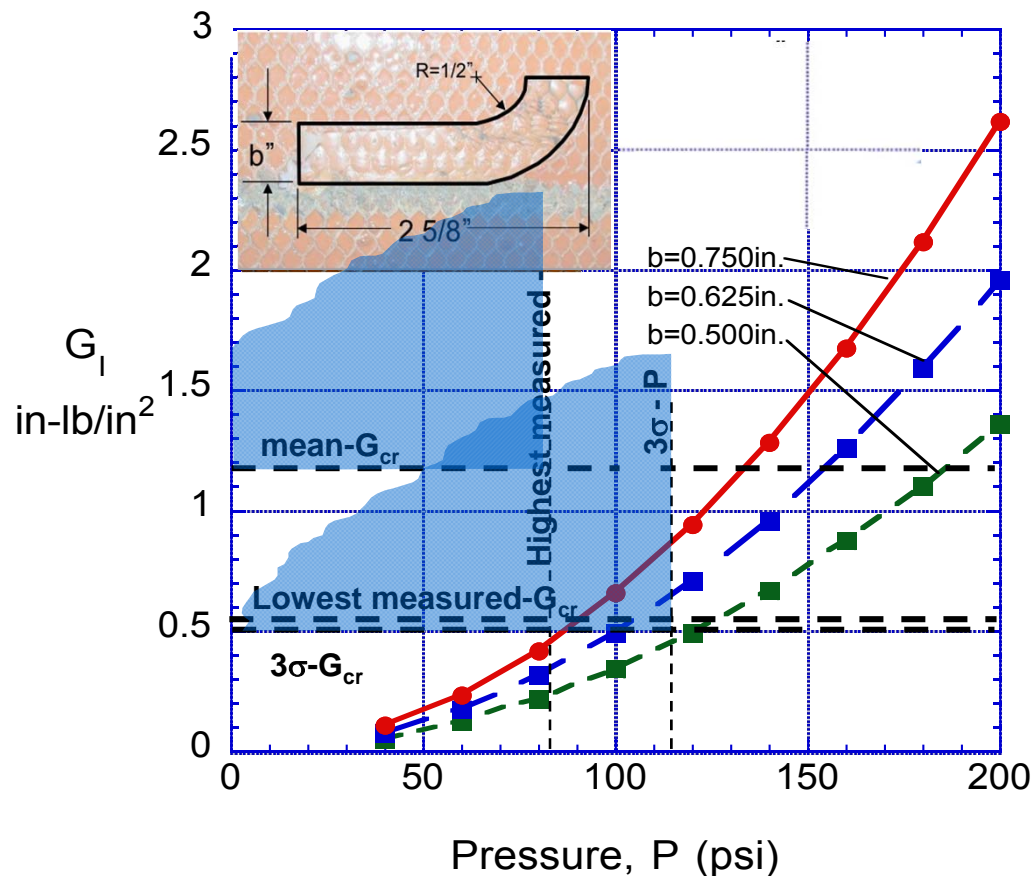
Analysis of J Defect

- Nominal values do not explain failure
- Variability makes the failure plausible
