## Space Shuttle Boundary Layer Transition Flight Experiment Ground Testing Overview

Karen T. Berger

Thermal & Fluids Analysis Workshop  
TFAWS 2014

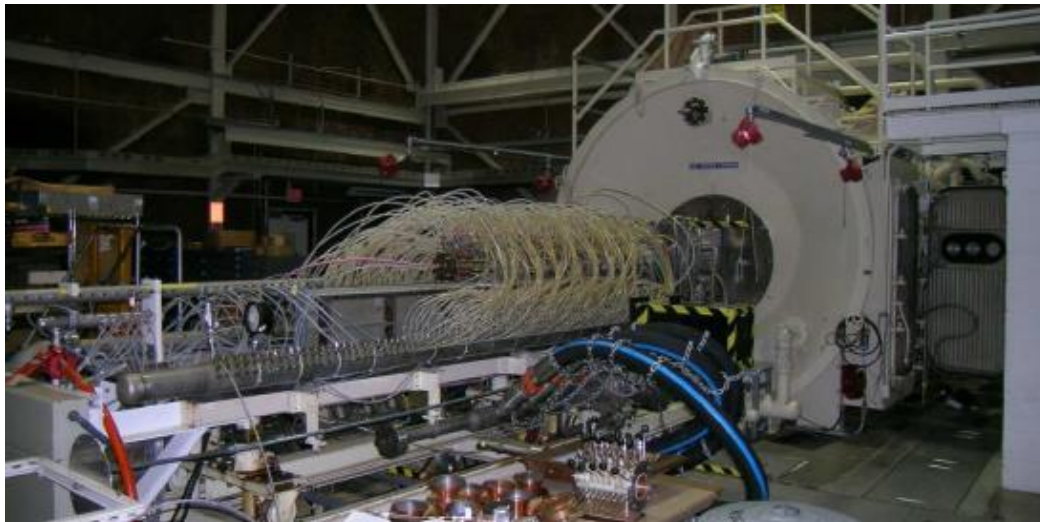
# NASA JSC Arc Jet Facility

- Atmospheric Reentry Materials and Structures Facility (ARMSEF)
- Vacuum chamber corresponds to ~204,000-182,000 ft altitude
- Test position 1:
  - Channel nozzle arc-jet
  - Study flat surface heat transfer at zero degree angle of attack
  - Up to 24x24-in flat plate models
- 10 MW arc heater, 12-ft dia. test vacuum chamber with diffuser
- 5-14 arc heater packs (10 and 14 pack configurations used)

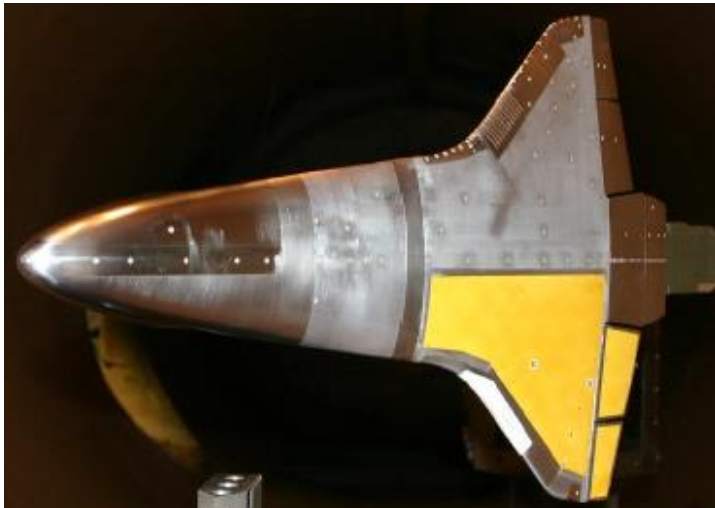
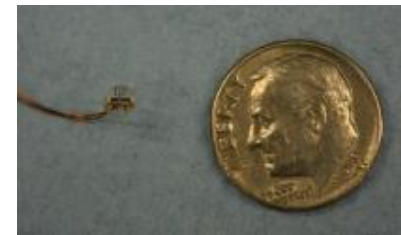
# MH-13 Model

- 1.8% scale steel and aluminum model
- Initially designed to support the Return-To-Flight Program
- Large amount of instrumentation already present (~100 thin film sensors in centerline/wings, ~200 thin films in wing leading edge)
- Temperature sensitive paint added to starboard wing
- 18 thin-film sensors added in locations similar to flight instrumentation
- 0.0075 and 0.015-inch protuberances instrumented to represent flight protuberance on both wings

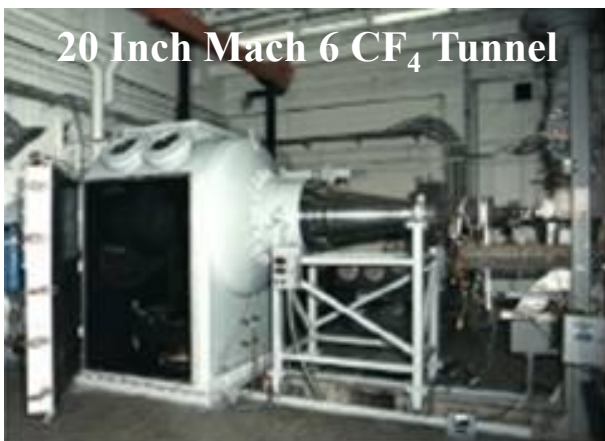
## 20 Inch Mach 6 CF<sub>4</sub> Tunnel

| Tunnel | Gas | Mach | Re (x10 <sup>6</sup> /ft) | Run Time | AoA (deg) | Beta (deg) |
|---|---|---|---|---|---|---|
| 20-Inch Mach 6 CF <sub>4</sub> | CF <sub>4</sub> | 6 | 0.01 – 0.55 | 20 sec | -10 to +50 | -5 to +5 |

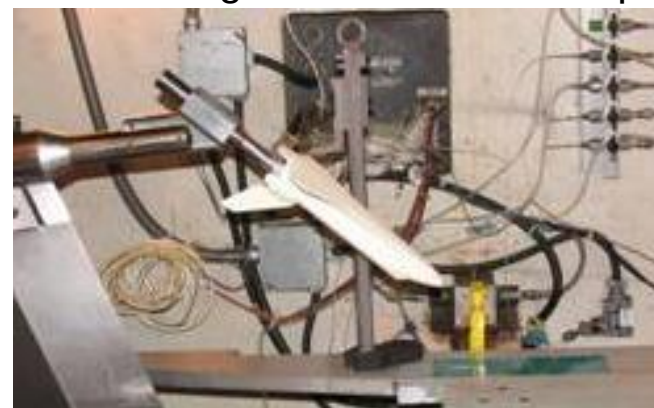
# Ceramic Models

- 0.75% scale models
  - 0.05x0.05-in tape trips of varying thicknesses (did not represent scaled flight protuberance)
  - Some fabricated with deflected control surfaces to match STS-119 and STS-128
- 0.9% scale models
  - Undeflected control surfaces
  - Fence trips machined into metal rods, represent the scaled flight protuberances
  - Two trips installed per model (port and starboard wings) to maximize the data collected
  - Trips fabricated by EDM Dept., Inc., included 0.006, 0.010, 0.015, 0.0175 and 0.020-in
- Global Phosphor Thermography
  - Two-color relative-intensity technique, dependent on incident light, local surface temps
  - Images converted to temperature mappings via temperature-intensity calibration

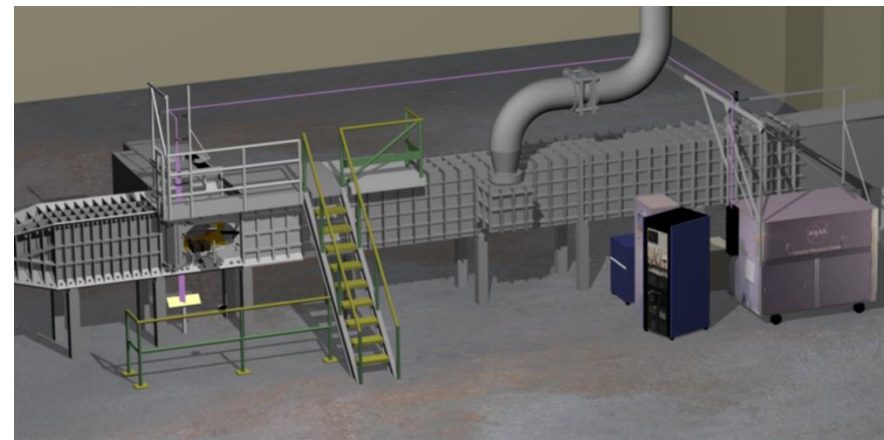
# PLIF and TSP Models

- 20 deg full-angle wedge with sharp leading edge, 5 in. wide, 6.4 in. long
- Two protuberance shapes
  - BLT FE, 0.039-in. or 0.098-in. tall, 0.42 in wide, 45° (NanoFormTM)
  - rectangular fence trip, oriented at 45 deg, 0.039 in. high, black, sharp edges/corners
- Temperature Sensitive Paints applied with via conventional spraying over white primer
  - Model illuminated with LED based arrays (400 nm), imaged with 14-bit digital camera
  - ~5-7 sec on centerline, data normalized to Fay-Riddell stagnation point heating
- Planar Laser Induced Fluorescence – Nitric Oxide gas seeded through centerline slot
  - Flow rates of 150 and 300 sccm
  - Images acquired using 2 Princeton Instruments PI-MAX II CCD
  - Laser sheet translated in tunnel, measurements along/away from surface

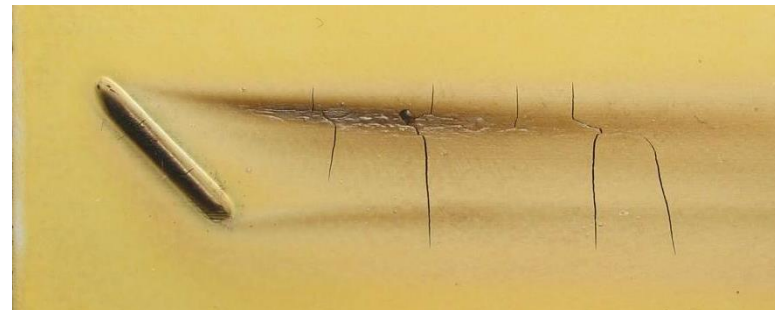
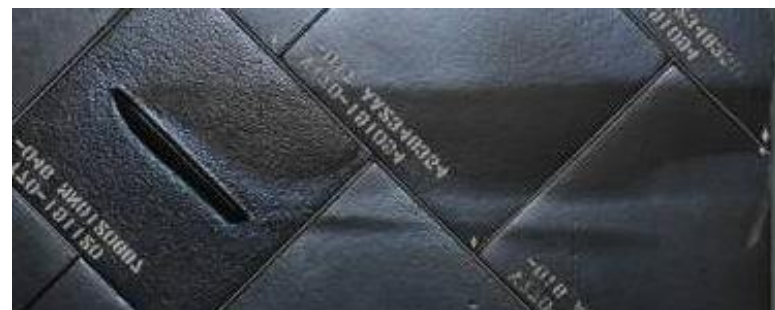
# LaRC TSP Testing

- With TSP, increased heating with strong streak below and weaker above trip
- Increased heating immediately in front of protuberance
- Lower than baseline heating noted upstream and directly downstream of trip
- As Reynolds number increased, streaks increased in intensity and size
- TSP inserts (made of NanoForm) degraded similar to arc jet test articles

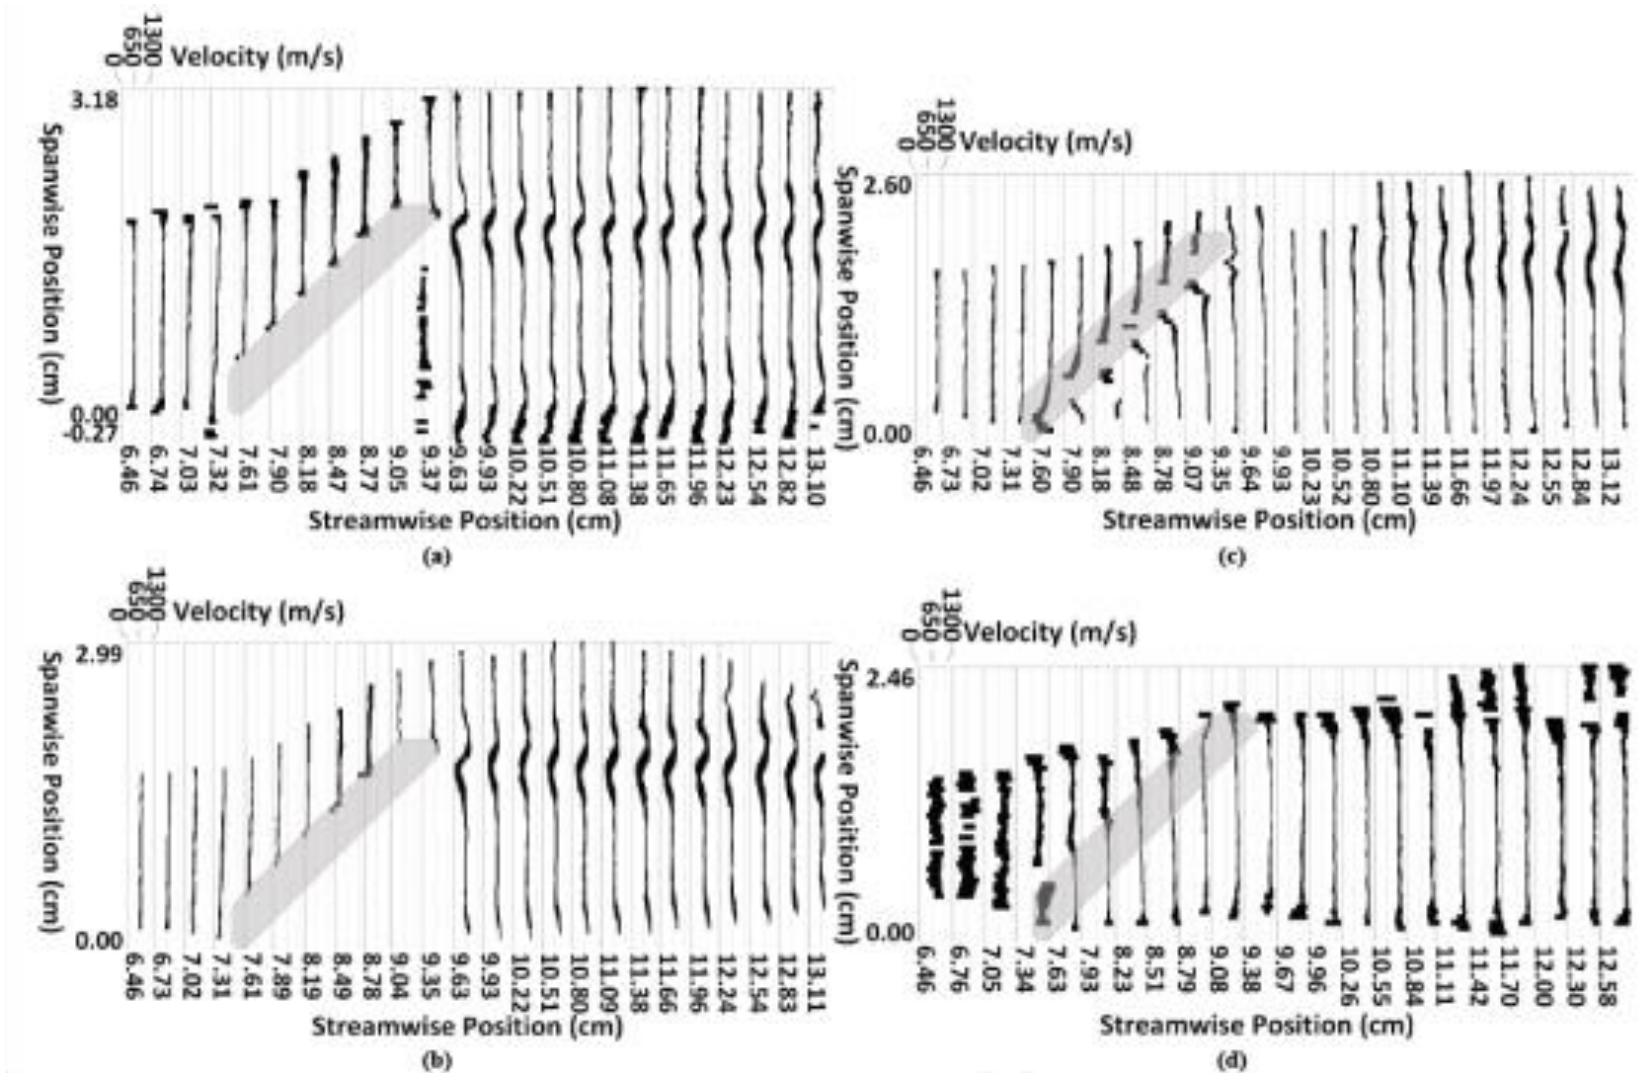
# LaRC PLIF Velocimetry

Two  $0.5 \times 10^6$ /ft runs with laser velocimetry (0.039-in, 0.098-in protuberance)
