# Characterization of Al Parts Fabricated by Additive Friction Stir (AFS) Manufacturing

Cecilia Stoner, Marcia Domack, Eric Hoffman

Advanced Materials and Processing Branch, NASA Langley Research Center, Hampton VA

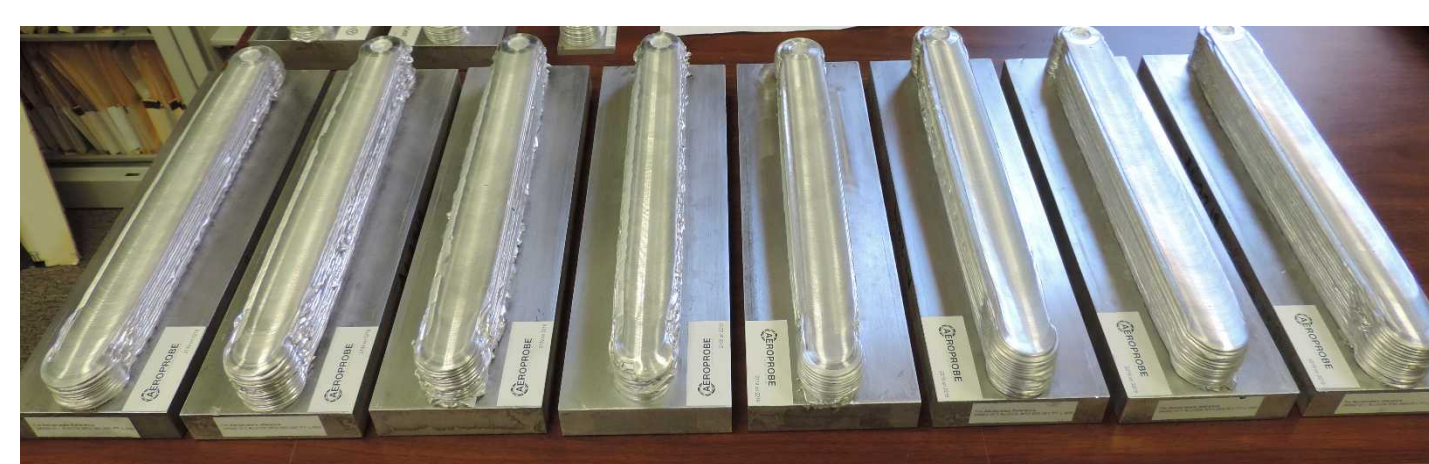
Aluminum 2219 and 2139 samples

- Aluminum alloys 2219 and 2139 were deposited in stringers of various heights for extraction of tensile and compact tension specimens, as well as metallography samples
- The 2219 and 2139 samples were divided into three groups for heat treatment: as-deposited, solution heat treated (SHT) and aged, and direct aged (no SHT)
- Techniques employed across these samples include microstructural characterization, mechanical properties testing (tensile, fracture toughness, hardness), and x-ray computed tomography (XCT) scanning for defects
- Four aluminum alloy 6061+SiC MMC deposits of varying vol% SiC, including a functionally graded structure, for SiC percent reinforcement analysis
