Responses of Florida Scrub Vegetation to Water Additions from a Groundwater Treatment Project

Paul A. Schmalzer, Ph.D.
Tammy E. Foster, Ph.D.
Ecological Program
Kennedy Space Center
ESA August 2020

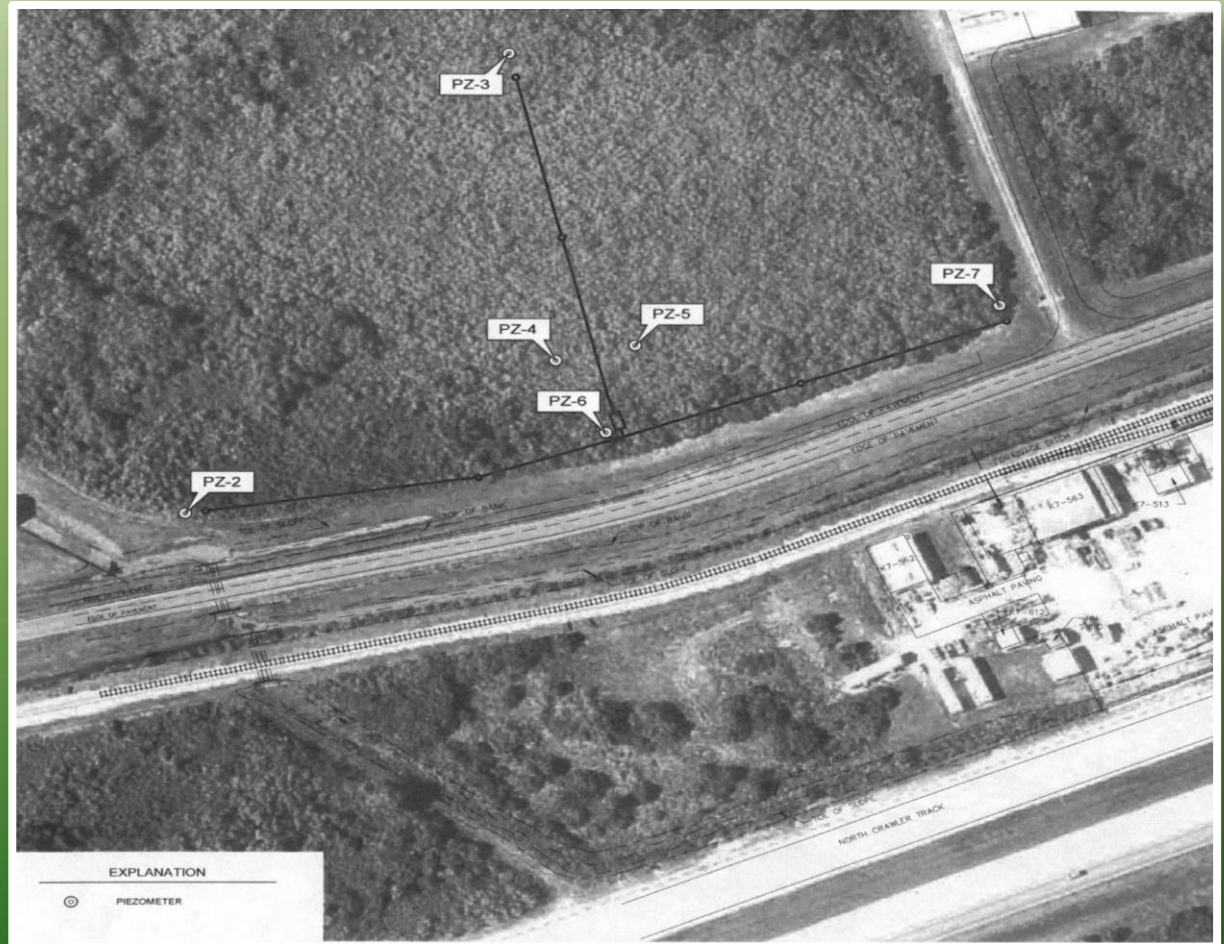
CCF Remediation and Scrub Site

The three legs of the water exfiltration gallery were each ca. 121.9 m in length.

Six piezometers were located near the exfiltration gallery to record depth to the water table.

The remediation site was to the lower right (southeast of the scrub site).

- The exfiltration gallery was placed in scrub vegetation near the CCF remediation site. It consisted of three legs each ca. 121.9 m in length.
- The remediation project operated in two phases:
 - Interim project - October 2002-March 2004, 494 days, 1.74×10^8 L treated water, mean rate = 3.52×10^5 L/day (HSW 2004).
 - Final project – March 2005-August 2008, 1251 days, distributed 1.9×10^8 L treated water, mean rate = 1.52×10^5 L/day (Jacobs 2006-2009).
 - During the interim project the depth to the water table near the exfiltration gallery was monitored by 6 piezometers (HSW 2004).
- Several interruptions to operations of the remediation system occurred due to equipment problems and hurricanes.

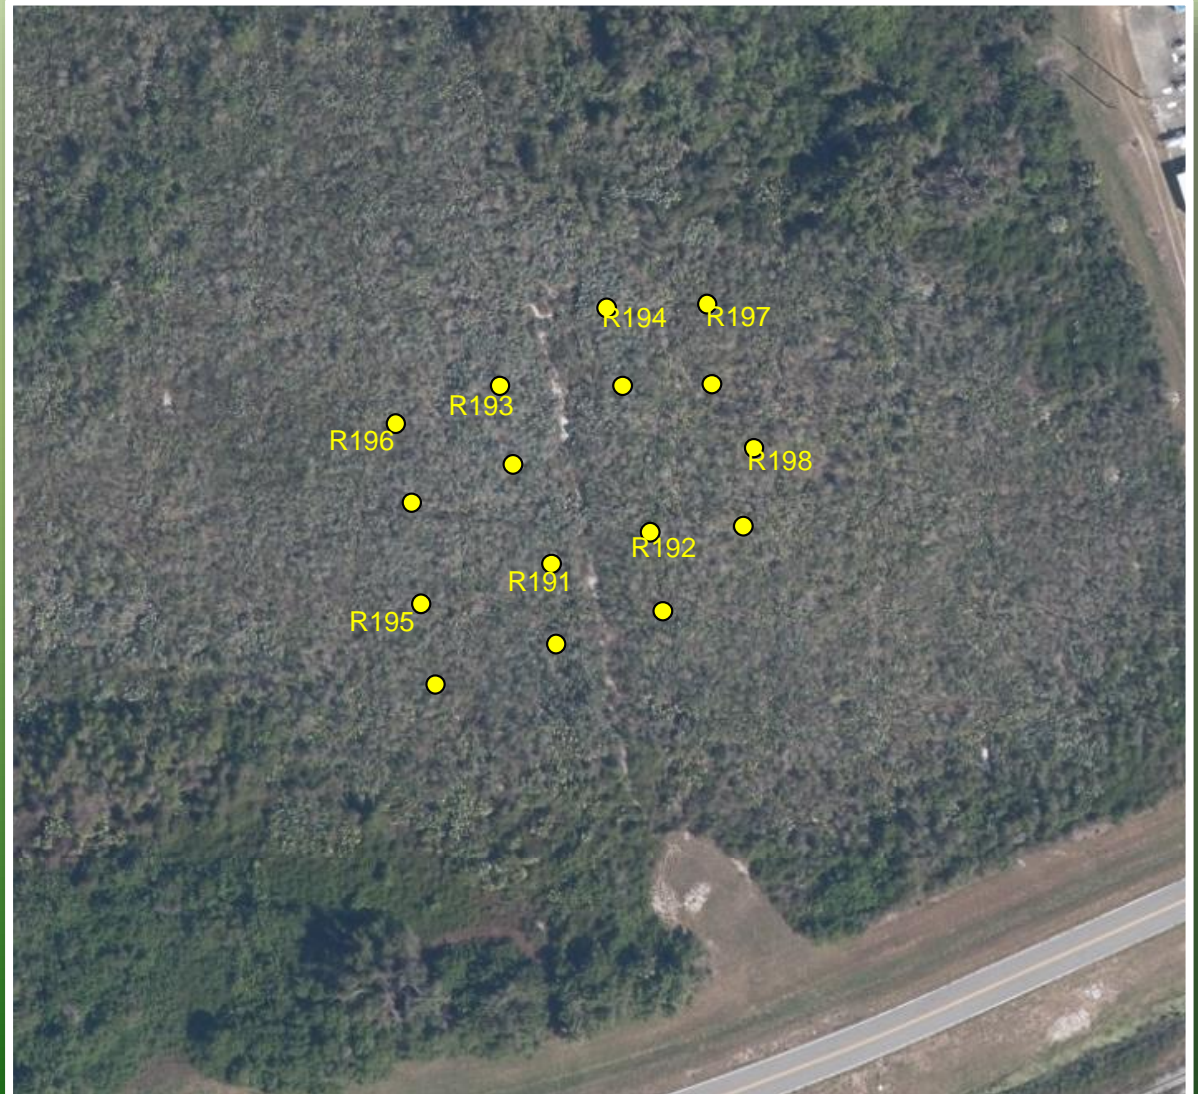
CCF Scrub Map

Location of 8 vegetation transects at the CCF scrub site

Four transects (R191-R194) were close to the central leg of the water exfiltration system.

Four transects (R195-R198) were more distant from the water exfiltration system.

The Component Cleaning Facility was located south of the road shown at the bottom of the map.

- We located 8 permanent line-intercept transects in the CCF scrub site in May 2002 five months before groundwater pumping began.
 - Transects were 15 m in length.
 - Four transects were near the water exfiltration gallery and four were more distant from it.
 - We sampled vegetation in two height strata, < 0.5 m and ≥ 0.5 m, along each transect and measured vegetation height at four points (0, 5, 10, 15 m).
 - This sampling was repeated annually through 2019.
- The site was typical of oak scrub on Kennedy Space Center/Merritt Island National Wildlife Refuge (Schmalzer & Hinkle 1992). It had been cut and burned for restoration in 1996, 6 years prior to initiation of the remediation project.

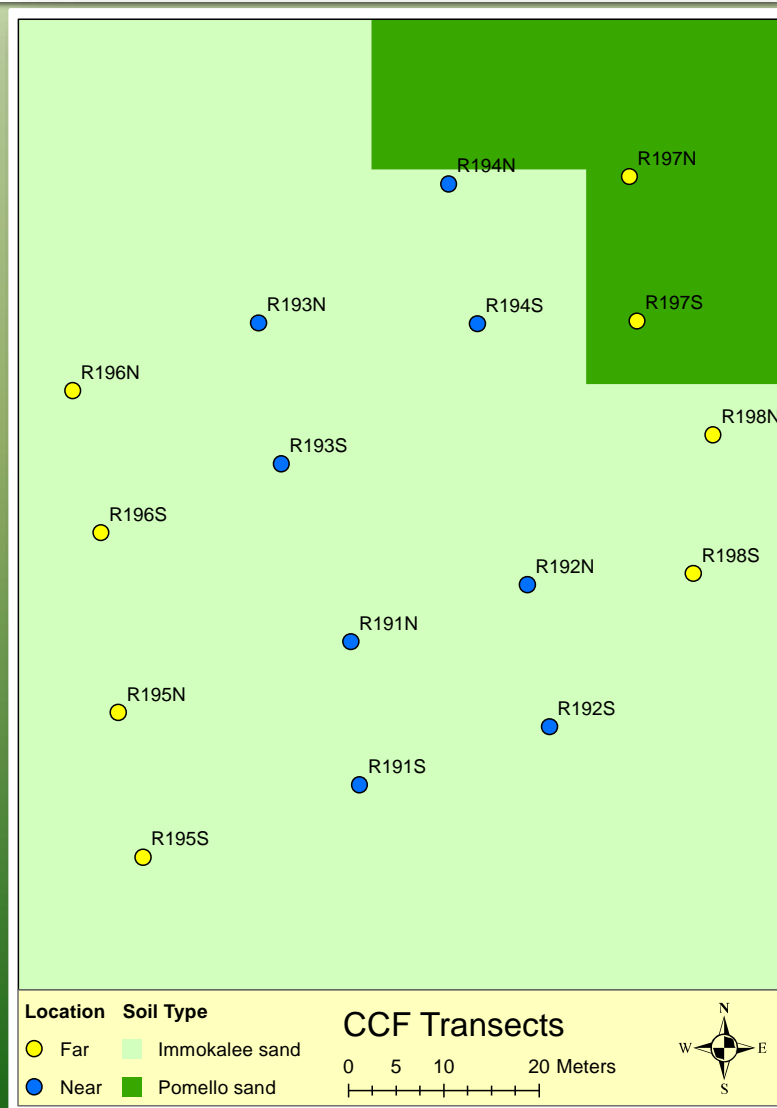
Soil Map

Overlaying transects on the soil map (Huckle et al. 1974) indicated that seven of the transects were on Immokalee sand (Arenic Alaquod) and one on Pomello sand (Oxyaquic Alorthod), both Spodosols.

These are typical soils of oak-saw palmetto scrub on KSC/MINWR.
