Fatigue Failures at Defective Grains in a Single Crystal Nickel-Base Superalloy

NASA/TM-20205003422

Abstract

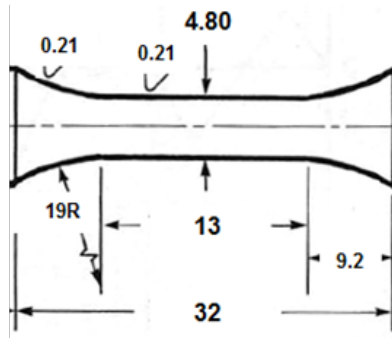
Figure 1.—Fatigue test specimen gage configuration, with dimensions in mm.

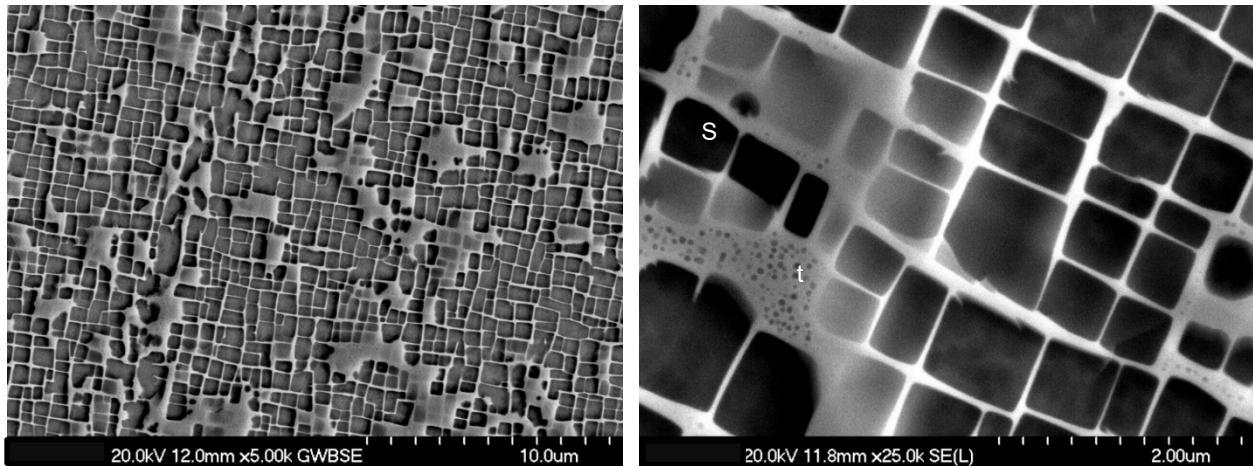
Figure 2.—Typical microstructure of the single crystal superalloy tested, showing larger cuboidal secondary (S) and smaller spherical tertiary (t) γ' precipitates.

The typical microstructure of the single crystal superalloy tested is shown in Figure 2. Cuboidal secondary γ' precipitates had an average cube width of $0.49 \mu\text{m}$, while spherical tertiary γ' precipitates had an average width of $0.05 \mu\text{m}$.

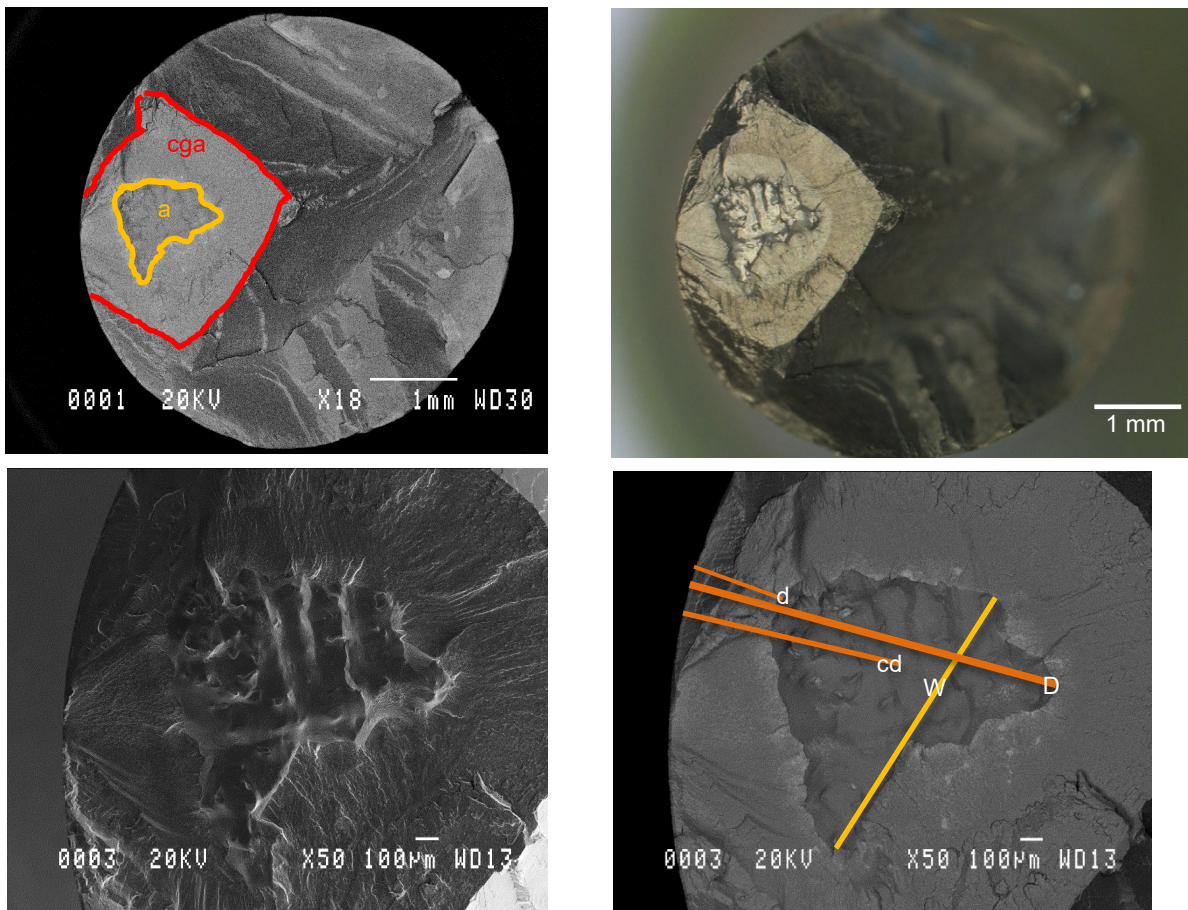
The first failure encountered in this group was studied in detail. Optical and SEM images of this fracture surface are shown in Figure 4. Stereo pair images of each mating surface of the fracture (“conjugate”) were analyzed using MeX software in order to determine surface profiles of each half. The line profiles in Figure 5 match well and indicate this failure initiation site was not a void, but was a large embedded feature. The backscattered electron imaging mode is sensitive to average atomic number of the surface, so these images also suggested the overall average atomic number of the feature is comparable to that of the superalloy.

Figure 4.—First specimen to fail from this mode: coated, unexposed specimen 019-LA2 failed at 1,239 cycles. Measurements are annotated with lines: maximum width (W), minimum depth (d), maximum depth (D), centroid depth (cd), defective grain area (a), total crack growth area (cga).

angles to the loading axis. This flat area encompassing both fatigue crack initiation and fatigue crack growth was also measured (cga). Each dimension is illustrated on Figure 4.

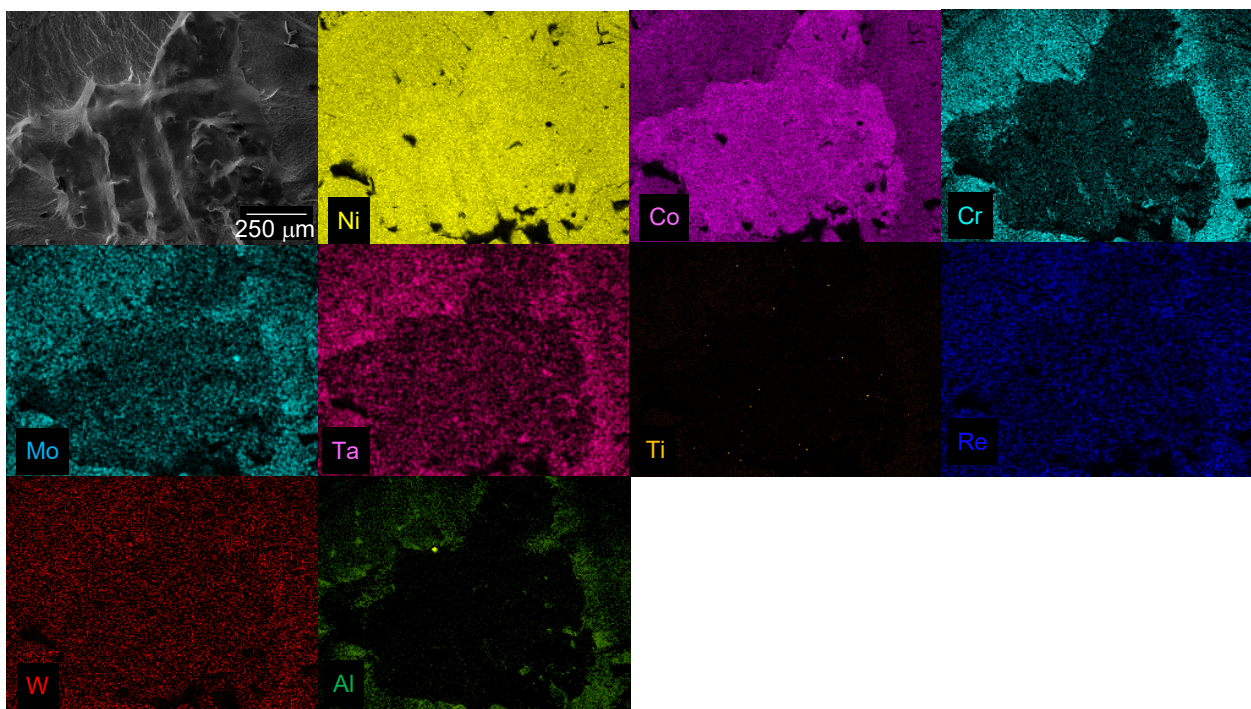
The composition of the large feature was further evaluated in the Tescan MAIA3 SEM using the Oxford EDS in the x-ray elemental mapping mode. The resulting chemical maps are presented for different elements in Figure 6. The maps indicate the defect, in comparison to the adjacent single crystal, had higher amounts of Co and Ni, and relatively lower levels of the elements Cr, Mo, Ta, Re, W, and Al. As shown in Table II, preliminary composition measurements of the feature indicated increased levels of Co and Ni, and decreased levels of Cr, Mo, Re, W, and Al. The changes were near 2 wt.% for most elements, however the decrease in Al was over 4 wt.%. It is noted that surface roughness may influence x-ray signal strength, and this could not be compensated for in these maps. In future work, attempts will be made to prepare a metallographic section through the defective grain to produce a flat, unoxidized surface for further evaluations of its composition.

Figure 6.—SEM X-ray maps indicating differences in composition between the defective grain and the single crystal.

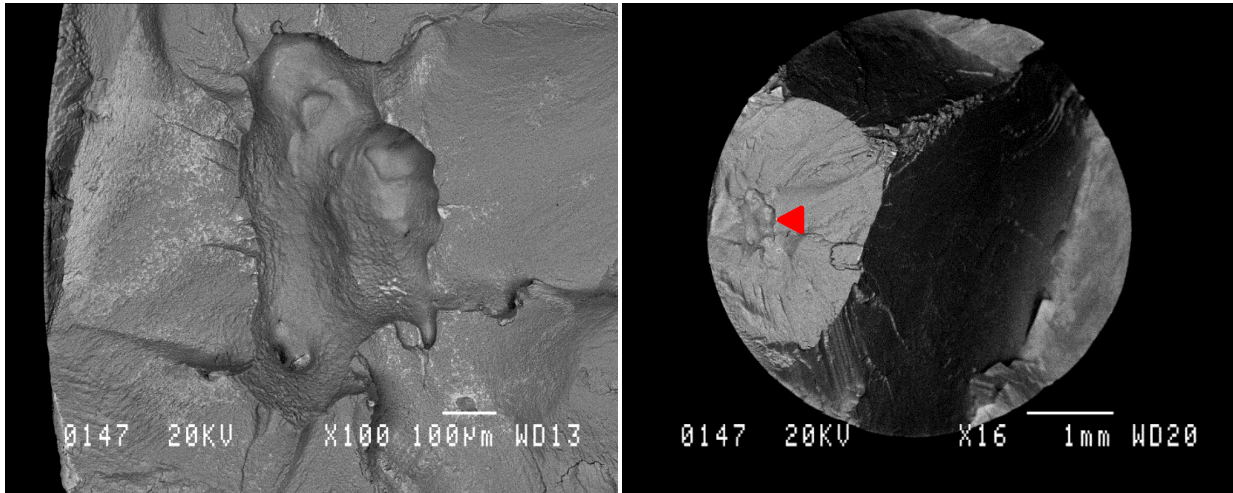
Figure 8.—Uncoated, unexposed specimen 019-LB2 failed at 2,113 cycles from a near-surface defective grain 0.75 mm in maximum width.

The other fractures from this group of specimens with low lives were also imaged and are shown in Figure 8 to Figure 15. In most cases, comparison of the conjugate fracture surfaces indicated a defective grain of similar morphology was embedded in one half of the fracture, as previously described. The largest defective grain with a maximum width of 3.322 mm was observed for an uncoated, exposed specimen shown in Figure 10. The smallest defective grain with a maximum width of 0.096 mm was observed for a coated, unexposed specimen shown in Figure 12. One interesting exception is shown in Figure 11, a relatively large feature of similar appearance was observed, but neither surface had the grain remaining. This suggested that either the defective grain had fallen out or this feature could be a large pore, even though it does not contain typical features associated with pores. For all these fracture surfaces, the same key dimensions of the failure initiation sites were measured and tabulated, including defective grain area, grain maximum width, grain minimum depth, grain maximum depth, grain centroid depth, and total fatigue cracked area. These measured dimensions are summarized in Table III.

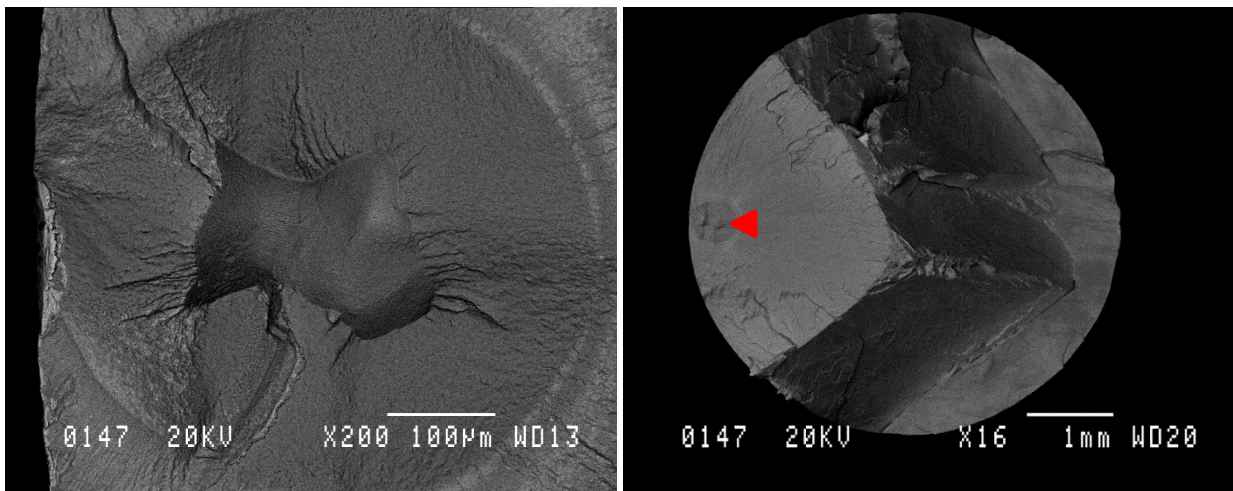
Figure 9.—Uncoated, unexposed specimen 117-LA1 failed at 4,907 cycles from a near-surface defective grain 0.25 mm in maximum width.

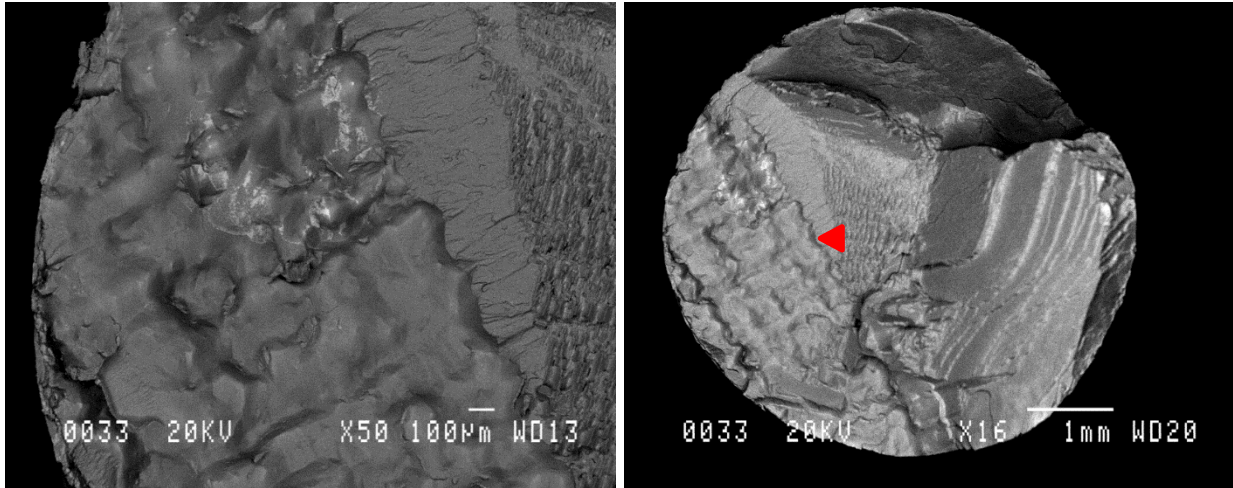
Figure 10.—Uncoated, exposed specimen 515-LA1 failed at 1,353 cycles from a surface defective grain 3.32 mm in maximum width.

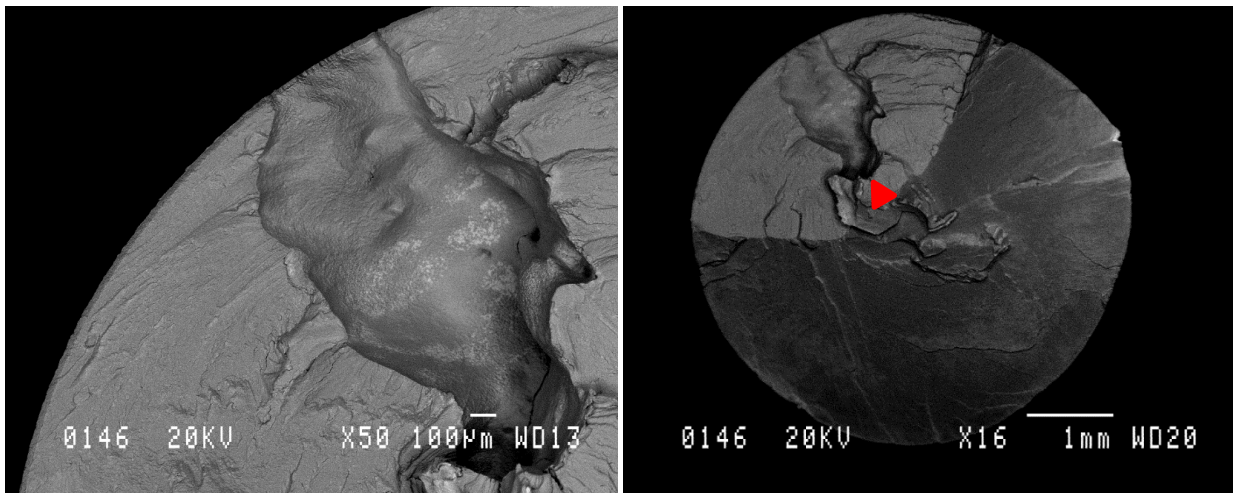
Figure 11.—Coated, unexposed specimen 019-LC2 failed at 934 cycles from a surface defective grain 1.80 mm in maximum width.

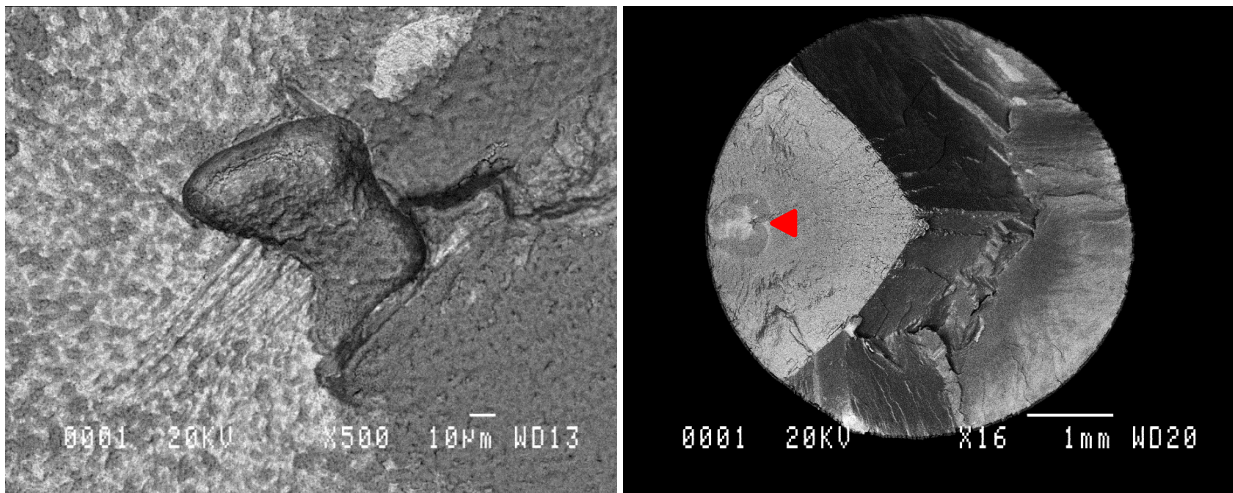
Figure 12.—Coated, unexposed specimen 019-LC1 failed at 26,883 cycles from an internal defective grain 0.096 mm in maximum width.

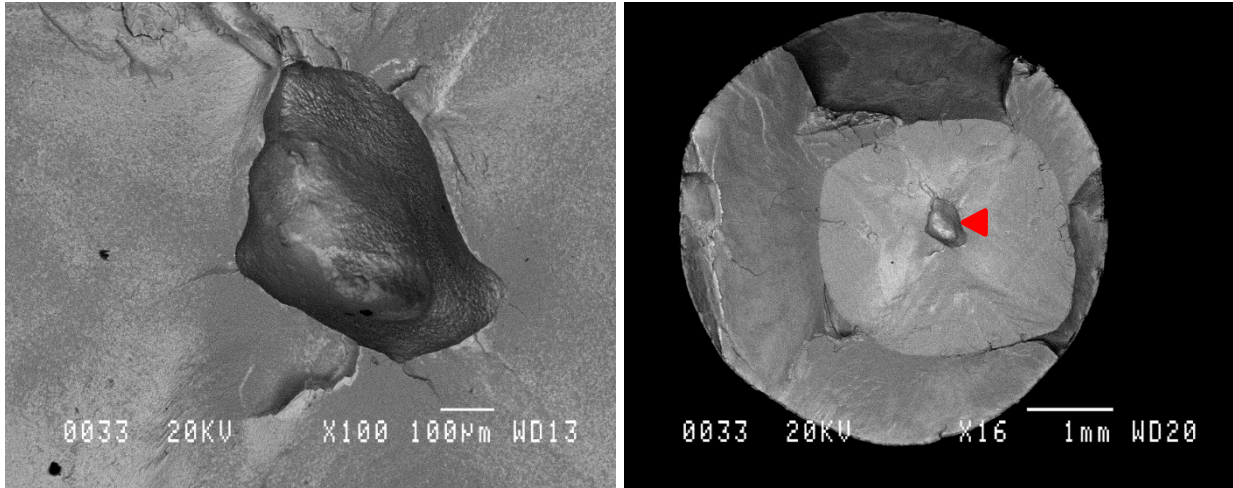
Figure 13.—Coated, exposed specimen 570-2-2-L2 failed at 6,848 cycles from an internal defective grain 0.64 mm in maximum width.

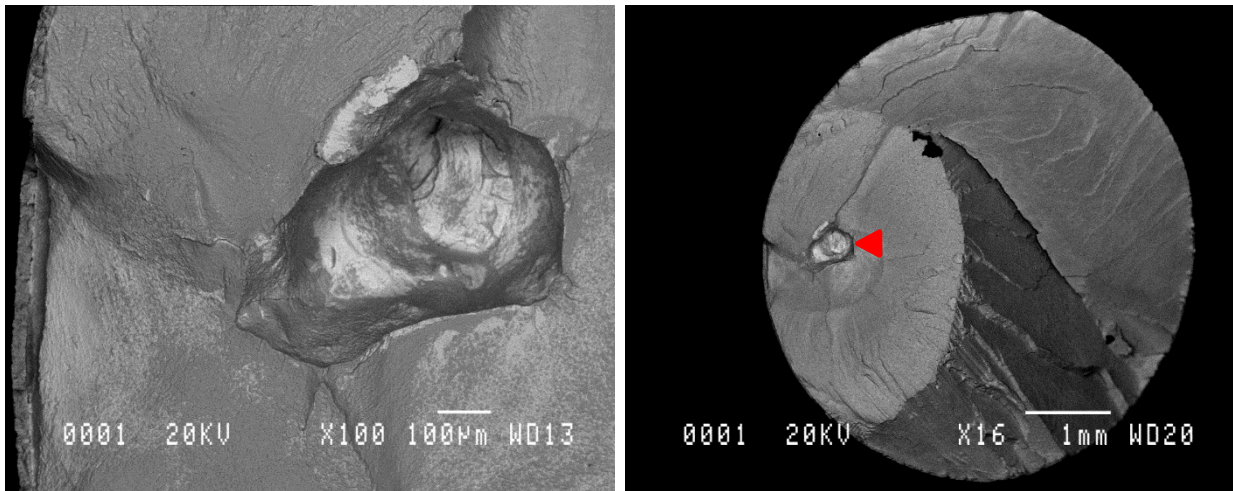
Figure 14.—Coated, exposed specimen 570-2-2-L6 failed at 7,575 cycles from a near-surface defective grain 0.66 mm in maximum width.

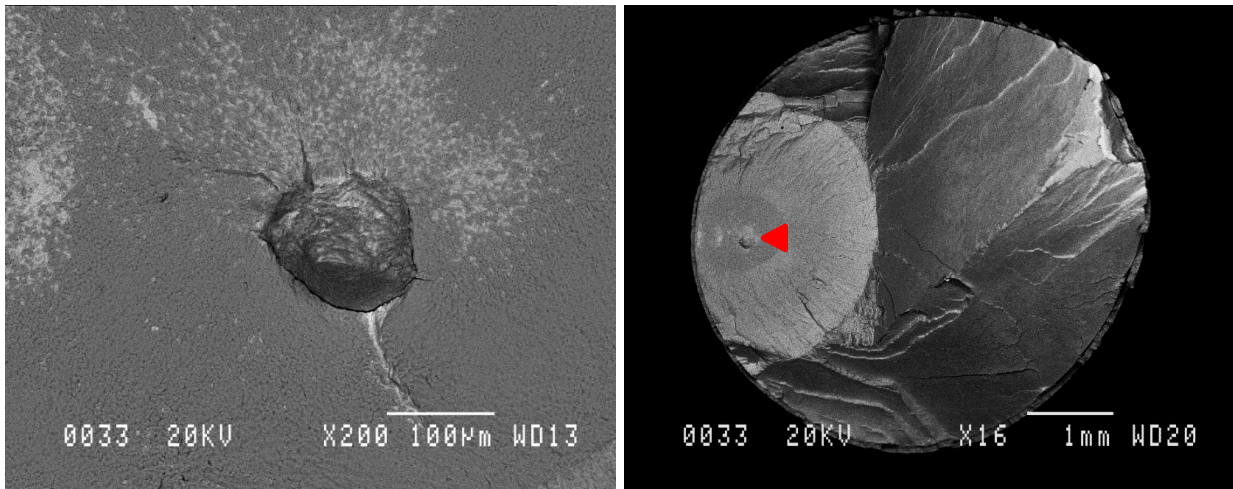
Figure 15.—Coated, exposed specimen 435-1-3-L1 failed at 21,393 cycles from an internal defective grain 0.15 mm in maximum width.

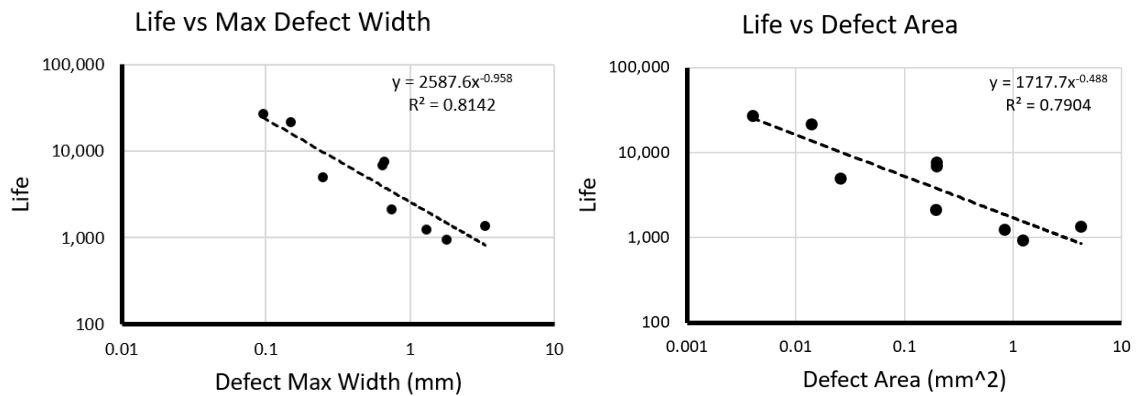
Regressions were performed in order to determine which factors in Table III were correlated with fatigue life. No significant correlations were detected between life and the presence of a coating or the application of oxidation plus hot corrosion exposures. No significant correlation was detected between fatigue life and total fatigue cracked area. However, significant relationships existed between fatigue life and dimensions of the defective grains. Fatigue life clearly decreased with increasing defective grain width and with increasing defective grain area, as shown in Figure 16. Therefore, the defective grains strongly influenced fatigue life, and they could be considered life-limiting defects.

Figure 16.—Significant relationships existed between fatigue life in cycles and grain dimensions: life decreased with increasing defective grain width and area. No significant relationships were detected between fatigue life and presence of a coating or application of the exposures.

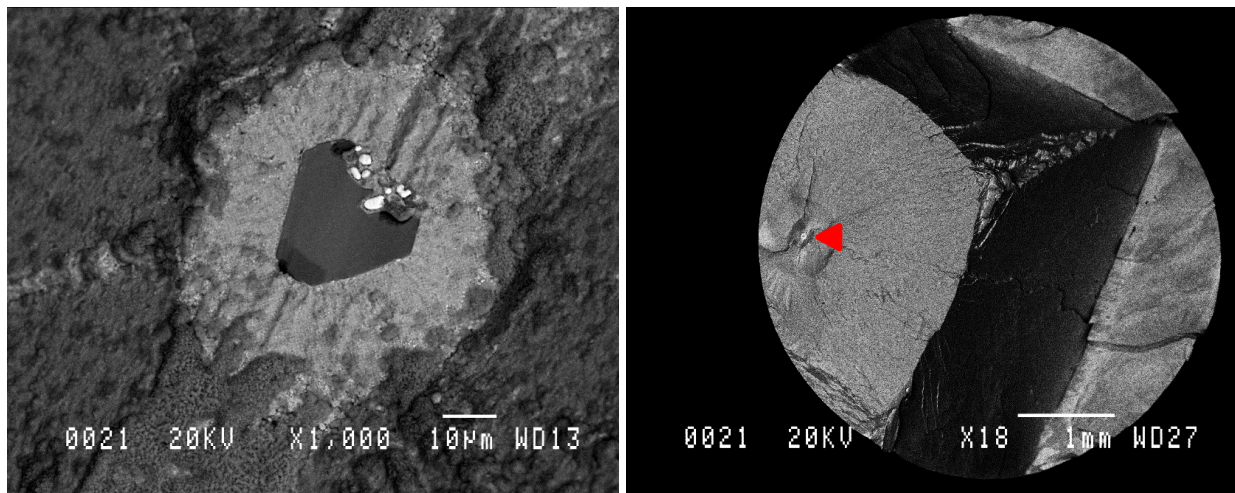
The fracture surfaces of two fatigue specimens having much longer fatigue lives are shown in Figure 17 and Figure 18 for comparison purposes. The failure initiation site of an uncoated, unexposed specimen that failed at 231,555 cycles is shown in Figure 17. This specimen failed from an internal aluminum-rich non-metallic oxide inclusion having a maximum width of 0.030 mm. The failure of a coated, exposed specimen that failed at 198,398 cycles is shown in Figure 18. This failure was also from an internal aluminum-oxide inclusion, having a maximum width of 0.041 mm.

Figure 17.—Uncoated, unexposed specimen 034-LA2 failed at 231,555 cycles from an internal aluminum-rich oxide inclusion 0.030 mm in maximum width.

The areas of flat crack growth surrounding the inclusions were very similar, and the total areas of fatigue cracking in these specimens were comparable to those of the prior specimens failing at defective grains, as also listed in Table II. Since the total area of fatigue cracking appeared comparable for all these specimens, it was valid and of interest to estimate the number of cycles necessary to grow each fatigue crack from the circumference of the crack initiation site across the flat area to the final shear crystallographic facet failure. In this way, the portion of each fatigue failure life attributable to crack growth could be compared.

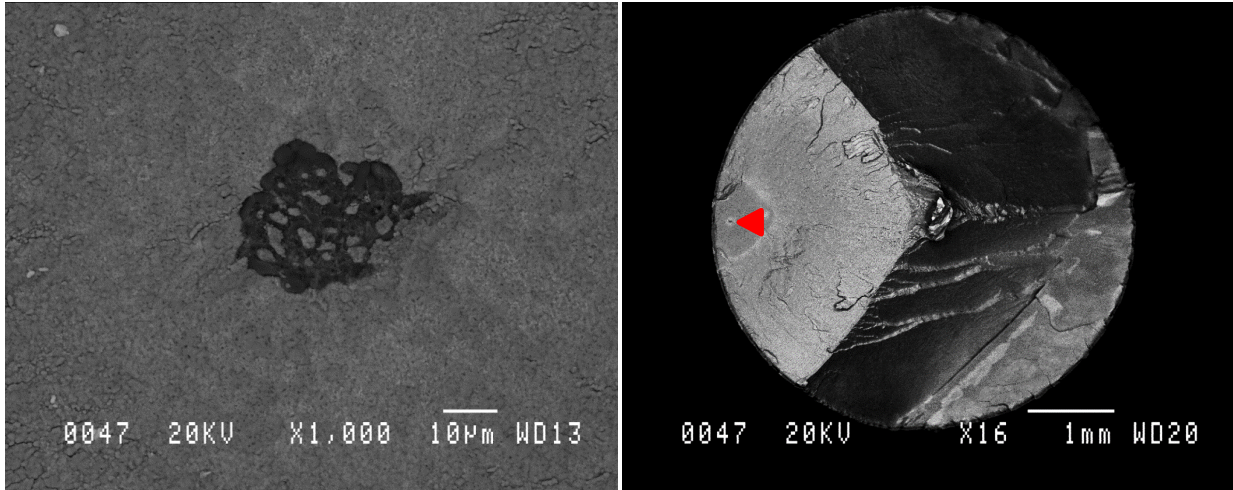
Figure 18.—Coated, exposed specimen 034-LA1 failed at 198,398 cycles from an internal aluminum-oxide inclusion 0.041 mm in maximum width.

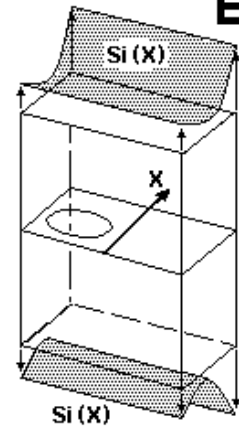
Figure 19.—Internal flaw specimen geometry EC05 available and applied in NASGRO. No solution was available in NASGRO for an internal flaw in a cylindrical specimen. This geometry with a square cross section of the same width as the actual fatigue test specimens was employed. The solution allowed one to set flaw location and aspect ratio to approximate each observed fracture surface.

The NASGRO 9.0 (Ref. 17) fracture mechanics and fatigue crack growth prediction code was used to estimate crack growth response of all these presented specimens. No fracture mechanics solution existed in NASGRO for internal flaws in cylindrical specimens. Instead, a specimen geometry with a square cross section of the same width as the diameter of the actual fatigue test specimens was employed, as shown in Figure 19. This NASGRO solution allows for the flaw location and aspect ratio to be similar to those measured on the fracture surfaces of the failed specimens. For surface flaws in cylindrical specimens, the same situation occurred, and so the available surface flaw geometry shown in Figure 20 was employed, again using a square cross section having the same width as the fatigue specimen diameter.

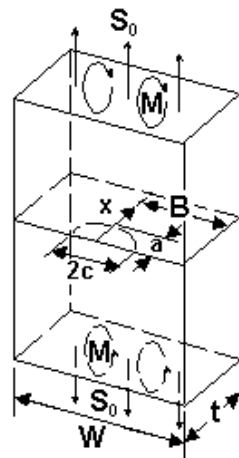
Figure 20.—Surface flaw specimen geometry SC30 available and applied in NASGRO.

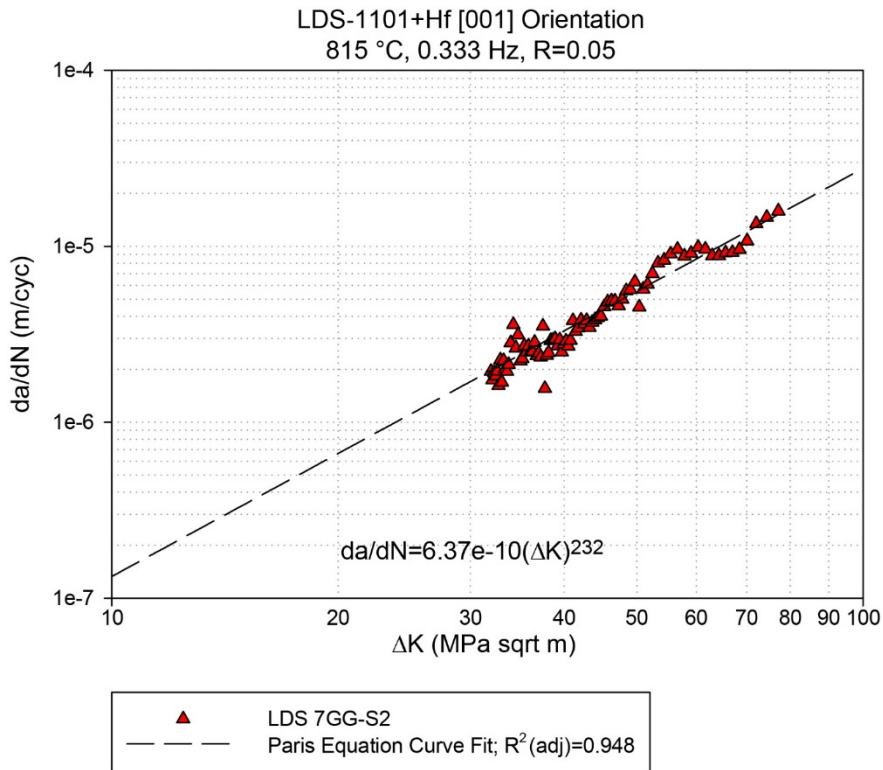
NASGRO requires input of a crack growth equation as a function of the applied stress intensity range. A Paris regime equation was fitted to the only available single crystal test data set performed at similar conditions as those of the LCF tests, as shown in Figure 21. This test was performed on a single crystal superalloy NASA LDS-1101+H_f (Ref. 18) specimen oriented near the [001] crystallographic direction, with $R_{\min/\max \text{ stress}} = 0.05$ and frequency of 0.333 Hz in air. As shown in Table I, this tested superalloy was judged to have a sufficiently similar composition to that of the present alloy, and so the test data was applied here. The test data set did not extend into the threshold regime and thus a conservative approach of strictly using only the Paris regime relationship was used. This is in line with much of the small crack growth data literature which does not use the long crack FCG thresholds in the belief that they are a product of the buildup of crack closure in the crack wake of the long crack growth tests (Refs. 19 and 20). While internal cracks would not be exposed to air until breaching the specimen surface, no data was available for fatigue cracks growing in vacuum. Therefore the crack growth relationship generated in air was also applied for internal cracks, which was also thought to be a conservative approach.

Figure 21.—Input crack growth rate versus stress intensity range test data and relationship used in NASGRO, generated in a single test of NASA LDS-1101+Hf specimen oriented near the [001] crystallographic direction, with $R_{\min/\max \text{ stress}} = 0.05$ and frequency of 0.33 Hz in air at 815 °C.

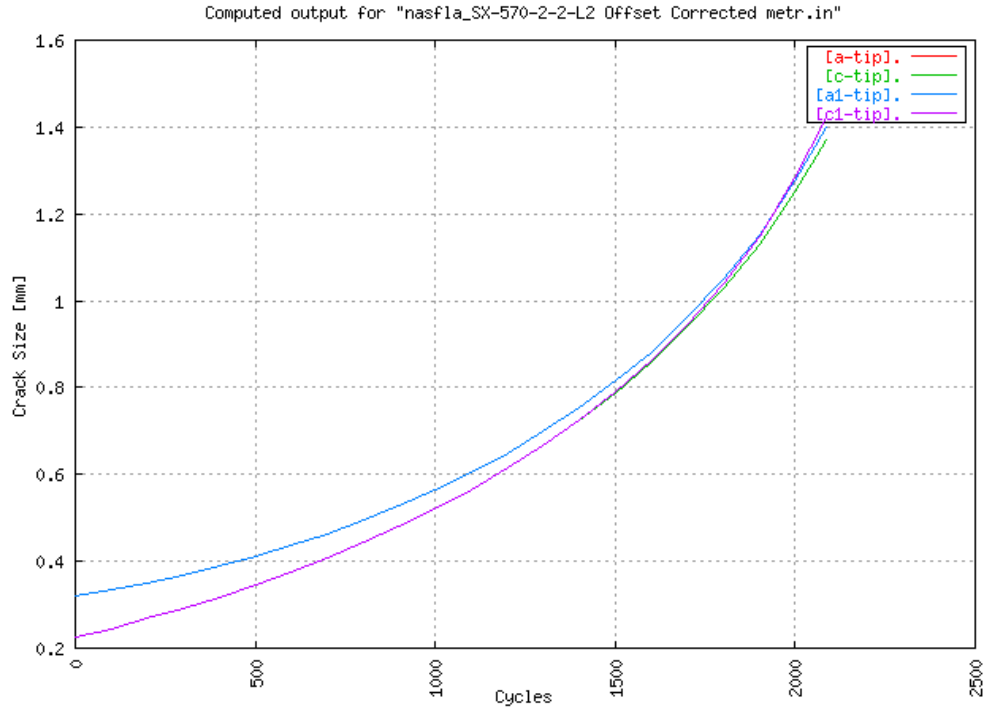
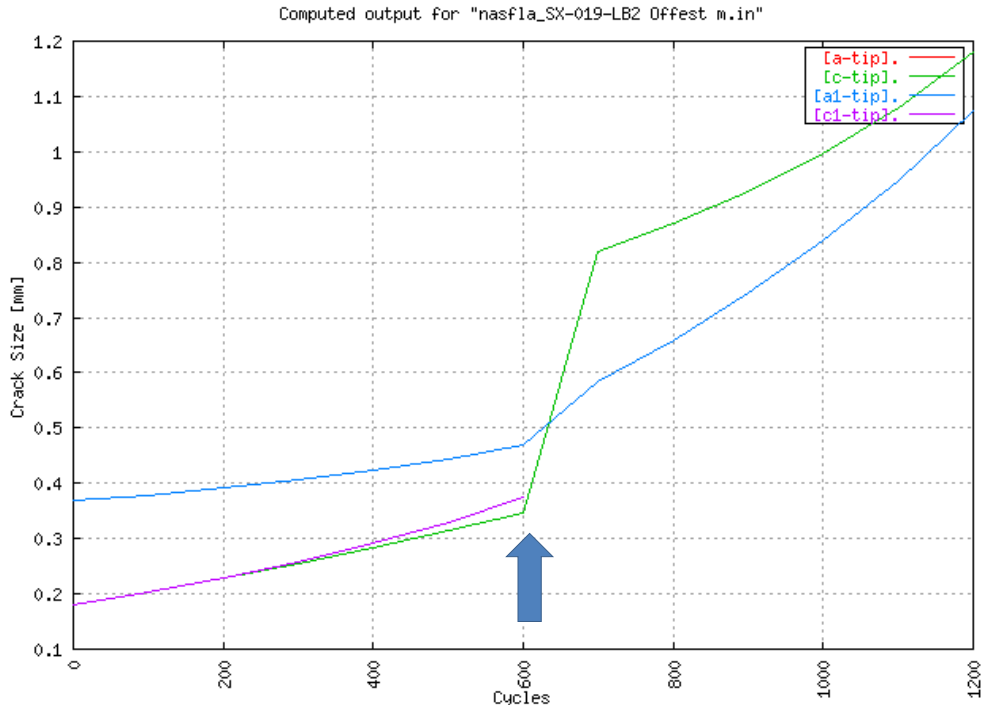
Typical examples of the NASGRO generated crack size versus cycles are compared in Figure 22 for two of the specimens failing at defective grains. In Figure 22(a), crack growth remained internal to the specimen surface all the way to failure, so NASGRO continued crack growth calculations only using the internal flaw geometry illustrated in Figure 19. In Figure 22(b), the crack grew to reach the surface at the number of cycles indicated by the arrow. At that arrow, NASGRO automatically shifted from the internal flaw geometry of Figure 19 to the surface flaw geometry illustrated in Figure 20 for crack growth calculations.

Figure 22.—Typical examples of the crack length versus cycles calculated in NASGRO for two of the specimens failing at defective grains, (a) crack growth remained internal to the specimen surface all the way to failure, (b) the crack grew to reach the surface at the number of cycles indicated by the arrow. At that arrow, NASGRO automatically shifted from the internal flaw geometry of Figure 19 to the surface flaw geometry illustrated in Figure 20 for crack growth calculations.

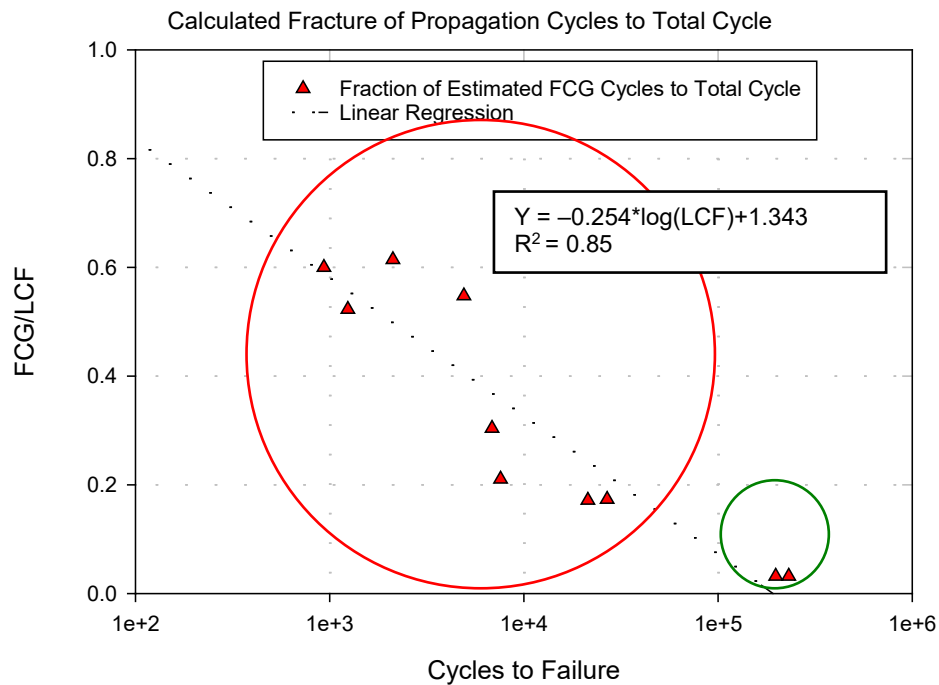
The calculated number of cycles expended by crack growth before failure are compared with overall fatigue life (N_f) in Table IV. The fraction of crack growth/ N_f cycles is also listed, and this is shown versus cycles to failure in Figure 23. The results for specimen failing from defective grains shown in Figure 23 indicated a higher fraction of life was taken up by crack growth for larger defective grains to give shorter fatigue life. The results for all specimens including failures initiating at grains and at inclusions indicate a consistent trend across both failure initiation sites, with a high coefficient of determination R^2 . Referring to Table IV and the summary Table V, it is clear that crack propagation accounts for a much lower fraction of fatigue life for specimens failing from the relatively small internal inclusions. Hence, the presence of defective grains appears to be more detrimental to fatigue life than the presence of inclusions.

Figure 23.—Fraction of crack propagation cycles to total cycles versus cycles to failure from defective grains (red circle) and from inclusions (green circle).

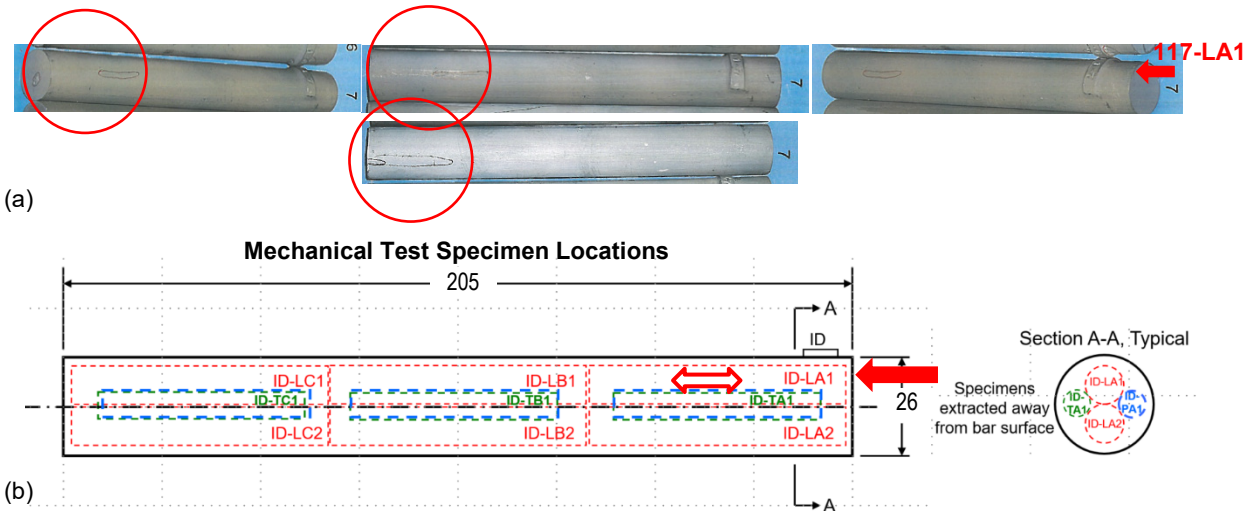
Figure 25.—Images of (a) macro-etched bar 11471-1-7 showing circled freckle grains, (b) specimen extraction diagram. The location of specimen 117-LA1 was not near freckle grains on the left end of the parent bar 11471-1-7.
