# Characterizing Effects of Witness Marks in L-PBF

Omar Mireles, William Tilson, Omar Rodriguez.  
NASA Marshall Space Flight Center (MSFC)

# Background

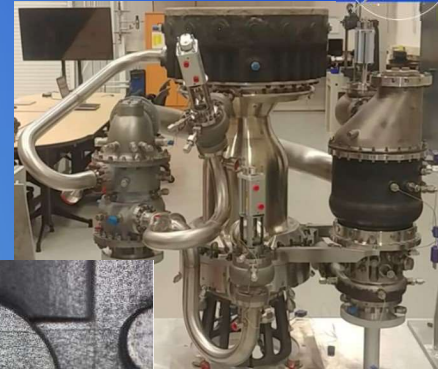
Additive Manufacture Demonstration Engine (AMDE).

Witness marks (horizontal lines) via the L-PBF process.

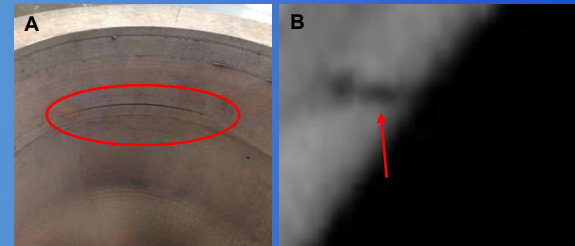
Example of short feed induced LOF defect (A) and CT image of LOF defect (B).

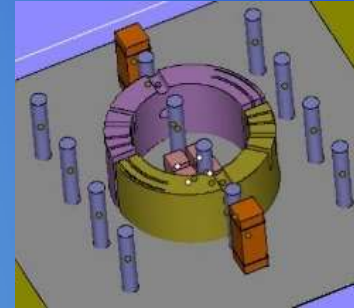
Specimen Build Layout

- CT gauge blocks.
- CT bars (engineered defect radii from 0.25-1.0 mm).
- Metallographic cubes.
- Mechanical test cylinders.

- VAI parameters for AlSi10Mg.
- Build 1: no pause (build plate at 200 °C, argon).
- Build 2: 1 hr pause (build plate at 200 °C, argon).
- Build 3: 1 hr pause (build plate heat turned off, argon).
- Build 4: 24 hr pause (cooled to RT, exposure to air).

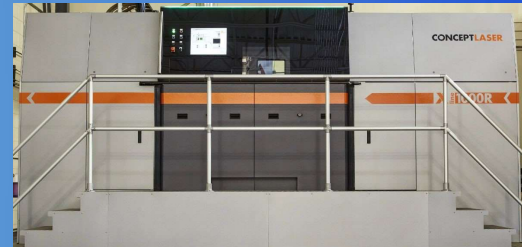
VAI Concept Laser X-Line 1000R

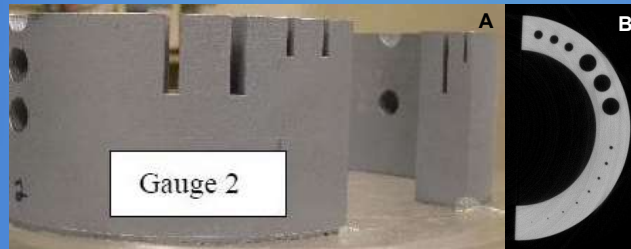
CT gauge specimens (A) and 2 MeV Linatron image in the XY plane (B).

- CT (MSFC) was unable to detect the witness marks on gauge blocks even at known locations. The larger engineered defects were detected in the CT bars.
- $\mu$ -CT (3D Engineering Solutions) was able to detect the engineered flaws, edge porosity, and witness marks on the surface but no indications within the parts.
- AlSi10Mg has low radio-opacity and is easy to CT. Difficult to detect defects in radio opaque materials (Fe, Ni, Co, Nb, Mo, W base alloys).

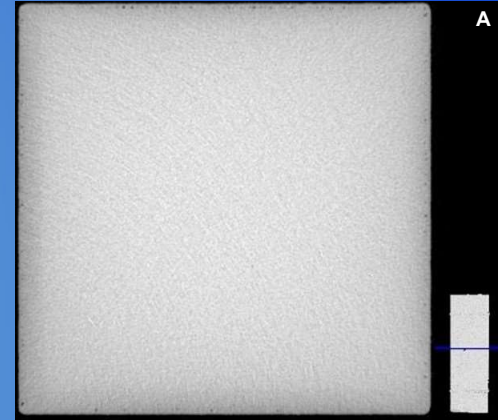
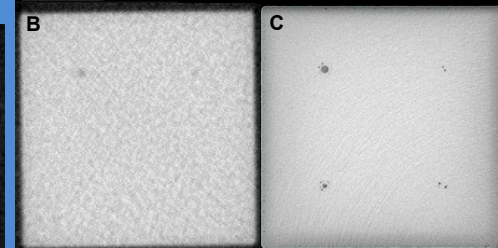
$\mu$ -CT of Bar 4 at witness mark location in XY (A). Comparison of Bar 4: 2 MeV CT image (B) and  $\mu$ -CT image (C), both in XY plane.

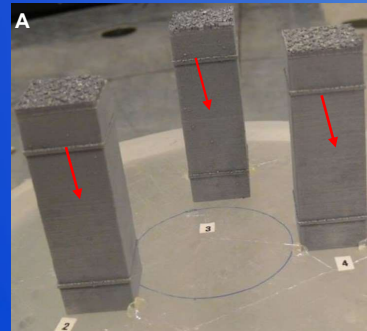
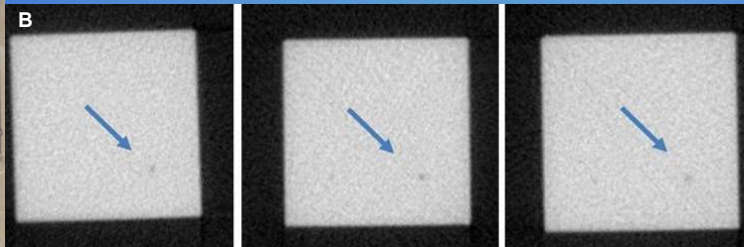
CT bars 1, 2, and 3 with red arrows indicating the witness marks (A). CT images show low density areas in XY plane as indicated by the blue arrows (B).

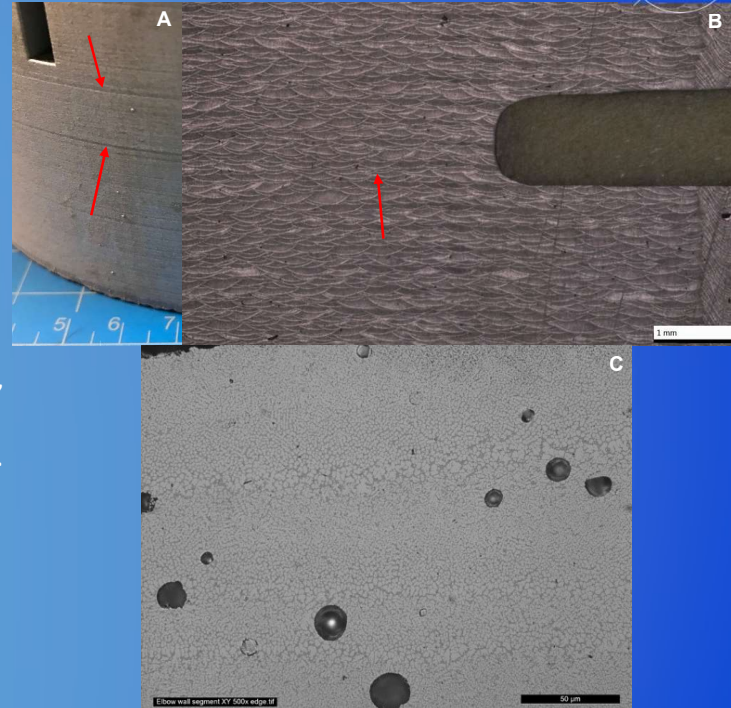
Witness marks across gauge block (A), cross section optical micrograph at 50x (B) and SEM micrograph at 500x showing edge and gas porosity but no indications of the witness mark (C).

- Four met blocks printed in each of four builds
  - Optical microscopy
  - Scanning electron microscopy (SEM)
  - Determine extent witness marks have on microstructure.
- Results
  - Homogeneous microstructure.
  - Density representative of L-PBF.
  - Porosity primarily observed within 500  $\mu\text{m}$  of the surface, typical for L-PBF core/counter scan interface zone.
  - Spherical gas-type pores (with a mirror-like finish) typical.
  - No indication of excessive porosity, LOF defects, etc.
  - No evidence that witness marks propagate into the bulk or induce microstructural irregularities and indicate they are a surface feature phenomenon.
