# Space Station Receives First Truss-Mounted Wi-Fi® Access Point

September 21, 2020 by Chatwin Lansdowne

**NASA astronauts route first Ethernet cable onto truss and install a Wi-Fi Access Point**

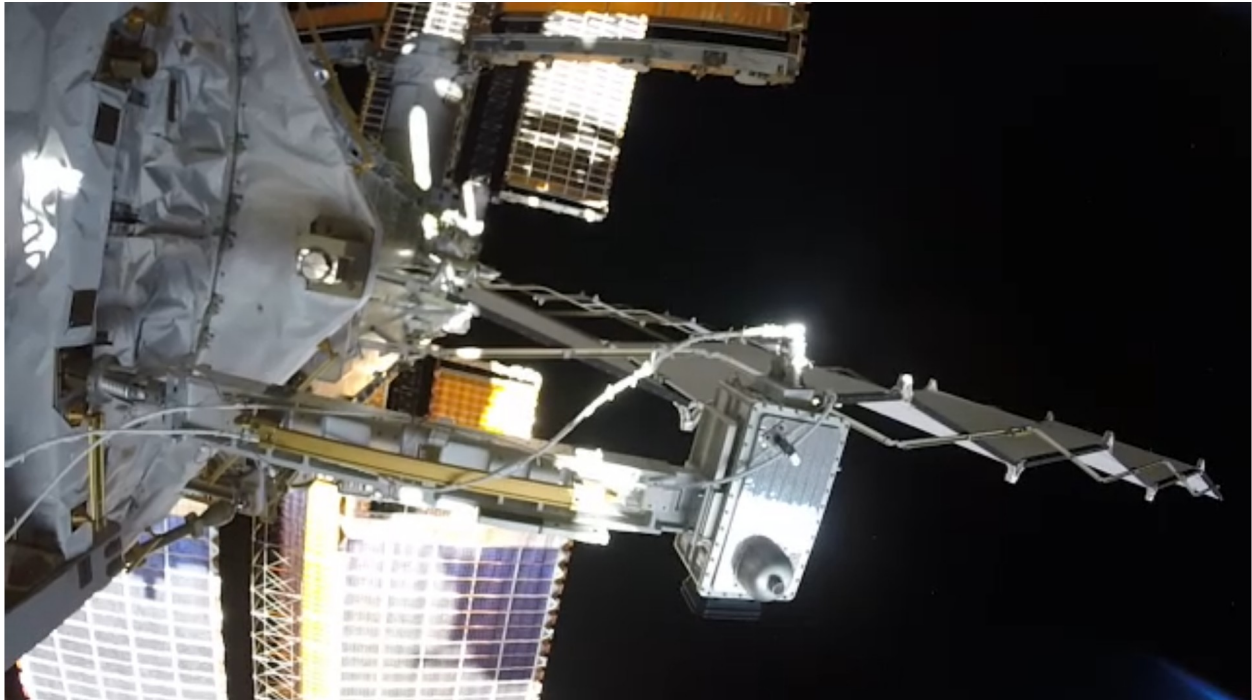
*Figure 1: Closeout photograph of the International Space Station's newest Wi-Fi access point. Source: NASA*

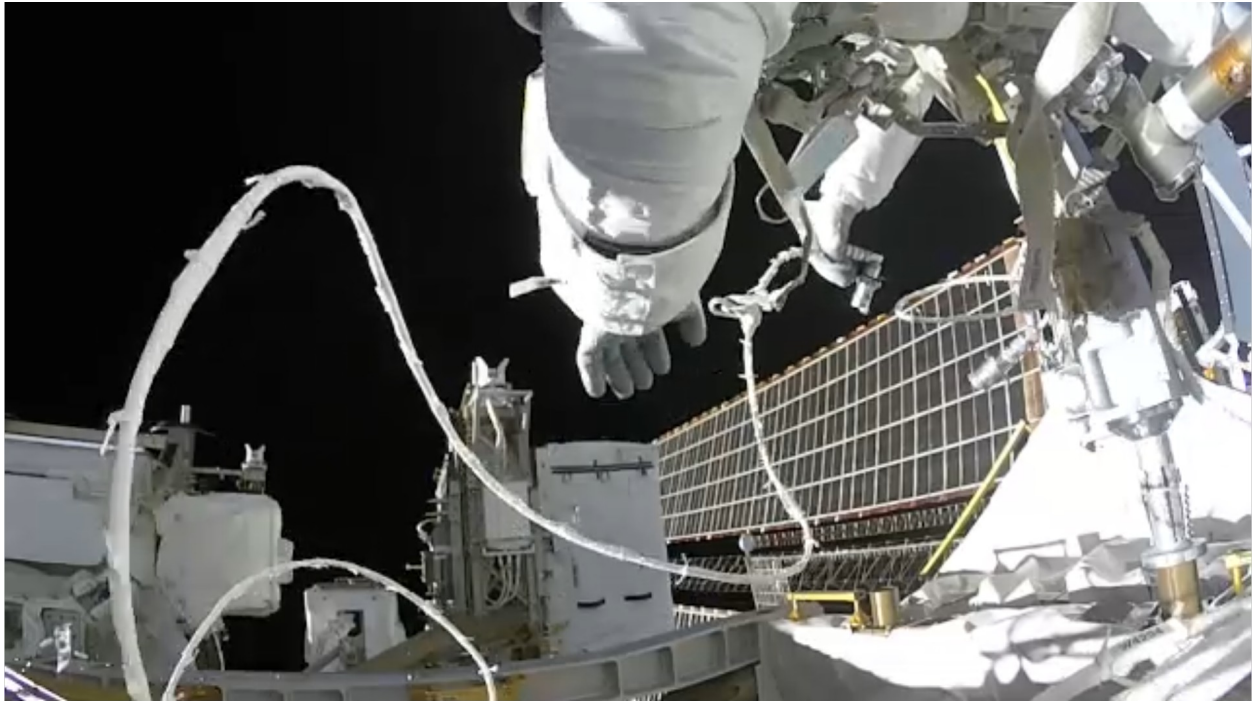
*Figure 3: Chris Cassidy prepares to connect an Ethernet cable to a Wi-Fi access point on the starboard truss of the International Space Station. Source: NASA*

Two weeks later, on [July 16](#), Cassidy returned to the station's starboard truss carrying an access point packaged with a camera and pre-assembled with pigtail cable onto a fixed boom. Chris installed the boom into a socket on the truss, assured himself it was captive and would not float away, then mated the power and Ethernet connections before proceeding past the solar panels to assist Behnken with exchanging more batteries. The new access point Chris placed is on the aft face of the starboard truss near the solar array rotary joint. From the vantage of the truss, it provides coverage down to the modules. Presently this is the only access point on the truss, aft of the truss, or peripherally starboard. The first access points had been mounted on the modules, with the original intent of offering network connectivity from inside the modules to payloads on the truss. The camera and boom had been on board and assembled since September 2019. Chris and Bob insisted on installing the camera before their primary task, so that the airlock would be empty if there were any emergency that required an early return.

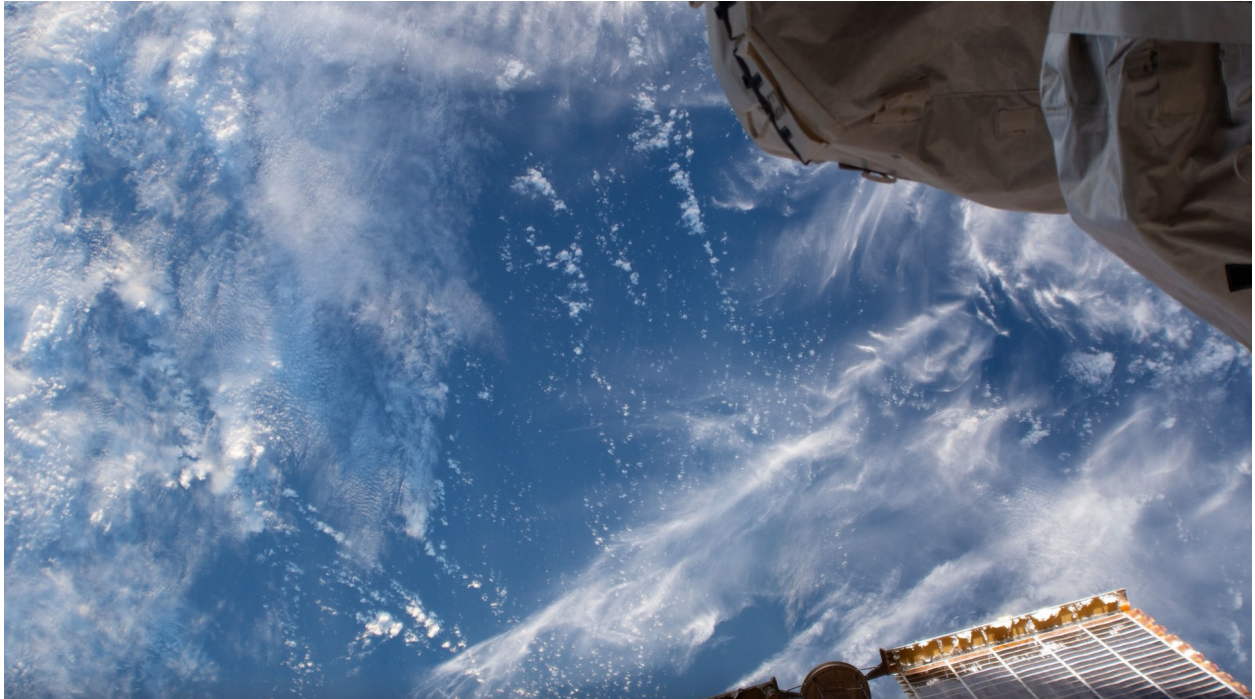
*Figure 4: First image from new Ethernet-connected camera, zoomed wide. A solar panel and a spare control-moment gyroscope are visible in the periphery. The camera shares an Ethernet cable with a Wi-Fi access point. Source: NASA*

The cameras are well-sited to be access points, but they were not designed for that purpose. The camera team had however provided an Ethernet test connector for themselves to use for development and testing on the ground. A person wearing gloves cannot reliably install or remove the test connector, and so engineers provided an Ethernet pigtail for the crew to install while in their living quarters. Some cameras were to be mounted on pan and tilt assemblies and so the conversion from wireless to wired connectivity introduced the concern of binding and kinking. Several cable candidates were evaluated before a suitable product was found. Other cameras were mounted in fixed locations. But antenna pointing and camera pointing are coupled. In the case of this first truss AP, NASA prioritized Wi-Fi capability and the antennas were pointed port and starboard to optimize coverage, constraining the camera angle to a plane from which the Imagery Group selected an Earth view.

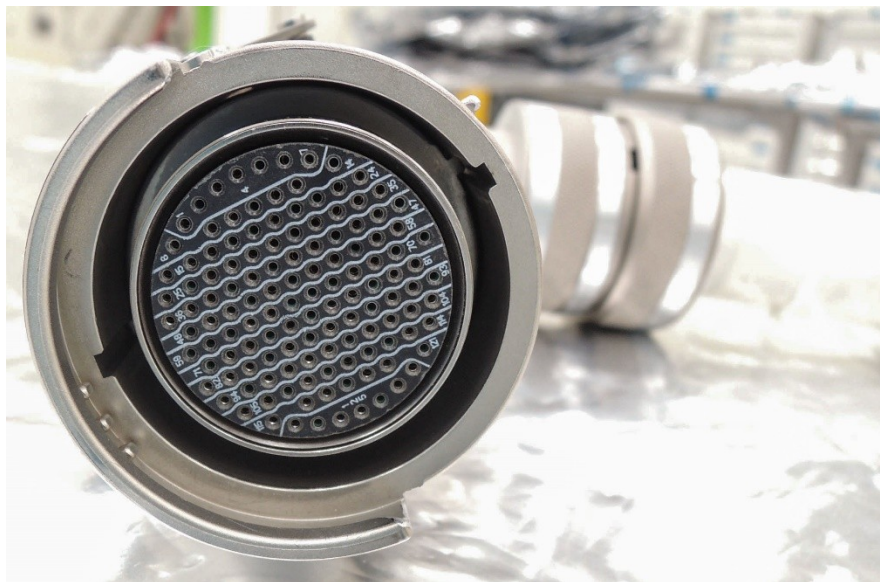
*Figure 5: A connector on the flight external cable that breaks out ten Ethernet cables connected through the pressure wall of the International Space Station. Astronaut Ann McClain installed the zero-force multi-pin cable underneath a micrometeorite shield in April, 2019. Source: NASA*

Because NASA designed and fabricated modules during the 1990's, NASA had no penetrations through the pressure hull that meet Category 6 Ethernet requirements. Several Ethernet cables and other signals would need to penetrate the International Space Station's vacuum-tight aluminum hull through a few zero-force multi-pin connectors. Engineers were very concerned about crosstalk and reflections among signal wire pairs at this connector stack, and Boeing conducted ground tests to develop confidence that gigabit speeds were achievable over the extension segment lengths concatenated by zero-gravity connectors.
