The Effect of Heating on the Degradation of Ground Laboratory and Space Irradiated Teflon® FEP

Prepared for the
Sixth International Conference on Protection of Materials and Structures From Space Environment
cosponsored by the ITI, UTIAS, MMO, AFOSR/NL, CRESTECH, EMS Technologies, and MDRobotics
Toronto, Canada, May 1–3, 2002

NASA/TM—2002-211704

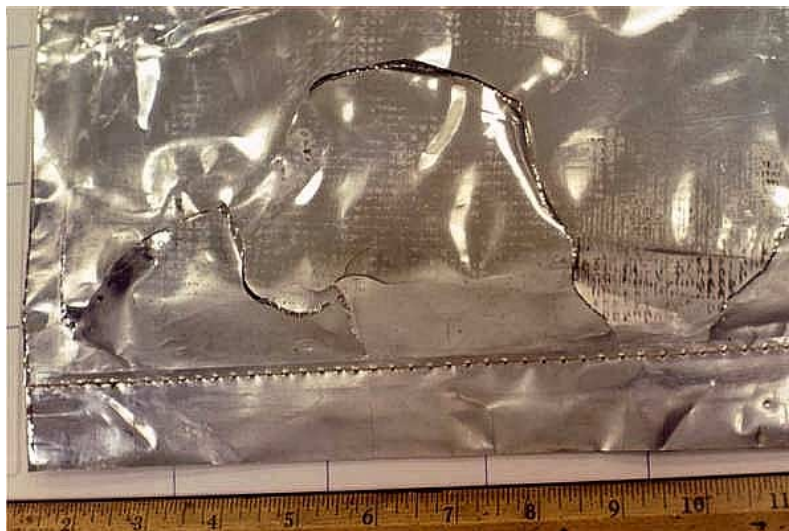
Figure 2. Cracks present in 5 mil thick Al-FEP Bay 10 MLI, photographed after retrieval during SM3A.

During SM3A, original MLI from Bay 10, which experienced 9.7 years of space exposure, as well as 2 mil thick Al-FEP patch material, which experienced 2.8 years of exposure, were retrieved and available for degradation analyses. Post-retrieval analyses have shown that FEP retrieved during SM2 after 6.8 years exposure was more embrittled, with a 0% elongation to failure, than FEP retrieved 2.8 years later during SM3A, after 9.7 years exposure.^{7,8} Because the retrieved SM2 material curled with the FEP surface in compression, exposing the lower emittance Al surface to space, it experienced a higher temperature extreme during thermal cycling (~ 200 °C) than the nominal solar facing MLI experiences (~ 50 °C). As this was the only sample retrieved during SM2, it was important to determine the difference between the measured properties of this excessively heated sample and nominally heated MLI FEP. Another back surface metallized Teflon insulation, 2 mil thick Al-FEP thermal shields that covered the solar array bi-stems of the second pair of HST solar arrays (SA-2), thermal cycled to a maximum temperature of 130°C on-orbit. Because of the various temperatures experienced by HST FEP materials, it is necessary to understand the effect of temperature on FEP degradation on HST. Understanding temperature effects is important for determining degradation mechanisms, and for facilitating the prediction of FEP degradation in LEO.

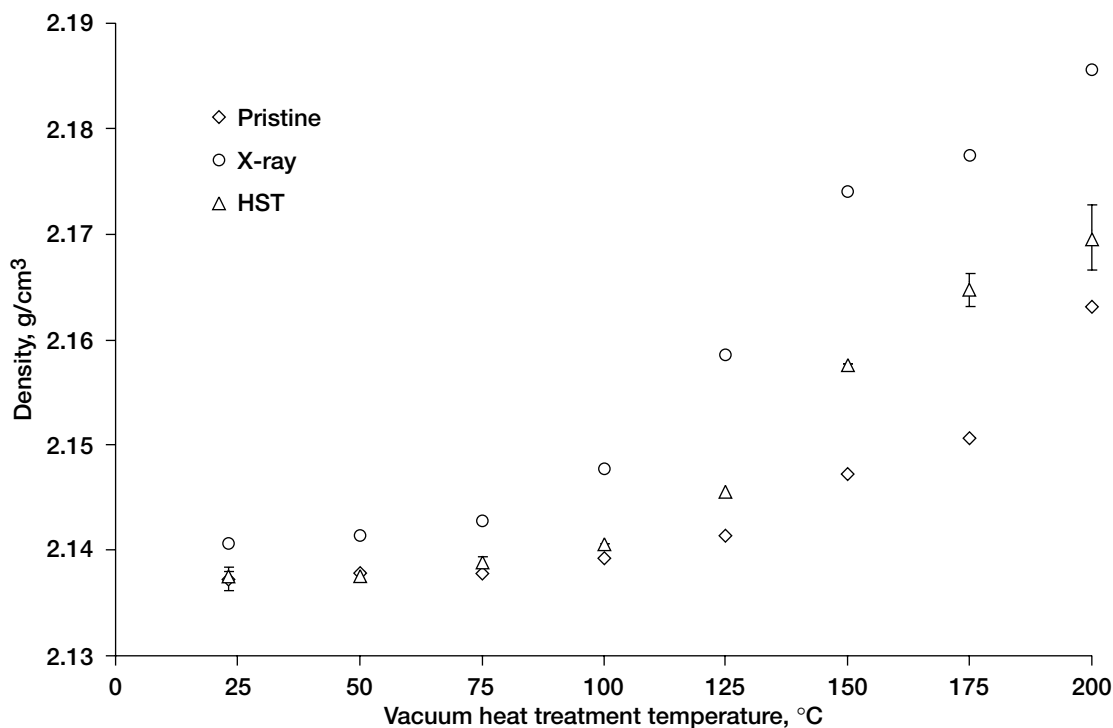
Figure 5. Density of pristine, ground laboratory x-ray exposed and retrieved HST FEP as a function of vacuum heat treatment temperature.

There were very gradual increases in the density with heating up to 75°C for all samples. Significant increases started at 100°C, with larger increases corresponding to higher temperatures. Although the density increased with temperature for all samples, larger increases occurred at a particular temperature for the samples that had been irradiated either in space or in the ground facility than for pristine FEP. These results are consistent with de Groh's previous studies that show pristine FEP increases in density with heating, but FEP from HST has greater increases in density for the same heat treatment (200°C exposure, reference 7 and 9). This is attributed to irradiation-induced scission of bonds in space, which allows for greater mobility and crystallization upon heating than that which occurs with non-irradiated FEP. Previous x-ray diffraction studies verify that the increases in density correlate to increases in polymer crystallinity.^{7,9} The density results further support chain scission as the primary mechanism of degradation of FEP in the space environment.

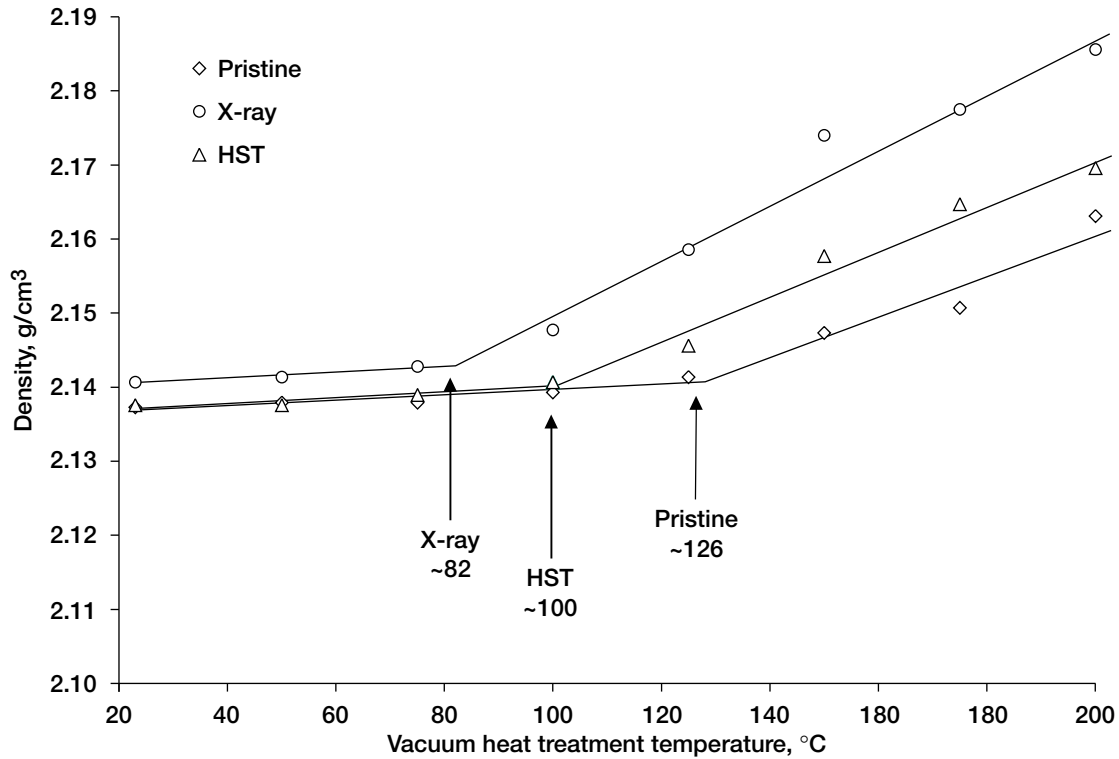
Figure 7. Change in the slope of the density data of pristine, ground laboratory x-ray exposed and retrieved HST FEP as function of vacuum heat treatment temperature.

When comparing the curves for the elongation and density data, it was observed that in each set of data there appeared to be a noticeable change in the slope of the data around 100°C. The data was therefore graphed with linear fits for two sections of the data. The lines chosen were based on the best fit for each individual section of data. The resulting curves for the elongation at failure and density data are shown in Figures 6 and 7, respectively. The “change-of-slope” temperature has been highlighted in these graphs at the intersection of the two linear fits. The change-of-slope temperature of the pristine FEP (115°C for the elongation data and 126°C for the density data) correlates well with the glass I transition temperature (α relaxation), which is listed from $\approx 83^\circ\text{C}$ to 150°C in the literature, dependent on hexafluoropropylene (HFP) content.⁹ Eby and Wilson report transition temperatures for FEP with densities (2.136 to 2.135 g/cm³) similar to the pristine FEP examined in this report at $\approx 150^\circ\text{C}$ and $\approx 127^\circ\text{C}$ for 10.7 and 17.7 mol % HFP, respectively.¹⁸ Commercially available FEP is reported to be 20 mol % HFP,¹⁹ which would indicate that the transition temperature for pristine FEP would be close to 125°C based on the Eby study, which is consistent with the change-of-slope temperatures for the pristine FEP. Another interesting observation is that the irradiated samples have lower change-of-slope temperatures than pristine FEP. For example, the temperature in which the density of the ground-laboratory irradiated FEP starts to increase quickly is 82°C , while it is 100°C for the HST retrieved FEP and 126°C for pristine FEP. These results indicate that irradiation causes changes in the polymer structure allowing increases in crystallization to occur at a lower temperature than which it occurs in pristine FEP.
