# The Effects of Arcing Ejecta on Space Suit Materials from ISS RPCM Hot Mate/Demate During EVA

**Onboard ISS, taking systems off-line when powering down to perform servicing on Remote Power Control Modules (RPCMs) introduces operational risk. An investigation lead by the NASA Engineering and Safety Center (NESC) was performed by a multi-center team to assess the safety of performing on-orbit replacement of RPCMs without powering down. This investigation revealed the potential for molten metal particulate generation in the event of an arcing occurrence. As RPCM replacement can be performed outside ISS during an Extra Vehicular Activity (EVA), it is necessary to assess the effects of this molten metal ejecta contact with the Extravehicular Mobility Unit (EMU) Space Suit Assembly (SSA) during an arcing event.**

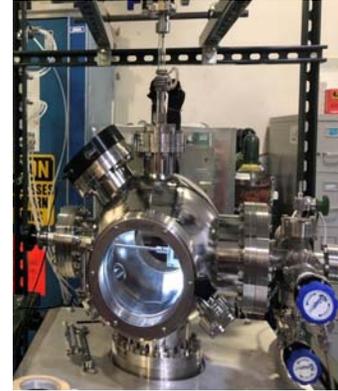
**Figure 9: The HELMET Chamber at UCR.**

The electromagnetic levitation setup at UCR was used in conjunction with an ultra-high vacuum chamber such that levitation experiments could be conducted in a vacuum as opposed to the traditional argon/helium cover gas method. This chamber/levitation apparatus was named the Heating & Electromagnetic Levitation of Metals for EMU Testing (HELMET) Chamber. A picture of the HELMET chamber is presented in Figure 9, where the top portion consists of the traditional induction coil setup with a quartz tube, leading down into a vacuum chamber where the molten and superheated metal particles (herein referred to as “particles”) can impact the sample.

The HELMET chamber contained various vacuum flanges, which allowed for versatility in data acquisition. Temperatures were measured on the backside of the samples using an infrared camera mounted in front of an IR transparent viewport. For calibration of the temperature measurements, thermocouples were used in conjunction with infrared (IR) camera measurements. For molten metal temperature measurement, two pyrometers were used in the setup. A small GoPro video camera was used to capture the impact of the particles onto the EMU material.

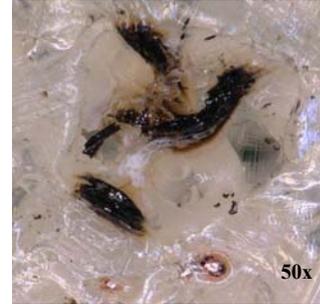
**Figure 17: Entrapped Ejecta and Damage to TMG Palm Material**

While larger particles (greater than 3 mm) showed significant damage to the materials in the finger front cross-section, particles in the arcing ejecta size range showed considerably less damage in comparison to the finger back. The TMG palm material contains a light coating of silicone rubber that provided insulation and prevented molten metal seepage, imparting thermal protection to the underlying materials. As shown in Figure 17, the thermal damage did not extend beyond the silicone coating.
