# Post-Test Inspection of NASA's Evolutionary Xenon Thruster Long-Duration Test Hardware: Discharge and Neutralizer Cathodes

*Rohit Shastry and George C. Soulas  
Glenn Research Center, Cleveland, Ohio*

The NEXT Long-Duration Test is part of a comprehensive thruster service life assessment intended to demonstrate overall throughput capability, validate service life models, quantify wear rates as a function of time and operating condition, and identify any unknown life-limiting mechanisms. The test was voluntarily terminated in February 2014 after demonstrating 51,184 h of high-voltage operation, 918 kg of propellant throughput, and 35.5 MN-s of total impulse. The post-test inspection of the thruster hardware began shortly afterwards with a combination of non-destructive and destructive analysis techniques, and is presently nearing completion. This paper presents relevant results of the post-test inspection for both discharge and neutralizer cathodes. Discharge keeper erosion was found to be significantly reduced from what was observed in the NEXT 2 kh wear test and NSTAR Extended Life Test, providing adequate protection of vital cathode components throughout the test with ample l

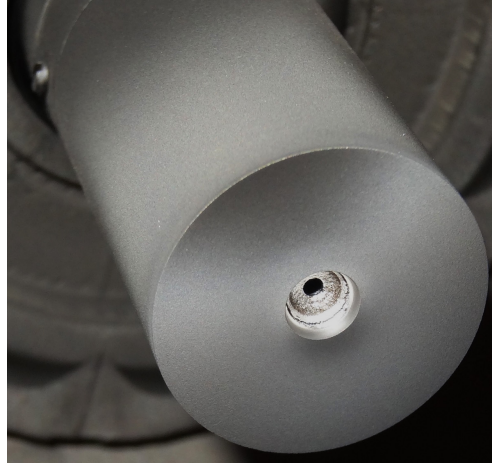
The discharge cathode assembly (DCA) was visually inspected after removal of the ion optics from the thruster. Figure 2 shows a photograph of the discharge cathode prior to removal from the discharge chamber. The discharge keeper, whose primary purpose in NEXT is to protect internal cathode components from the discharge plasma, appeared intact with little erosion, even after 51.7 kh of cathode operation. The exposed portion of the cathode orifice plate had a highly textured appearance, exhibiting a bowl-like shape that indicates significant erosion. Substantial deposition was also found within the gap between keeper and cathode plate surfaces, at a location coincident with the keeper orifice circumference. All of these features are discussed in more detail in the sections below.

Figure 2.—Photograph of the discharge cathode within EM3 shortly after the ion optics were removed.

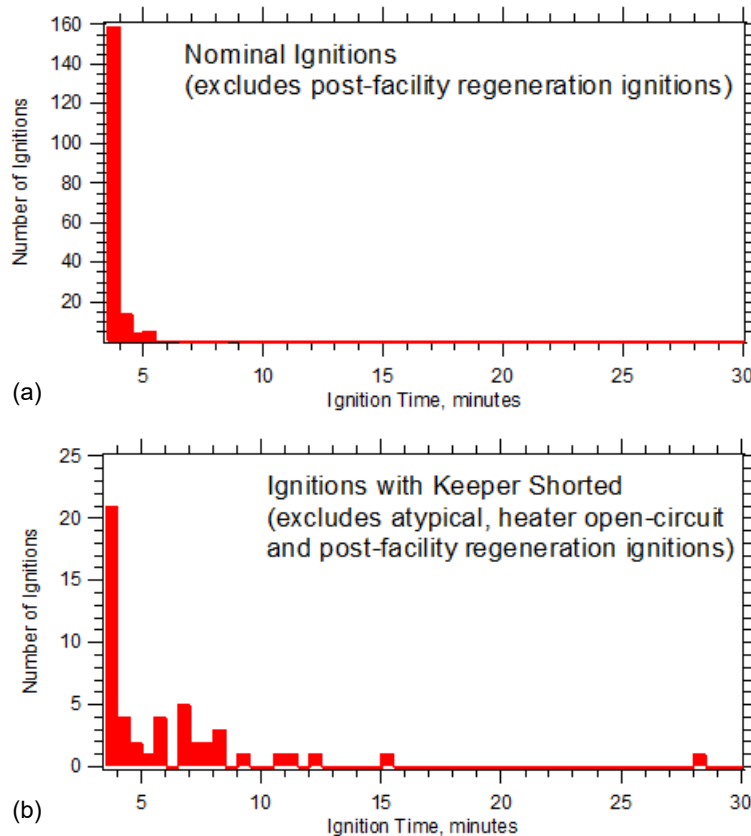
Figure 8 provides histograms of ignition times for “nominal” ignitions where no issues were present (also excludes ignitions performed directly after a facility regeneration), as well as ignitions where a cathode-keeper short was the only issue present (excludes post-regeneration ignitions, ignitions where the heater went open-circuit, and ignitions considered “atypical” due to factors such as operator error). For nominal ignitions, 185 ignitions took place with an average ignition time of 3 min 44 s and a maximum of 8 min and 53 s. For ignitions where the keeper was shorted to cathode, 50 ignitions took place with an average ignition time of 6 min 5 s and a maximum of 28 min. These data indicate that the short does increase ignition time, but by an average of  $\sim 2.5$  min. An ongoing ignition study is presently being performed on engineering model NEXT hardware to provide additional data that characterizes the impact of a cathode-keeper short on ignition time. The preliminary results of this study also indicate that the presence of an electrical short increases ignition times by  $\sim 2$  min on average (Ref. 45).

Figure 8.—Histograms of discharge ignition times from the NEXT LDT. (a) Ignition time distribution of nominal ignitions with no issues present. Average ignition time was 3 min 44 s. (b) Ignition time distribution with the cathode-keeper short being the only issue. Average ignition time was 6 min 5 s.

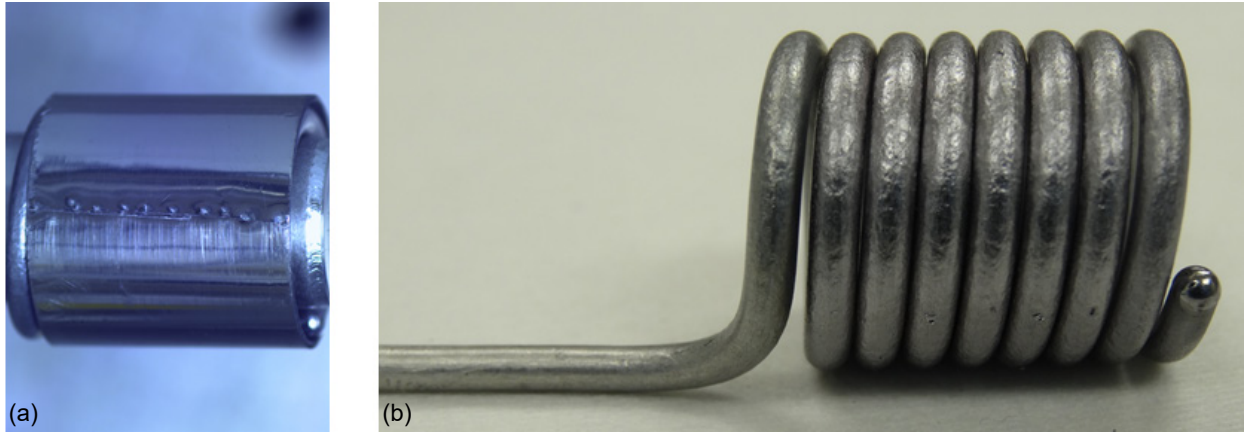
Figure 9.—Photographs of (a) the DCA heater radiation shield and (b) the heater coil after removal from the cathode tube. No visible wear or defects were found to be caused by cathode operation.

The exposed cathode heater and radiation shield were visually inspected after the keeper was removed from the DCA. Figure 9 shows photographs of these two components during post-test inspection. The radiation shield was found to be in remarkably good condition, with no visual indications of any wear. The heater coil was also in excellent condition, with both heater terminations intact. Post-test measurements of the heater coil resistance (prior to removal from the cathode assembly) using a milliohmmeter yielded an average value of  $0.452 \Omega$ , which is only 1.5 percent lower than the pretest value of  $0.459 \Omega$  and within the measurement variation. This lack of observable wear is not surprising. Given the minimal amount of erosion found on the discharge keeper, it had adequately protected the cathode orifice plate, heater coil and radiation shield from the discharge plasma during thruster operation for over 51 kh. This is a marked improvement over what was observed in the NSTAR ELT, which had significant damage to these components due to excessive keeper erosion and subsequent exposure to the discharge plasma (Ref. 41).

During the NEXT LDT, an intermittent, thermally-induced discharge heater open circuit was observed during cathode ignitions from  $\sim 13$  to 29 kh. This open circuit typically caused increased cathode ignition times. It had been speculated that this open circuit was caused by poor contact between the heater sheath and the cathode tube. For the engineering model cathode, a “friction fit” contact between the heater coil and the downstream end of the cathode tube was used as the only return path for heater current (Ref. 32). It was speculated that initial thermal expansion of the heater coil during the ignition procedure had caused the heater to momentarily separate from the cathode tube, resulting in the open circuit. As heat is transferred to the cathode tube, it expands as well until contact with the heater is reestablished.

While the lack of a positive return path is an issue for the engineering model discharge cathodes, it is not expected to occur for the NEXT flight cathodes. The present flight design incorporates a more reliable, secure connection between the cathode tube and heater sheath, and Aerojet Rocketdyne is working to ensure such a connection is adequate in preventing heater open circuits during ignitions and cathode conditioning sequences.

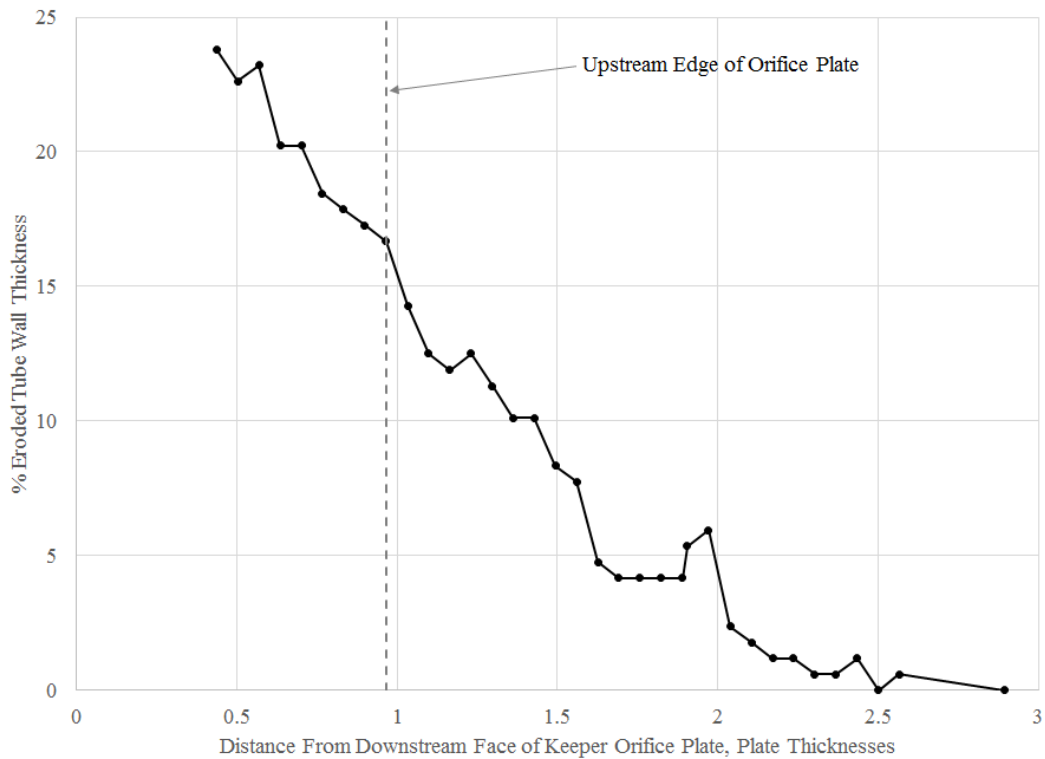
Based on the measurements at the furthest downstream location, approximately 24 percent of the tube wall thickness had been eroded by the end of the test. However, these measurements were taken in the area of the weld between the orifice plate and the tube, which is downstream of the cathode orifice plate and heater. Upstream of the keeper orifice plate, the maximum eroded depth was approximately 17 percent of the pretest tube thickness, with erosion observed up to 2.5 plate thicknesses upstream of the downstream face of the keeper orifice plate. By comparison, the maximum erosion observed during the NEXT 2 kh wear test was 7.5 percent of the pretest tube thickness, with erosion observed up to 6.7 plate thicknesses upstream. Thus, there is a significant reduction in the extent of erosion observed in the NEXT LDT. The primary factor responsible for this difference is likely the reduced beam extraction diameter between the engineering model optics (used in the NEXT 2 kh wear test) and prototype model optics (used in the NEXT LDT). This effectively decreased the keeper tube area exposed to the ion beam, as well as reduced the overall ion flux to the surface. Furthermore, the flight design of the keeper incorporates a tube wall that is 50 percent thicker than what was tested in the NEXT LDT. This change, coupled with the reduced erosion rates observed during the NEXT LDT, indicates that keeper wear through should not be a life limiter for the thruster.

Figure 14.—Extent of erosion of the beam-side of the keeper tube wall as a function of upstream axial distance. The location of the upstream surface of the orifice plate is provided for reference.

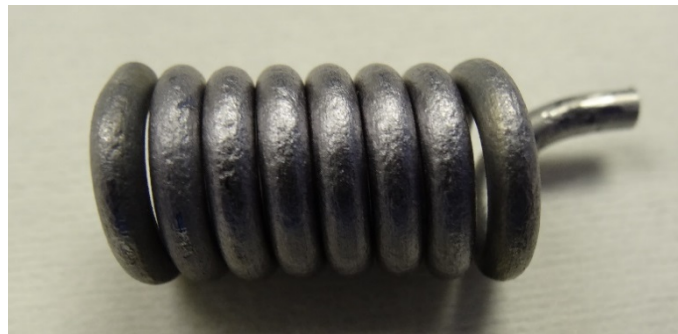
Inspection of the heater also revealed texturing on the downstream face (see Figure 16(a)). Aside from this, an inspection of the heater coil indicated it is in excellent condition (see Figure 20), with both heater terminations remaining intact. Post-test measurements of the heater resistance yielded an average value of 0.260  $\Omega$ , which is an 8.6 percent increase from the pretest average measurement of 0.240  $\Omega$ . This increase is surprising given that the neutralizer was only ignited 348 times during the test, and the heater voltage increased by at most a few percent during that time. It is possible that contact resistances in the circuit had artificially increased the overall measured resistance, even though the resistance of the measurement leads were accounted for. Indeed, the cathode heater resistance during initial inspection and disassembly

Figure 20.—Photograph of the heater coil after removal from the neutralizer cathode tube. Aside from texturing on the downstream face, the coil was found to be in excellent condition.
