Post-Test Inspection of NASA's Evolutionary Xenon Thruster Long Duration Test Hardware: Ion Optics

*George C. Soulas and Rohit Shastry
Glenn Research Center, Cleveland, Ohio*

A Long Duration Test (LDT) was initiated in June 2005 as a part of NASA’s Evolutionary Xenon Thruster (NEXT) service life validation approach. Testing was voluntarily terminated in February 2014, with the thruster accumulating 51,184 hours of operation, processing 918 kg of xenon propellant, and delivering 35.5 MN-s of total impulse. The post-test inspection objectives for the ion optics were derived from the original NEXT LDT test objectives, such as service life model validation, and expanded to encompass other goals that included verification of in situ measurements, test issue root causes, and past design changes. The ion optics cold grid gap had decreased only by an average of 7 percent of pretest center grid gap, so efforts to stabilize NEXT grid gap were largely successful. The upstream screen grid surface exhibited a chamfered erosion pattern. Screen grid thicknesses were ≥ 86 percent of the estimated pretest thickness, indicating that the screen grid has substantial service life remaining. Depositio

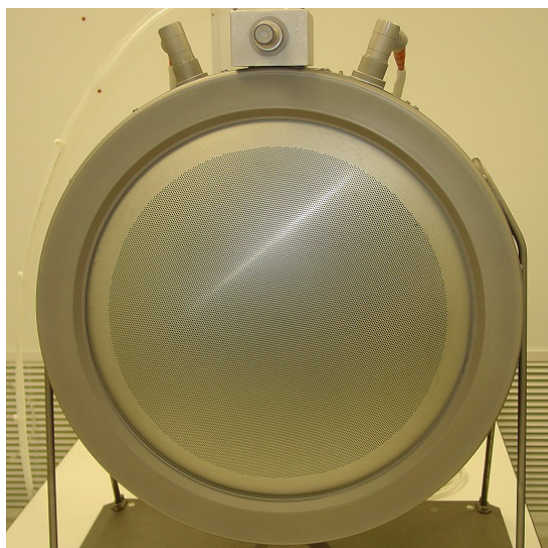
Figure 1.—Pretest image of the NEXT LDT thruster.

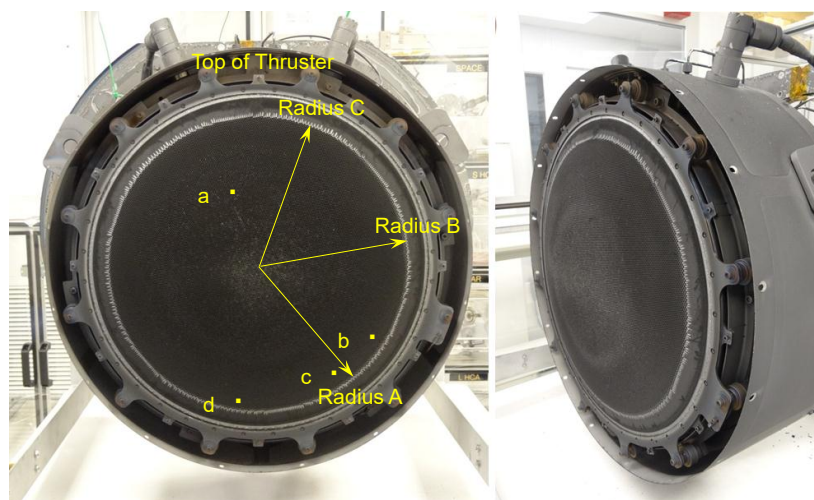
An image of the post-test ion optics mounted on the NEXT LDT thruster is given in Figure 2. The dark areas of the exposed accelerator grid are net deposits of back-sputtered carbon from the graphite panels lining the interior of the vacuum facility. These dark areas of net carbon deposition are persistent throughout most of the perforated area of the grid, including the grid central area. This is discussed in greater detail in the accelerator grid section and the Appendix. A photograph of the upstream screen grid is shown in Figure 3. Most of the exposed grid surface appears metallic with some uneven discoloration along the outer perimeter of the unperforated region of the grid. More detailed screen and accelerator grid inspection results will be shown in later sections.

Figure 2.—Post-test ion optics assembly mounted on the NEXT LDT thruster but with the front mask and neutralizer removed. The three radii for the measurements and images presented herein are also shown. The yellow squares labeled a to d identify approximate locations of rogue holes.

During the NEXT LDT, a careful inspection of ion optics long range images showed four accelerator apertures whose shape was deformed by erosion. Their approximate locations are shown in Figure 2 and are labeled (a) to (d). The erosion of these apertures, referred to as “rogue holes,” was likely caused by debris on the corresponding screen aperture. The debris deformed the upstream sheath and deflected beam ions into the walls of the accelerator aperture. Following the test, the rogue apertures were located and carefully inspected, especially aperture (a) whose diameter approached that of the screen aperture diameter. Interestingly, the corresponding screen apertures exhibited excessive deposition on the aperture walls that is non-uniform azimuthally (i.e., partial ring deposition) and showed some signs of spalling. However, this was not the cause of the rogue hole but likely a result of the erosion. In addition, the rogue holes were identified at 29.4 kh, which was prior to the formation of the partial ring deposition. The debris that likely caused the rogue holes are believed to have been removed some time during the LDT. The rogue holes had no noticeable impact on ion optics performance.

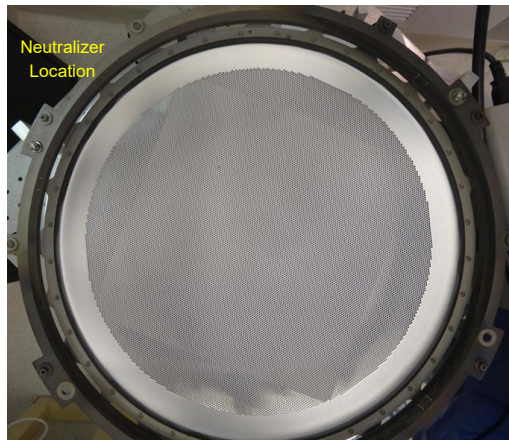
Figure 3.—Post-test upstream screen grid mounted to the ion optics assembly. The orientation of the neutralizer is shown.

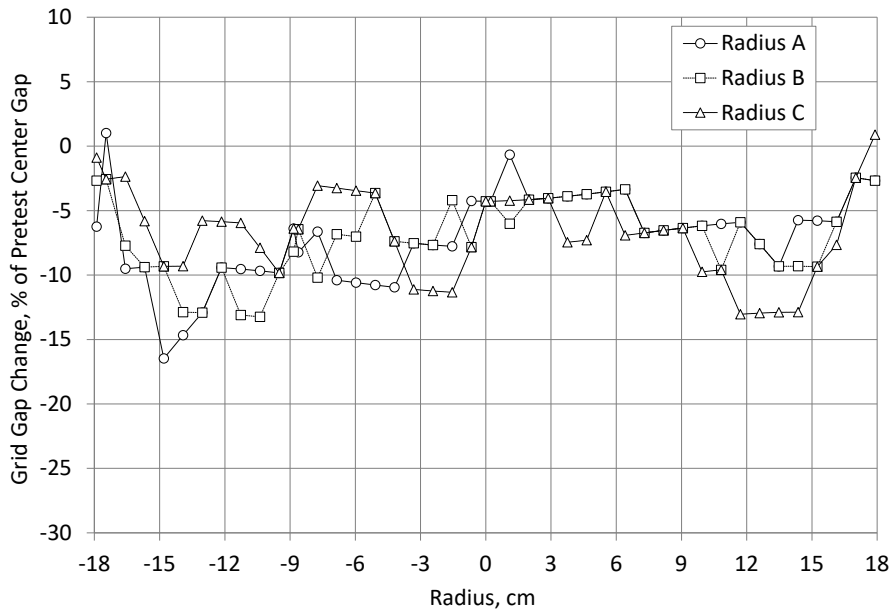
The cold grid gap at the center of the ion optics was measured in situ throughout the NEXT LDT and was found to have remained unchanged (Ref. 8). However, post-test measurements show that the grid gap at the optics center had decreased by 4 percent of the pretest value, as shown in Figure 4. The primary reason for this discrepancy was that the uncertainties of both measurement techniques overlapped. The post-test measurement uncertainty was ± 4 percent and in situ uncertainty was ± 6.4 percent of the pretest gap. So the change in grid gap at the optics center was ultimately too small to discern.

Figure 4.—Cold grid gap change as a function of radius along three radii (see Figure 2 for radial orientations). The post-test measurement excludes deposition. The grid gap is expressed as a percentage of the pretest grid gap at the ion optics center. The measurement uncertainty was estimated to be ± 4 percent.

Downstream surface deposition thicknesses are shown in Figure 13 as a function of radial location. The figure shows that deposition thicknesses were ultimately a small percentage of the cold grid gap. Deposition thicknesses generally increased with increasing radius and the maximum thickness was on the ID side at larger radii. As with aperture wall deposition, this uneven deposition is most likely the result of the non-uniform accelerator aperture wall erosion discussed earlier. As a result, the downstream webbing ID surface collected more deposition because of its proximity to the erosion site of the accelerator grid. The maximum deposition thicknesses of Figure 13 were used to correct the measured cold grid gap data to create Figure 4.

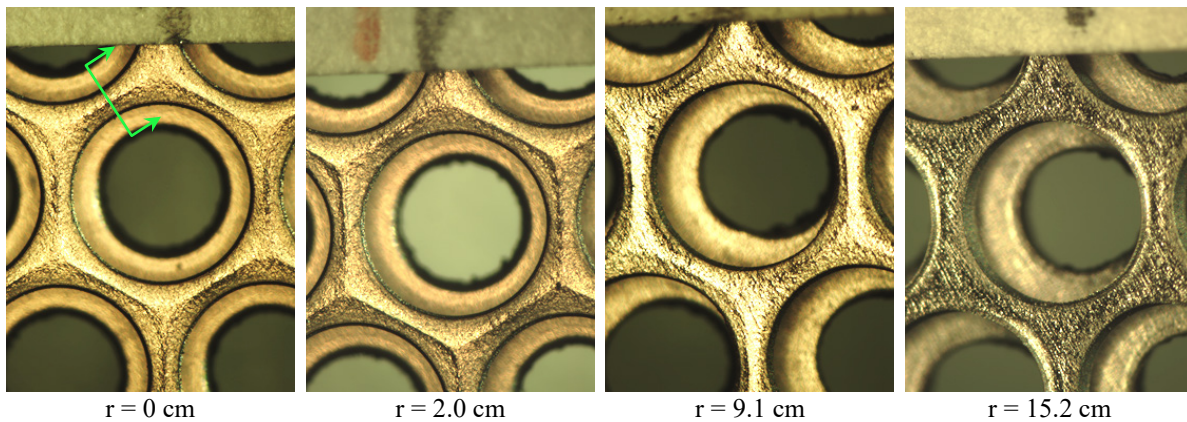
Post-test images of the screen grid upstream surfaces are shown in Figure 5 at various radial locations. The upstream screen surface exhibited a chamfered erosion pattern that was pronounced near the center of the grid and faded away at larger radii. This erosion pattern is very similar to that of the NSTAR thruster that was measured following the ELT (Ref. 19). Surface profilometry of this chamfering at several radial locations is shown in Figure 6. The images show six peaks separated by connecting ridges of decreased height to form the chamfered appearance. Of the several profiles measured, the difference in heights between the peaks and ridges was measured to be within about 5.2 percent of the nominal grid thickness. Ridges perpendicular to the radial direction of the optics increased in height with optics radius until they were level with the adjacent peaks.

Figure 5.—Post-test images of upstream screen grid surfaces at various radial locations along radius C (see Figure 2). All images are oriented with the grid center to the left and the outer perimeter to the right. For all images, the camera was pointing in the axial direction; so the screen and corresponding accelerator apertures appear misaligned because of the grids' curvature. The green arrows of the $r = 0$ cm image indicate the orientation of screen grid sectioning.

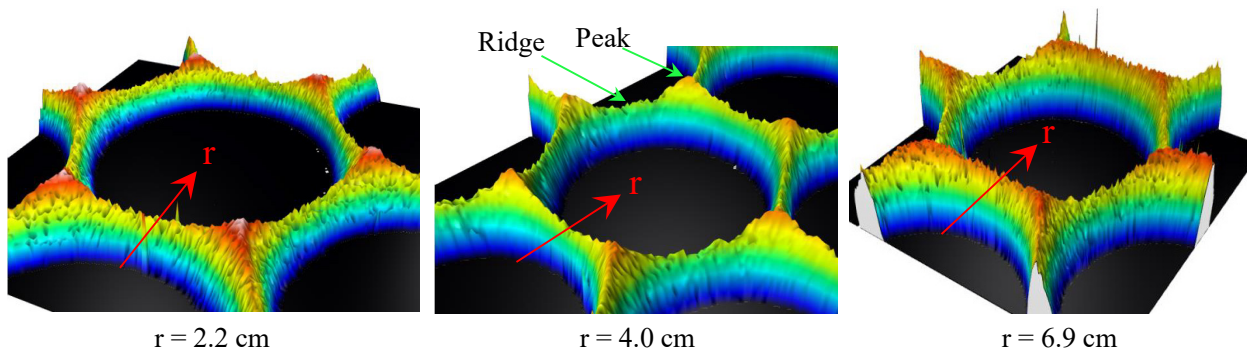
Figure 6.—Post-test profiles of upstream screen grid surfaces at various radial locations along radius C (see Figure 2). The arrows indicate increasing radius from the optics center. The eroded depth was exaggerated for clarity. A ridge and peak are indicated in the $r = 4.0$ cm profile.

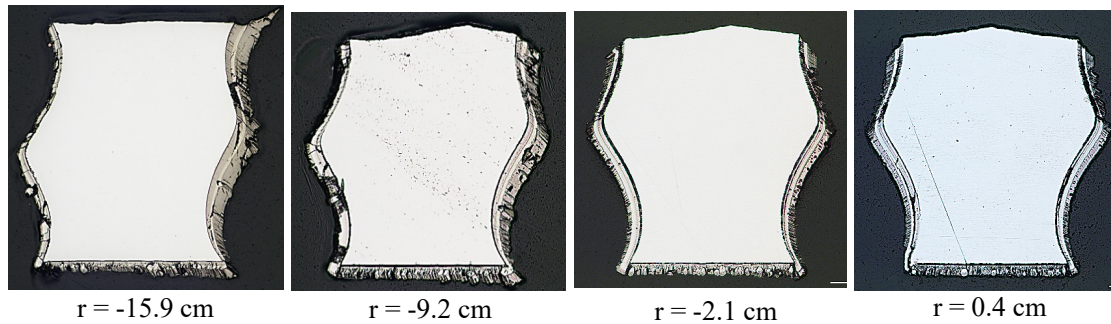
Figure 7.—Photomicrographs of screen grid webbing cross sections at various radial locations along radius B (see Figure 2). Figure 5 shows the orientation of the grid sectioning. All images are oriented with the optics center to the right and the outer perimeter to the left; the top surfaces are the upstream surfaces. The white central region is the grid webbing substrate and the grayish material surrounding the webbing is deposition.

Because the worst case screen webbing erosion was closer to the center of a ridge, the screen grid webbing was sectioned at the middle of a screen web for inspection as shown in Figure 5. The grid sections were mounted in epoxy prior to polishing to ensure that grid deposition was not removed during the preparation process. Sample screen grid webbing cross sections are shown in Figure 7 at various radial locations. The grid was sectioned along radius B of Figure 2 because this radius most closely tracked beam current density measurements. In addition, most measurements were made along the negative radius side because it was measured to have slightly higher beam current densities, and so higher erosion rates (Ref. 8). The photomicrographs of the screen webbing show that the ridge is centered with the webbing near the optics center, but the ridge shifts towards the grid center at larger radii. At even larger radii, the ridge is barely discernable. The photomicrographs also show deposition on the aperture walls and downstream surfaces, which will be discussed in the next section. Finally, Figure 7 shows cusps along the aperture walls that are artifacts of the manufacturing process. The NSTAR ELT thruster also exhibited a ridge that was centered with the webbing near the grid center, but shifted at larger grid radii (Ref. 21). However, it was unclear if the shifting was in a particular direction for the NSTAR thruster.

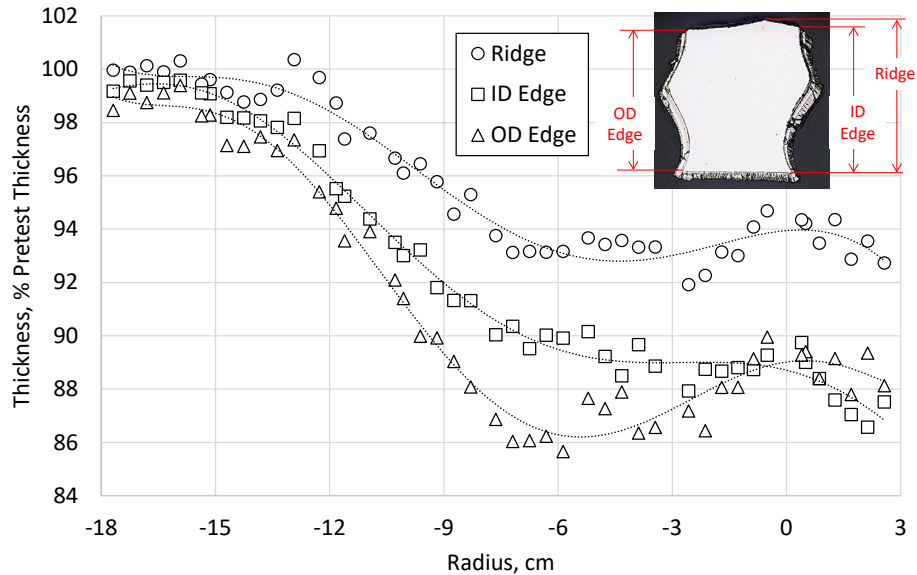
The NSTAR ELT screen grid webbing exhibited more erosion than that of the NEXT LDT grid (Ref. 21). However, the NSTAR peak beam current density at full power was significantly larger than that of the NEXT thruster at full power and screen grid webbing erosion tracked the beam current density profile. Peak beam current densities at full power were 5.9 mA/cm^2 for the NSTAR ELT thruster and 4.2 mA/cm^2 for the NEXT LDT thruster (Refs. 8 and 20). In addition, the double-to-single beam ion

Figure 8.—Screen grid webbing thicknesses at three webbing locations as a function of radial location along radius B (see Figure 2). Thicknesses are shown as a percentage of the estimated pretest thickness. Thicknesses > 100 percent are due to measurement and pretest thickness estimate uncertainties.

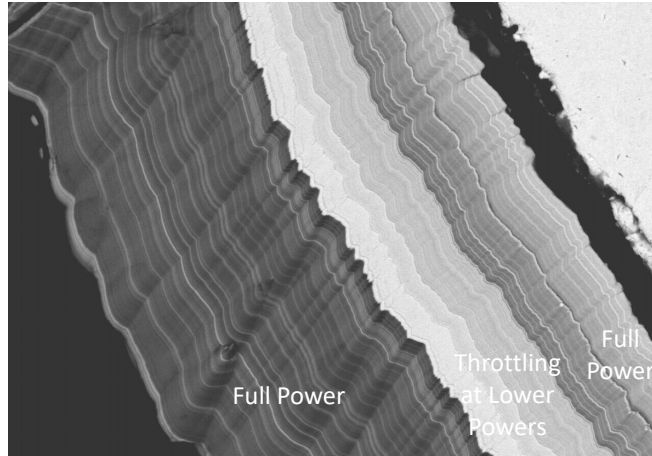
The downstream surface deposition had very similar features as that of the aperture walls. The deposition was composed of the same constituents and exhibited similar discoloration bands indicative of extended operation at different throttle levels, as well as the whitish lines indicative of grid material-rich layers, likely due to perveance measurements. The only differences were that the discolored bands of full power operation had a higher grid material content and that the structure of the deposition was less continuous, exhibiting a unique growth pattern.

Figure 9.—Scanning electron microscope image of aperture wall deposition using backscattered electrons. The aperture was located at $r = 0.4$ cm along radius B. The darker regions are dominated by carbon while the lighter regions are dominated by grid material. The deposition separated from the grid substrate, likely during preparation of the cross section.

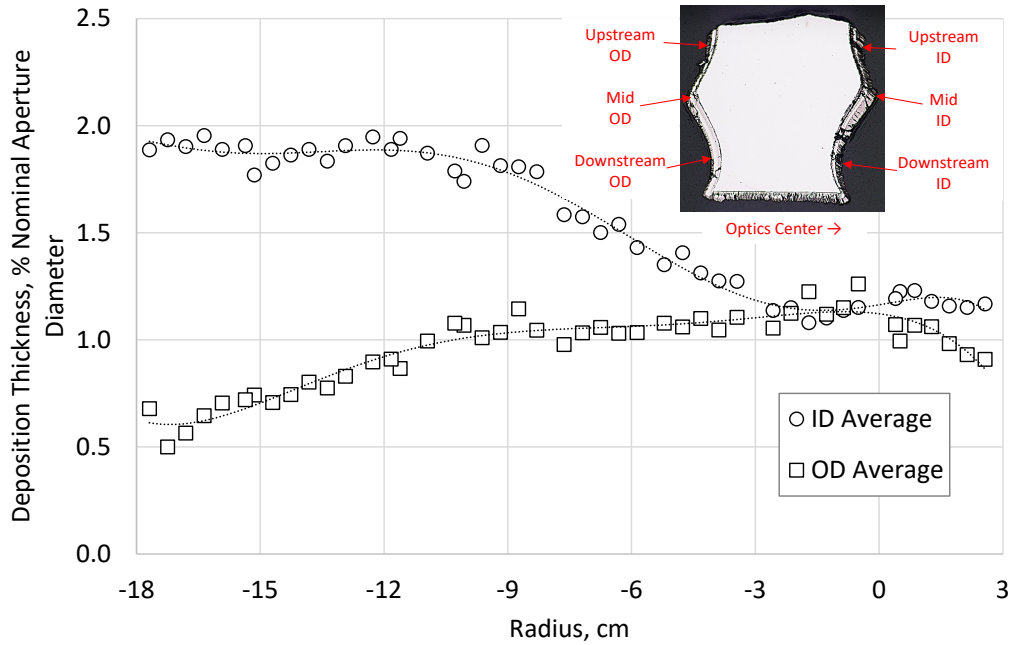
Aperture wall deposition thicknesses are shown in Figure 10 as a function of radial location. Deposition thicknesses on the ID and OD surfaces (i.e., the surfaces closest to and furthest from the ion optics center, respectively, as shown in Figure 10) are plotted separately. The figure shows that deposition thicknesses were ultimately a small percentage of the aperture diameter. In addition, deposition thicknesses were similar between ID and OD locations near the optics center. However, deposition thicknesses were larger on the ID surface at larger radii. This uneven deposition is most likely the result of non-uniform accelerator aperture wall erosion, which is discussed in the accelerator grid section. Accelerator aperture walls eroded unevenly due to a slight misalignment between the screen and accelerator apertures in the grid radial direction. As a result, the screen webbing ID surface collected more deposition because of its proximity to the erosion site of the accelerator aperture.

Figure 10.—Aperture wall deposition thicknesses as a function of radial locations along radius B (see Figure 2). Thicknesses are shown as a percentage of the screen grid aperture diameter. The image shows the three inner and outer diameter locations that were averaged and plotted in the graph.

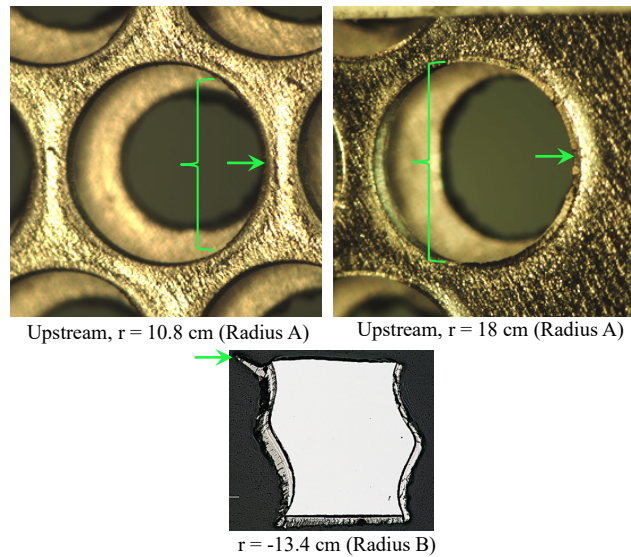
An interesting feature of the aperture wall deposition was the appearance of a slightly larger, partial ring at the upstream surface at the larger radii, which is shown in Figure 11. This partial ring-shaped deposition, which was a part of the aperture wall deposition, was non-uniformly distributed azimuthally about the aperture and was apparent for the mid- to outer-radius apertures. The center of the azimuthally non-uniform deposition pattern was aligned with the optics outer radius and the azimuthal extent of coverage increased with increasing grid radius from about 90° at mid-radius to 240° at 18 cm. The maximum protrusion of the deposition into the aperture was only about 4 percent of the nominal screen aperture diameter. An image of this deposition that was created with backscattered electrons is shown in Figure 12. The image shows that the partial ring deposition was predominantly formed during the second full power segment, following throttled operation (i.e., after 29.2 kh). Although the cause of this ring is presently unknown, the dominant carbon content of this deposition suggests that this was predominantly a facility effect. The impact of this deposition was a slightly reduced screen grid ion transparency during the second full power test segment, which is discussed later.

Figure 11.—Upstream screen aperture wall partial ring deposition. The green arrows indicate the deposition and the braces indicate the azimuthal extent of the deposition around the aperture. All images are oriented with the grid center to the left and the outer perimeter to the right.

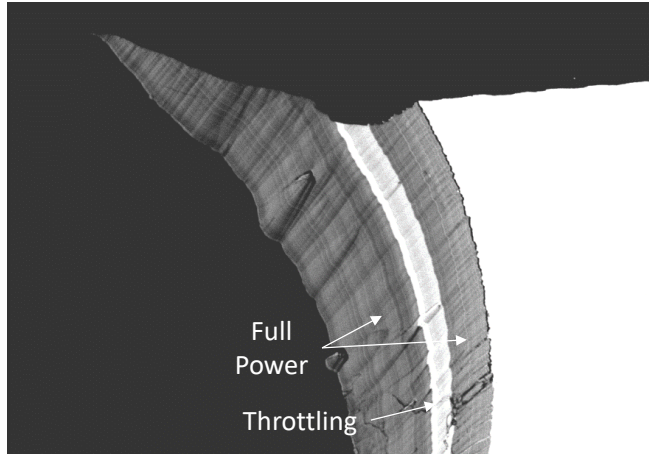
Figure 12.—Scanning electron microscope image of aperture wall partial ring deposition using backscattered electrons. The aperture was located at $r = -16.4$ cm along radius B. The darker regions are dominated by carbon while the lighter regions are dominated by grid material.

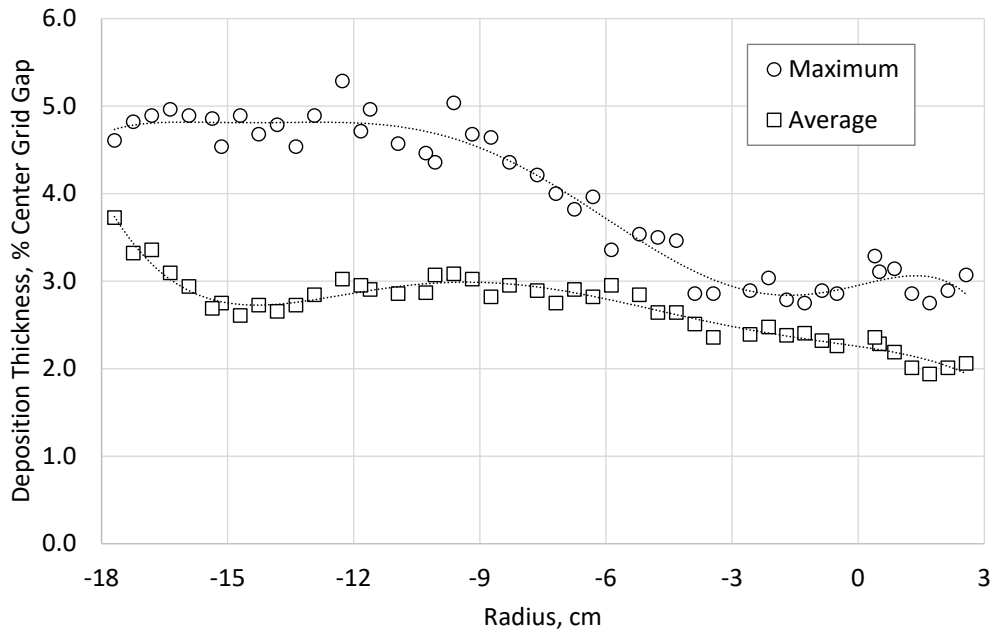
Figure 13.—Downstream webbing deposition thicknesses as a function of radial locations along radius B (see Figure 2). Thicknesses are shown as a percentage of the cold grid gap at the ion optics center. Three measurements at OD, middle, and ID locations were averaged and plotted in the graph.

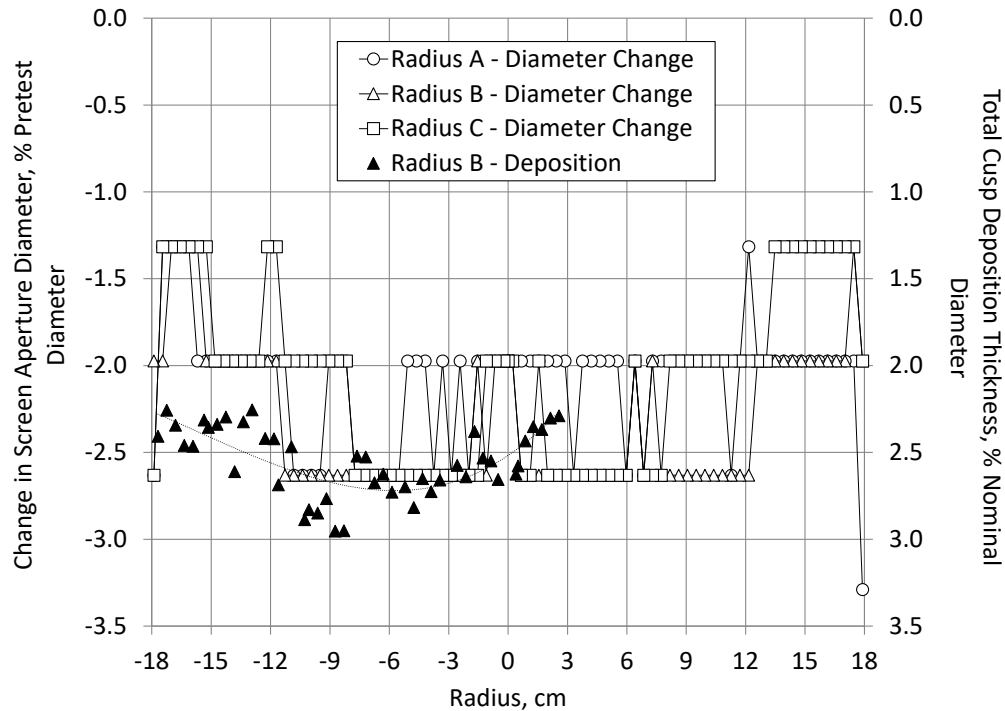
The change in screen grid aperture diameters from pre- to post-test as a function of radius is shown in Figure 14. As the figure shows, aperture diameters decreased by 1.3 to 2.6 percent of the pretest values, with a 2.2 percent average decrease. Also shown in the figure is the total deposition on both cusps of an aperture measured along radius B. As the figure shows, the deposition on the cusps was responsible for the decrease in screen grid aperture diameters.

Figure 14.—Change in screen grid aperture diameter from pre- to post-test as a function of radial location along three optics radii. Also included is the screen aperture wall deposition measured along radius B (see Figure 2) at both cusps of an aperture. Aperture diameters were measured with pin gages in increments of 0.67 percent of the nominal screen aperture diameter. Changes in aperture diameter are expressed as a percentage of the pretest measurement and deposition thickness as a percentage of the nominal screen aperture diameter.

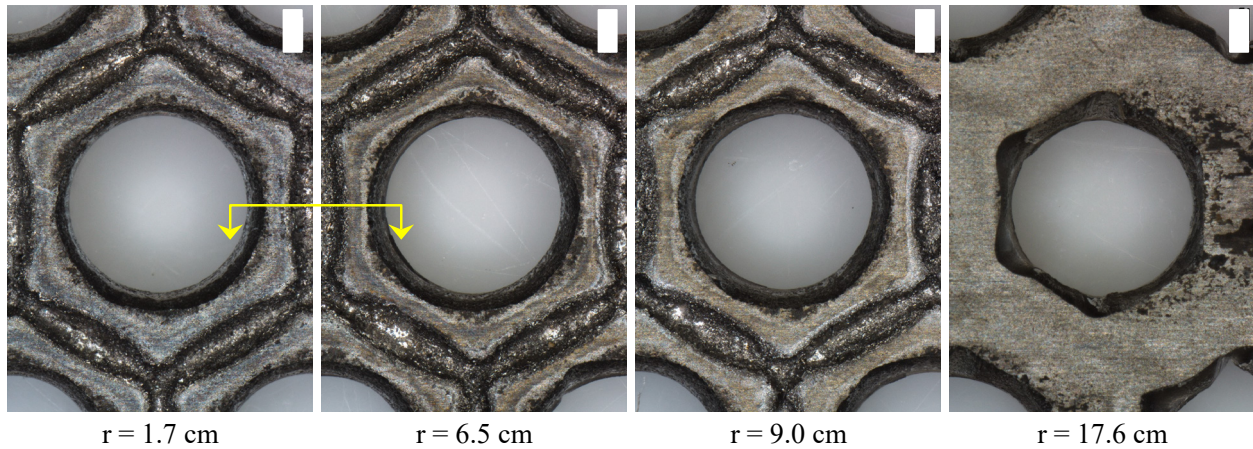
The appearance of net carbon deposition on the accelerator aperture walls was expected because aperture wall wear rates decrease as the aperture enlarges (see, for example, Figure 5.3-2 of Ref. 21). The aperture would enlarge to the point where the decreasing ion flux eroding the walls is overcome by the back-sputtered carbon flux, leading to net carbon deposition. This temporal transition from net erosion to net deposition was confirmed with in situ images of the center aperture taken during the NEXT LDT. The

Figure 15.—Post-test images of downstream accelerator grid apertures at various radial locations along radius A (see Figure 2) following soda blasting. All images are oriented with the optics center to the left and the outer perimeter to the right. The yellow arrows indicate the orientation of the webbing sections of Figure 17 relative to the ion optics center.

appearance of net carbon deposition in the pit and groove erosion pattern on the downstream surface was, however, unanticipated. An investigation of this finding, which is described in the Appendix, revealed that net erosion of the pit and groove erosion at locations within about mid-radius persisted through 36.5 kh.

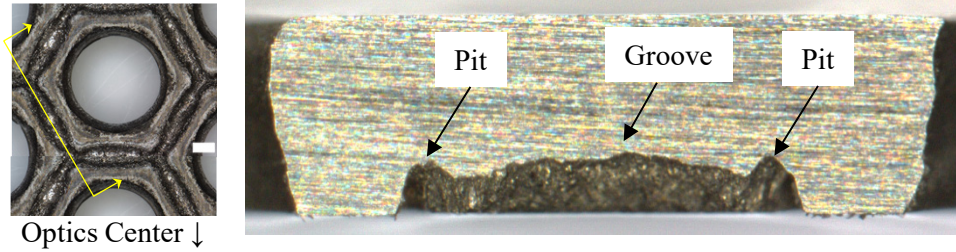
A cross section of a pit and groove erosion pattern is shown in Figure 16 for a grid section whose deposition was also removed. An interesting feature of the pit and groove erosion pattern is that although the depths of the pits and groove appear similar, a careful inspection shows that the grooves are actually deeper than the pits. This was unlike the NSTAR ELT thruster operating conditions, which produced pit depths that were far greater than groove depths (Refs. 19 and 21). To quantify the depth of the grooves, the accelerator grid webbing was sectioned at the middle of a web for inspection as shown in Figure 15. The grid sections were mounted in epoxy prior to polishing to reduce the amount of grid deposition removed during the preparation process. Sample accelerator grid webbing cross sections are shown in Figure 17 at various radial locations. The grid was sectioned along radius B of Figure 2 because this radius most closely tracked the beam current density measurements. In addition, most measurements were made along the negative radius side because it was measured to have slightly higher beam current densities, and so it was anticipated to have higher erosion rates (Refs. 8). Although the deposition was not purposely removed for these sections, spalling had occurred prior to and during the preparation process, so some downstream sites exhibited deposition while others did not.

Figure 16.—Post-test photomicrograph of a sectioned and polished accelerator grid webbing at a radius of about 6.3 cm near radius B (see Figure 2). The yellow lines and arrows on the image to the left indicate the orientation of the sectioning.

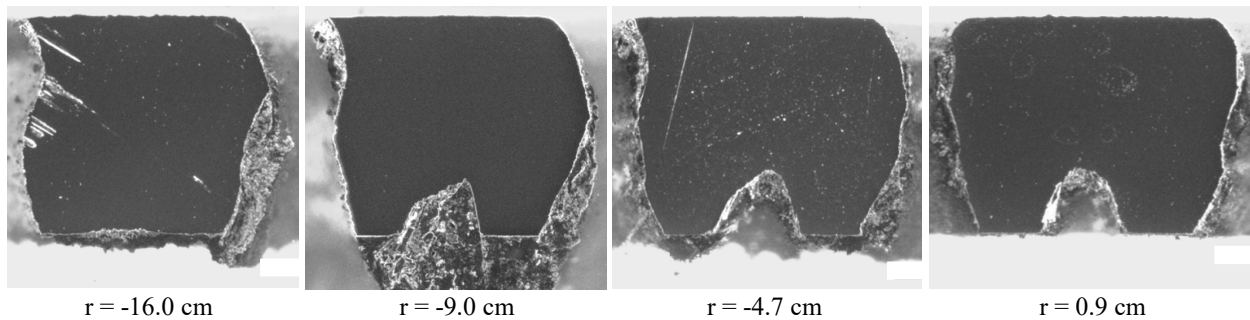
Figure 17.—Photomicrographs of accelerator grid webbing cross sections at various radial locations along radius B (see Figure 2). Figure 15 shows the orientation of the grid sectioning. All images are oriented with the optics center to the right and the outer perimeter to the left; the bottom surfaces are the downstream surfaces. The solid, dark central regions are the grid webbing substrate and the grayish material surrounding the webbing is deposition.

Figure 17 shows many important features of erosion and deposition. The upstream surfaces showed little erosion. Erosion of the aperture walls was asymmetric away from the optics center such that there was net deposition evident on the outer diameter side of the webbing while there was net erosion of the inner diameter side. The downstream surfaces next to the grooves were uneroded, likely due to net carbon deposition on those surfaces early in testing. Lastly, net carbon deposition was porous, resulting in ridges surrounding the pit and groove erosion pattern that were measured to be as large as about 70 percent of the grid thickness by the end of the test.

The result of this misalignment is non-axisymmetric accelerator aperture wall erosion, which is evident in webbing images of Figure 17 for apertures away from the ion optics center. The webbing surfaces closest to the optics outer perimeter of a given aperture show a chamfered erosion pattern while the opposite surface shows little or no erosion. In addition, the latter surface exhibits net deposition, which is evident in Figure 17. The deposition at these locations was examined using a scanning electron microscope. The constituents of the deposition were grid material and carbon. Also evident in the images produced with backscattered electrons were broad discolored bands indicative of throttling during the

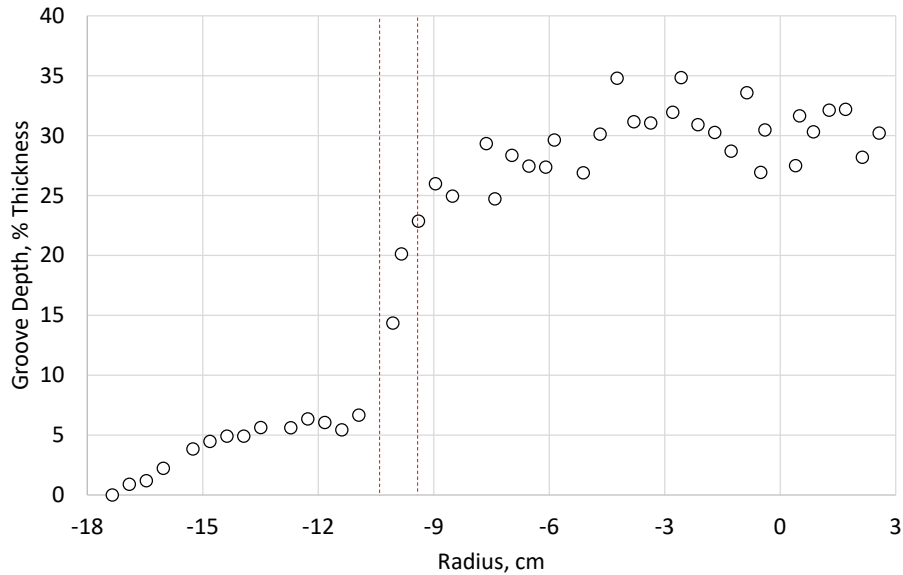
The maximum measured groove depth of 35 percent of the grid thickness was about half that estimated with in situ diagnostics, so this discrepancy was investigated. Although the in situ measurement technique suffered from a number of inaccuracies, the most significant appeared to be the lack of an adequate reference plane (Ref. 24). Most measurements were averages of distances from the groove to the downstream and upstream grid surfaces. Unfortunately, the downstream grid surface was masked by porous carbon deposition that grew to a substantial thickness relative to the grid thickness. And the upstream accelerator aperture edge had eroded (see the inner diameter edges of Figure 17). Therefore during the LDT, both reference planes shifted in a manner that exaggerated the true depth of the eroded grooves.

Figure 18.—Accelerator grid groove depths as a function of radial location along radius B (see Figure 2). Depths are shown as a percentage of the estimated pretest thickness. The red dotted lines indicate the measured transitions from net erosion to net deposition at 10.7 cm at the end of the first full power test segment (i.e., 13.0 kh) and 9.4 cm during the second full power test segment (i.e., 36.5 kh) (Ref. 25).

More pit and groove erosion measurements are presently being made at different locations on the grid. This will help to verify the true deepest groove erosion sites and to establish the service life of the thruster based on this failure mode.

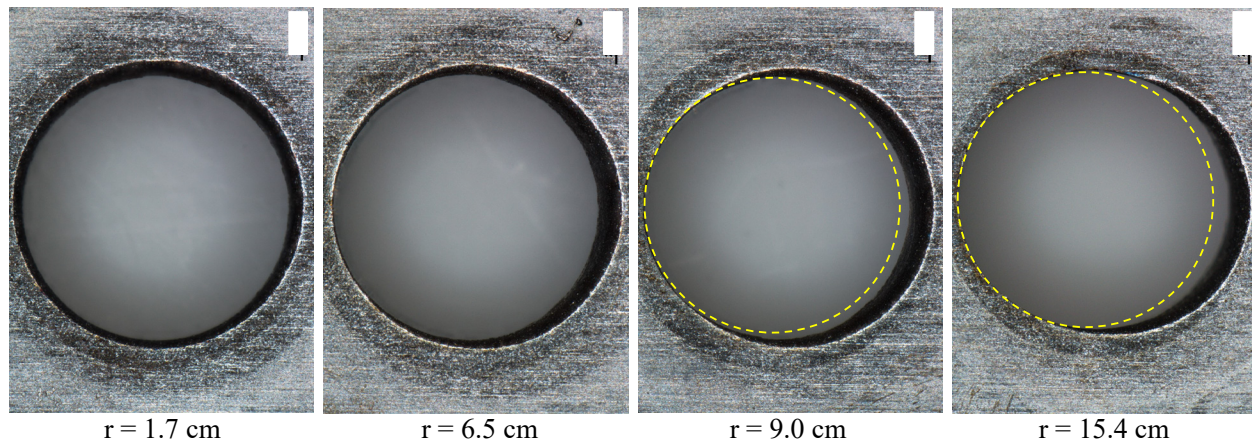
Figure 19.—Post-test images of upstream accelerator grid apertures following soda blasting at various radial locations along radius A (see Figure 2). All images are oriented with the grid center to the left and the outer perimeter to the right. The dashed yellow circles indicate the approximate pretest aperture.

LDT and thinner whitish lines, similar to that of the screen grid deposition (see Figure 9). The thickness of the deposition was also measured at various radial locations. It was found to vary, reaching peak values between the optics center and mid-radius apertures of 13 percent of the grid nominal thickness. Also, there were sites on the upstream accelerator grid where this deposition was found to have spalled, though it is unclear if this was the result of atmospheric exposure or post-test handling. Regardless, the majority of the deposited material’s atomic composition was measured to be carbon, which is a facility effect that would not be present in a spaceflight application.

These results indicate that although changes in aperture alignment as a result of the earlier NEXT 2000 h wear test reduced notching erosion, they were still not enough (Ref. 6). The resolution to this minor misalignment is straightforward. Screen and accelerator aperture pairs are set during manufacture to yield a particular alignment. This can easily be adjusted to account for the misalignment noted in this section. Doing so can mitigate any potential concerns regarding deposition, spalling, and performance.

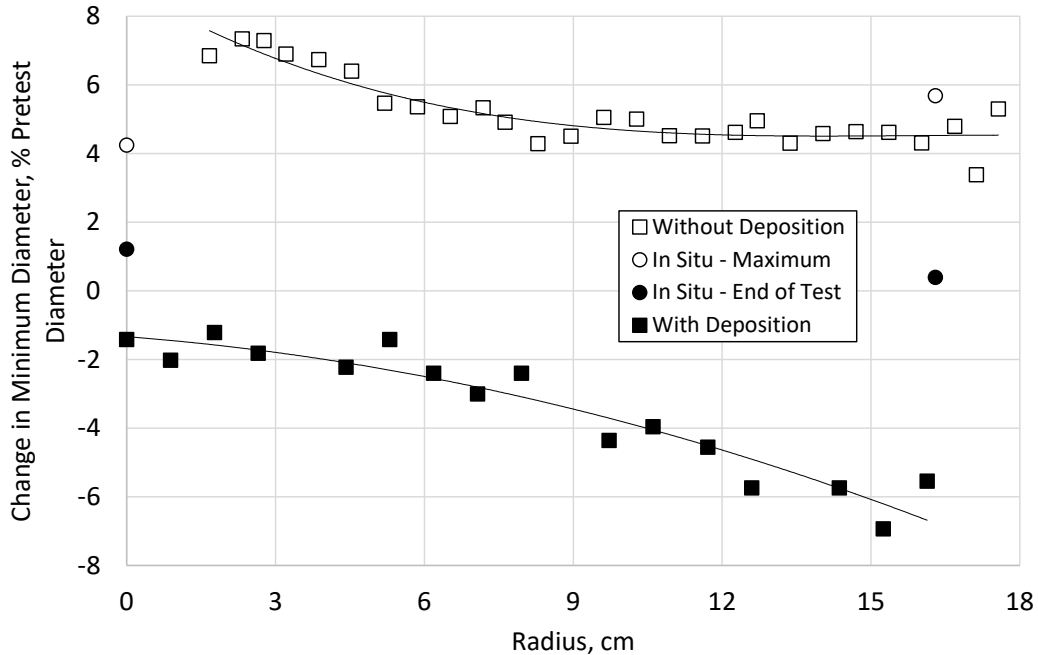
Figure 20 shows that post-test aperture minimum diameters with deposition removed with soda blasting grew by about 5 percent of the pretest value at the outer radius to about 7 percent of the pretest value near the center. According to in situ measurements, these diameter increases occurred during operation at throttled power levels between 13.0 and 29.2 kh. This is an indication that operation at full power for the NEXT thruster did not significantly increase the minimum diameter, although this is not the case for the upstream and downstream surfaces, which is discussed later in this section. The increases in minimum diameters were smaller than those of the NSTAR ELT thruster. NSTAR ELT post-test accelerator apertures diameters increased by as much as 24 percent of the pretest measurements (Ref. 21).

Figure 20.—Change in accelerator grid aperture minimum diameter from pre- to post-test as a function of radial location along radius A (see Figure 2). Also included are the maximum and end of test in situ measurements. Changes in aperture diameter are expressed as a percentage of pretest measurements.

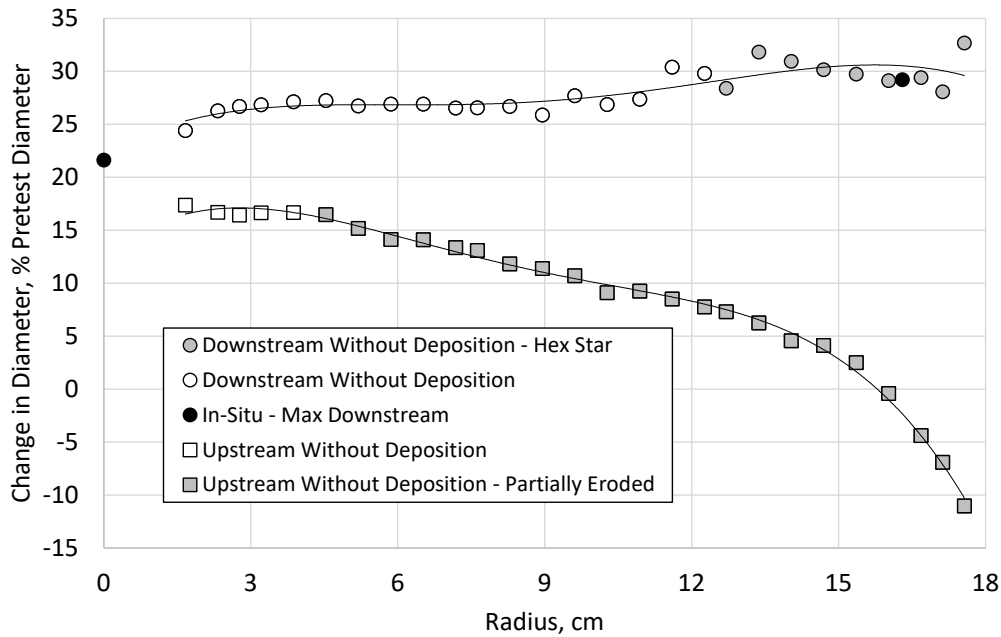
Figure 21.—Change in accelerator grid aperture downstream and upstream surface diameter from pre- to post-test as a function of radial location along radius A (see Figure 2). Also included are the maximum and end of test in situ measurements. Changes in aperture diameter are expressed as a percentage of pretest measurements.

This was likely due to the larger beam current densities of the NSTAR ion thruster and smaller pretest diameters compared to NEXT. Peak beam current densities at full power were 5.9 mA/cm^2 for the NSTAR ELT thruster and 4.2 mA/cm^2 for the NEXT LDT thruster (Refs. 8 and 20). This and the 11 percent larger beginning of life NEXT accelerator aperture diameters led to modest minimum diameter enlargement of the NEXT LDT ion optics (Ref. 5).

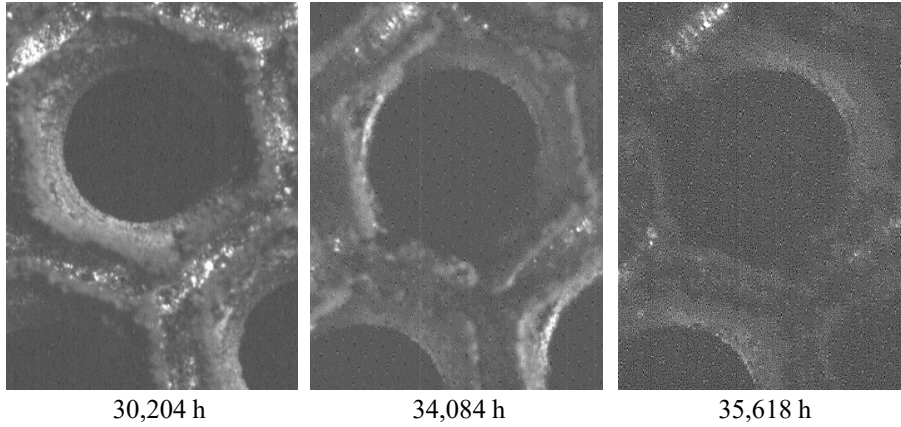
The NEXT LDT was equipped with in situ cameras that could image the accelerator grid apertures throughout the test. The cameras that image the aperture and cold grid gap at the ion optics center could potentially be used to evaluate when net carbon deposition had occurred within the pit and groove erosion pattern. Unfortunately, the lighting for the cameras was severely degraded at 30.8 kh and this severely limited the quality of the images thereafter. Figure 22 shows an image of the center aperture just prior to the failure of the imaging system's lighting. This image, and all images prior to this time, show net erosion within the pit and groove erosion pattern. The darker areas within the erosion pattern are due to shadowing from the surrounding walls and the granular texture of the eroded grid surface. Following the lighting system degradation, attempts were intermittently made to illuminate the erosion pattern using external lighting. Figure 22 also shows the latest images following the lighting system degradation when the external lighting was sufficient enough to illuminate the pits and grooves erosion pattern. The images taken at 34.1 and 35.6 kh only show some of the groove pattern, but the visible grooves show no net carbon deposition.

Figure 22.—In situ center accelerator grid aperture images taken at 30,204, 34,084, and 35,618 h. The image at 30,204 h was taken just prior to degradation of the imaging system's lighting. The dark gray structures surrounding the pits and grooves and on the aperture walls are back-sputtered carbon. External lighting was used to obtain the two images to the right.

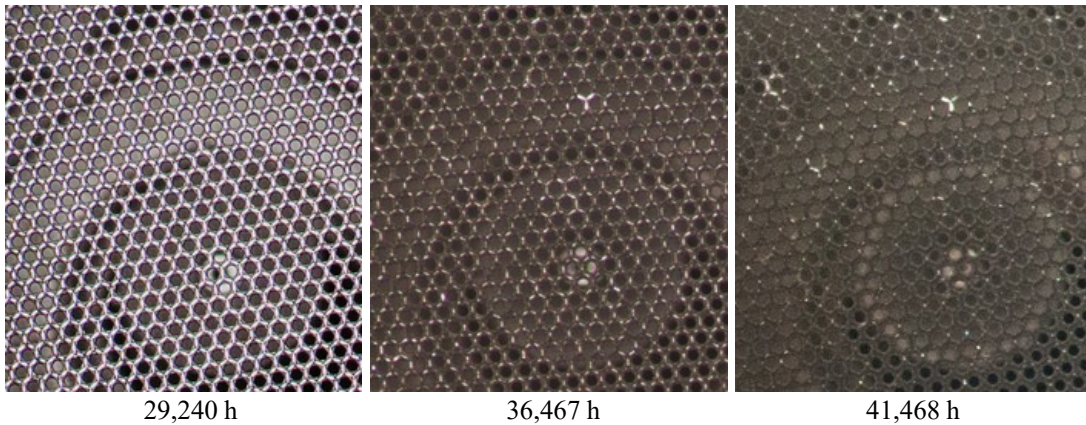
To understand the root cause for the net deposition within the pit and groove erosion sites, long range images were further evaluated. These images of the accelerator grid show that during the second full power segment (i.e., after 29.2 kh), the transition radius from net erosion to net deposition increased. During full power operation at 41.6 kh, the net erosion area was an annulus, with the grid center exhibiting net deposition as shown in Figure 24. This is in contrast to the end of the first full power test segment at 13.0 kh, also shown in Figure 24. Because neither the back-sputter rate nor the accelerator current had changed (Ref. 8), the only known mechanism that could have caused this was a change in accelerator current density distribution across the downstream surface of the grid. Unfortunately, the cause for this change is presently unknown.

Figure 23.—Long-range images of the accelerator grid. The images were taken at 29,240, 36,467, and 41,468 h. The discharge cathode assembly is visible behind the grids.

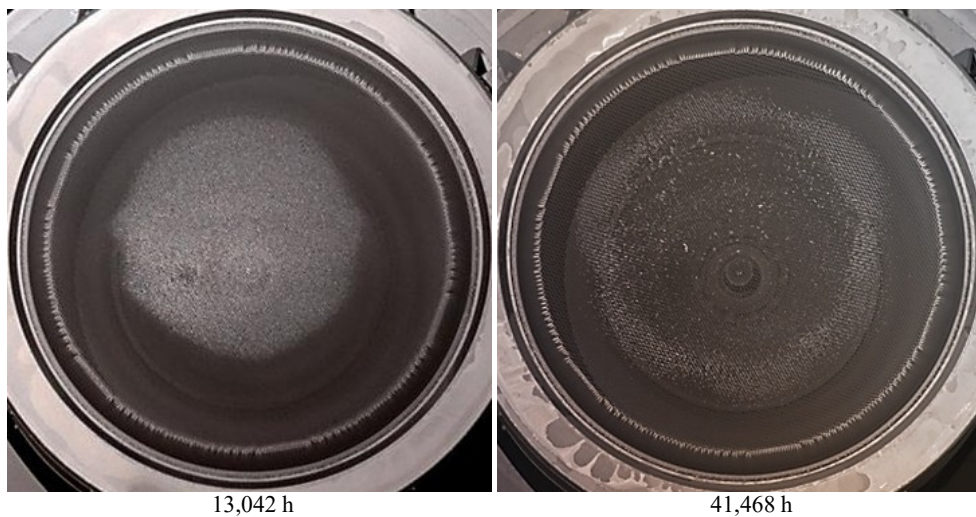
Figure 24.—Long-range images of the accelerator grid. The images were taken at 13,042 h at the end of the first full power segment and at 41,468 h during the second full power segment. The discharge cathode assembly is visible behind the grids. Note the larger diameter annulus of net erosion at 41,468 h.
