American Airlines Flight 587 Crash Investigation: NASA Langley Research Center Participation and Perspective

Guest Lecture

Clarkson University: AE 466

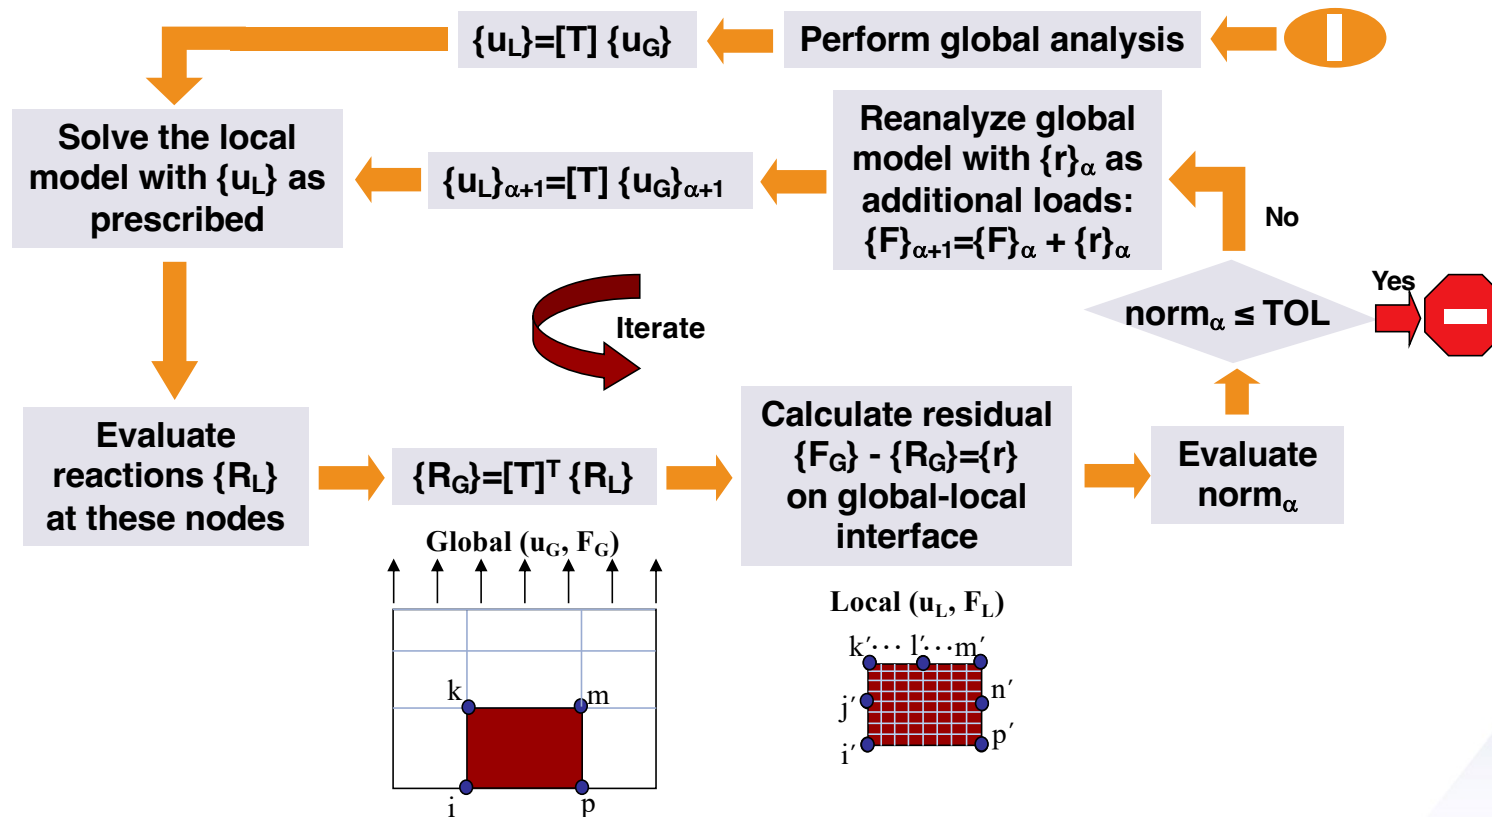
Global-Local Analysis Process

- Used to provide flight loads to the local models and more accurately represent local lug stiffness in the global model

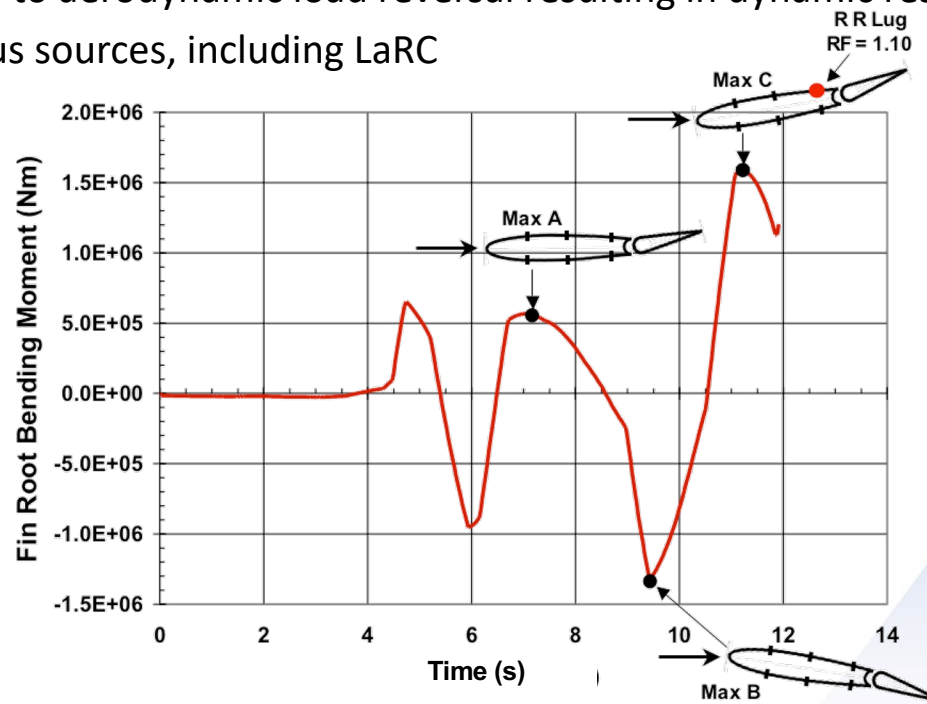
Main Attachment Fitting Failure: Pristine VTP

- Used the LaRC original finite element model
- Flight simulation based on flight data recorder (FDR) data
 - Time history of fin root bending moment, torsion and shear loads
 - Bending moment increased due to aerodynamic load reversal resulting in dynamic response
 - Loads were developed by various sources, including LaRC
 - Linear analyses conducted at maximum locations (A, B, C)
 - Lowest reserve factor (RF) at right rear lug at Max C
 - Minimum RF = 1.1
 - Most likely failure scenario

(Note: VTP cross-section icons viewed from above throughout presentation.)

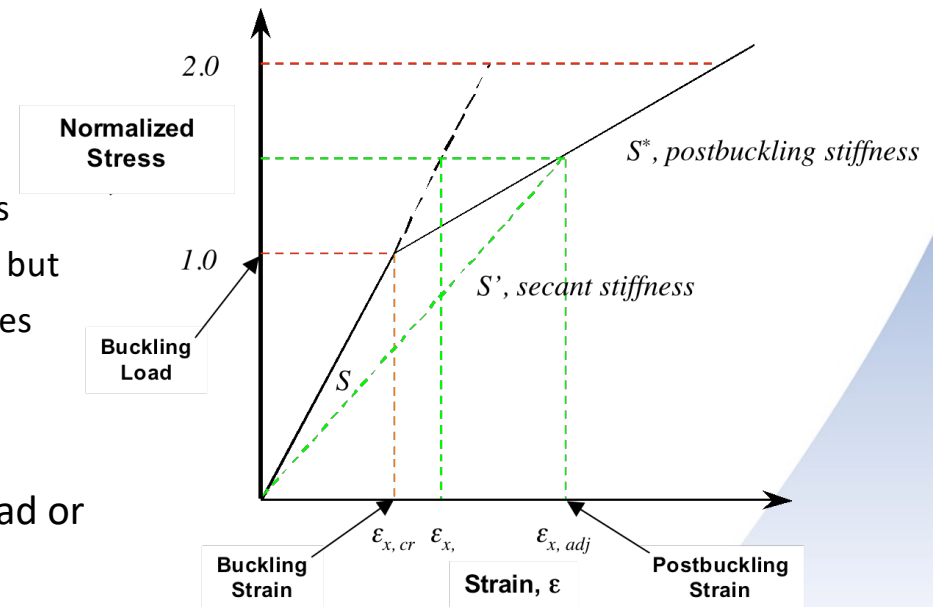
Buckling of Fin Causing Failure Elsewhere

➤ Preliminary analyses of the VTP indicated sections could exhibit buckling at accident loading conditions

- Not necessarily failure, but could cause detrimental load distribution
- Due to reduction in stiffness, so approximated using secant stiffness
 - Applied to regions that might buckle
 - Used 50% of prebuckled stiffness
 - Skin strains increased around regions
 - Conservative allowables and large stiffness reduction indicate skin might have failure, but physical evidence did not show such failures
 - Load redistribution to lugs minimal effect

- Buckling of fin skin did not affect the failure load or mode of the VTP

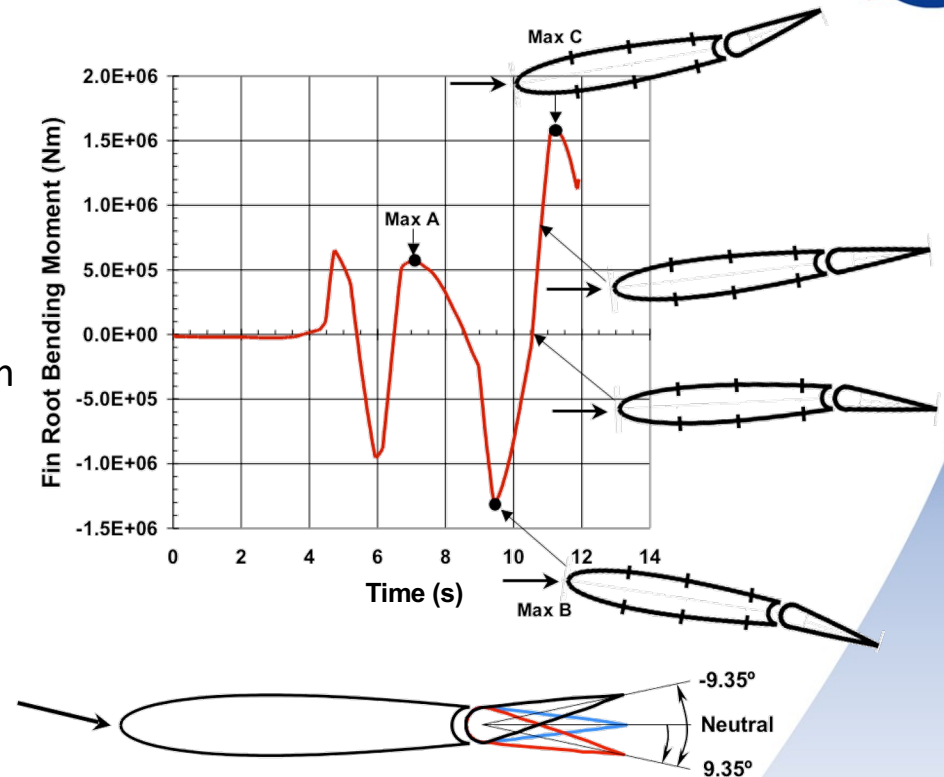
Actuation of Bent Rudder

➤ Examine if bent VTP could affect rudder motion

- LaRC original finite element model used
 - Maximum loading condition used
 - VTP only used, lugs restrained
 - Actuation by thermal load to actuator beam
 - Nonlinear analysis
- Rudder stiff in torsion, low in bending
 - Conforms easily to bent condition
 - Required fitting forces are small
 - Effect negligible to response

- Rudder binding did not affect the VTP response

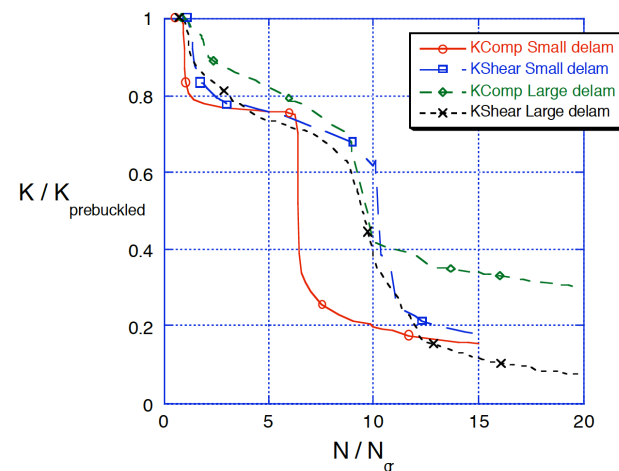
Flutter of VTP From Delamination of Rudder Skin

- **Skin delaminations could cause flutter and subsequent failure of VTP**
 - Two delamination sizes were studied
 - Approximate shear and compression stiffness reductions in global analysis
 - Local model used to develop stiffnesses
 - Effective stiffness function of normalized load
 - Skin stiffness reduced and core eliminated
 - Modal results provided to aeroelasticity group
 - Little effect on overall flutter response of VTP
- **Finding:**
 - Flutter-induced failure not likely initiator of the VTP

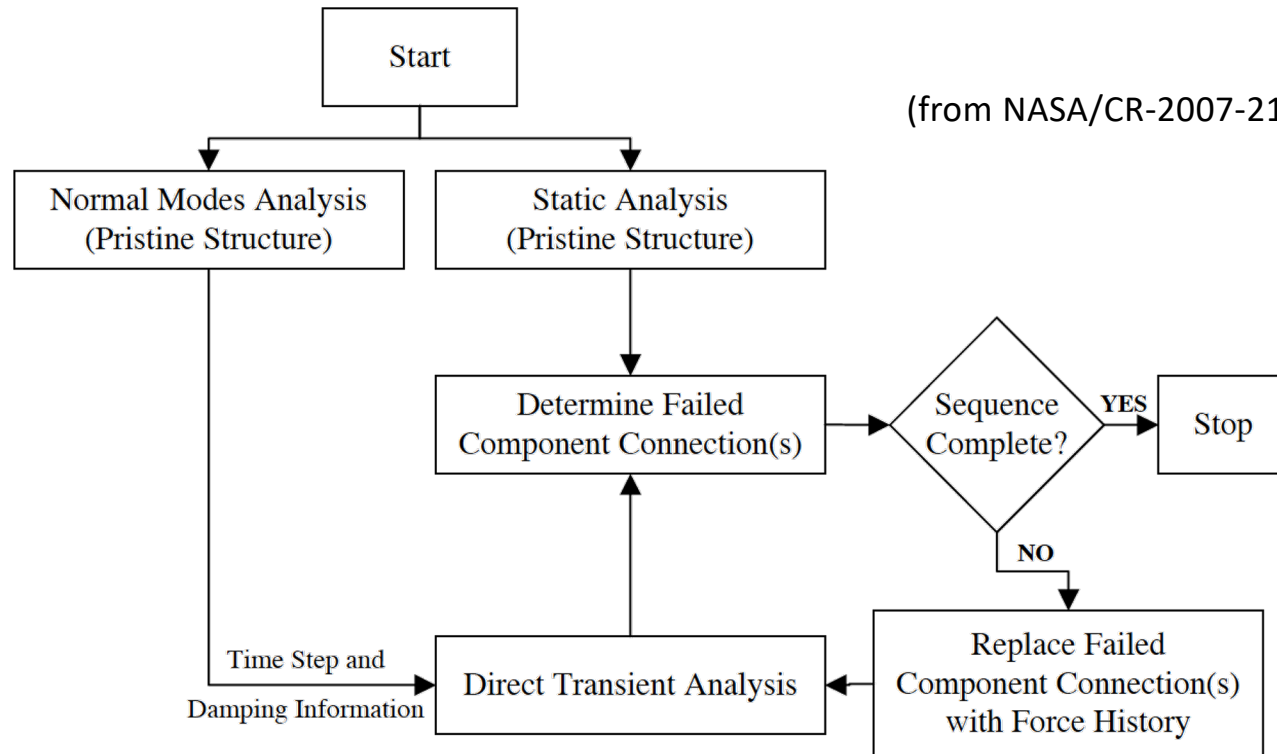
Transient Failure Sequencing: Process

➤ Modified the LaRC refined finite element model

- Multi-point constraints connect VTP to fuselage clevises
- Failed component multi-point constraints replaced with force-time history in next analysis

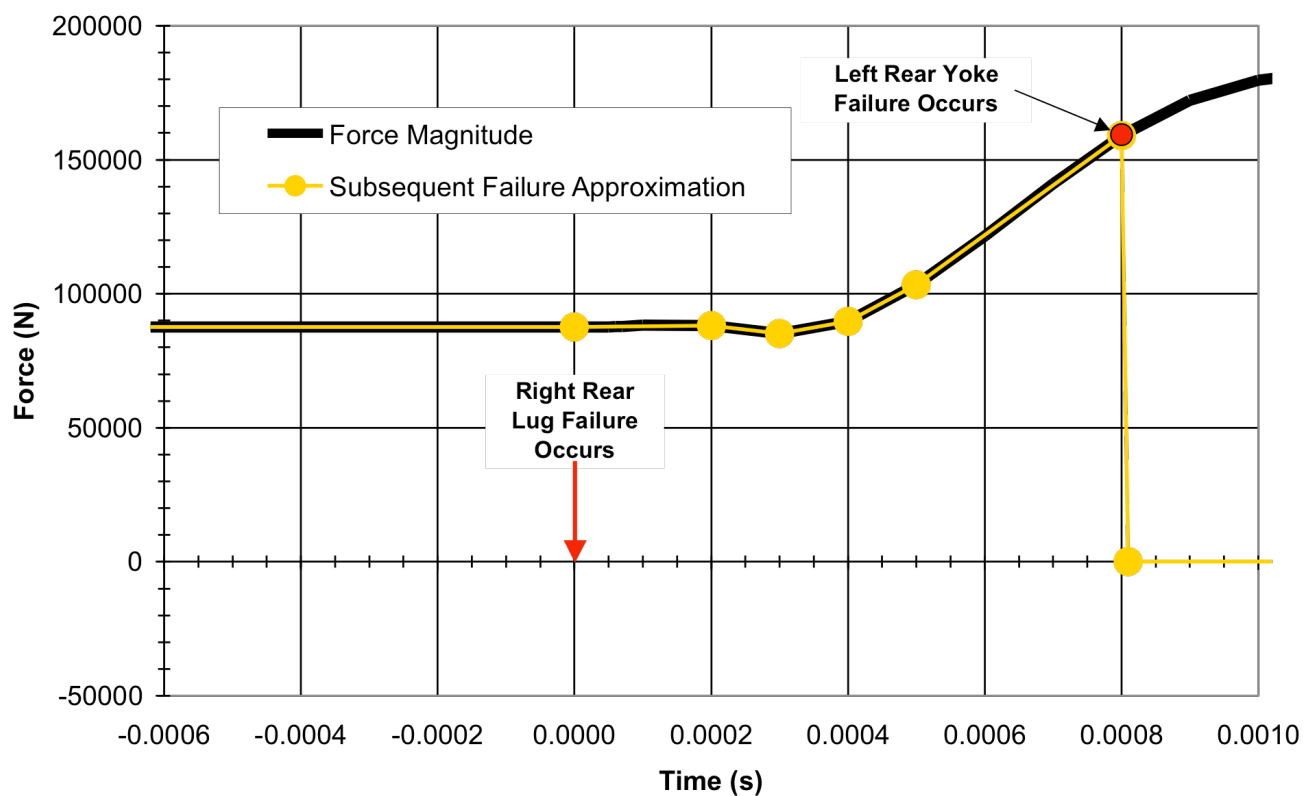
Transient Failure Sequencing: Analysis

- Conducted at Max. C load conditions (right rear lug failure)
- Example of force-time history approximation, left rear yoke
