# Battery Relevant Cell Side Wall Rupture Characterization

**Eric Darcy/NASA JSC**  
**David Petrushenko/White & Associates**

**The Battery Safety Summit**  
**29-30 June 2021**

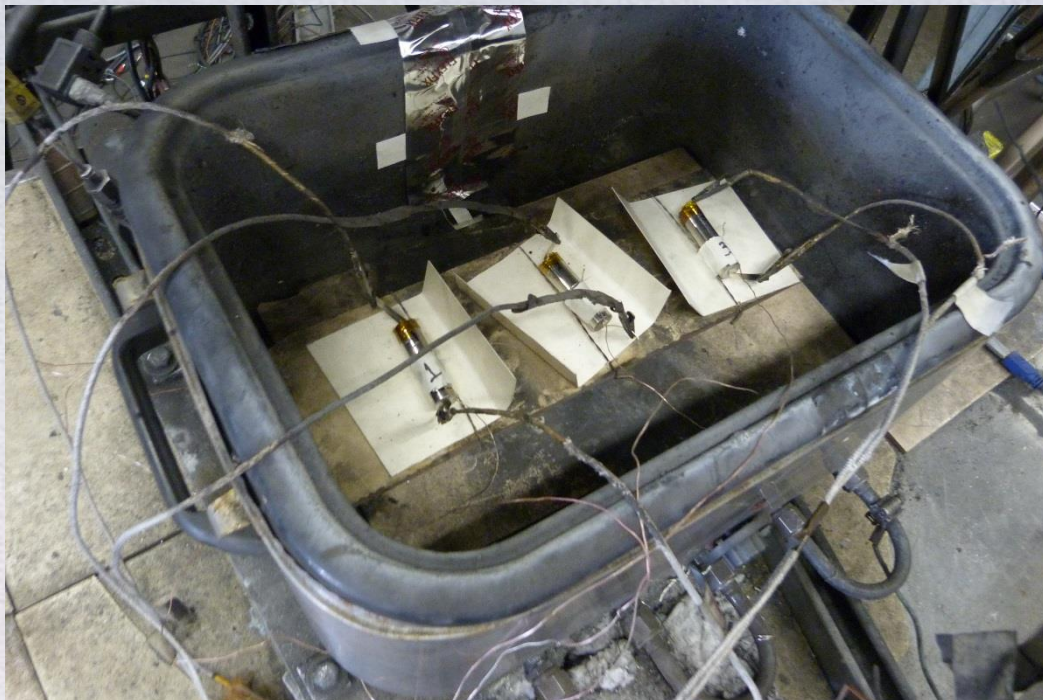
“Turkey Roaster Test”

## – Test Setup:

- Cells are charged to 4.1V.
- Run 3 cells at a time.
- Increase the oven temperature ~ 2-4 deg per minute until cells are going to thermal runaway.

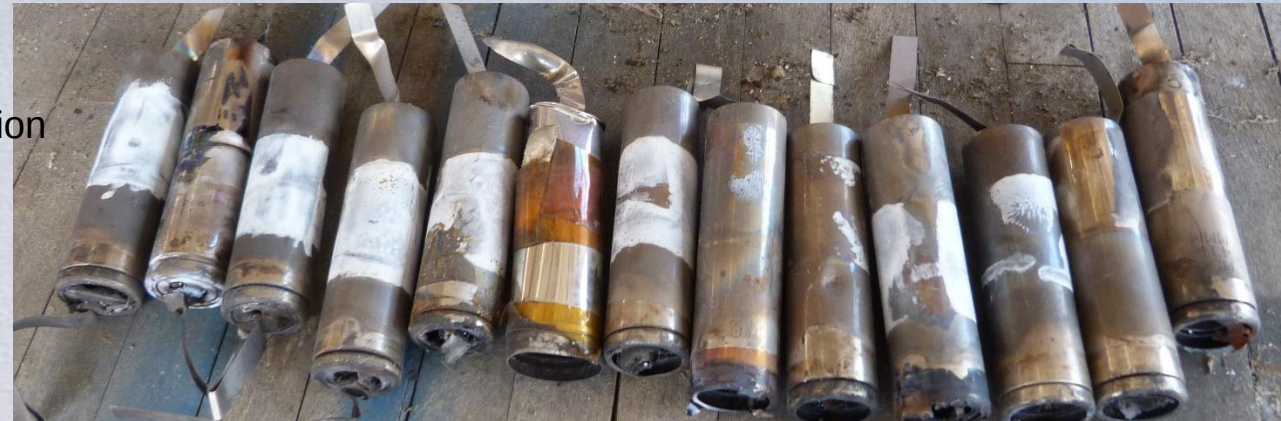
Panasonic NCR18650B with 125  $\mu\text{m}$  can wall thickness

- 18 cells
- 2 side wall breaches,
- 3 bottom breaches,
- all top vent, 10 blew off the Top Caps, 4 JR Ejection

Conclusion: SWR risk is low

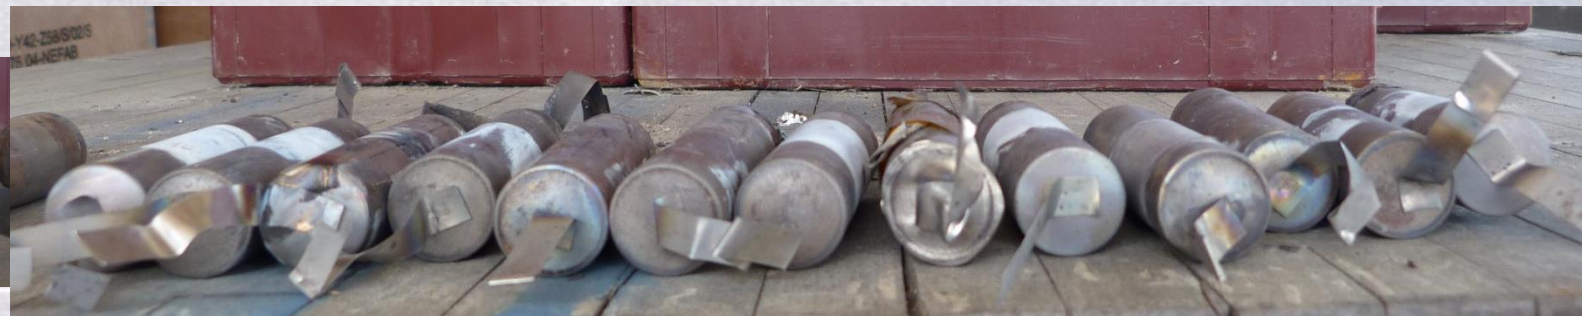
Bottom breach

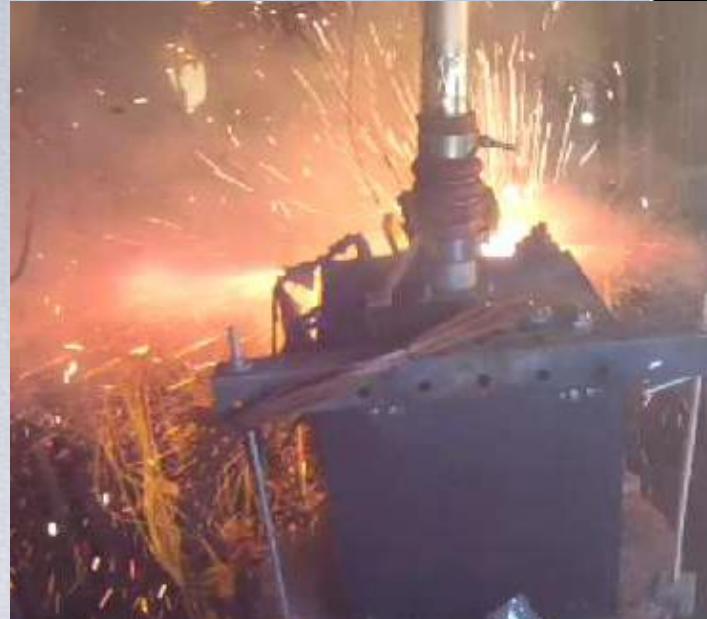
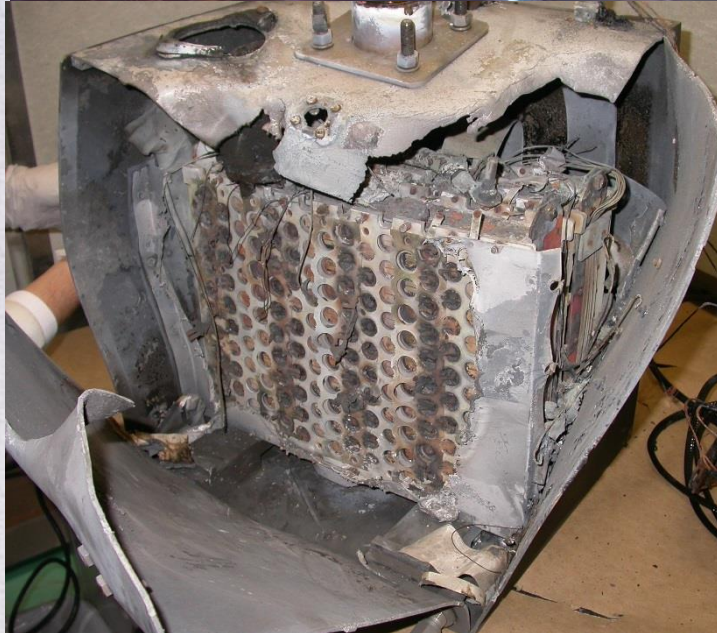
- 320-cell module catastrophically fails during single cell PPR testing
  - Multiple cells propagated TR nearly simultaneously
  - DPA revealed numerous cell can side wall ruptures (> 75%)
- Design did follow guidelines
  - Didn't protect against sidewall rupture
    - Nomex paper (yellow) is weaved in between cell can walls
    - Cell secured at their ends with G10 capture plates maybe held too tightly
  - Didn't provide sufficient heat dissipation between cells
    - Cell heat is dissipated through Ni bussing
    - Ni is a poor thermal conductor

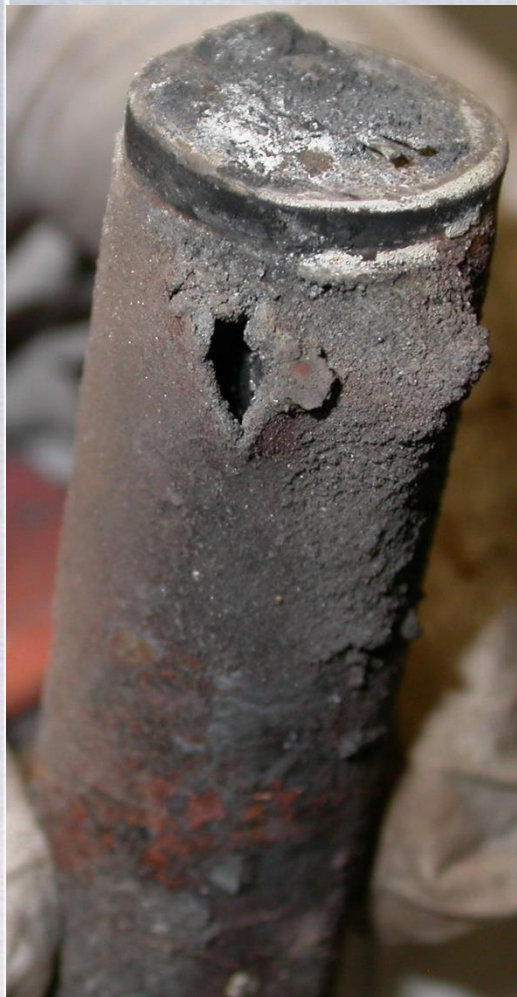
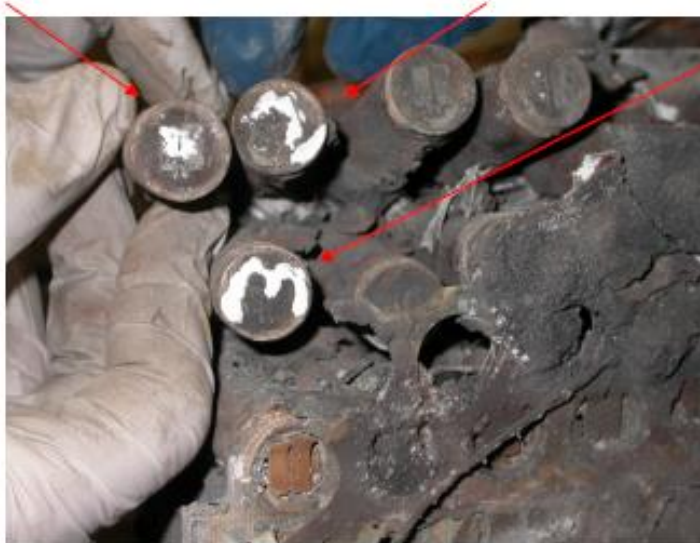
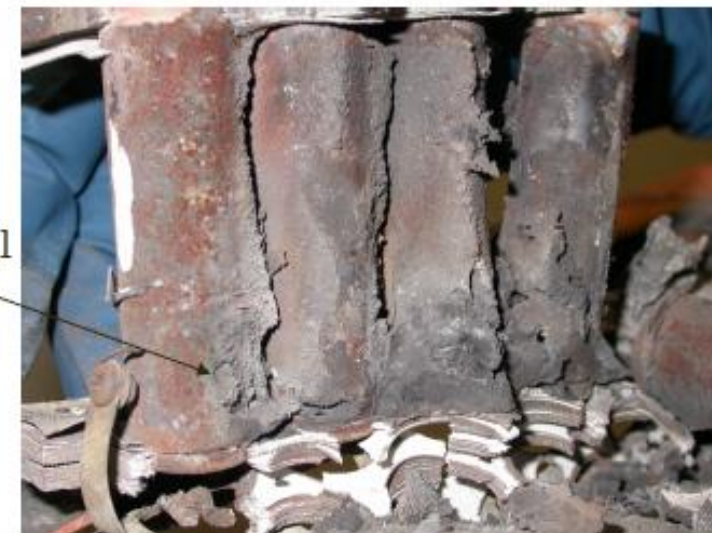
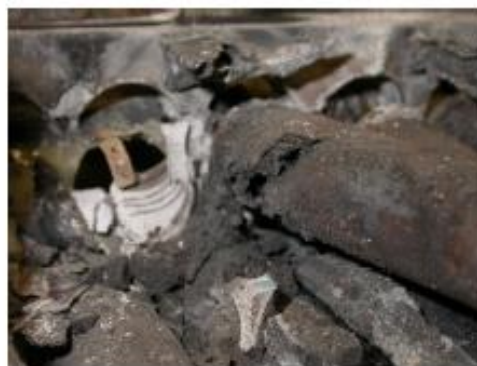
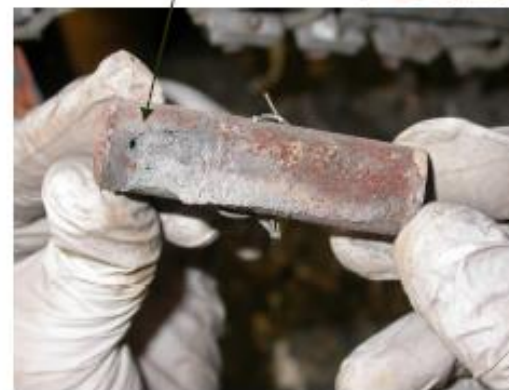
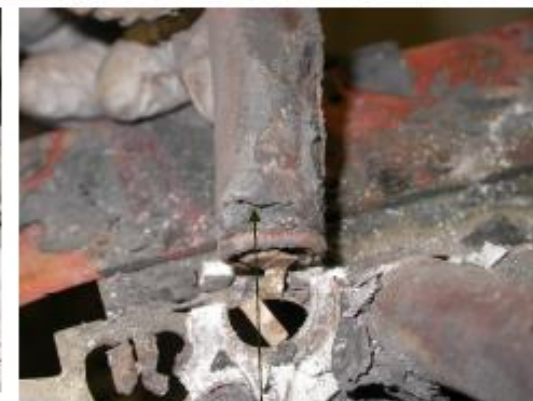
## Pictures of cells – Multiple Sidewall ruptures

T1=Trigger Cell T2=Adjacent cell to trigger

T3=Adjacent cell to trigger

T1- Side wall rupture

T2- Side wall rupture

- No crimp-sealed headers were allowed to burst away
  - Headers were burned through, but not ejected
- Suggests cell headers too constrained by G10 capture plates
  - Capture needs to be less structurally stiff in constraining the cell height

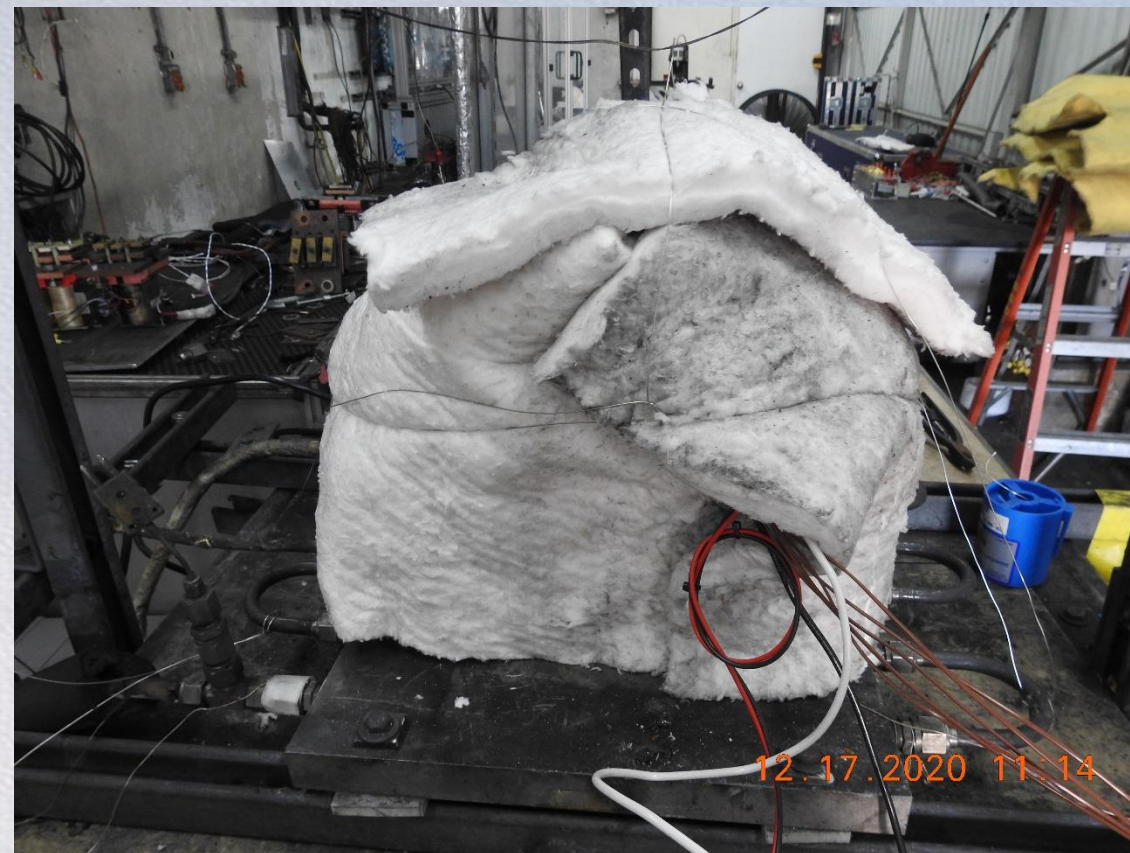
Mica covers (9x)

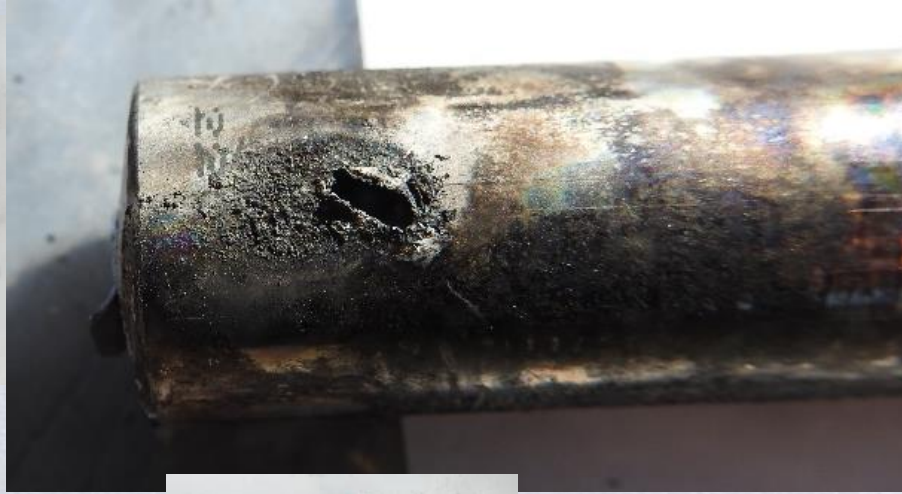
# Examination of NCR A Carcasses – Cell 1

- 2 SWRs
- 2 SGRs

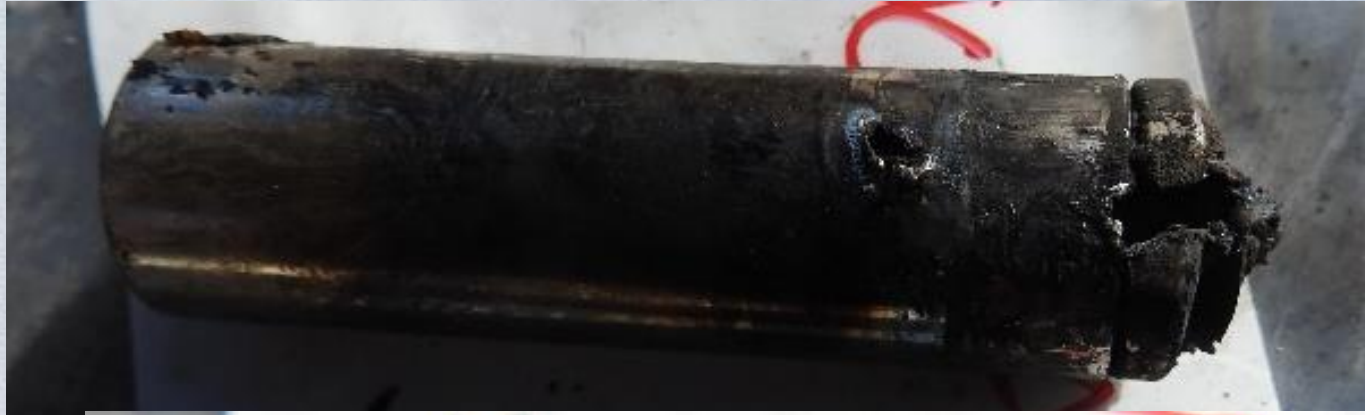
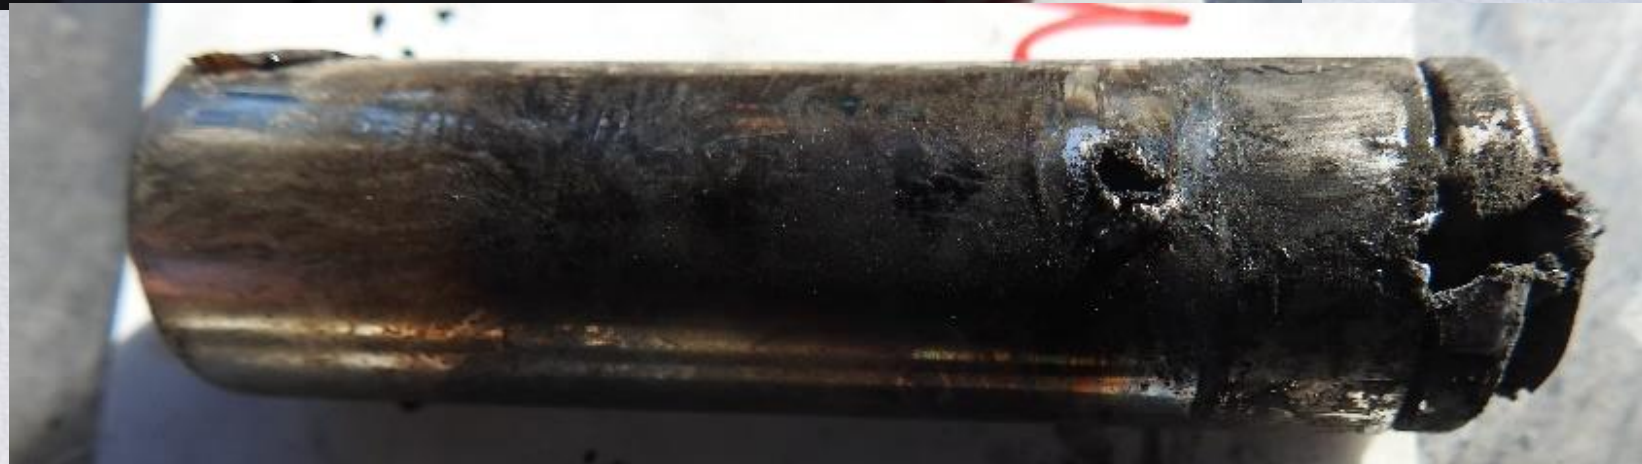
## Examination of NCR A Carcasses – Cell 9

- 1 SGR
- 1 SWR
- 1 header breach

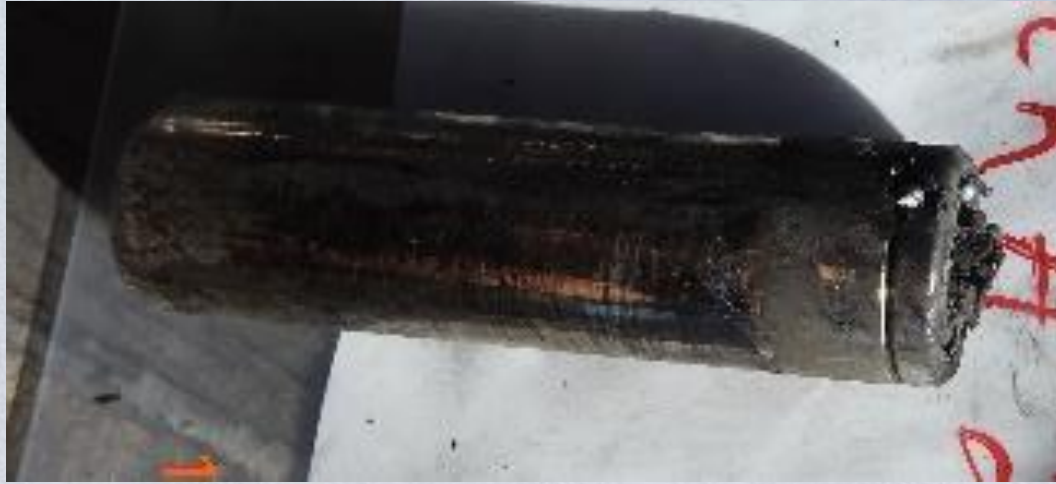
## Examination of NCR A Carcasses – Cell 2

- 1 SGR

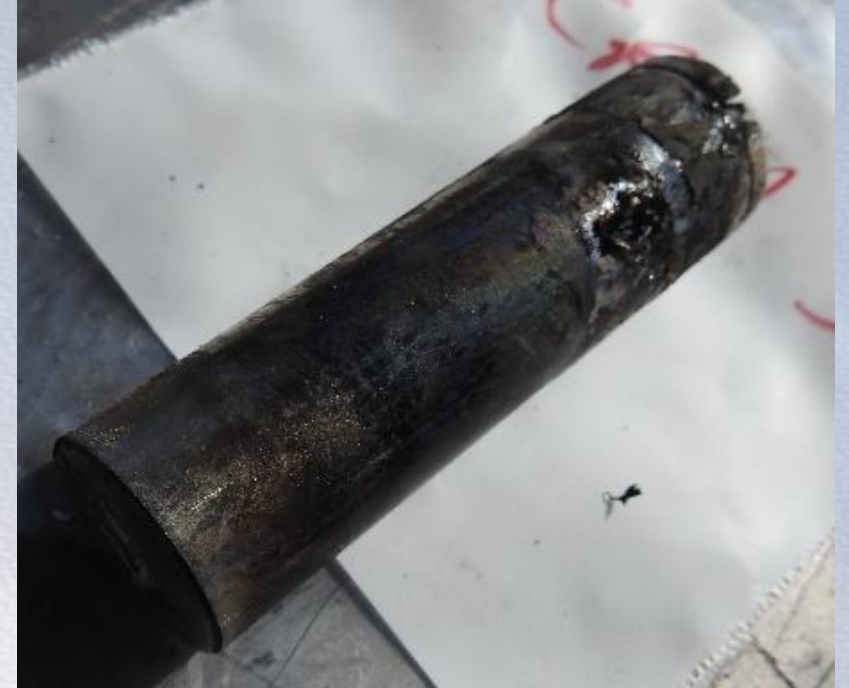
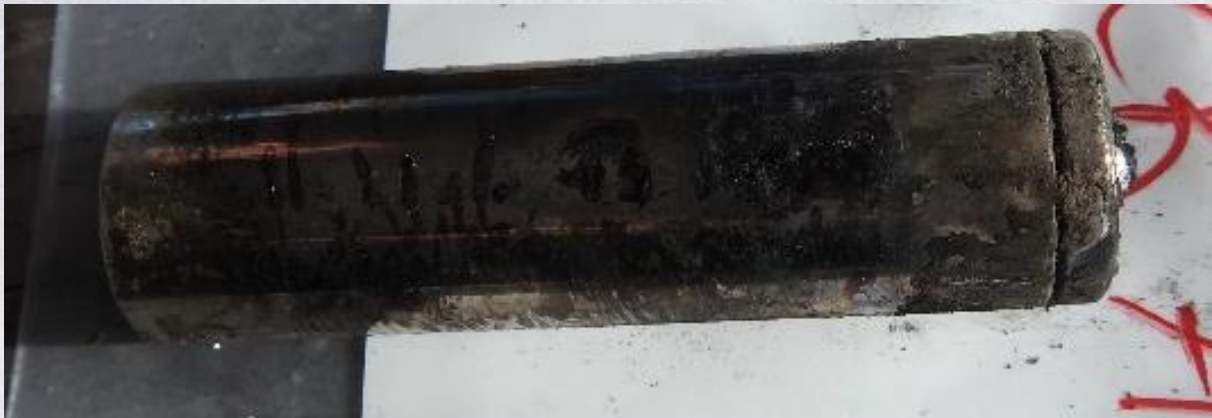
## Examination of NCR A Carcasses – Cell 3

- 2 SWRs

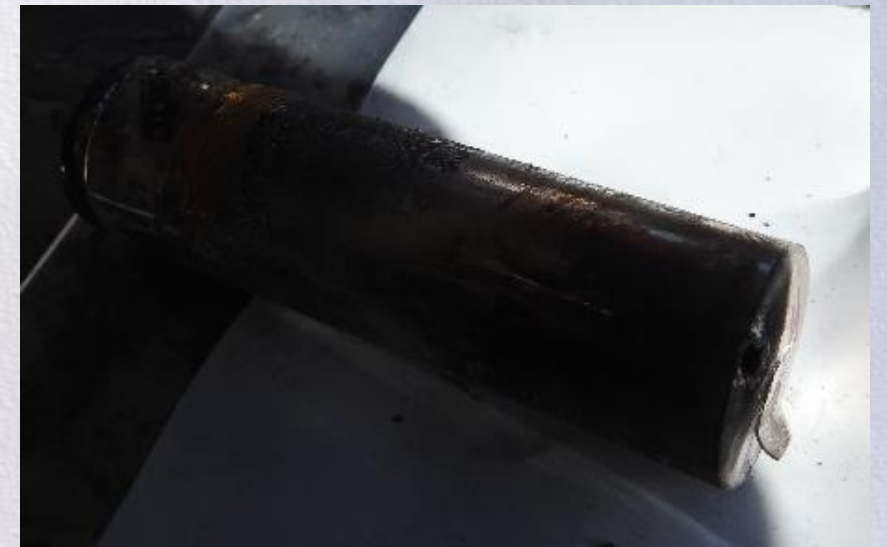
## Examination of NCR A Carcasses – Cell 4

- 1 Bottom breach

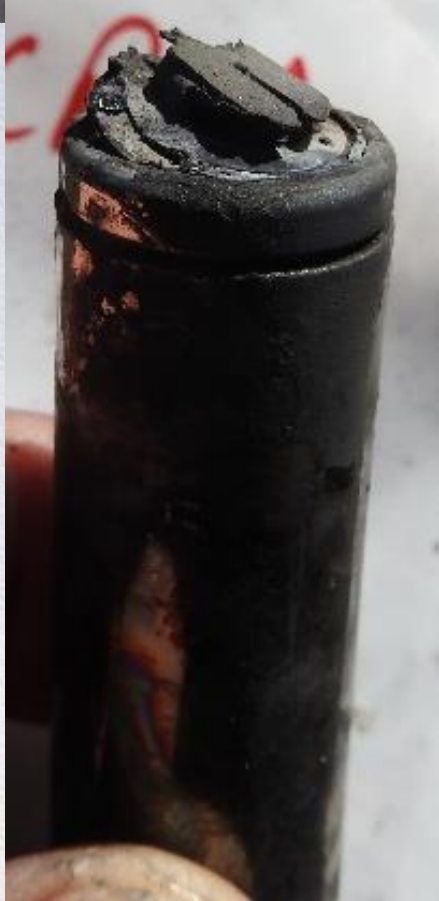
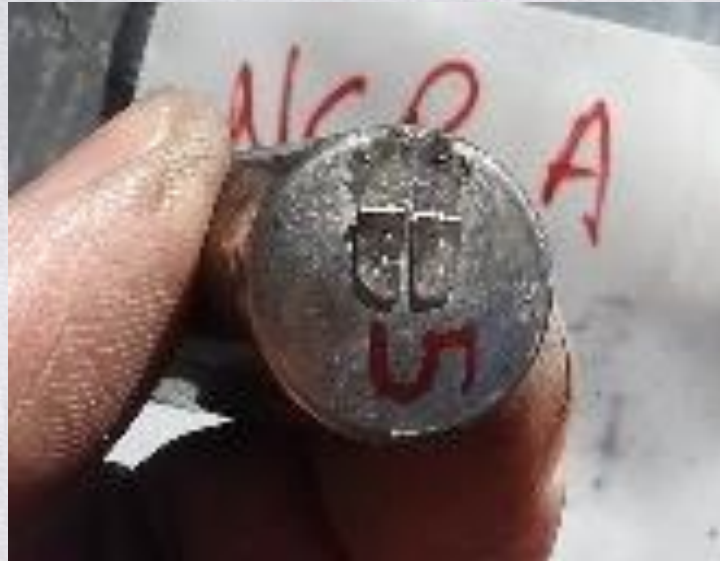
## Examination of NCR A Carcasses – Cell 5

- Nominal vent

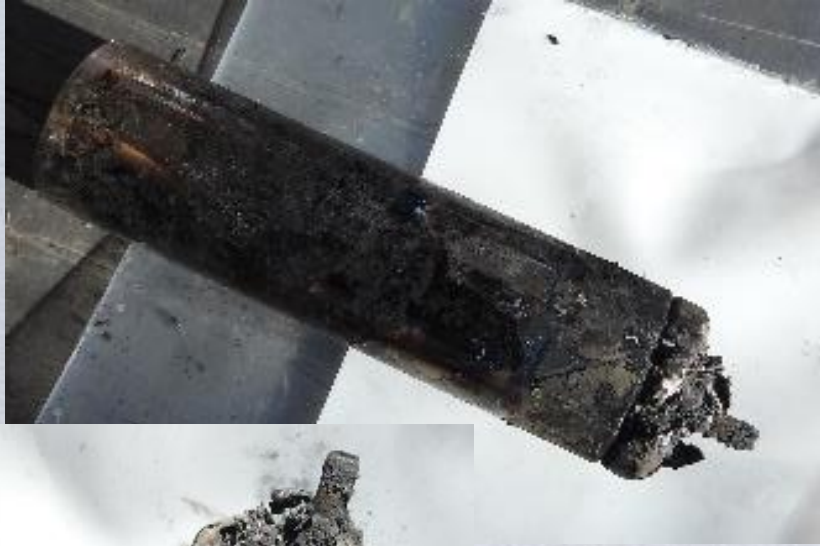
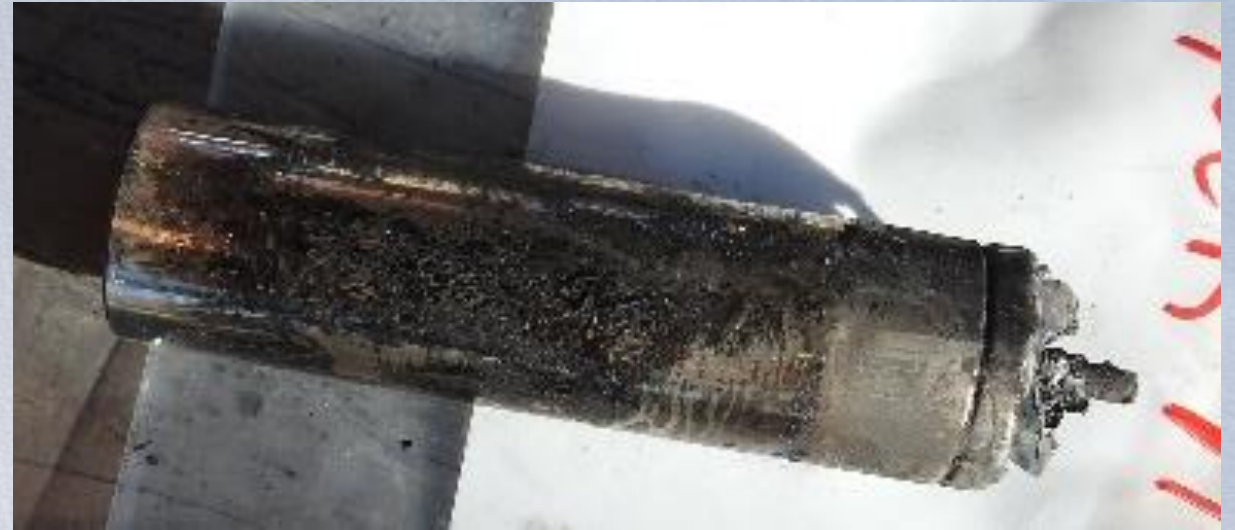
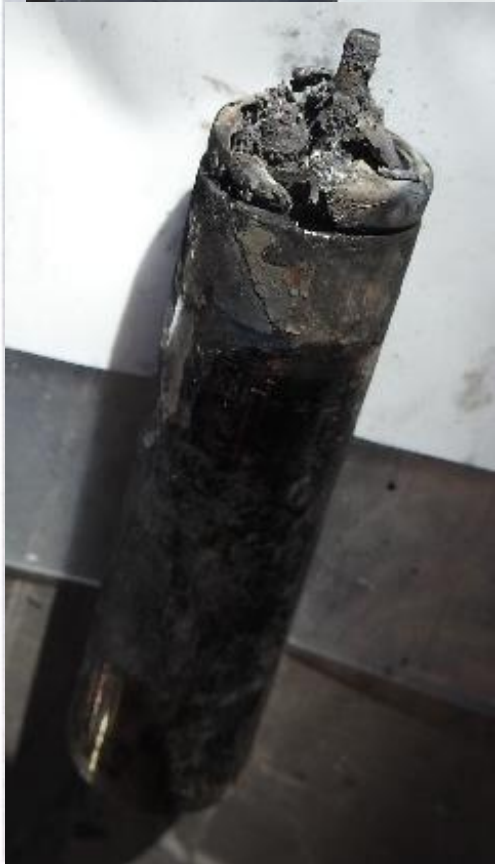
## Examination of NCR A Carcasses – Cell 6

- 1 SGR
- 1 SWR

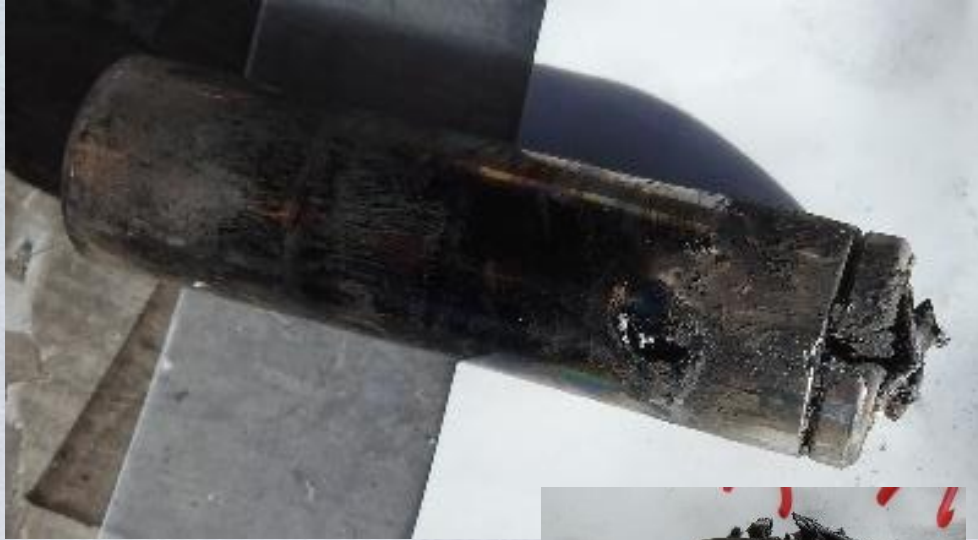
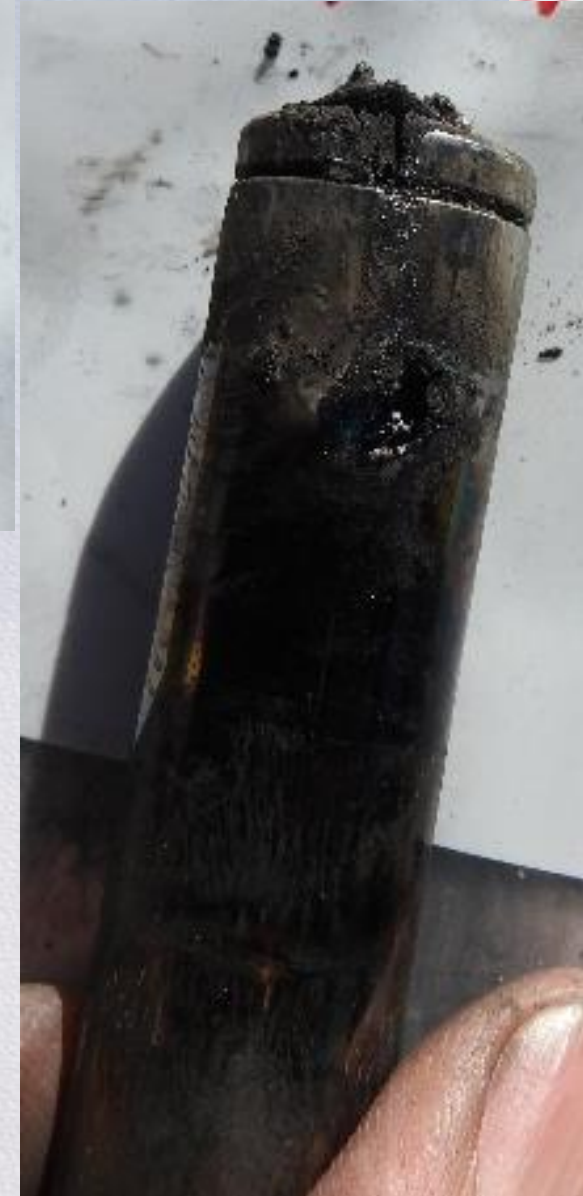
# Examination of NCR A Carcasses – Cell 7

1 SWR  
1 SGR

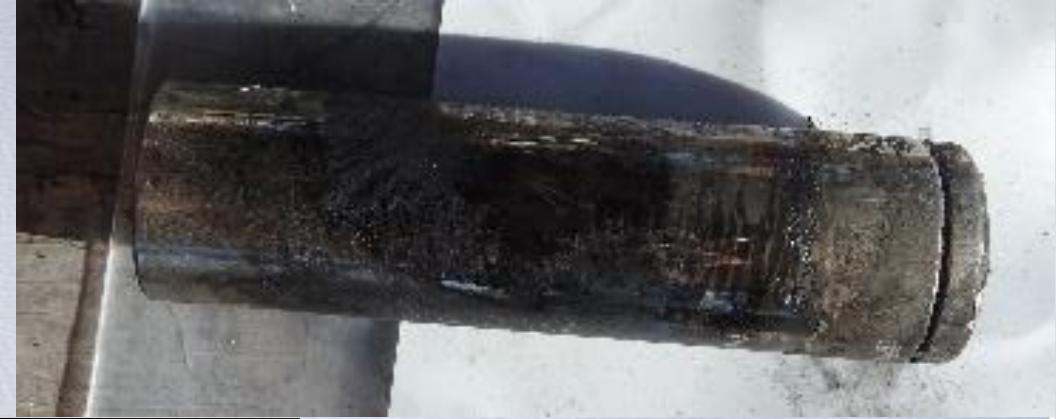
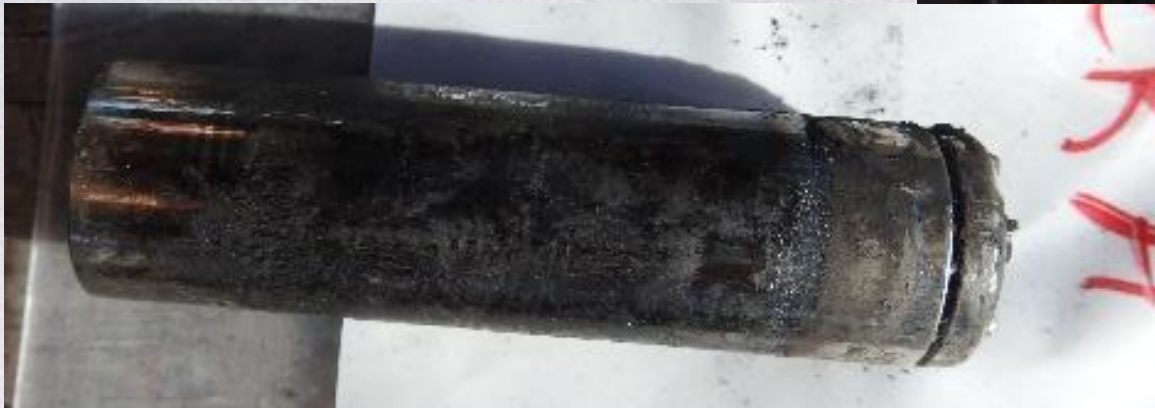
## Examination of NCR A Carcasses – Cell 8

- 1 SGR
