NASA/TM-20210017474

A Summary of ATD Results from a Full-Scale F28 Crash Test

*Justin D. Littell, Jacob B. Putnam
Langley Research Center, Hampton, Virginia*

June 2021

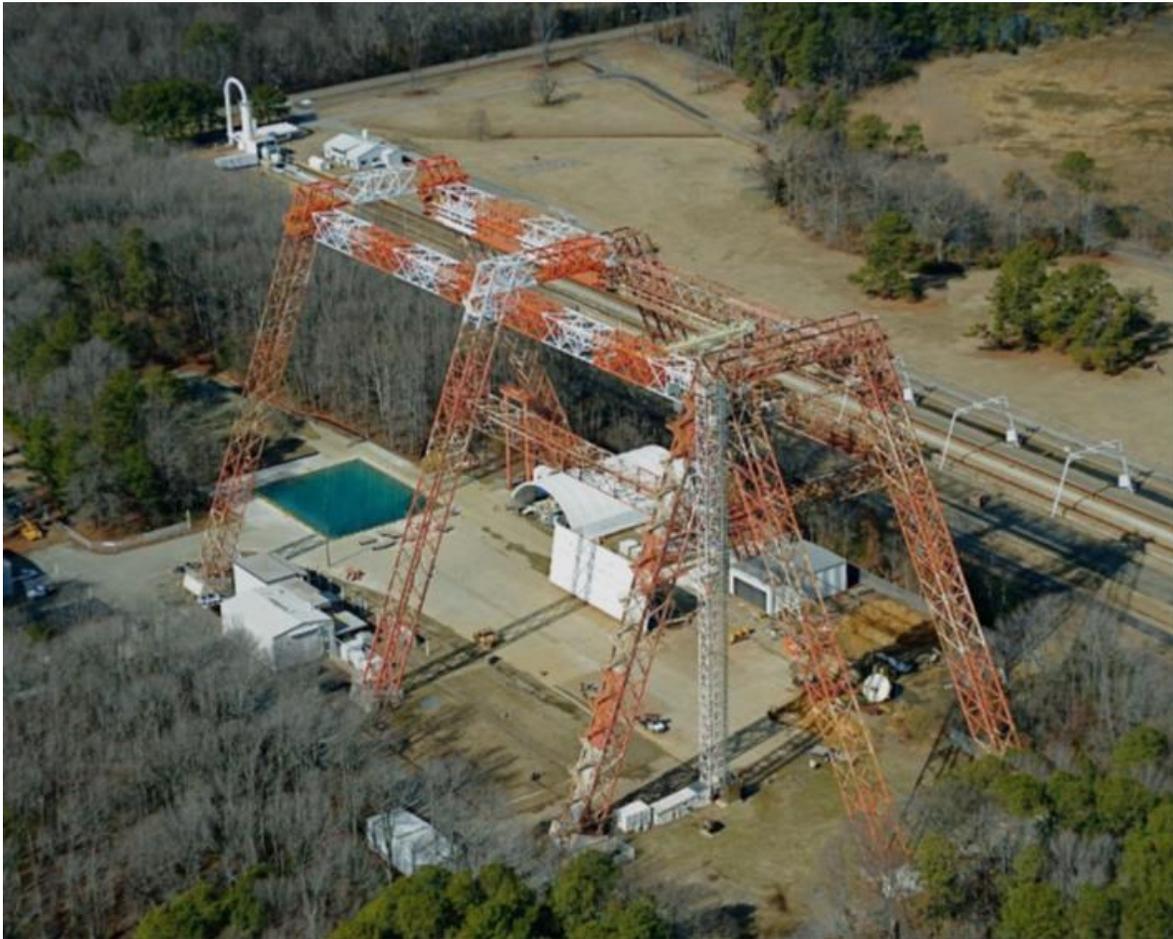
Figure 1. Landing and Impact Research Facility (LandIR)

Fortunately, the Landing and Impact Research (LandIR) facility at LaRC provides the opportunity to study full-scale aircraft crash tests under controlled conditions. LandIR provides the capability of lifting and pendulum-swinging full-scale aircraft up to 64,000 lb in weight. The LandIR facility is shown in figure 1.

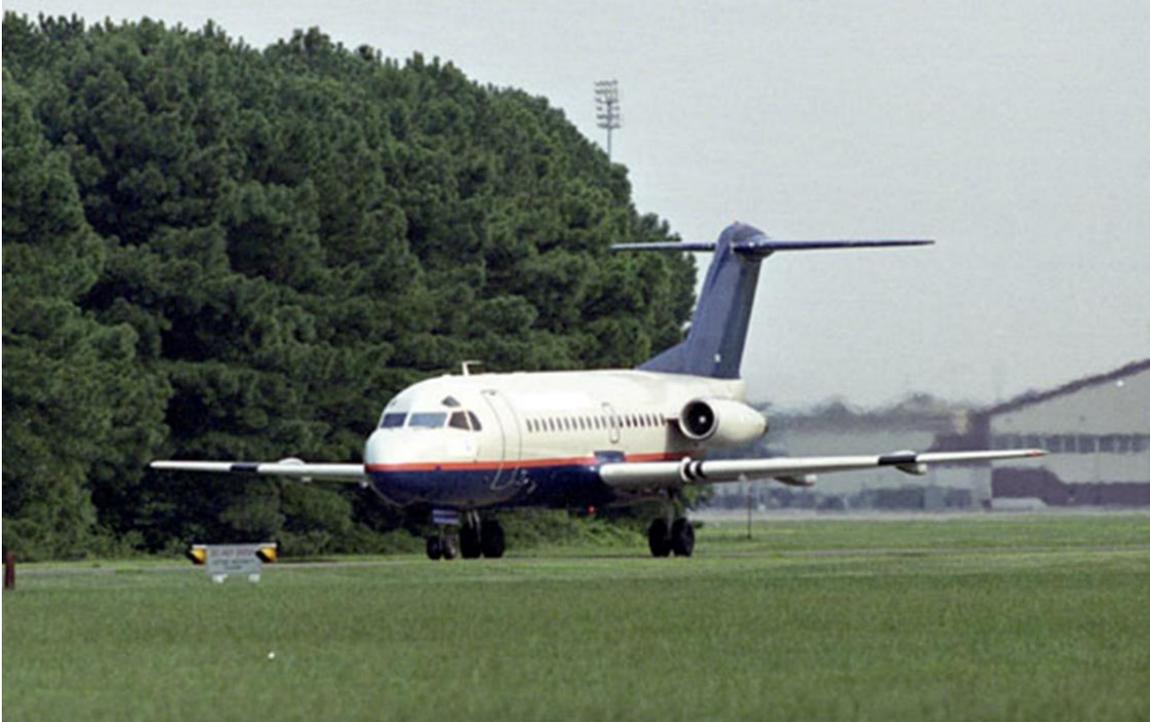
Figure 2. Fokker F28 Tail # C-GCRN taxi into LaRC (2001)

A brief summary of test buildup is provided in this section for completeness. The test article was a Fokker F28 Mark 1000, tail number C-GCRN, purchased by NASA in 2000. Figure 2 shows the aircraft as it taxied into LaRC in 2001 after landing at Joint Base Langley-Eustis (LFI). The aircraft was then placed into outside storage until the test campaign began in late 2018.

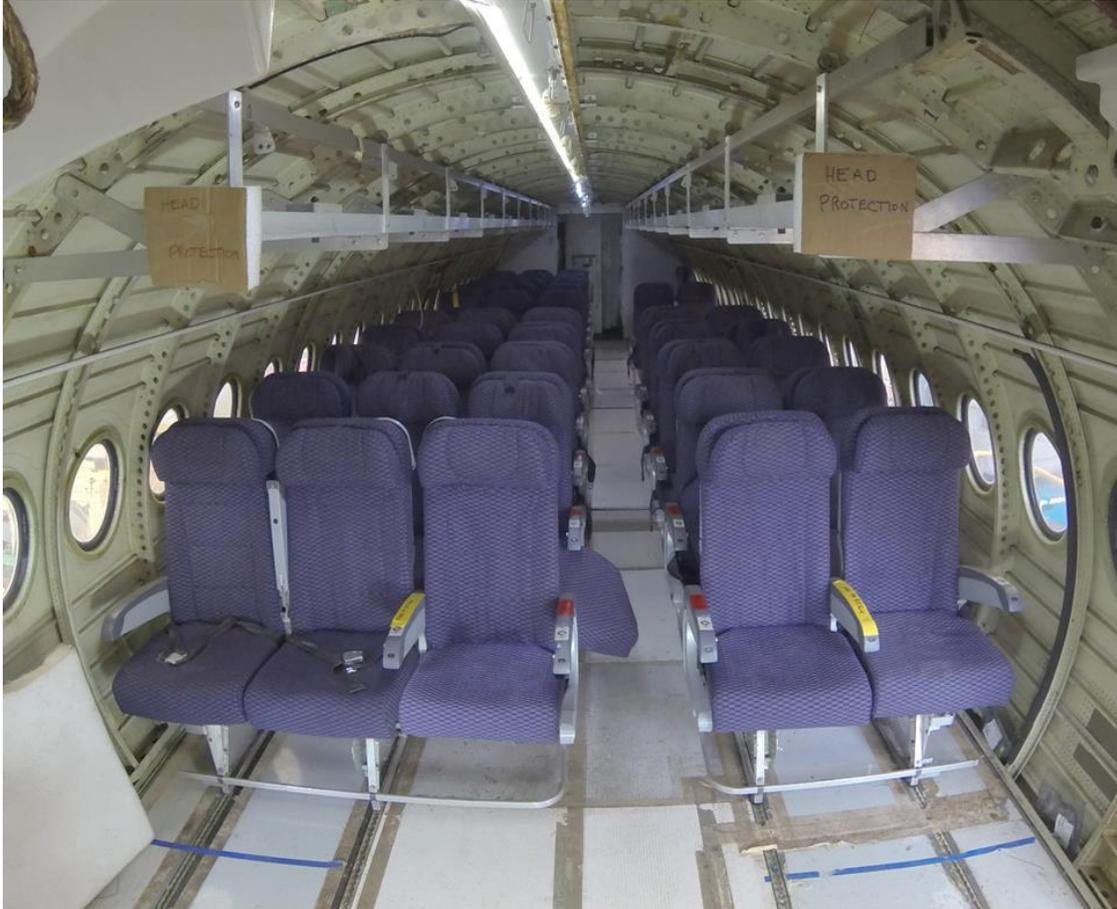
Figure 4. Installed seat configuration

The original seats were removed due to their deteriorated condition from being stored in outside storage. In their place, a set of triple seats that have been 14 CFR §25.562 certified were used. These seats were removed from an in-service Boeing 737 aircraft and modified to interface into the F28 aircraft for the full-scale test. The original seat leg configuration positioned the two seat legs underneath the junction between the middle and window seat for the outboard leg, and between the middle and aisle seats for the inboard seat legs. Reconfiguring these tests essentially shifted both seat legs outboard, creating a cantilevered

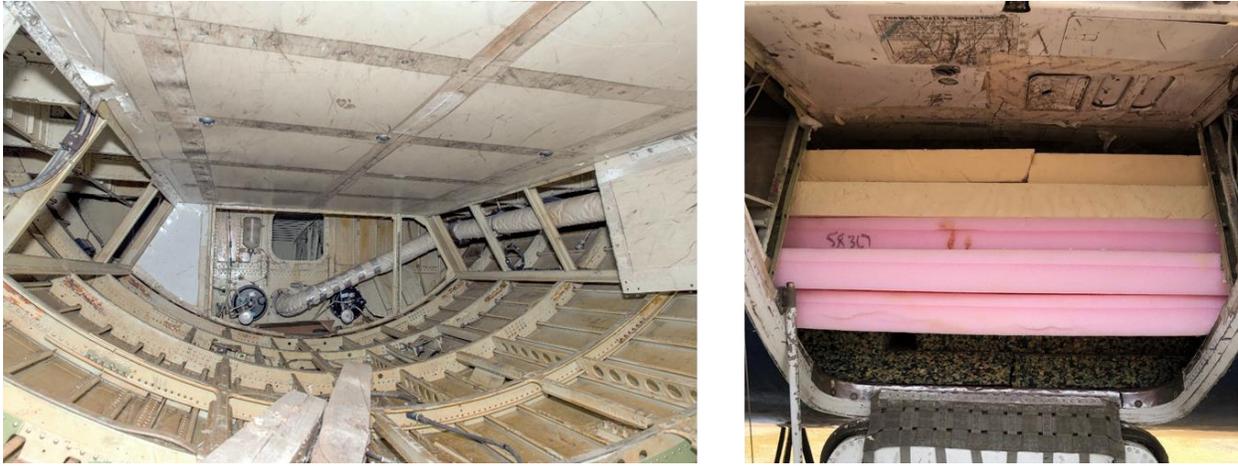
Figure 7. Forward section subfloor structure. Cavity prior to luggage foam install (left) and luggage foam (right)

As figure 6 shows, the first six rows of the aircraft were located in the Cargo Hold portion of the cabin, which has a hollow cavity in the subfloor and is where the luggage was stowed. As previously mentioned, this hollow cavity was filled with layers of foam to simulate a full luggage load, and the only aircraft structure capable of providing support besides the luggage foam was stanchions going between the seat track and the bottom frames. Figure 7 shows the empty Cargo Hold (left) and the foam luggage simulant (right).

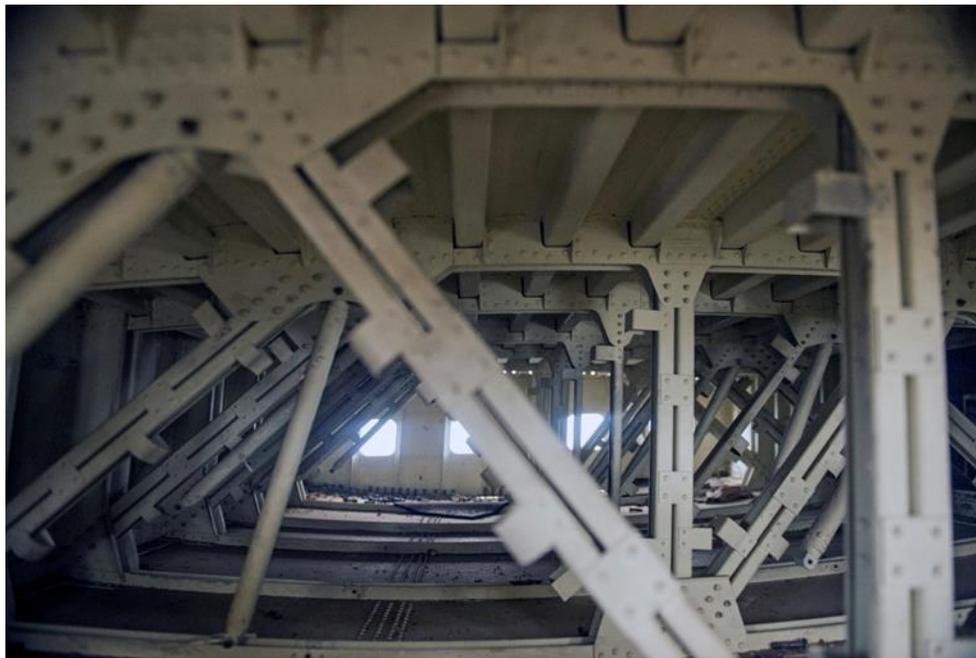
Figure 8. Wingbox stiffened structure

The Wingbox section was located beneath Rows 7–9. Unfortunately, due to the circumstances of the test, there were only two rows on the starboard side and one on the port side available for ATD placement. The wingbox itself had a stiffened truss structure in the subfloor region to distribute the wing loads from the aircraft during flight. It was the stiffest part of the aircraft due to these features. Figure 8 shows the internal wingbox truss stiffeners.

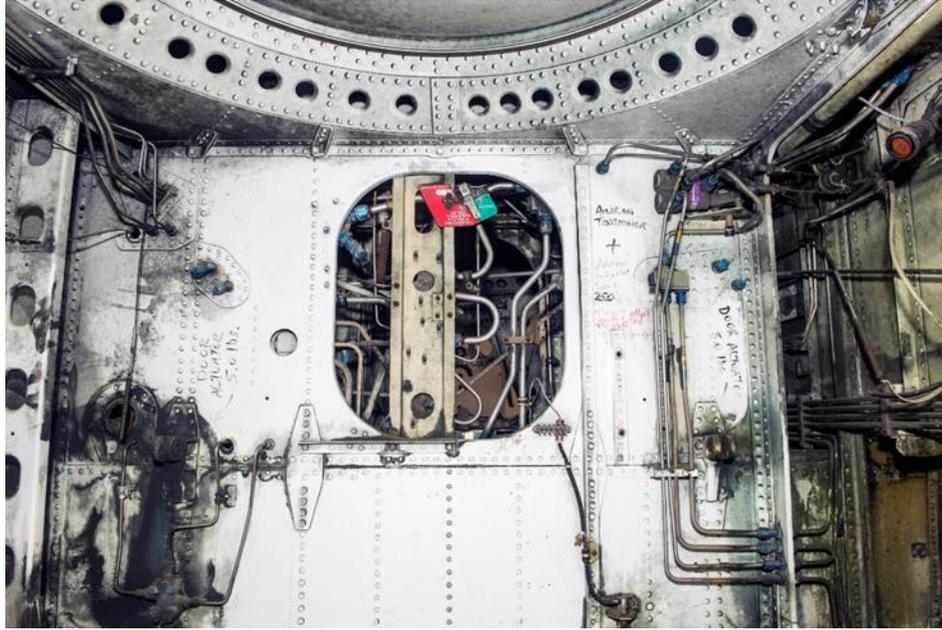
Figure 9. Aft fuselage structure

The Aft Fuselage section near the rear of the cabin ran between the aft portion of the wingbox and the rear pressure bulkhead, which encompassed Rows 10–12. This area contained critical aircraft systems, along with two keel beams and a cavity for the landing gears to retract. It was the only area of the aircraft structure which contained the two keel beams which made it structurally different than the other two sections. Figure 9 shows an internal view of the Aft Fuselage structure, noting that the prominent feature is the vertical keel beam, and the void in the foreground is the landing gear compartment.

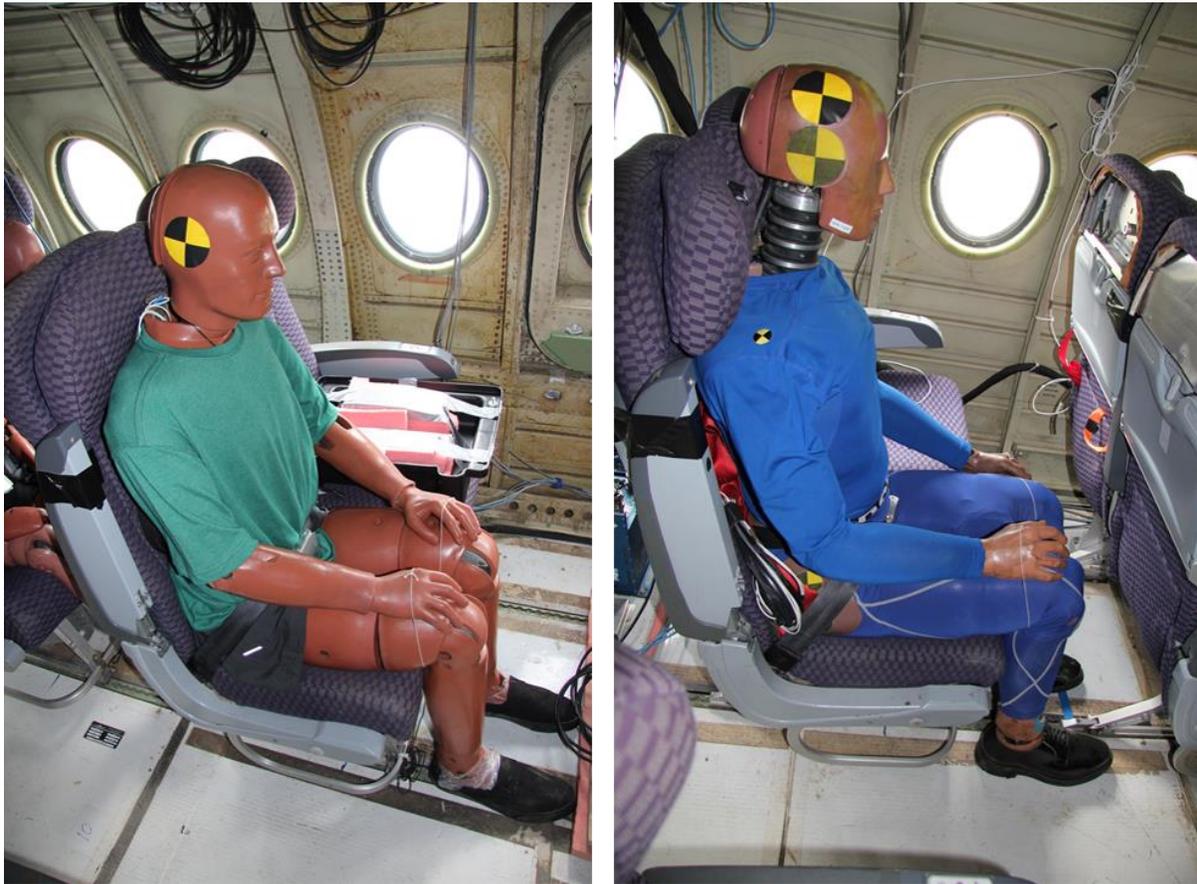
Figure 10. Hybrid II ATD (left) and Hybrid III ATD (right)

included an upper neck load cell and rotational rate sensors in the head. Figure 10 shows examples of the HII and FAA HIII ATDs used in the test.

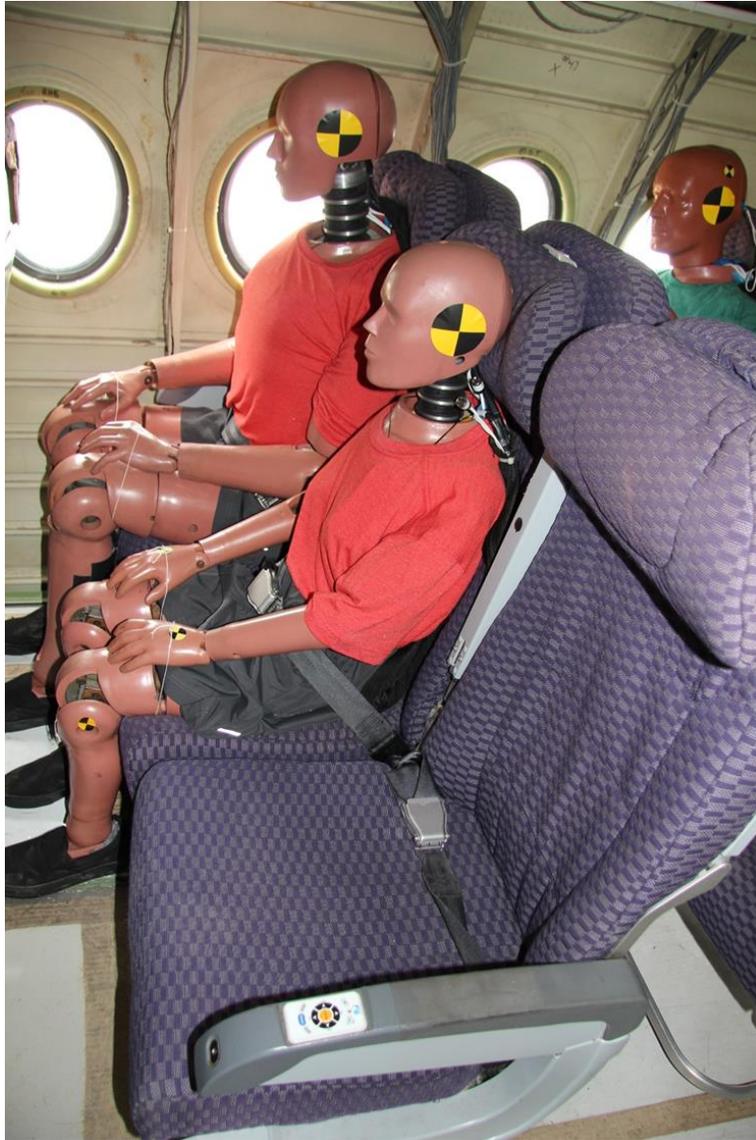
Figure 11. Non-standard size ATDs. 95th percentile, background, and 5th percentile, foreground

In addition to the standard-sized Hybrid III ATDs, there were two non-standard sized Hybrid III ATDs included in the test which were used to identify the effect of anthropometric size on occupant response. The two non-standard sized ATDs were a 5th percentile female and a 95th percentile male. The 5th percentile female was seated in Seat 5B, while the 95th percentile male was seated in Seat 5A. This configuration mimicked the configuration used on the vertical section drop tests, and therefore measurements obtained can be directly compared to those vertical drop test measurements. Figure 11 shows the non-standard sized 95th and 5th percentile ATDs.

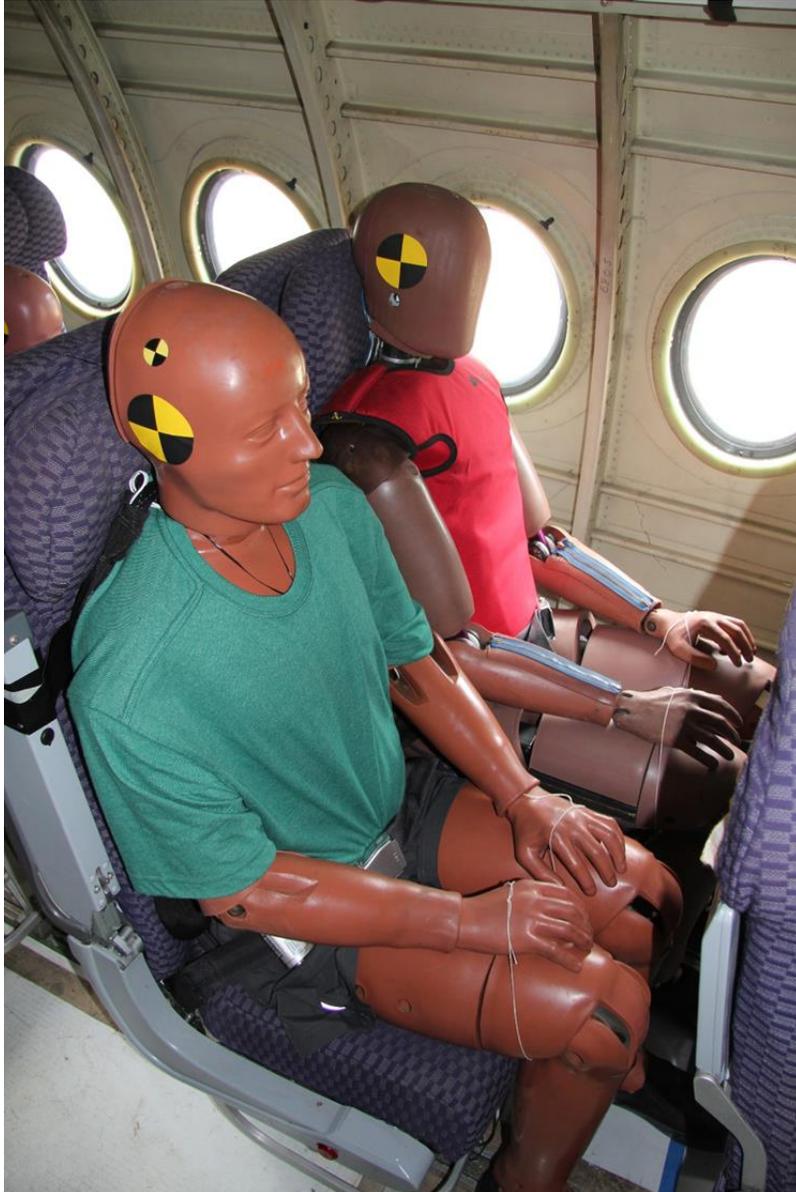
Figure 12. Hybrid II 50th percentile, foreground, and THOR-K, background

A THOR-K [14] was recently developed for automotive certification applications, and utilized in the test to evaluate its performance under aerospace loading. The THOR ATD is grouped as one of the advanced, non-standard ATDs used on the test, which encompassed adult-sized ATDs not in the HII or HIII families. These ATDs contain higher biofidelic components and advanced sensor suites. The THOR ATD, while designed to be a primarily frontal impact ATD, has been used in previous NASA testing in both the vertical [15] and horizontal directions [16] for the evaluation of injury prediction use in NASA applications. The THOR was instrumented with head, chest, and pelvic accelerometers, along load cells in the upper and lower neck and lumbar spine. It was seated in seat 3E and positioned in the neutral position. This ATD was positioned next to a standard HII ATD so that comparisons between the two ATDs could be made. Figure 12 shows the THOR ATD in the background, with a standard HII 50th percentile ATD in the foreground.

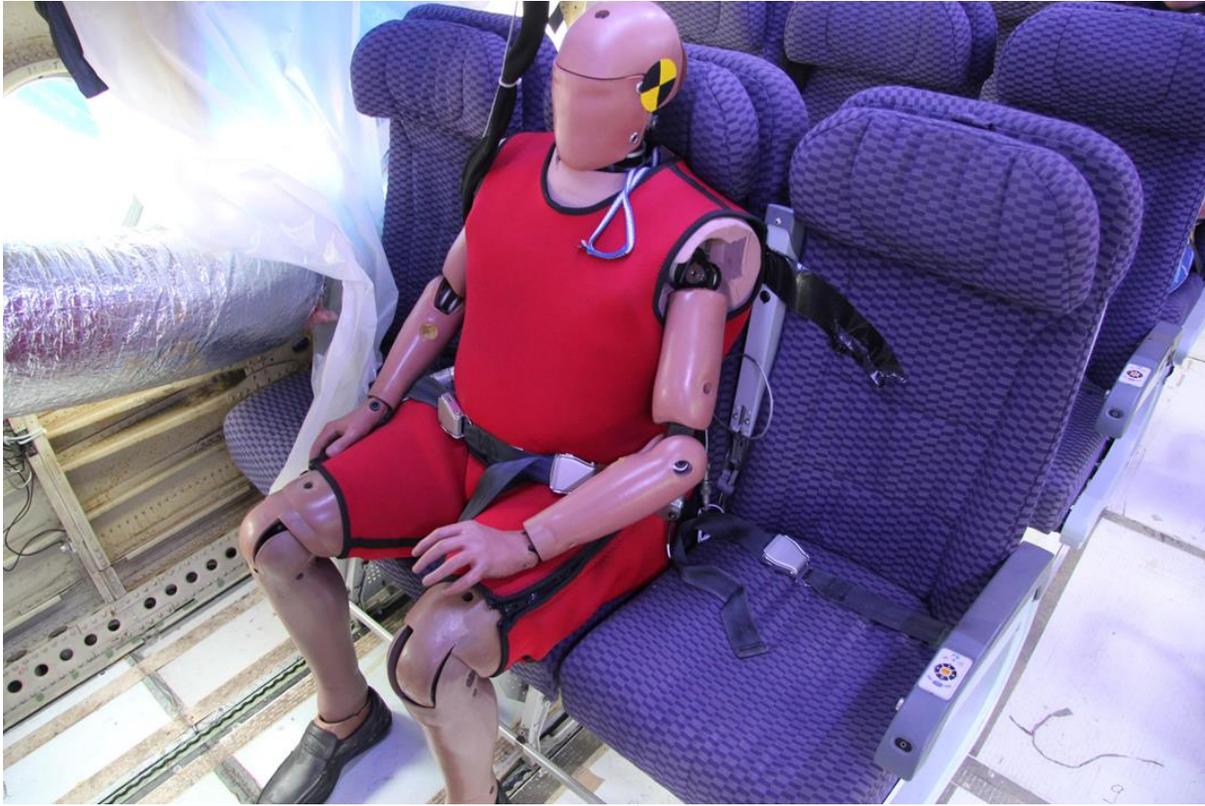
Figure 13. Obese ATD seated in Seat 8B

The Obese ATD [17] was the second advanced ATD added to the test and was included in the test as an experiment to gather information on occupant responses from larger sized adults. The Obese ATD was a concept prototype provided by Humanetics and does not represent their current design. This ATD was based on the THOR platform and targeted a Body Mass Index (BMI) of 35 kg/m^2 , which categorizes this ATD as Obese. Material was added to the chest jacket to simulate increased superficial tissue and abdominal fat, which put the ATD total weight at 273 lb. This ATD was seated in Seat 8B which was behind an empty Row 7 and chosen in part due to the accessibility of the seat, but also to limit the interaction between this ATD and other experiments should the ATD or seat adversely move during the impact. The distance between the front of the face to the rear seat back in Row 6 was 52 inches which allowed for this ATD to experience 52 inches of motion before contact with the seat would occur. Since it was experimental, this ATD only contained sensors to measure head, chest, and pelvic accelerations. The data collected from the ATD will be for reference use only. Figure 13 shows a picture of the Obese ATD seated in Seat 8B.

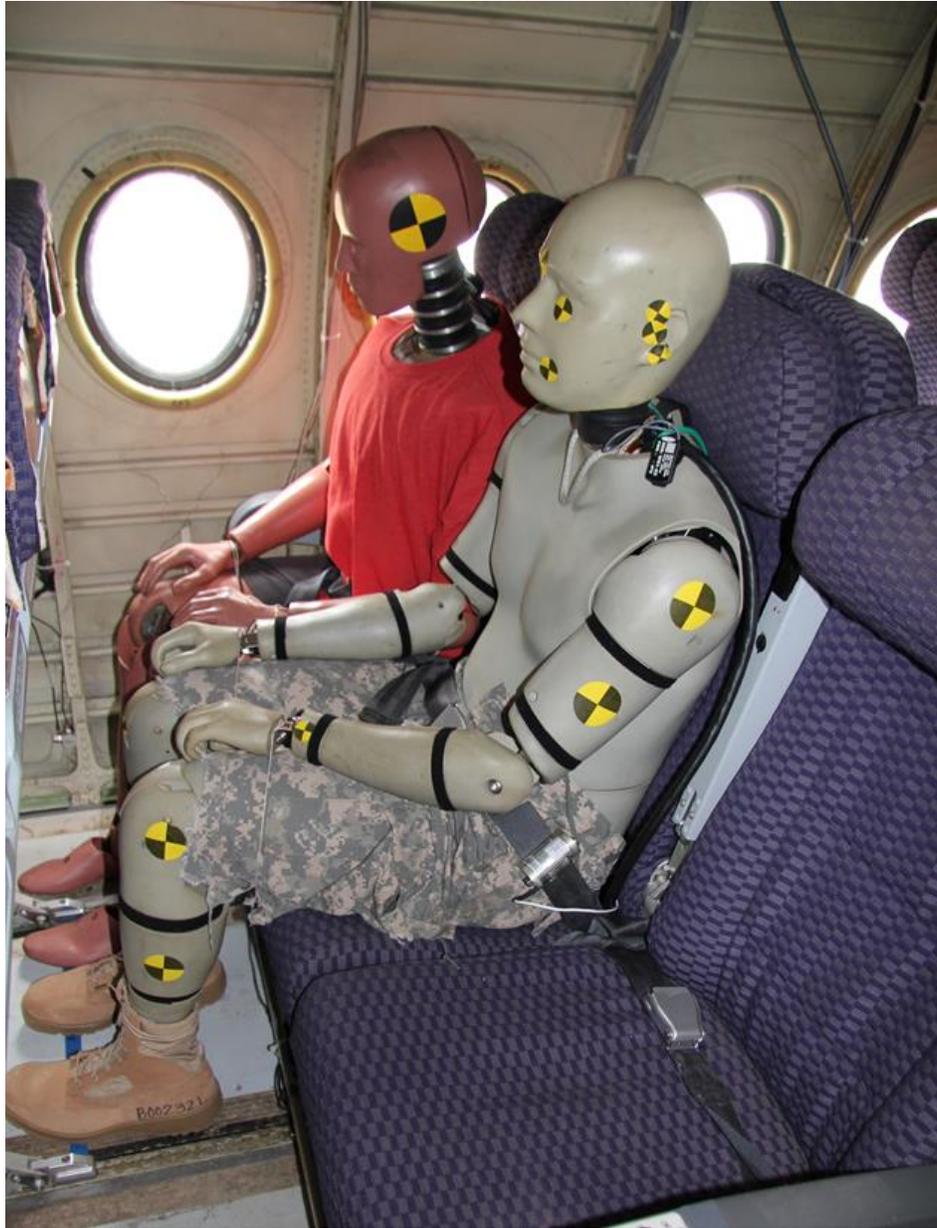
Figure 14. ARL WIAMan, foreground, and FAA HIII, background

Two Warrior Injury Assessment Manikins (WIAMan) [18] were operated by ARL and provided a third type of advanced ATD in the test. The two WIAMan ATDs were spaced such that one was near the front of the cabin and one was near the rear to allow for positional comparisons. The WIAMan ATDs were in the 50th percentile range; however, they did not anthropometrically match up to a standard HIII 50th percentile ATD. The WIAMan ATD data acquisition systems were self contained and seated next to FAA HIII ATDs in each location. The WIAMan response and its comparisons to the standard Hybrid ATD data will be the subject of a separate report. The WIAMan is shown in the foreground of figure 14.

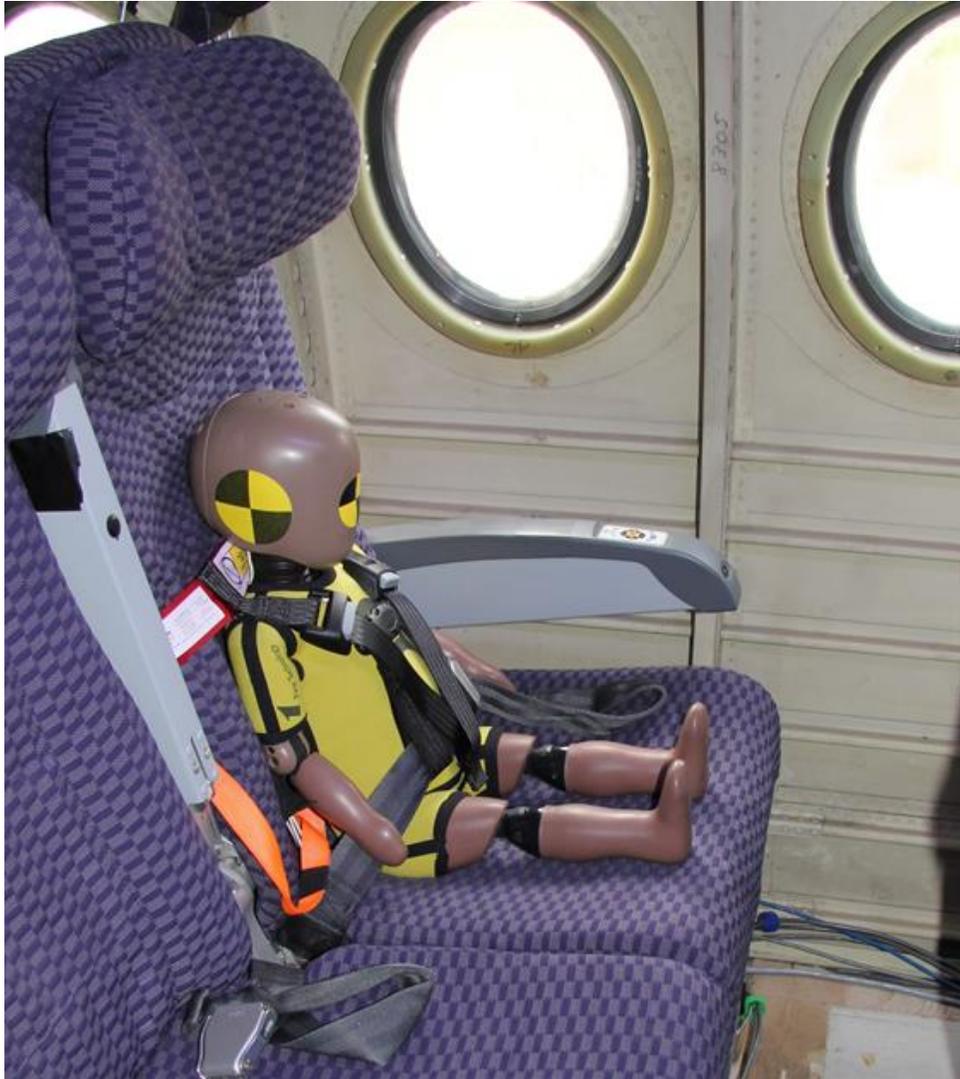
Figure 15. ATD 17, Q-1 with CARES configuration

There were seven child ATDs utilized for the test. These ATDs ranged between a Quarter 1 (Q-1) infant to a 10 year old (10 YO) sized child. The Q-1 infant, labeled ATD 17, was seated in Seat 5E, and secured using the Child Aviation Restraint System (CARES) device [19]. This device fastened around the seat back and provided additional shoulder harness restraints to restrict the ATD head and chest motion. This ATD contained sensors in the head measuring accelerations and an upper neck load cell measuring forces and moments. Figure 15 shows the Q-1 ATD with CARES device attached.

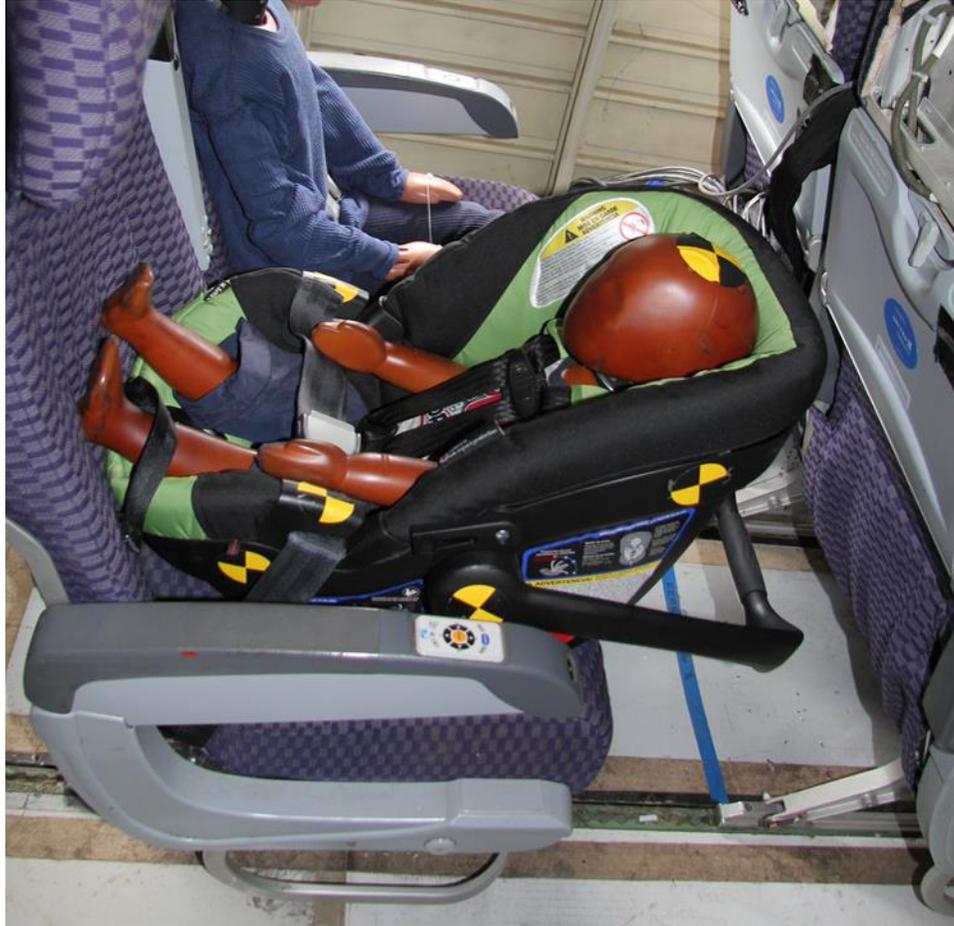
Figure 16. ATD 25 configuration

The Child Restraint and Airbag Interaction (CRABI) infant, labeled ATD 25, was located in Seat 4D. This ATD was placed in a rear facing car seat which was secured by attaching the lap belt through the guides near the legs. The ATD was secured into the car seat using its standard harnessing system. The lap belt buckle was secured over the knees of the ATD. The ATD itself weighed approximately 25 lb and was uninstrumented. Only loads from the lap belt were recorded for this ATD. Figure 16 shows the ATD in the test configuration.

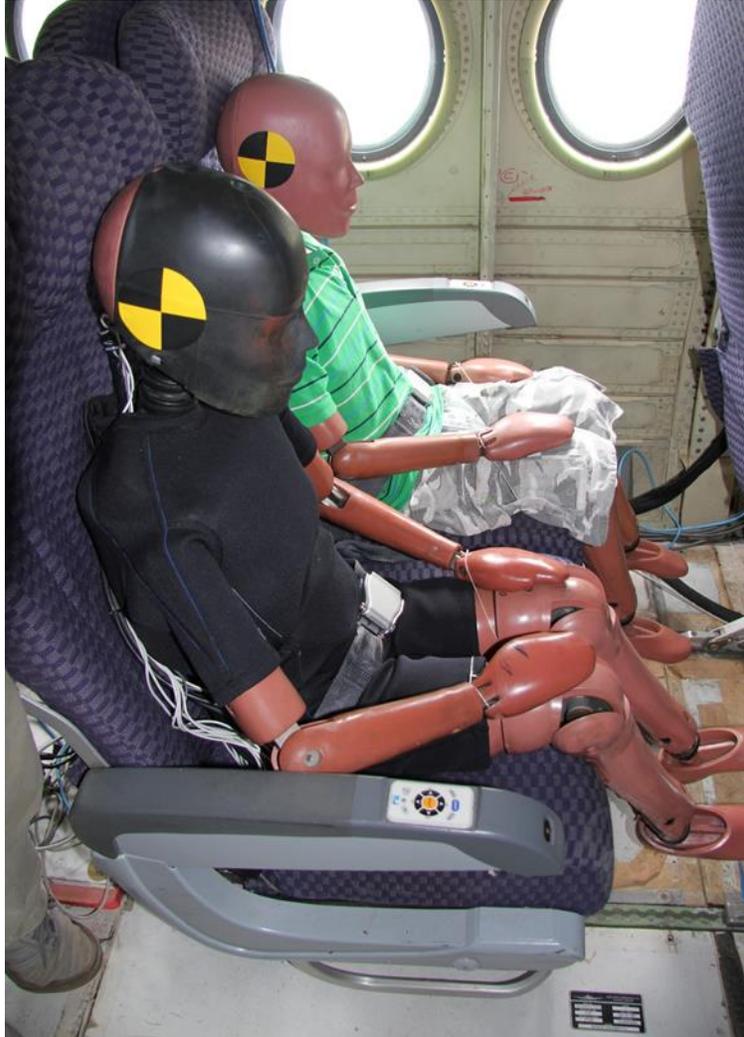
Figure 17. LODC ATD, foreground, and Hybrid III 10 YO, background

The test also included an experimental child ATD, named the Large Omnidirectional Child (LODC). This ATD was a prototype 10 YO sized ATD and was developed by NHTSA [20] as an improved device to measure child injuries during automotive testing. It features an improved thoracic spine, thorax, and instrumented abdomen, along with a biofidelic pelvis which gives a more realistic representation of a child occupant compared to the standard Hybrid III 10 YO ATD. Instrumentation in the ATD included accelerometers in the head, chest and pelvis, along with a rotation sensor recording rotation rate in the head. It also included upper and lower neck load cells and pressure gages for recording abdominal pressure. The LODC was seated in Seat 10D, directly next to a standard Hybrid III 10 YO ATD so that comparisons could be made. Figure 17 shows the LODC in the foreground and the Hybrid III 10 YO in the background.

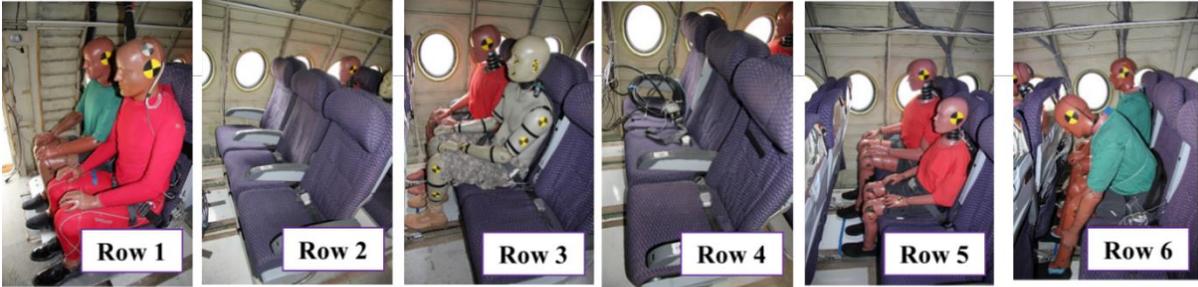
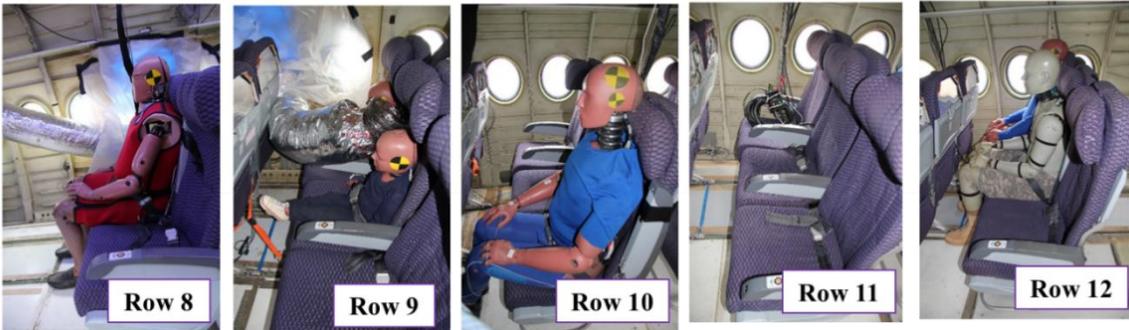
Figure 20. ATD starboard side layout

Figure 20 and figure 21 provide an overview of all ATDs on the starboard and port sides, respectively. Additionally these figures show the three areas of the cabin section: the Cargo Hold section which contained the luggage and included Rows 1–6- the Wingbox section which contained the stiffened underfloor structure used to tie in the wings to the fuselage and included Rows 8 and 9- and finally the Aft Fuselage section which contained the aft keel beams along with other equipment in the underfloor structure and includes Rows 10–12. The three different underfloor sections were of three different overall stiffnesses, and thus were expected to provide different amounts of floor support during the crash event. Thus, comparisons can be made between ATDs over differing aircraft sections.

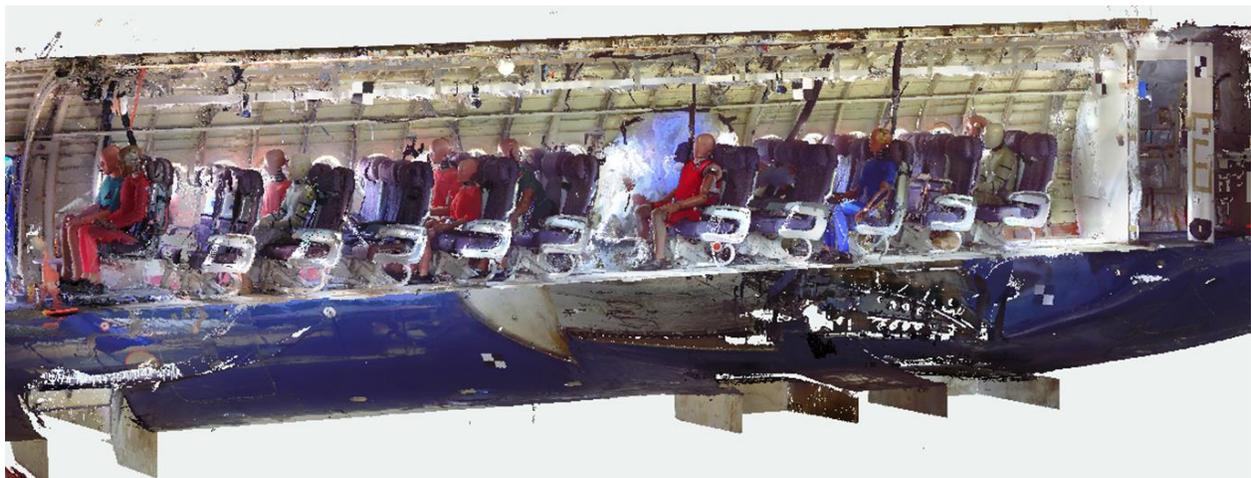
Figure 22. Laser scan of starboard side ATDs

All ATDs were placed in a nominal position, which oriented both the upper and lower legs and the upper legs to torsos at 90° angles to each other. Finally, because H-point measurements were not taken due to the complexity of the test setup and constraints on the space available, pre-test laser scans were used to capture the overall position of all of the ATDs prior to the test. The National Transportation Safety Board (NTSB) conducted and provided all of the laser scan measurements both inside and outside the aircraft. Figure 22 shows an overview of the starboard side ATDs while figure 23 shows an overview of the port side ATDs.

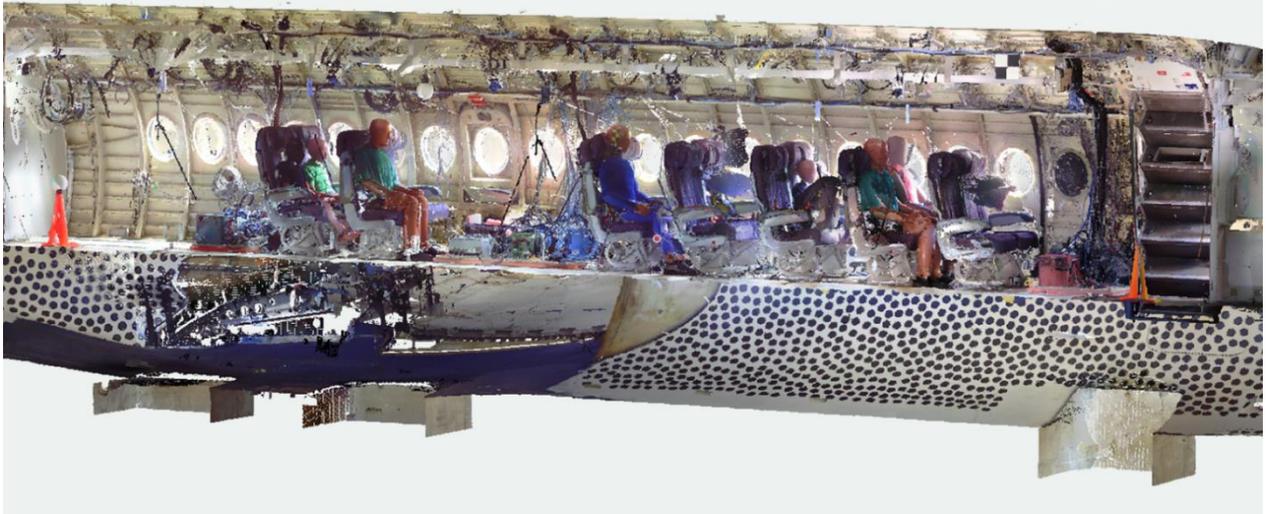
Figure 23. Laser scan of port side ATDs

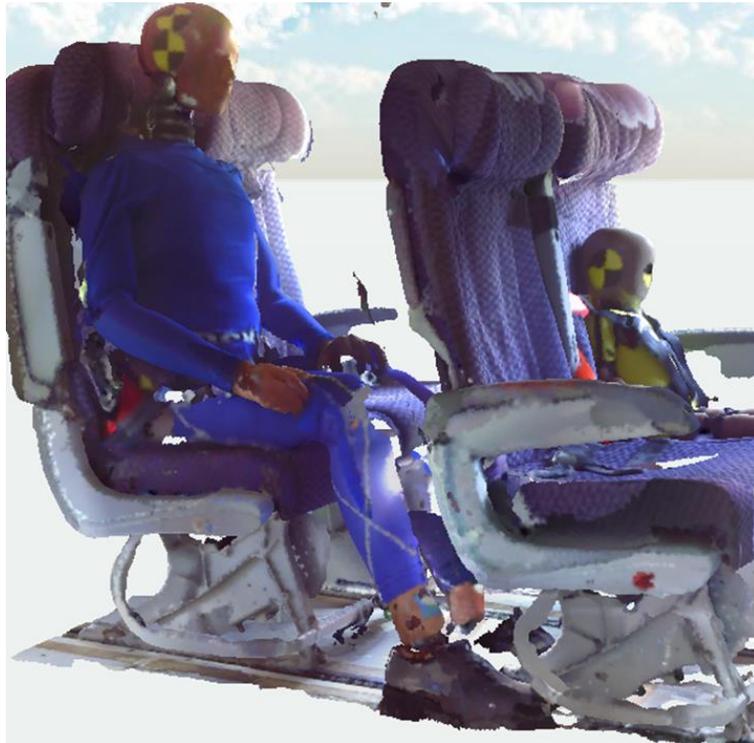
Figure 24. Laser scan detail of ATD 7 and 3

A detailed view of ATDs 3 and 7 is shown in figure 24. The detail of these scans was important because it demonstrated the laser scan technique was capable of providing detailed position measurements of all of the ATDs both pre- and post-test. This allowed for both initial and final conditions of the ATDs to be documented. Additionally, the laser scan proved to be invaluable for computer simulation efforts, wherein the ATDs in the simulations could be positioned to match the test configuration. Detailed views were available for all the ATDs onboard the aircraft.

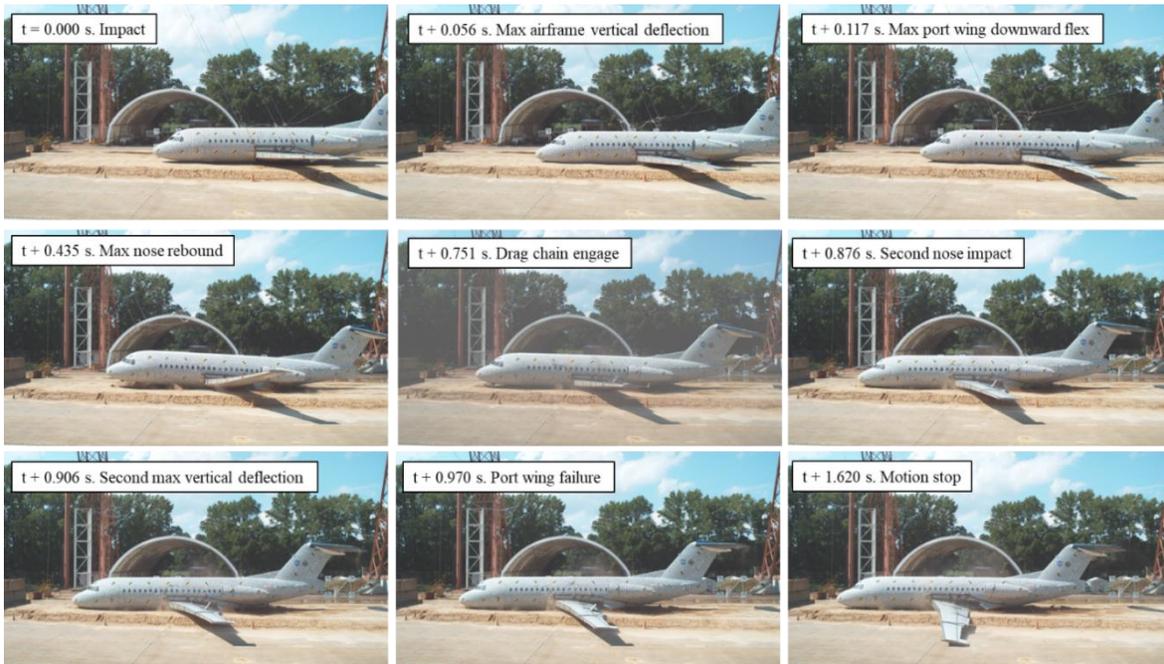
Figure 26. Impact motion sequence

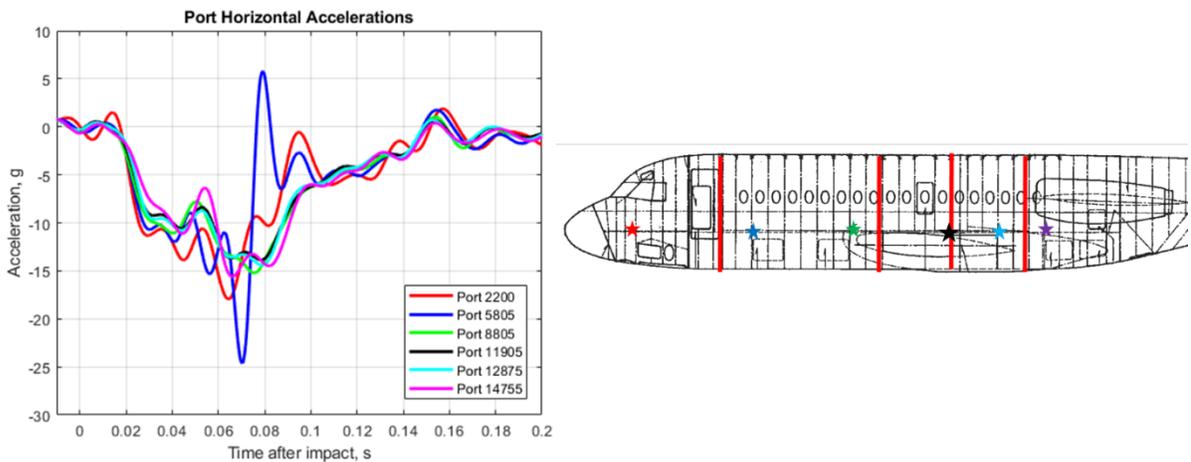
Figure 27. Cabin port side accelerations

Airframe accelerations in the horizontal and vertical locations were collected over the entire length of the cabin. The horizontal accelerations on the port side are first shown in figure 27, noting that the color of the trace in the plot corresponds to the starred cabin location on the right. Figure 27 also includes accelerations in the cockpit of the aircraft, which were collected to examine the pilot response.

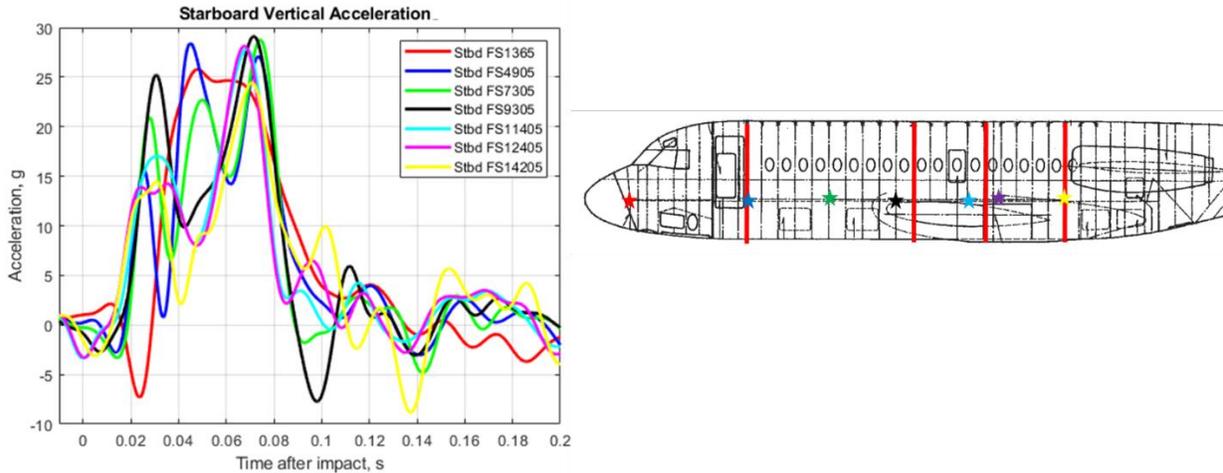
Figure 28. Starboard side accelerations

wing deflections, so it was likely that the additional downward deflection of the wings were pushing the aircraft into the soil, causing additional horizontal acceleration. After the minimum accelerations were measured, they tracked back toward zero and crossed the zero axis between 0.14 s and 0.16 s after initial contact. This time was after both of the wings achieved maximum flexure, and during the aircraft rebound. The aircraft contained horizontal motion well into motion stop at 1.62 s after impact; however, during this initial event and the second nose impact, horizontal accelerations were negligible. The second nose impact produced much smaller accelerations; however, the majority of the ATD response was a result of this initial impact. Further analysis on the horizontal acceleration measurements can be found in [11]. Next the vertical accelerations for the starboard side of the cabin are shown in figure 28.

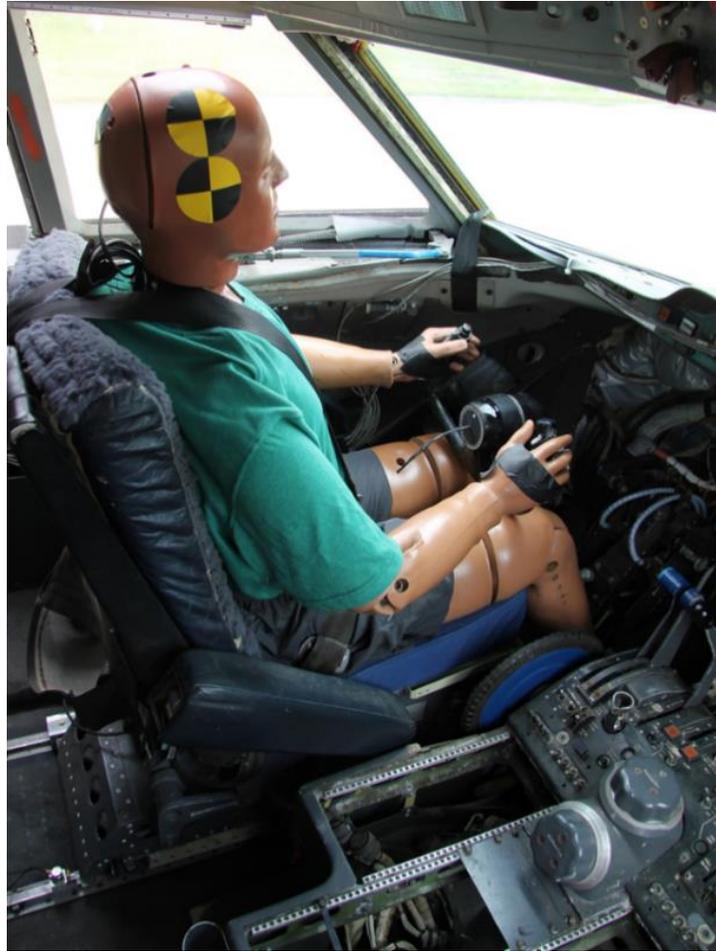
Figure 30. ATD 1

ATD 1 was Hybrid II 50th percentile seated in the pilot seat, which was unmodified. The seat was positioned in the furthest forward location and the hands were taped to the yoke and feet were taped to the pedals. The ATD was restrained with a 5-point harness which was tightened using the two finger method and the armrests were moved out of the way as to not interfere with the ATD motion. Unfortunately, there were no onboard cameras present to capture the motion during the event. Figure 30 shows the pilot ATD.

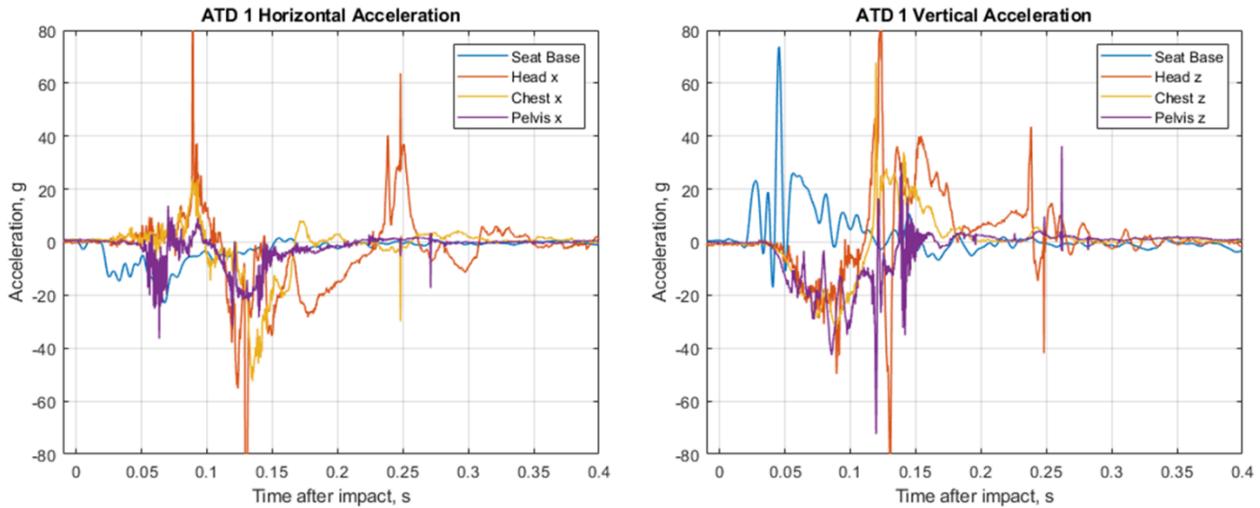
Figure 31. ATD 1 Accelerations

Between 0.1 and 0.2 s, acceleration in the chest and head reversed direction. This indicated the ATD slipped through the torso restraints, which was verified post-test, and rotated forward over the lap restraint. There was also a spiking response in the head acceleration which indicated potential contact with the aircraft. After 0.2 s, little motion was measured in the chest and pelvis of the ATD, while there is another spike in head acceleration response which indicated another head strike. Although there is no video to confirm the timing of ATD contact with the aircraft, the ATD was found under the control console post-impact indicating significant contact did occur.

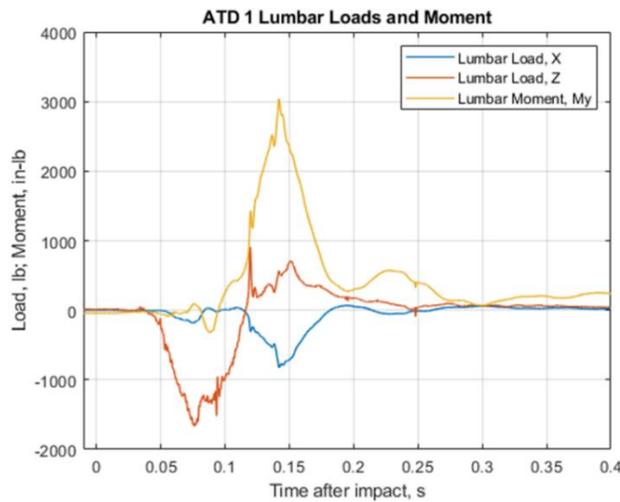
Figure 32. ATD 1 Lumbar loads and moment

The lumbar load response of ATD 1, which is shown in figure 32, followed the kinematic response previously discussed. Over the first 0.1 s, the lumbar spine was loaded primarily along with vertical direction (Z) as the pelvis was accelerated by the seat. Lumbar compressive load values exceeded the 1500 lb injury limit during this time period, reaching a maximum value of 1,657 lb. After 0.1 s, forward torso rotation was indicated by the increase in lumbar moment (My), which reached a maximum value of 3,021 in-lb at 0.142 s after impact. The rotation also caused an increase in the lumbar shear load (X).
