NASA/TM-20210017474

A Summary of ATD Results from a Full-Scale F28 Crash Test

*Justin D. Littell, Jacob B. Putnam
Langley Research Center, Hampton, Virginia*

June 2021

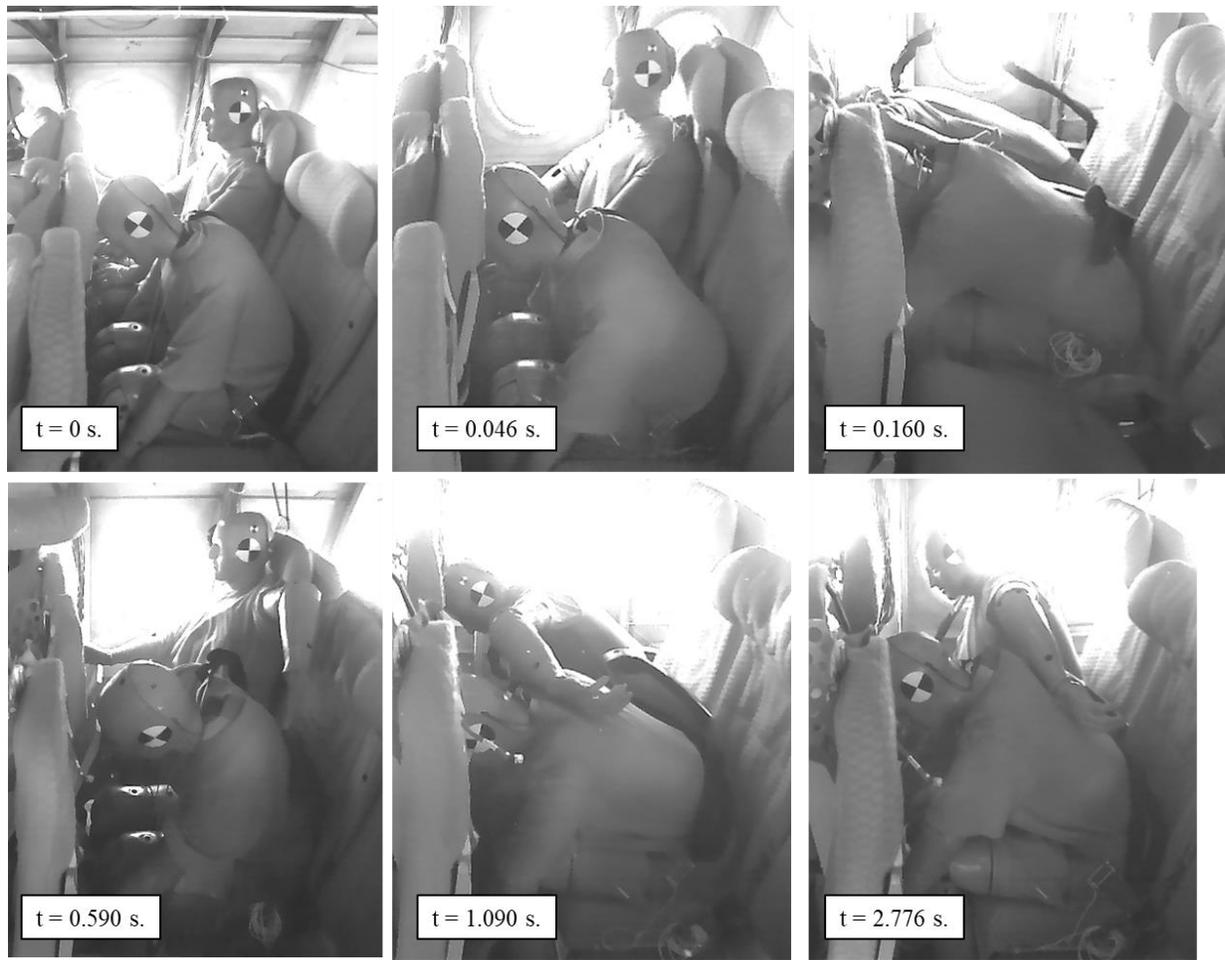
Figure 33. ATD 3 Image sequence

ATD 3 was a Hybrid II 50th percentile seated in Seat 6A. An onboard high-speed camera was used to record the ATD kinematics during the crash event, which is shown in figure 33. Within this figure, ATD 3 is in the background, nearest to the window. The high-speed camera captured the ATD rotating forward about the lap restraint and impacting into the forward seat back at 0.160 s after impact. At 0.590 s after impact, the ATD rebounded close to its original pre-impact position, and then began to rotate forward again due to the second impact of the aircraft. The final image in the lower right shows the ATD in its position after all motion has stopped.

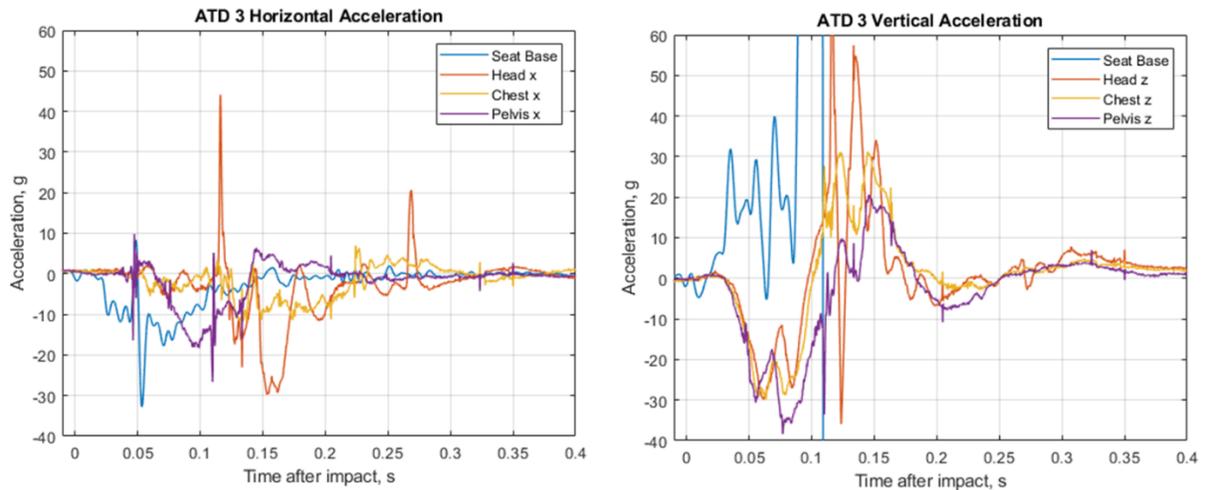
Figure 34. ATD 3 Accelerations

Vertical acceleration can only be partially compared to the seat vertical acceleration channel for approximately the first 0.1 s after impact. After this time, the seat cable severed, and the data was unusable. However, the accelerations in all parts of the ATD were nearly uniform and tracked the seat base acceleration. The maximum negative acceleration was measured in the ATD pelvis, which reached a maximum negative value of 38.2 g approximately 0.07 s after impact. After this time, the measurements trended toward the positive region and reached a positive maximum at the same approximate time as the head strike occurred. Maximum values in the head were somewhat skewed by the large oscillations in the head due to the contact, but the maximum value in the pelvis was approximately 20.4 g at this time.

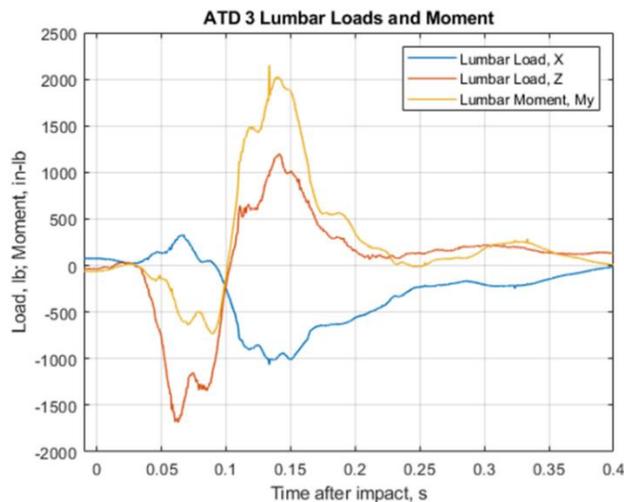
Figure 35. ATD 3 Lumbar load and moments

The lumbar load response of ATD 3, shown in figure 35, followed the kinematic response of the ATD pelvis. Compressive lumbar load increased over the first 0.1 s as the pelvis was accelerated into the seat foam, resulting in a peak compression value of 1,675 lb, which was greater than the 1,500 lb injury limit. After 0.1 s, the forward rotation of the torso around the lap belt resulted in an increase in lumbar spine moment until a maximum of 2,031 in-lb. was reached approximately 0.14 s after impact. Lumbar tension was also measured after 0.1 s; this was likely caused by the ATD pelvis rebounding upward from the seat foam into the lap belt. As the body accelerated upward, the pelvis became restrained by the lap belt and the lumbar spine was loaded in tension due to the inertial force of the torso pulling upward on the lumbar load cell.

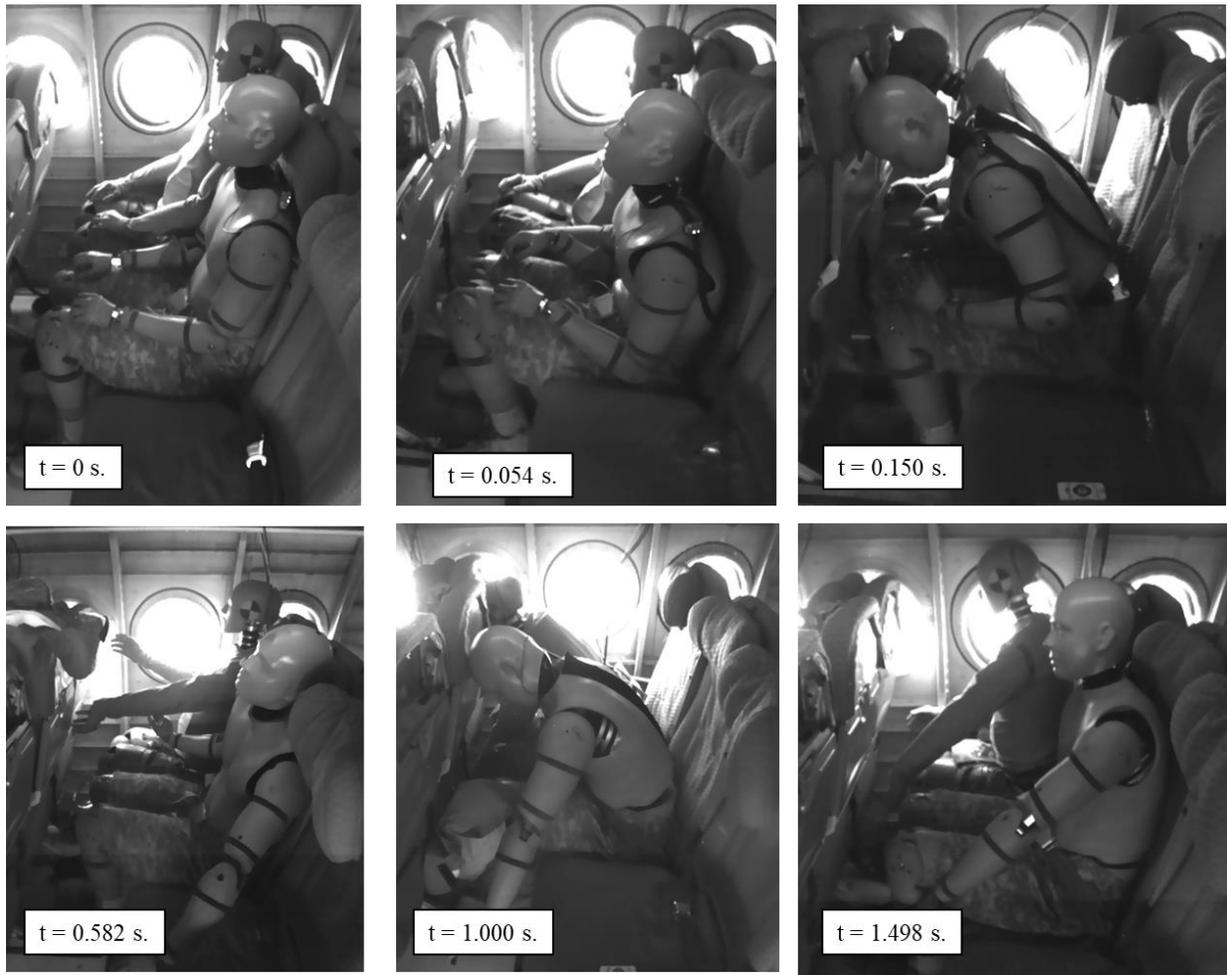
Figure 36. ATD 5 Image sequence

ATD 5 was an FAA Hybrid III 50th percentile seated at the rear of the aircraft in Seat 12A. An onboard high-speed camera was used to record the ATD kinematics during the crash event, which is shown in figure 36. ATD 5 was seated next to a WIAMan in seat 12B and is seated farthest from the camera in the window seat. The high-speed camera captured both ATDs rotating forward about the lap restraint and impacting into the forward seat back during the crash event at approximately 0.15 s. The head strike was verified at this time within the head acceleration response measured in ATD 5. Increased torso and neck flexibility is observed in the WIAMan compared to the FAA Hybrid III during the impact event, particularly the neck extension and torso compression observed under vertical acceleration which occurred over the first 0.05 s of impact. The WIAMan results are not included within the scope of this study.

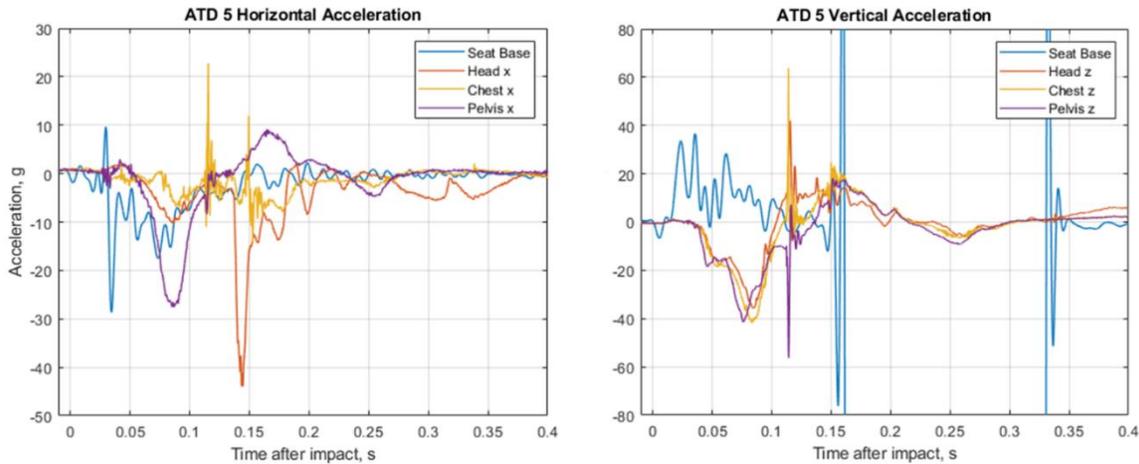
Figure 37. ATD 5 Accelerations

observed in the high-speed video. Head vertical acceleration was not shown to increase during this time period indicating the strike was perpendicular to the face of the ATD head.

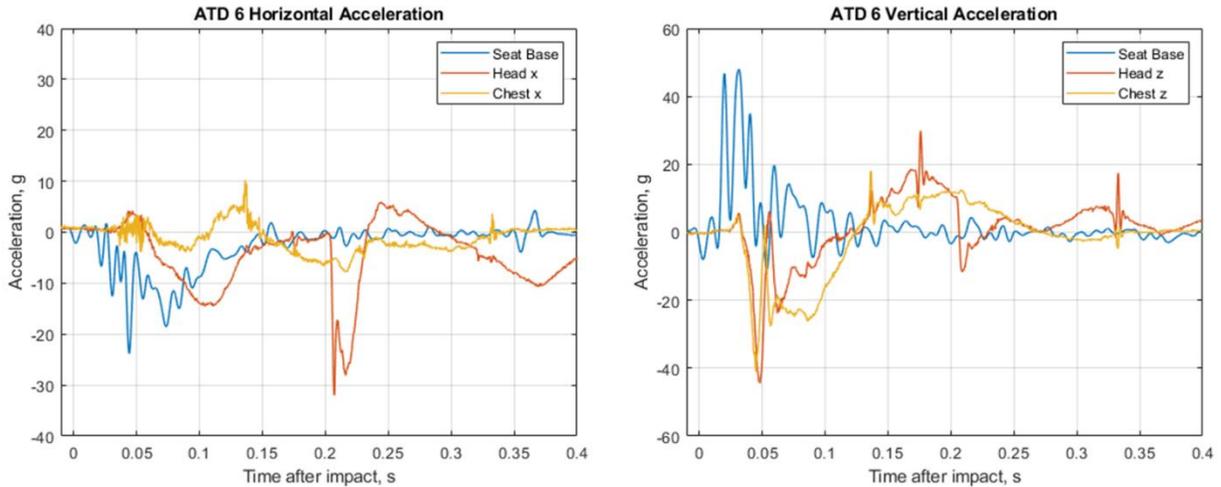
Figure 39. ATD 6 Accelerations

minimal, and pelvis acceleration was not recorded in this ATD. Head and chest vertical acceleration closely tracked vertical seat base acceleration. Magnification of ATD vertical acceleration compared to seat base was not prevalent in this seat configuration. The effect of the seat foam to magnify the impact acceleration within the ATD was likely offset by energy absorbed by the overhung seat as it deformed under the impact load. Head strike was indicated with the forward seatback at approximately 0.2 s by a spike in head horizontal and vertical acceleration.

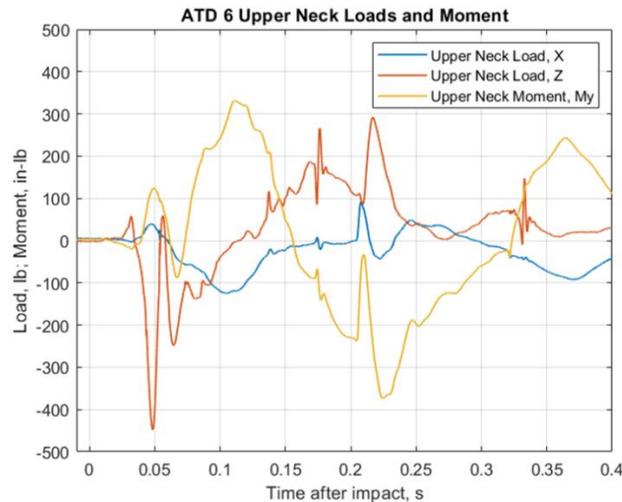
Figure 41. ATD 6 Upper neck loads and moment

approximately 443 lb. The shape of this response matched head vertical acceleration. Neck shear force peaked at 0.1 s at approximately 125 lb and matched the shape of head horizontal acceleration. Upper neck moment matched the shape of head rotation, peak moment occurred in extension at 0.22 s at approximately 331 in-lb. This occurred after head strike.

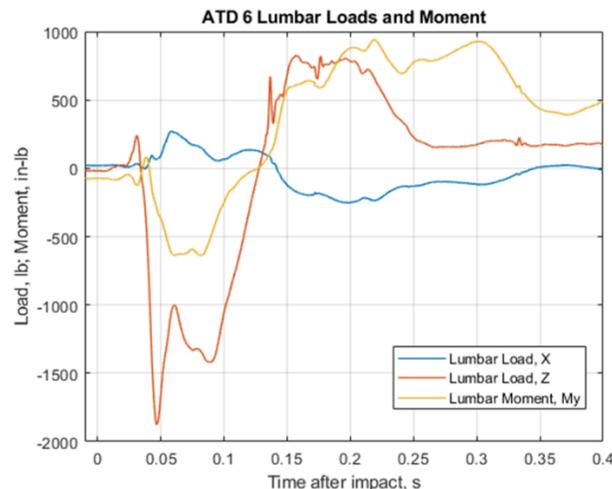
Figure 42. ATD 6 Lumbar loads and moment

Compared to the other 50th percentile ATDs tested in this region of the aircraft, the compressive lumbar load in ATD 6, shown in figure 42, was relatively low, but briefly above the injury metric limit. This indicated that the overhung seat did absorb some of the impact energy within this test, verifying the trends observed in the fuselage component tests. Shear force was also low in this ATD compared to others tested. The lumbar moment closely tracked the shape of the lumbar force response throughout the impact event.

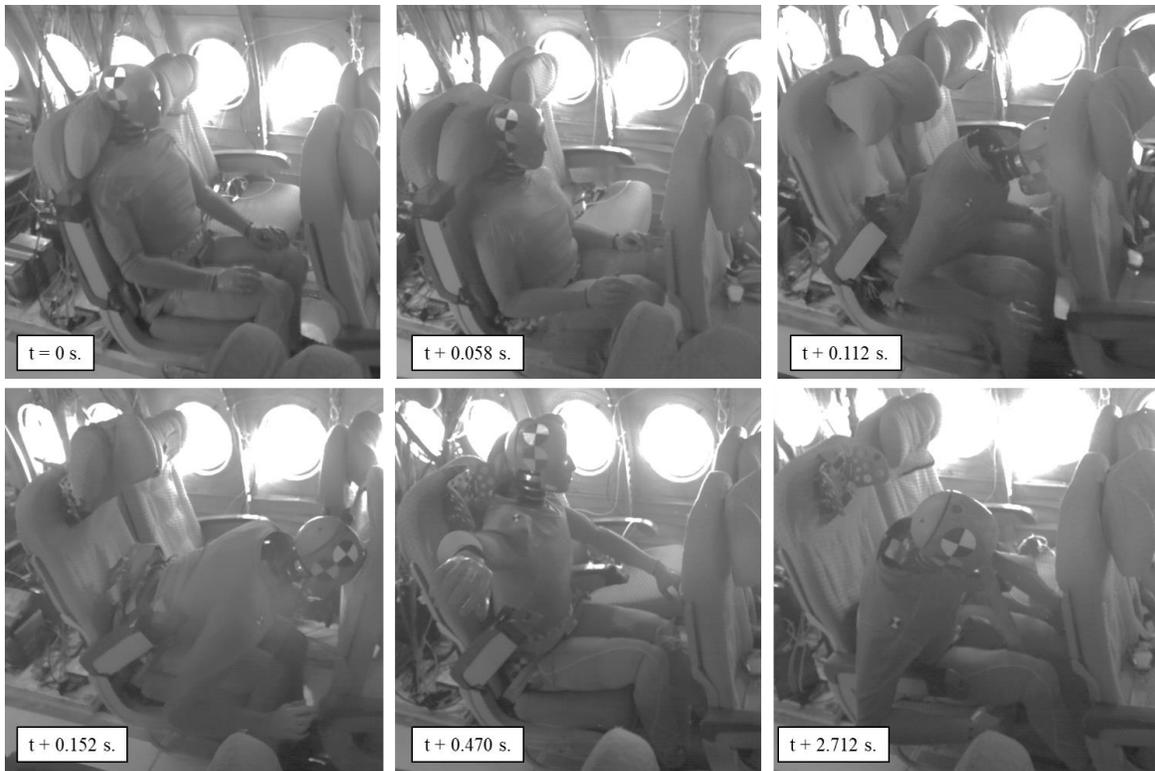
Figure 47. ATD 13 Image sequence

ATD 13 was an FAA Hybrid III 50th percentile seated in Seat 6D. The motion sequence in figure 47 depicts six distinct events of this ATD during the impact event. The first in the upper left image is the ATD position at the time of impact. The upper middle image depicts the ATD at its maximum vertical deflection, which occurred 0.058 s after impact. The image in the upper right depicts the ATD as it experienced the head strike event. The lower left image depicts the ATD at its maximum forward position which occurred 0.152 s after impact. The maximum rebound of the ATD is shown in the bottom middle image, and finally the post-impact position of the ATD is shown in the lower right. Note that the lower right image depicts a time well after the motion stop of the aircraft.

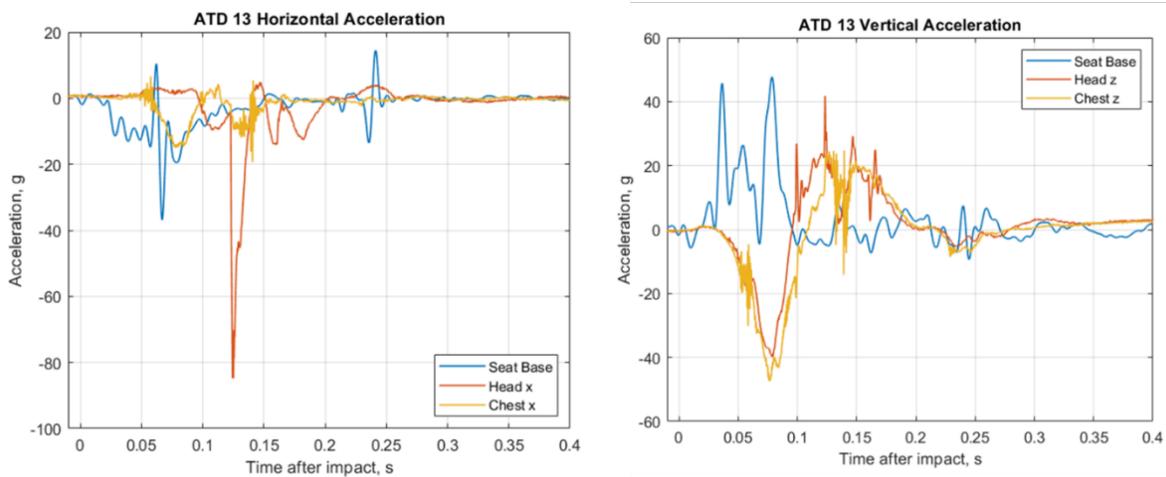
Figure 48. ATD 13 Accelerations

Chest horizontal acceleration tracked the seat base acceleration, though motion was delayed by approximately 0.05 s which is shown in figure 48. Head horizontal acceleration was even further delayed with minimal horizontal motion measured until after 0.1 s. A spike in head horizontal acceleration occurred at 0.125 s, which was indicative of a head strike condition. Vertical acceleration tracked through the chest and head with peak acceleration closely matching that measured in the seat.

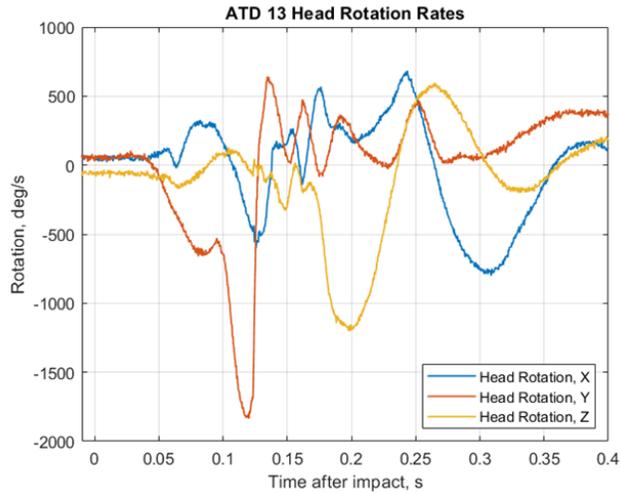
Figure 49. ATD 13 Head rotations

z-axis rotation became the dominant motion in the ATD head. This result indicated the ATD's head struck the forward seat with some non-zero out-of-plane tilt, inducing this off-axis head rotation.

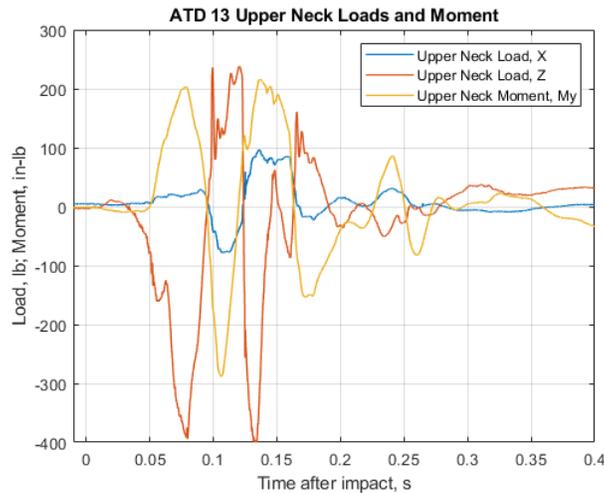
Figure 50. ATD 13 Upper neck loads and moment

Upper neck loads and moments were next examined and are shown in figure 50. An examination of the data showed that there was minimal upper neck shear force measured in ATD 13. Over the first 0.125 s, neck compression tracked the vertical acceleration of the chest and head. Peak neck compression occurred during the head strike event when the head was accelerated into the neck and forward moving torso mass. Moment generally followed head rotation, though its potential effect on neck injury risk would have been relatively low compared to neck compression in this condition. Neck shear force was minimal throughout the impact event.

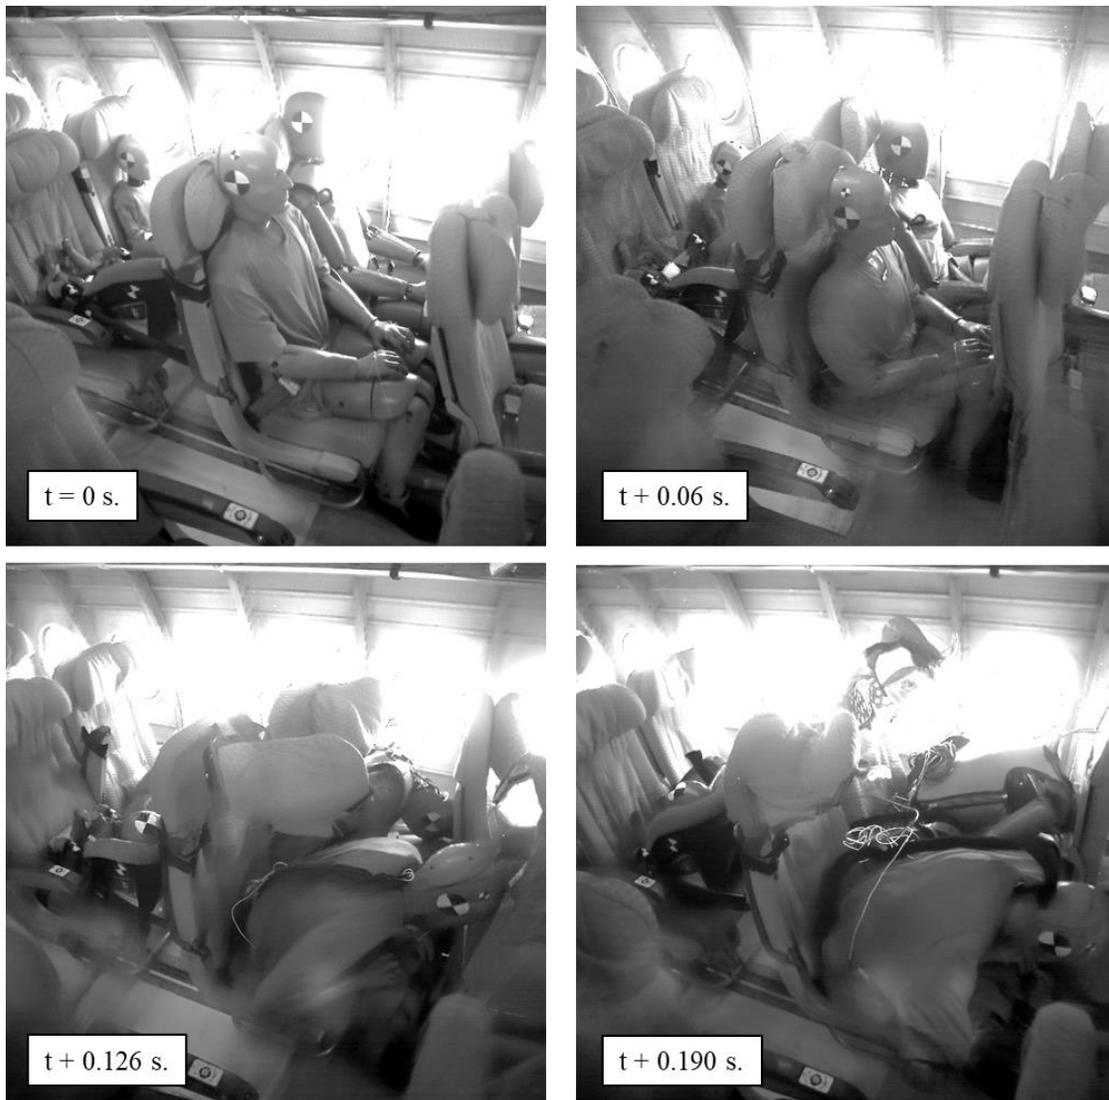
Figure 53. ATD 14 Image sequence

ATD 14 was a Hybrid II 50th percentile seated in Seat 3D. High-speed video was taken of this seat row and is shown in figure 53 with ATD 14 in the foreground, closest to the aisle. Over the first 0.06 s, ATD 14 was vertically loaded into the seat, and its upright posture was maintained as it sunk downward into the seat foam. After this point it began forward rotation about the lap belt and can be seen impacting the forward seatback at 0.126 s. The impact of ATD 14 into the forward seatback caused the seat adjustment mechanisms to fail and the forward seatback collapsed forward. This limited the rebound of ATD 14, which ultimately ended up in a forward folded position at the end of the impact event.

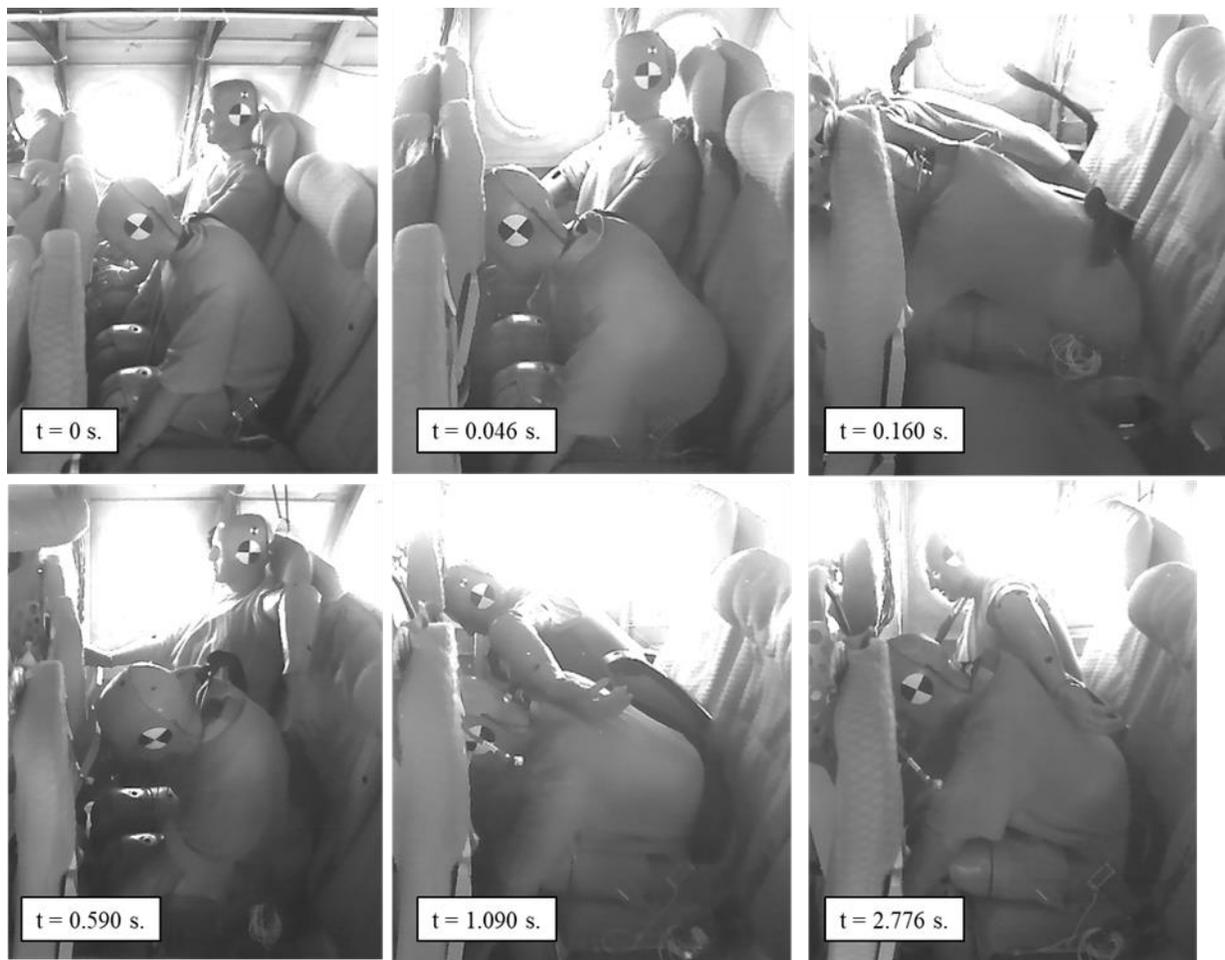
Figure 60. ATD 20 Image sequence

ATD 20 was a Hybrid II 50th seated in Seat 6B and placed in a braced posture configuration. An image sequence from the captured high-speed video is shown in figure 60 with ATD 20 in the foreground. The impact position of the ATD is shown in the upper left image of figure 60. Head strike, which occurred approximately 0.04 sec after initial impact, is shown in the upper middle image. The upper right image shows the time around the maximum forward motion of the ATD. The lower three images show the ATD rebound (lower left), the second head strike event due to the secondary aircraft impact (lower middle), and a post-test position (lower right).

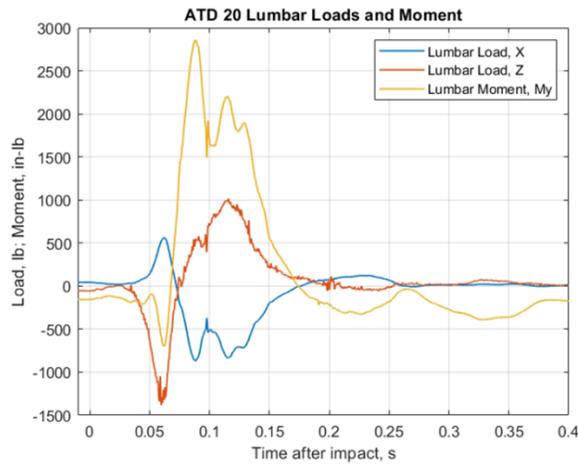
Figure 62. ATD 20 Lumbar loads and moment

Figure 62 shows the lumbar loads and moments from ATD 20. When examining spinal compression, ATD 20 was the only 50th percentile ATD to measure below the 1,500 lb injury metric limit, with a peak compressive lumbar load of approximately 1,383 lb. The braced posture of this ATD likely accounted for this lower value as the vertical acceleration vector from the impact was not directly aligned with the lumbar spine load cell in this condition. Although compressive lumbar load was limited in this posture, the lumbar moment during rebound remained significant reaching a peak value of 2,817 in-lb.

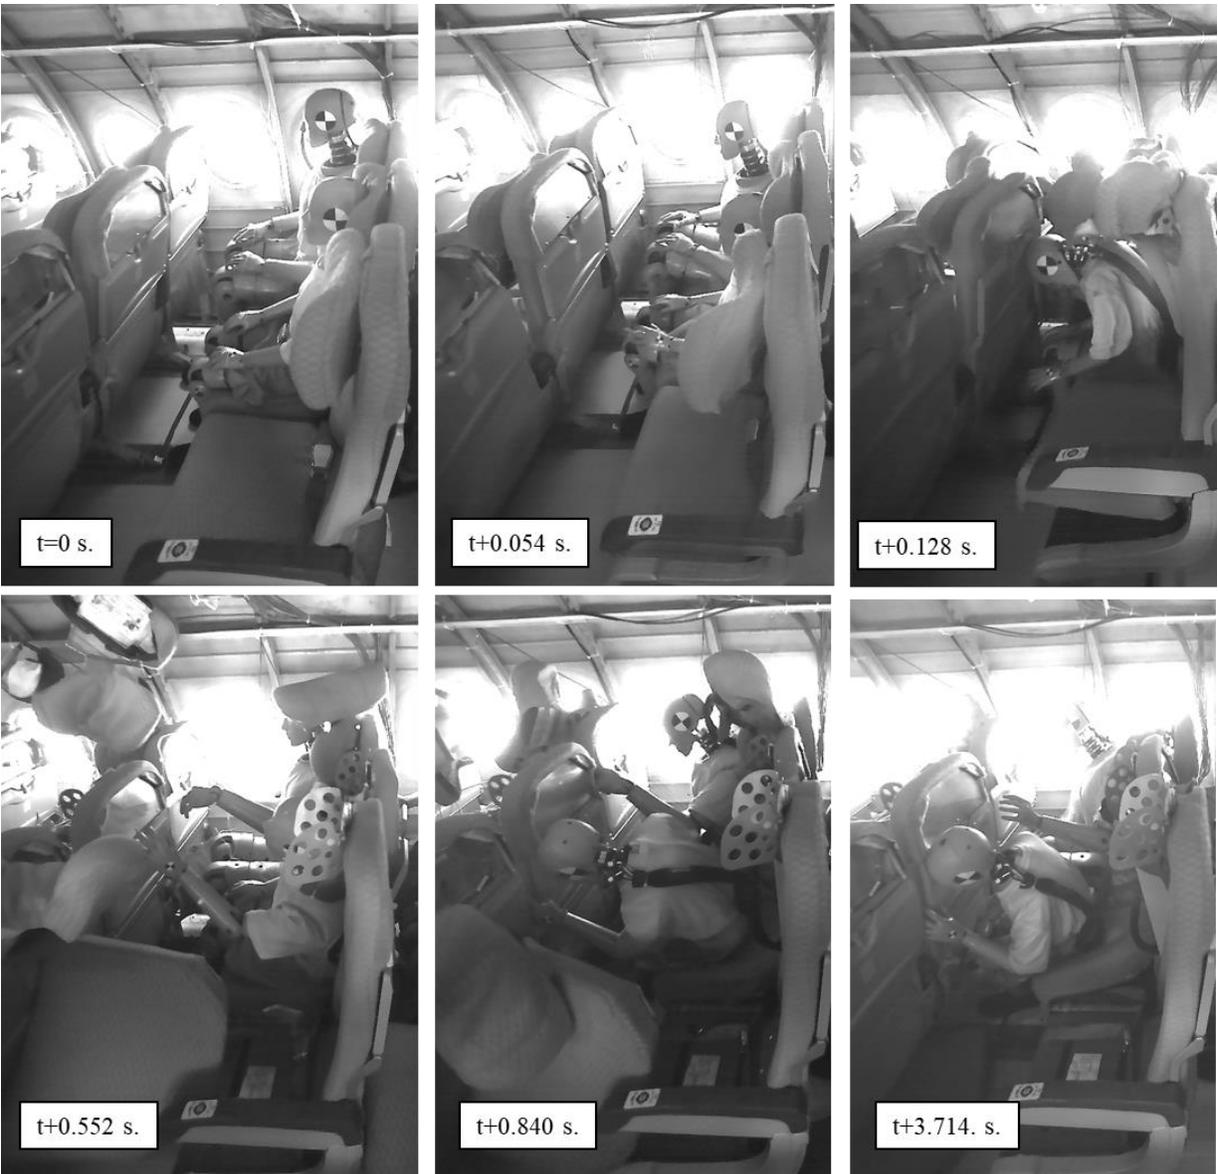
Figure 69. ATD 10 Image sequence

ATD 10 was a Hybrid III 5th percentile female seated in Seat 5B which was next to a Hybrid III 95th percentile male. An image sequence captured from the high-speed video is shown in figure 69, with ATD 10 in the foreground of the images. The upper left image shows the ATD at impact. Over the first 0.054 s ATD 10 was loaded vertically into the seat, with the torso remaining primarily upright, which is shown in the upper middle image. After this point, the torso began forward rotation ultimately impacting the forward seatback at approximately 0.0128 s after impact. Due to the shorter torso length of the 5th percentile female ATD, the torso underwent greater rotation than the larger ATD sizes before the head impacted the seat back, resulting in the contact being with the top of the head rather than the ATD face. After the primary impact occurred the ATD rebounded into its seat at 0.552 s which is shown in the lower left image, and then rotated forward again during the second aircraft impact, which is shown in the lower middle image. Finally, as the lower right image shows, the ATD came to rest turned laterally out of the seat after the impact event. During the impact, the lap belt came unbuckled which allowed the ATD to wind up out of its seat in this position; however, the precise timing of when the belt became unbuckled could not be determined. The belt was observed to be connected during the rebound of the first impact, and first image that the unbuckled belt can be observed occurred 0.682 s after impact, so it is presumed that the beginning of the secondary impact, which is shown in the lower left image in figure 69 is the approximate time the unbuckling event occurred.

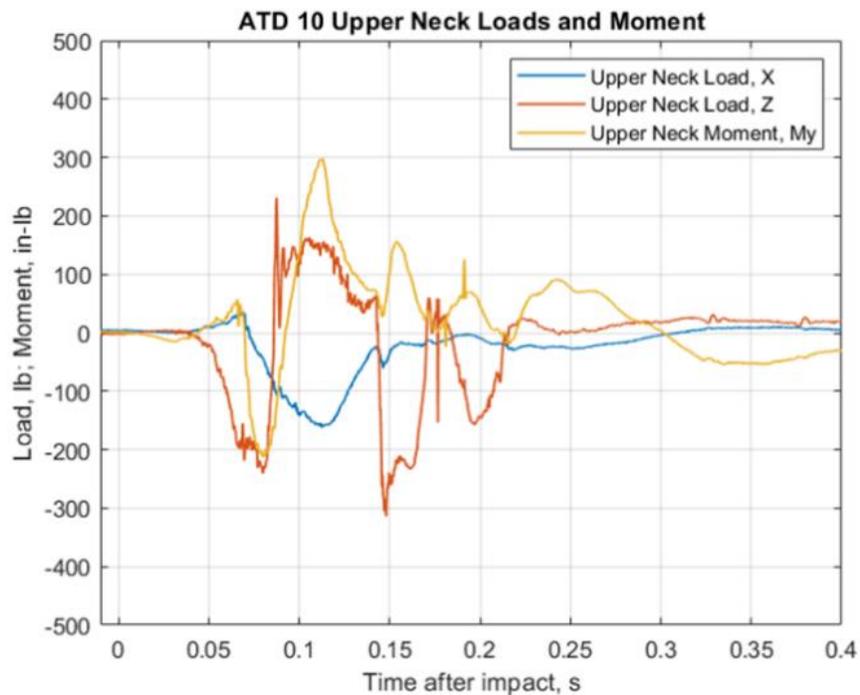
Figure 72. ATD 10 Upper neck loads and moment

Upper neck vertical force recorded its highest peak during head strike with a compressive force of 314 lb. Neck moment exhibited a peak value in flexion prior to head strike of 296 in-lb.

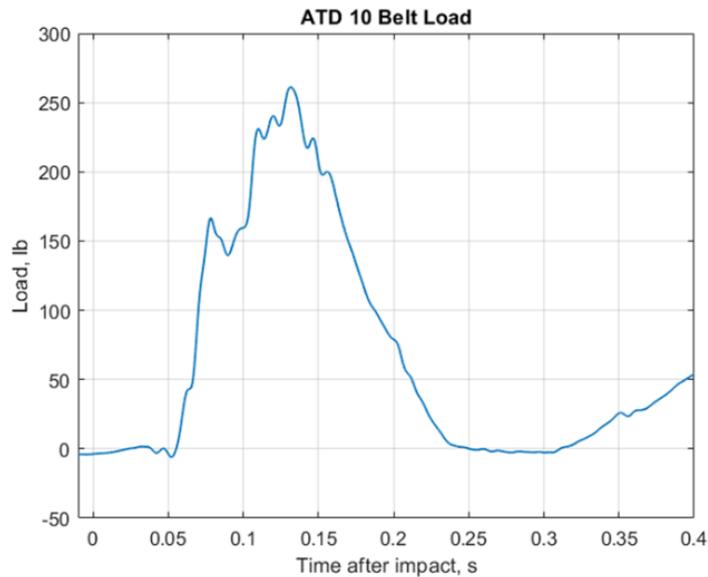
Figure 74. ATD 10 Belt load

The lap belt load measurements are next shown in figure 74. The belt loads, though lower than the rest of the ATDs measured, did not indicate a behavior during the primary impact which could be attributed to the differences observed in the response of this ATD. The belt loading curve had a similar curve shape to the other lap belts measured and indicated that the belt was attached for at least the initial impact event. The maximum value of the lap belt load measured was 261 lb, which occurred 0.13 s after impact, and was at the same approximate time that the ATD underwent maximum forward motion.

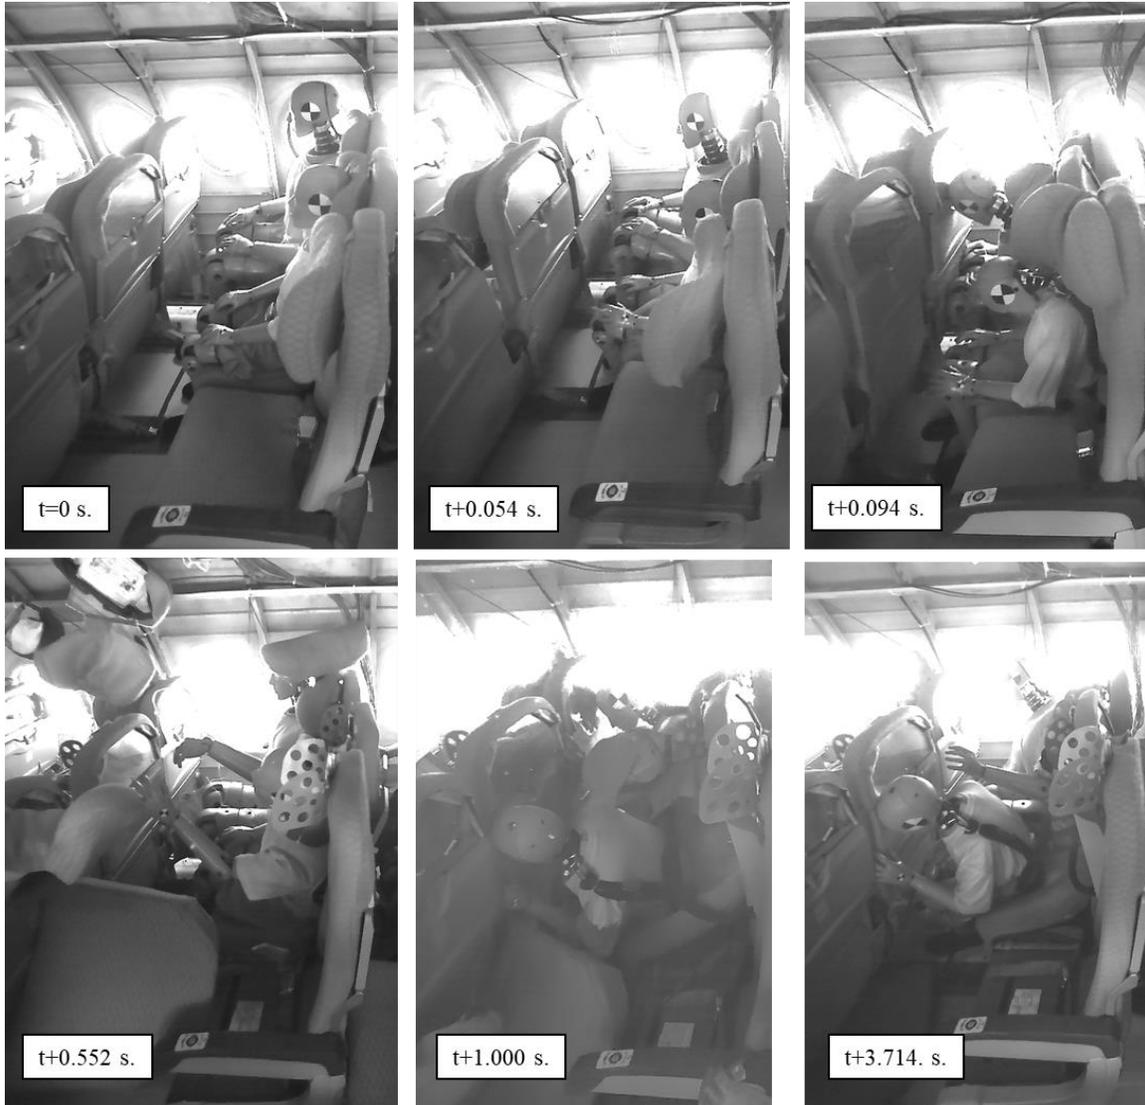
Figure 75. ATD 11 Image sequence

ATD 11 was a Hybrid III 95th male seated in Seat 5A. An image sequence from the high-speed camera is shown in figure 75, with ATD 11 in the background. The upper left image shows the ATD at impact. At approximately 0.054 s after impact, the ATD experienced its maximum vertical deflection into the seat, which is shown in the upper middle image. After the maximum vertical deflection, the ATD began to rotate

forward, eventually striking the seat back 0.094 s after impact, which is shown in the upper right image. Head strike with the forward seatback occurred earlier in this ATD compared to other ATD sizes due to its longer torso. After the initial head strike the ATD rebounded into the seat at 0.552 s, which is shown in the lower left image, and then re-struck the forward seatback at 1.0 s. In its post-test configuration, the ATD settled close to its original position within the seat, which is shown in the lower right image.

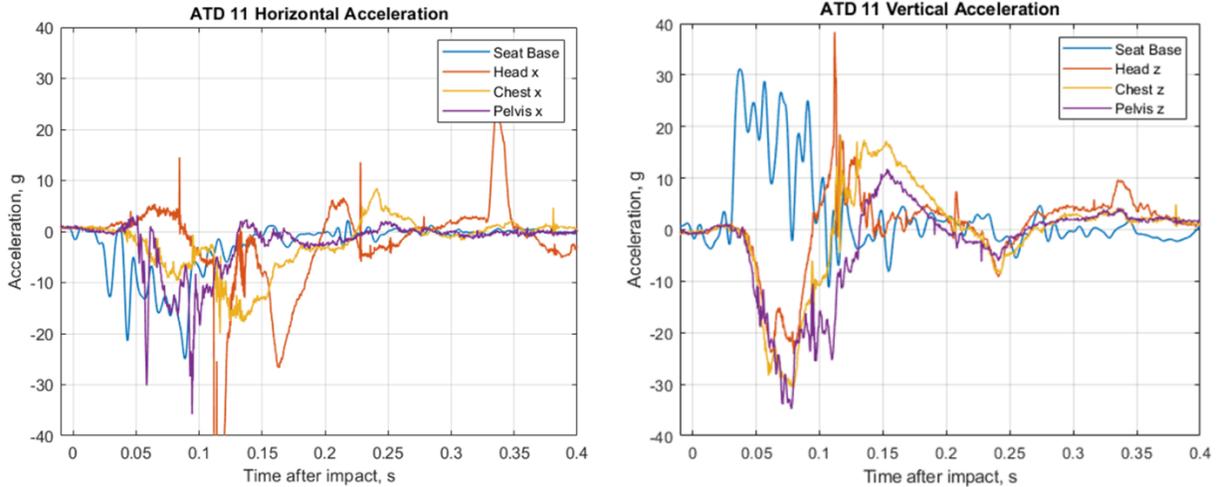
Figure 76. ATD 11 Accelerations

Accelerations in the horizontal and vertical directions are next shown in figure 76. The horizontal pelvis acceleration tracked the seat base acceleration closely, which indicated a tight connection to the seat through the lap belt on this ATD. Chest horizontal acceleration lagged the pelvis, while head lagged the chest. A large spike in head horizontal acceleration was observed at approximately 0.113 s, which indicated a head strike event occurred. There are a few smaller spikes in the acceleration response in the head, occurring at 0.163 s and 0.337 s, indicating the size of this ATD generated measurable secondary and tertiary head strike events. In the vertical direction, head, chest, and pelvis closely tracked each other, with maximum values of 34.6 g, 34.5 g, and 23.6 g occurring in the pelvis, chest, and head, respectively.

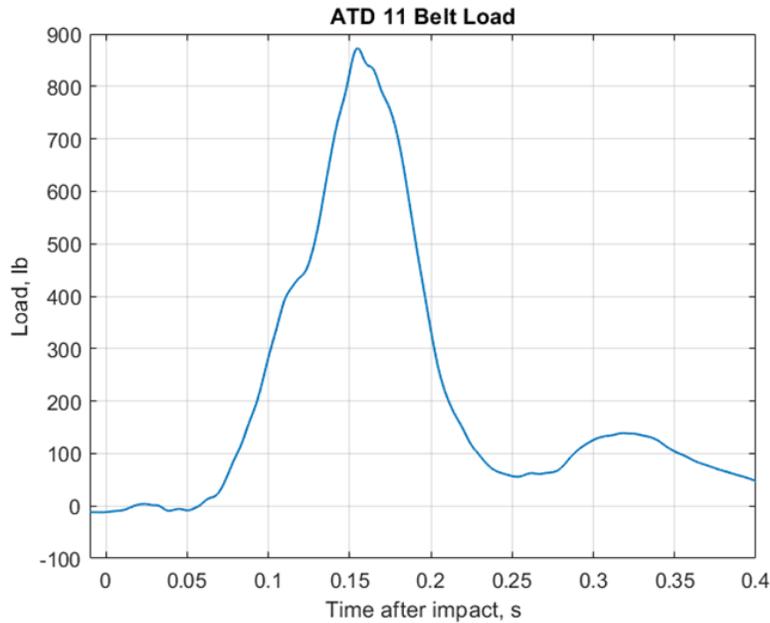
Figure 80. ATD 11 Belt load

The lap belt load measurements are next shown in figure 80. A continuous belt force was measured on the lap belt load cell of ATD 11, indicating the belt did not fail during the test event. Belt force began increasing

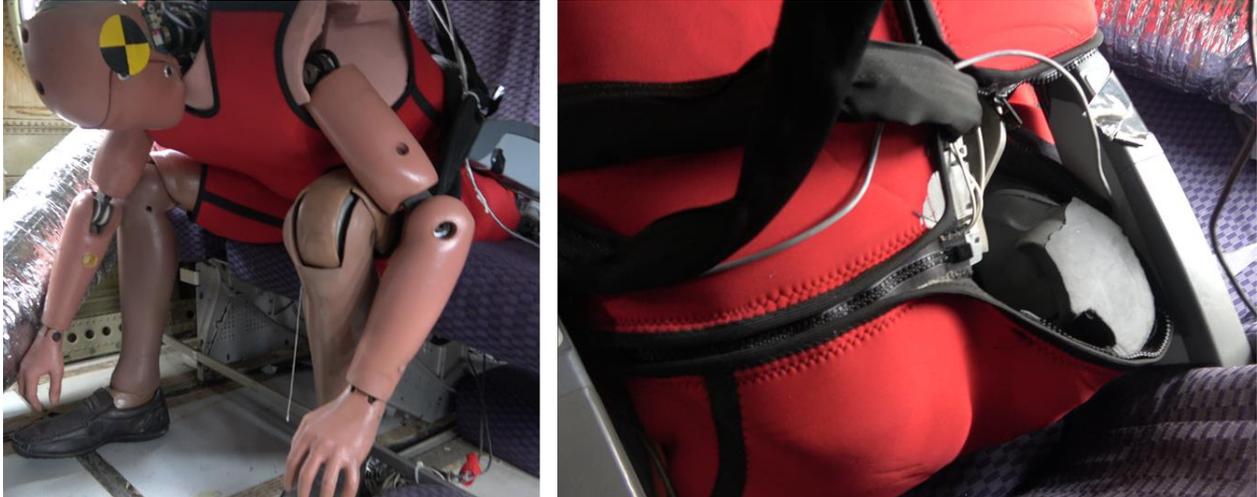
Figure 83. ATD 16 Post-test position (left), and pelvic to femur joint separation (right)

The post-test condition of ATD 16 is shown in figure 83. The ATD pelvis was damaged during the impact event. This resulted in the torso being flexed forward between the knees and the right femur joint of the ATD separating from the pelvis. The THOR Obese ATD configuration tested was a concept prototype still in the developmental stages, these results will be used to improve its durability under dynamic loading environments in the future.

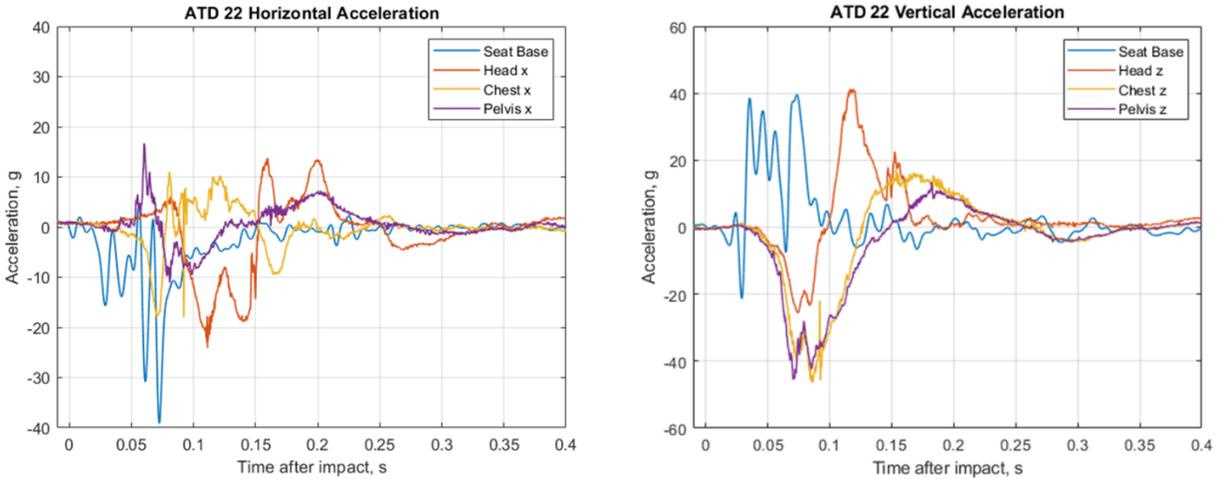
Figure 85. ATD 22 Accelerations

Accelerations in the horizontal and vertical directions are shown in figure 85. Pelvis horizontal acceleration began in the opposite direction of the seat base at 0.05 s after impact, then reversed direction at 0.025 s after which point it tracked the seat base acceleration. These results indicated a significant delay in horizontal force being transferred from the seat into the pelvis, potentially due to a gap between the pelvis and the belt or slippage of the belt. Due to failure of the belt load cell, the source can not be verified. Both chest and head horizontal acceleration were larger in magnitude than the pelvis acceleration with head acceleration showing the largest horizontal acceleration though it peaked much later in the impact. A long duration head contact was indicated in both acceleration directions and head rotation rate, which is shown in figure 86 at just before 0.1 s. At this point head horizontal acceleration increased, vertical acceleration reversed direction, and rotation rate increased significantly. Based on the high-speed video data, it appeared this event occurred when the ATD chin struck its upper torso. Head strike with the forward seatback occurred at approximately 0.15 s, indicated by a reversal in horizontal acceleration direction and a hump in both vertical acceleration and rotation rate. The effect of the head strike with forward seatback was minimal in this ATD as its relative forward velocity was low at the time of contact. Pelvis and chest vertical acceleration closely tracked the seat base throughout the impact event.

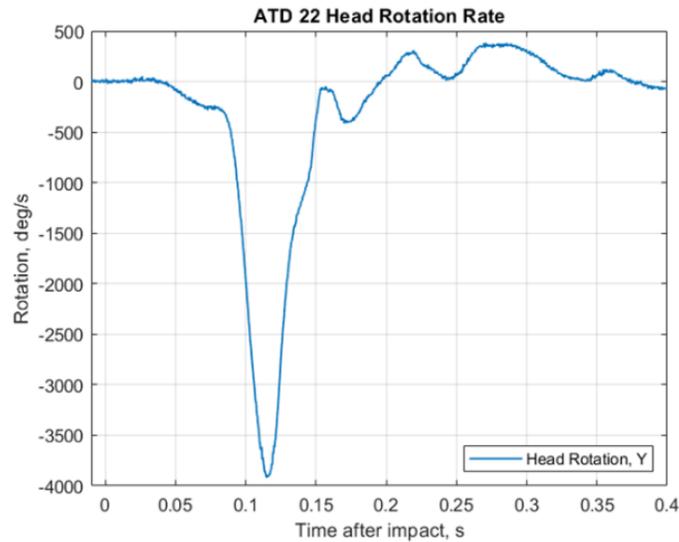
Figure 86. ATD 22 Head rotation rate

The rotation rate of the head is shown in figure 86. The rotation rate reached a minimum value of 3,897 deg/s which occurred 0.114 s after impact. It was at this approximate time that the head folded into the chest. The ATD’s head tucking under the seatback can be observed at approximately 0.15 s where there was a slight hump in head rotation rate. The minimal change in head rotation at this time further indicated the head tucking under the seat was a low-energy impact event.

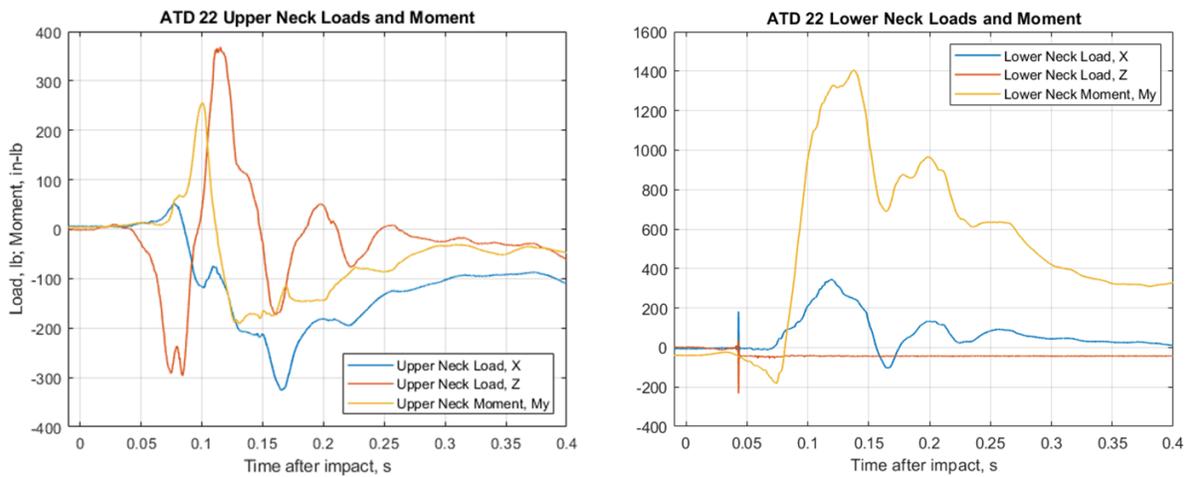
Figure 87. ATD 22 Neck loads and moments

Figure 87 shows the loads and moments from both the upper and lower neck load cells. ATD 22 exhibited upper neck compression and flexion until the head contacted the chest at which point the upper neck experienced tension and extension. Shear force in the neck increased until approximately 0.15 s when the head appeared to tuck under the forward seatback. A very large lower neck flexion moment was measured in ATD 22, which corresponded with the kinematics observed in the high-speed video. The post-test position of the head tucked under the forward seatback sustained a flexion moment in the ATD throughout the impact event. Lower neck shear force was similar in magnitude to that measured in the upper neck, and lastly it appeared that the lower neck vertical force channel was lost during the test.

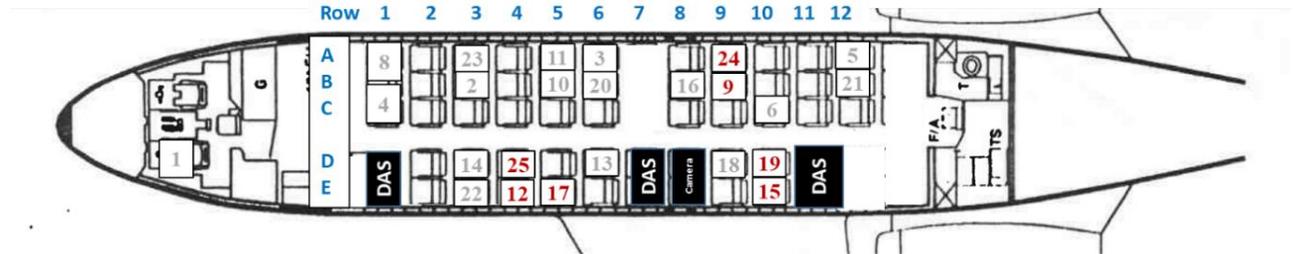
Figure 89. Child ATD locations

The child ATDs were located in the highlighted rows in figure 89 and identified in table 6. There were six different types of ATDs seated in configurations recommended by the FAA, with the smallest being a Q1 child, and the largest being 10 YO sized. Note that most did not include lumbar load cells to measure spinal compression, so most comparisons utilized the head accelerations and belt loads to gain an understanding of how the child responded during the test.
