NASA/TM-20210017474

A Summary of ATD Results from a Full-Scale F28 Crash Test

*Justin D. Littell, Jacob B. Putnam
Langley Research Center, Hampton, Virginia*

June 2021

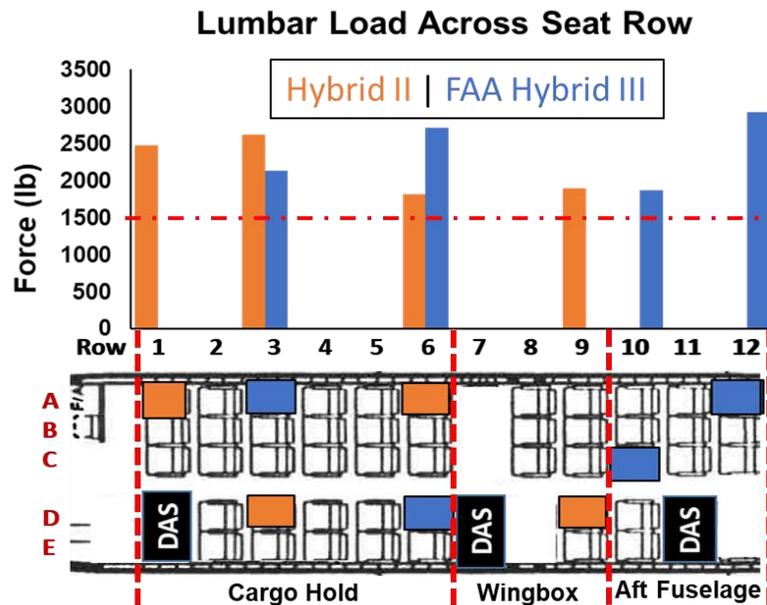
Figure 107. Lumbar load as a function of row position

The first major ATD comparison made was to examine the lumbar load values for all of the upright Hybrid II and FAA Hybrid III ATDs, which are used for certification. This comparison examines whether the placement of the ATD in the cabin had an affect on the lumbar load value. Figure 107 shows the measured lumbar load values throughout the aircraft cabin as a function of seat row. The lumbar loads measured in the Cargo Hold section of the cabin were similar between ATD configurations and measured an average peak value of approximately 2,500 lb. Although differences were observed between Hybrid II and FAA Hybrid III ATD configuration seated in the same rows, 3 and 6, the differences were not consistent in a manner to conclude an effect of ATD configuration on lumbar load. The Wingbox section had the lowest lumbar load compared to the average lumbar load measured in the Cargo Hold and Aft Fuselage sections. Subcomponent tests of Fokker F28 fuselages sections exhibited an opposite trend with the Wingbox section having larger lumbar load values than the Cargo Hold [3]. The cause of this discrepancy was hypothesized to be due to the pitch rotation of the aircraft about the Wingbox section at impact resulting in higher vertical impact velocities at the front of the vehicle [10]. The highest lumbar load is measured in the very rear of the aircraft in Row 12. The high lumbar load measured in this region of the aircraft corresponded with significant cabin intrusion observed in this portion of the aircraft during the test. The fuselage structure

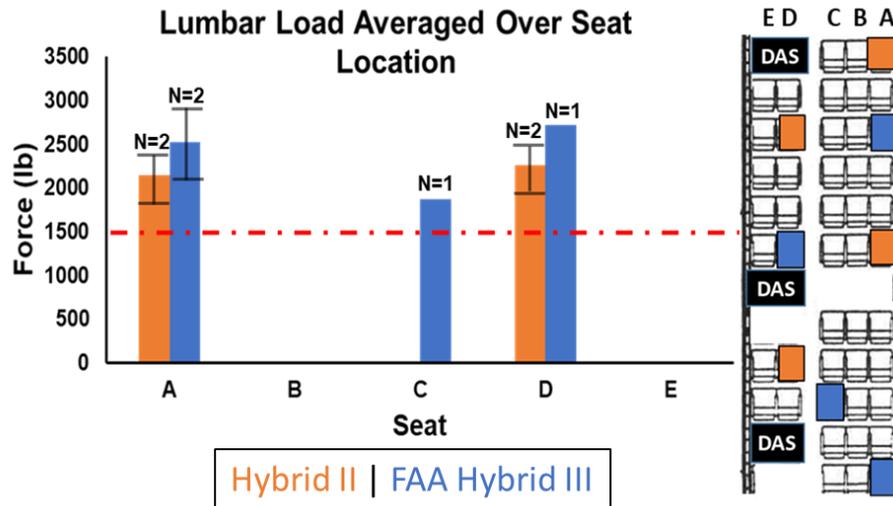
Figure 108. Lumbar load as a function of seat location

Hybrid II and FAA Hybrid III ATDs were placed within three seat locations throughout the aircraft: A, C, and D. Figure 108 shows the compressive loads averaged over each seat location for both ATD configurations. When averaged over seat location, the FAA Hybrid III had slightly higher lumbar loads within the same seat compared the Hybrid II, though this does not factor in differences due to row location. Seat C was shown to have the lowest lumbar load value across those tested, which matched trends observed in the subsection tests of this aircraft. In both of those tests, lower lumbar load values measured in seat C were attributed to greater energy absorption by this seat due to deformation on impact [3].

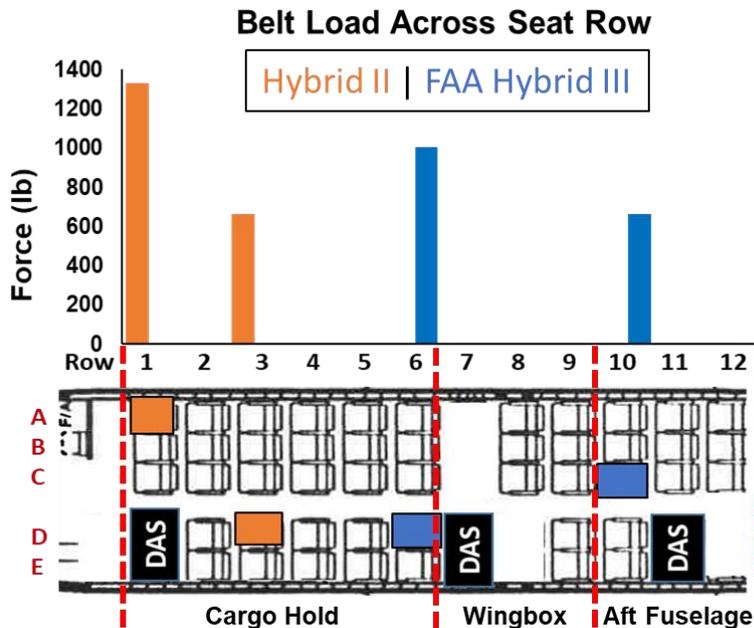
Figure 110. Belt load as a function of row position

Lap belt loads for the Hybrid II and FAA Hybrid III ATDs instrumented with lap belt load cells are provided in figure 110. The largest belt load, 1,329 lb, was measured in a Hybrid II in Seat 1A. There were no clear trends observed between ATD type or position on belt load in this test. All of the belts on these ATDs remained intact throughout the impact event, meeting certification requirements.

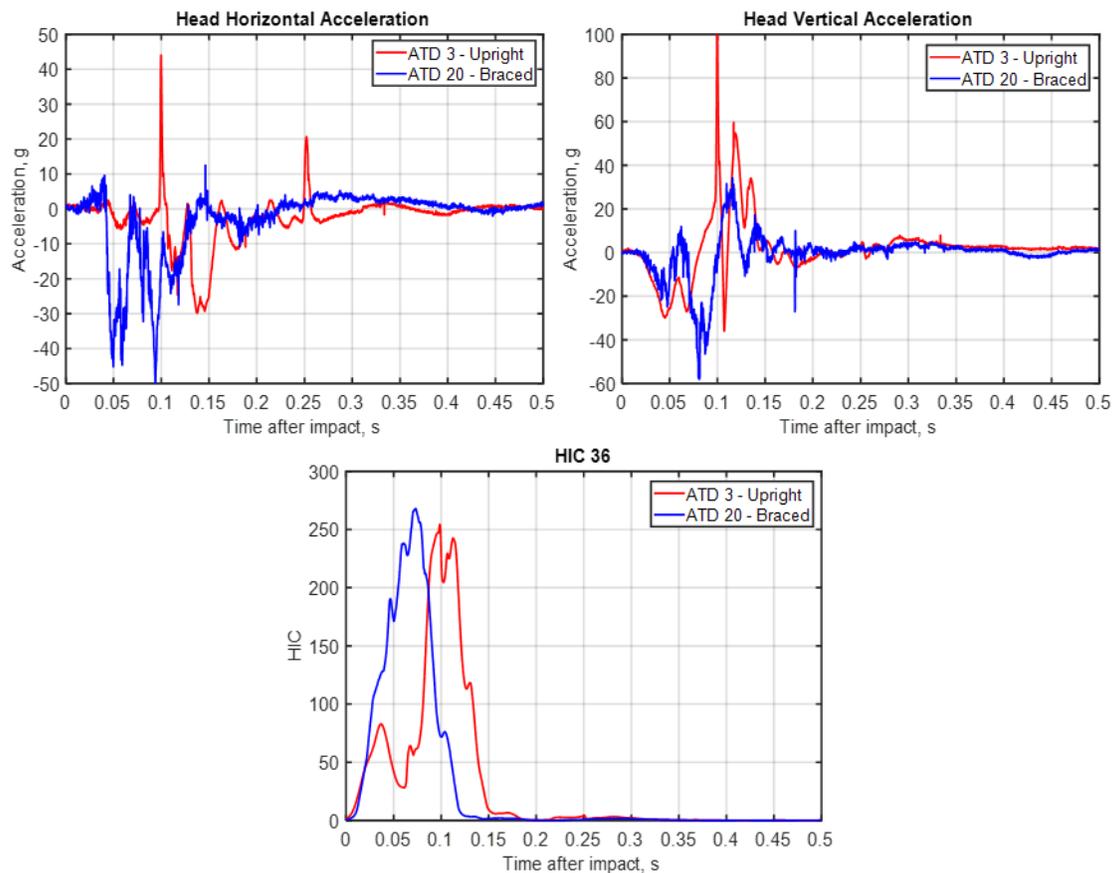
Figure 111. Head kinematic response – Upright vs. Braced position

The effect of positioning on occupant response during the crash can be evaluated by comparing ATD 3 and ATD 20, which were an upright and braced Hybrid II ATD, respectively, seated side by side in the starboard side of Row 6. ATD 20 was placed with its torso rotated forward and head on forward seatback to approximate one of the braced positions recommended for passengers to assume in a crash event by the FAA. This braced position caused ATD 20 to experience head horizontal acceleration earlier in the crash event than the upright ATD 3, as its head quickly struck the forward seatback, which is shown in the upper left plot in figure 111. Though initial head acceleration was increased in the braced ATD 20, the upright ATD 3 experienced the larger ultimate peak acceleration of 101.1 g in vertical acceleration when head strike occurred at 0.10 s post impact. Head injury risk calculated using HIC 36 shows slightly higher risk in the braced ATD as the high head acceleration experienced by the braced ATD was much longer in duration.

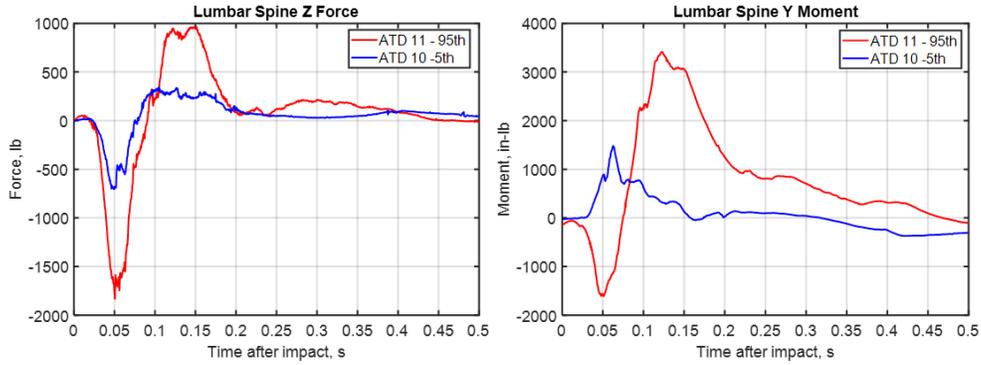
Figure 115. Lumbar response – 95th vs. 5th

Unlike head and neck response, lumbar spine output diverged significantly between the 5th and 95th ATDs. Lumbar spine force and moment for ATD 10 and 11 are shown in Figure 115. The 5th ATD had a peak compressive load of approximately 705 lb compared to 1,832 lb in the 95th ATD. Differences in torso mass over the lumbar spine are the main cause for the differences in these results. Additionally, the divergence in lumbar moment indicated that differences in torso kinematics may have also played a part in the lower lumbar moment in the 5th ATD. The early onset of lumbar flexion moment with no extension indicated the torso of the 5th began forward rotation much earlier than the 95th. This would have offloaded the compressive force applied into the spine by the torso further reducing it compared to the larger ATD.

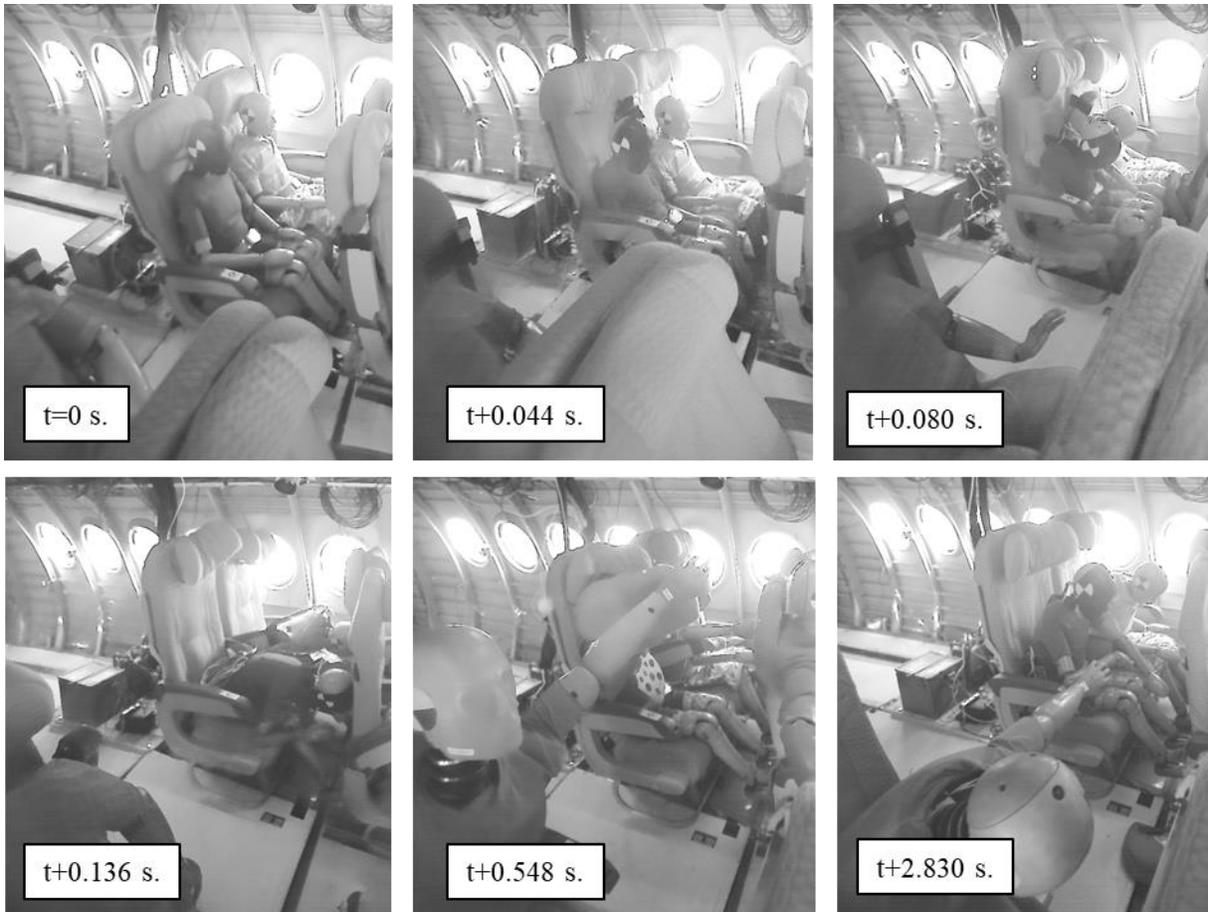
Figure 122. ATD 19 and ATD 15 Image sequence

Kinematic comparison captured in high-speed video is shown in figure 122. The kinematics between the Hybrid III and the LODC ATD show similar responses throughout the impact sequence. At time of impact, both ATDs are seated with the same approximate posture, then experience maximum sink into the seat at 0.044 s after impact. At 0.080 s after impact, the head rotation reached a maximum for both, and then both experienced forward rotation of their upper torso until a minimum point was reached at 0.136 s after impact. Rebound occurred at 0.548 s after impact, and they fell into their post-impact posture afterward. The main difference observed between the two in the high-speed video is that the Hybrid III developed a slightly higher slouch post-test.

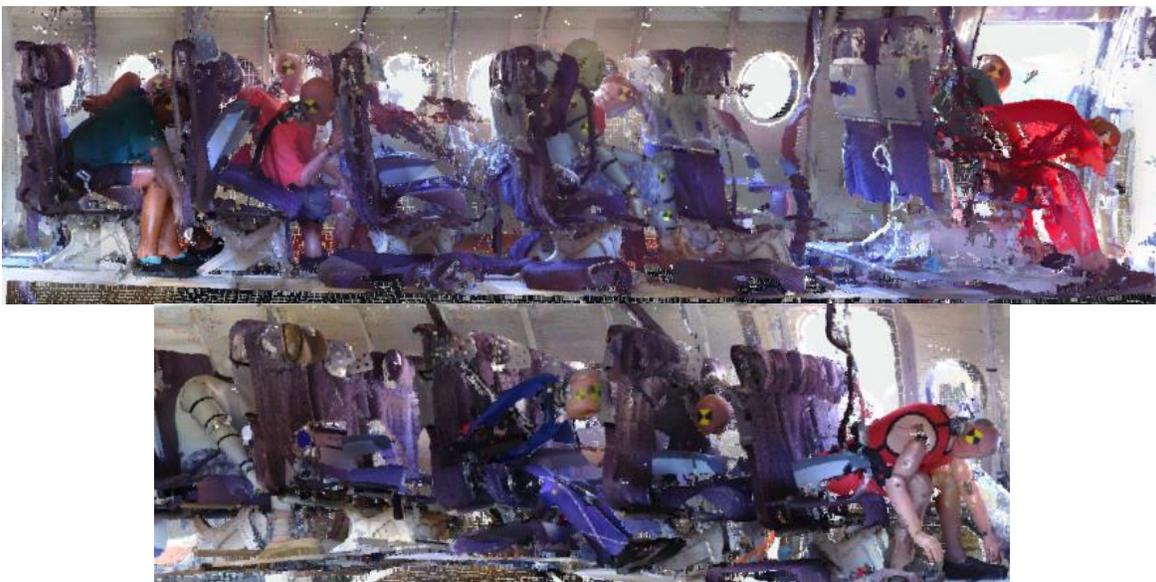
Figure 126. Post-test interior laser scan – Starboard side: Row 1–6 (Top) & 8–12 (Bottom)

Post-test ATD laser scans were taken of both the exterior and interior aircraft in order to document airframe deformation and the post-test occupant state. Similar to the pre-test scans, the NTSB conducted and provided all of the laser scan measurements and data. The interior post-test scan showing the starboard-side cabin section is shown in figure 126.

As shown in the post-test scan, the majority of ATDs ended up in a forward slouched position, either resting against the forward seatback or completely folded forward in cases in which there was no forward seatback.

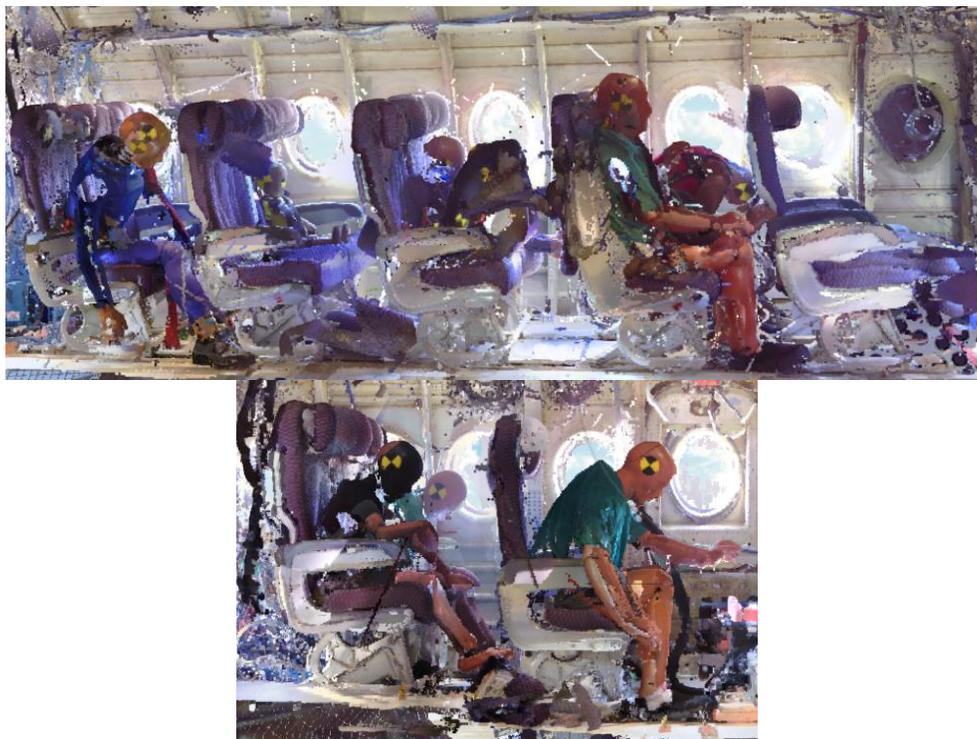
Figure 127. Post-test interior laser scan – Port side: Row 1–6 (Top) & 9–10 (Bottom)

The ATDs in the port side of the aircraft ended up slightly more upright than observed in the starboard-side, this difference may have been influenced by the slight yaw of the aircraft on impact. The laser scan shows the clear difference in post-test position between the Hybrid II and THOR seated in Row 3, with the Hybrid II ending in an upright posture while the THOR was folded under the forward seatback. The Seat 2E seatback in front of the Hybrid II can also be seen folded forward as the recline adjustment mechanism failed when the seatback was impacted by the ATD.
