# ***NASA Super Pressure Balloon Laboratory Test Program***

***Leyland G. Young, PhD***

***Christopher D. Yoder (presenter)***

# Scale Model Test (SMT) design

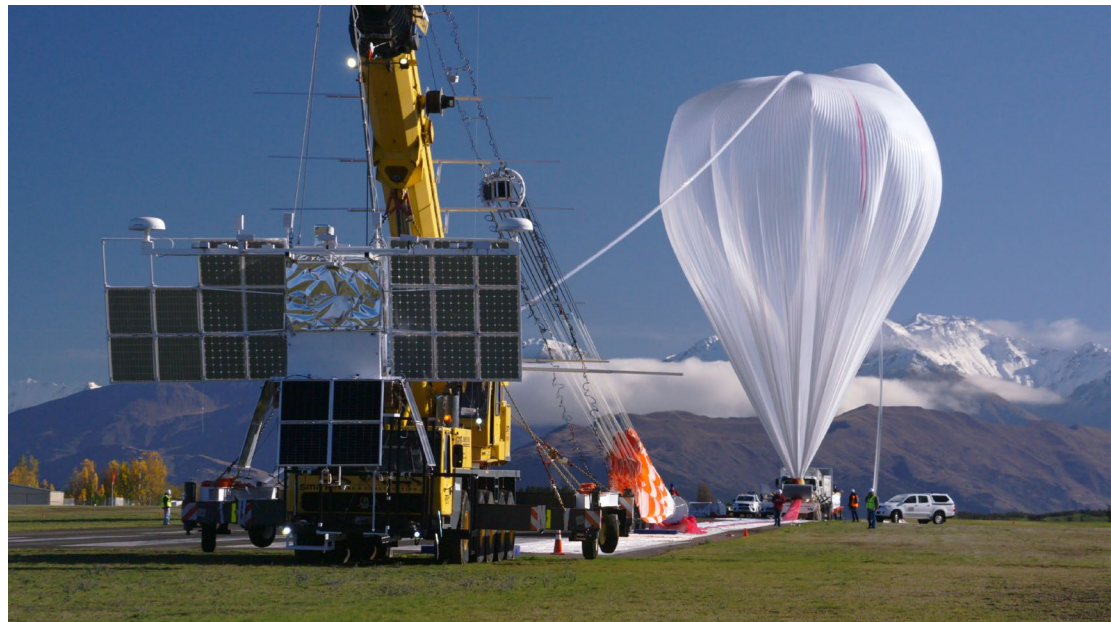
18.8 mcf SPB with the COSI gondola (Flight 669NT) during inflation.

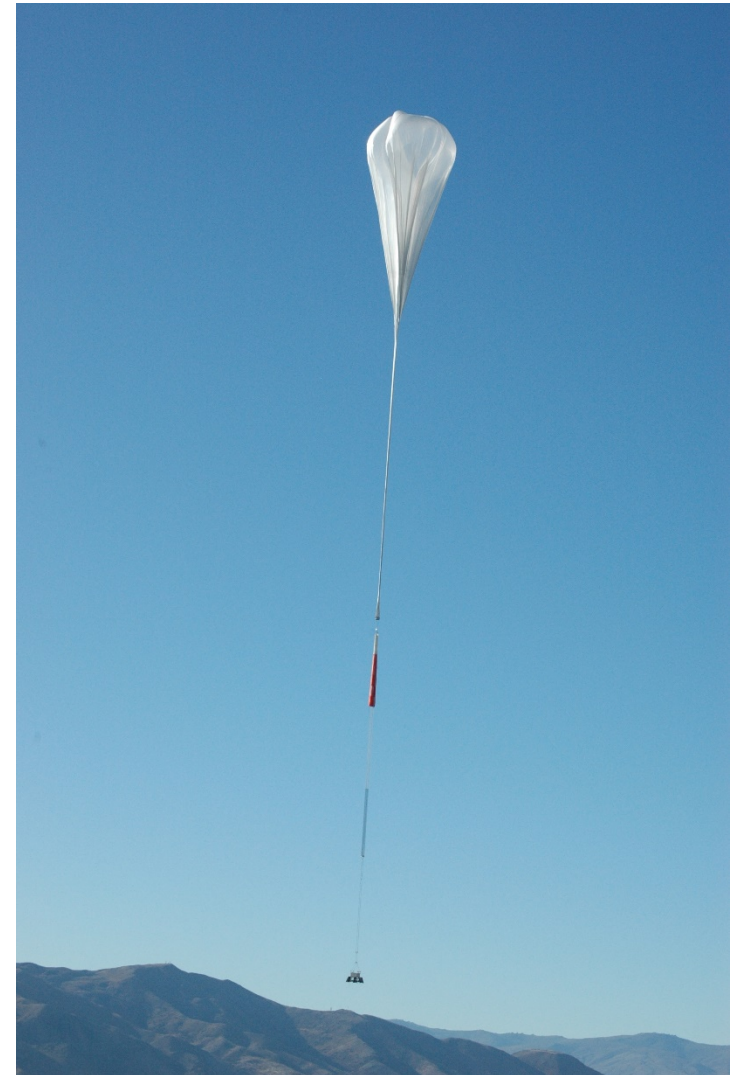
18.8 mcf SPB with the COSI gondola (Flight 669NT) after launch from Wanaka, NZ in 2016.

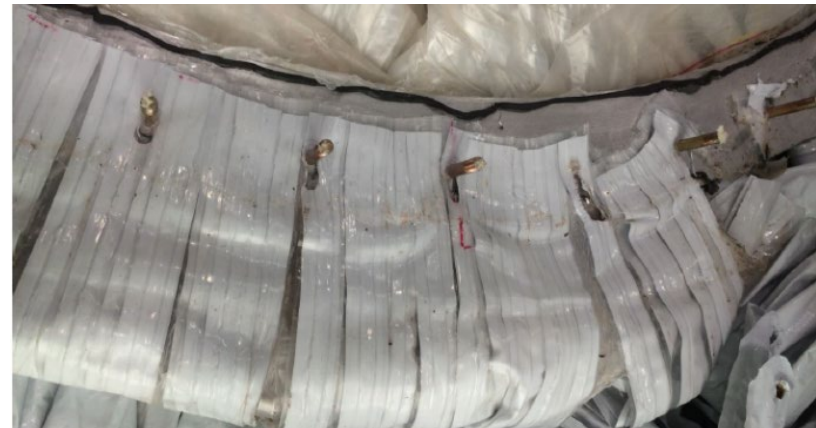
Post-flight end fitting inspection showing elongated holes.

- *Two recent flights: 662NT (2015) and 669NT (2016)*
  - *Both balloons were recovered post-flight*
  - *Inspections identify film damage in the form of film pullout and elongated fastener holes*
- *Design paradigm: the tendons should strain arrest the film*
  - *No evidence of pullout or elongation prior to 662NT*

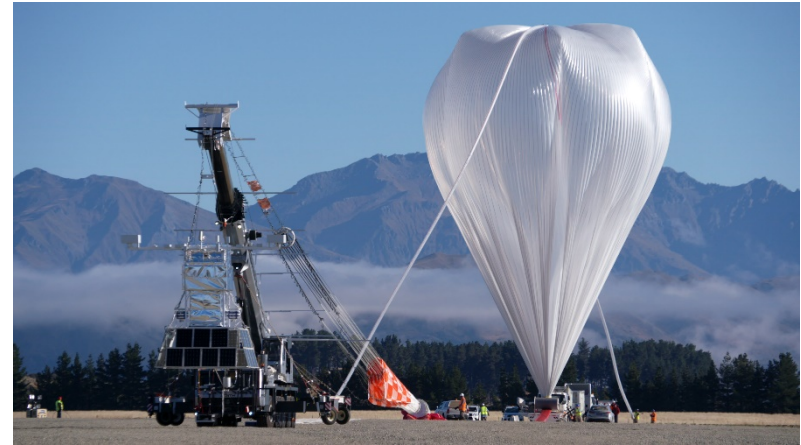
Flight 679NT, SPB SN06 with EUSO prior to launch.

- *Flight 679NT (EUSO-SPB, 2017, Wanaka)*
  - *Launched April 24<sup>th</sup>, 2017*
  - *Flight time: 12 days, 4.5 hrs*
- *Several items were identified as potential contributors*
  - *Prompted the BPO to implement a scale model test program*
    - *To investigate the addition of the WBW sleeve over Zylon*
    - *To investigate the glue bond strength in the WBW sleeve*

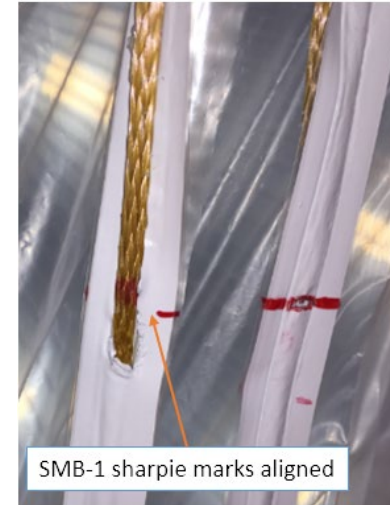
(left) SMB-1 showing alignment of the sharpie lines (made during manufacturing). (right) SMB-2 showing mis-alignment of sharpie lines due to a lack of glue.

- **SMB-1, SMB-3**
  - Shell motion towards the equator with increasing pressure
- **SMB-2**
  - Tendon displacement was found for SMB-2 (handling)
  - Tendon slack was removed with increasing pressure (due to tendon slipping into the sleeve)
