Microstructural Observations on Advanced Multilayer Protective Coatings for Nuclear Thermal Propulsion

*S.V. Raj and J.A. Nesbitt
Glenn Research Center, Cleveland, Ohio*

The present research discusses the microstructures of a new multilayered coating concept proposed to solve the “midrange corrosion” problem observed in NbC and ZrC-coated graphite (Gr) nuclear fuels during the NERVA/Rover programs. The concept envisions designing a compliant multilayered coatings architecture to accommodate the thermal expansion mismatch strains between the ZrC outer coating and the Gr/(U,Zr)C fuel matrix along with using a diffusion barrier to minimize carbon and hydrogen diffusion, respectively. Multilayered coatings were deposited on Gr substrates by chemical vapor deposition (CVD). Graphite disks, as well as the inner channels of a 19-hole hexagonal rod 152.4 mm long, were coated by CVD in proof-of concept process demonstration studies. Coated disk specimens were thermally-cycled between ambient and 1900 K for as long as 20 cycles with a 1 h hold time at the temperature using both stepped and non-interrupted thermal cycling methods. Detailed cross-sectional microstructural analyses were condu

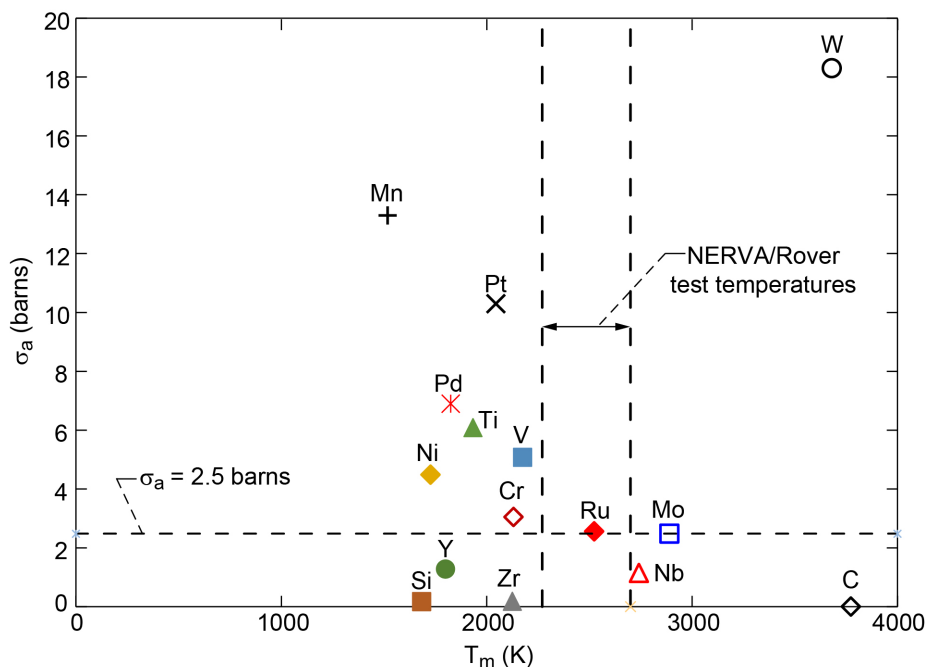
Figure 1.—Plot of the thermal neutron absorption cross-section [26,27,28] against absolute melting temperature [29] for some elements with $\sigma_a < 20$ barns.

As noted above, an important factor that must be considered in determining the composition of the compliant layer for a NTP engine is the effect of the coating architecture on the neutronics. Figure 1 shows the variation of σ_a for elements with $\sigma_a < 20$ barns [26,27,28] against T_m [29] for several elements in order to identify elements that satisfy (a) and (b) above. The two vertical broken lines represent the range of temperatures in which the NTP engines were tested during the NERVA/Rover programs. The horizontal broken line is the value of $\sigma_a = 2.48$ barns for Mo [26,27] although a value of 2.51 to 2.55 barns has also been reported [28]. An examination of Figure 1 reveals that only C, Mo and Nb have values of $\sigma_a \leq 2.48$ barns and $T_m > 2700$ K. In addition to using these elements in elemental form, their carbides and nitrides would have acceptable values of σ_a and $T_m > 2700$ K. In contrast, only ZrC and ZrN have $T_m > 2700$ K so that carbides and nitrides of Si and Y would not be suitable for use in a NTP coating architecture although they may possess low values of σ_a .

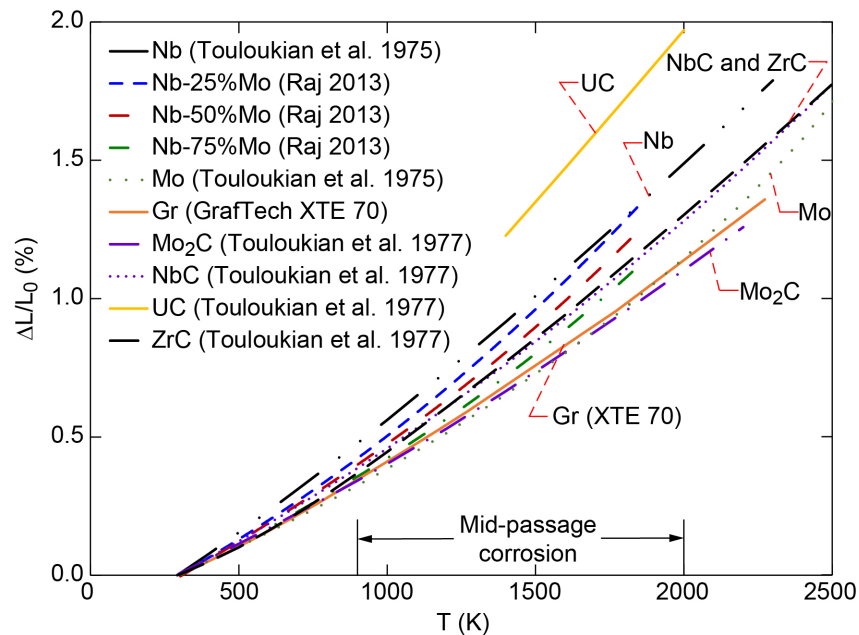
Figure 2.—Plot of longitudinal strain due to thermal expansion against absolute temperature for XTE 70 Gr [33], Mo [31], Nb [31], Nb-Mo alloys [32], Mo_2C [30], NbC [30], UC [30] and ZrC [30].

Figure 2 shows a plot of the thermal strain, $\Delta L/L_0$, where ΔL is the thermal expansion and L_0 is the original specimen length, as a function of the absolute temperature, T , for several carbides (Mo_2C , NbC , UC and ZrC) [30], Mo [31], Nb [31], $\text{Nb-25(wt.\%)}\text{Mo}^3$, Nb-50\%Mo and Nb-75\%Mo solid solution alloys [32], and GrafTech XTE 70⁴ Gr [33]. As evident in Figure 2, the thermal strains of Nb , Nb-25\%Mo , Nb-50\%Mo , NbC , UC and ZrC are significantly larger than Gr with the differences in the $\Delta L/L_0$ increasing with increasing T . In contrast, Mo and Mo_2C have similar values of $\Delta L/L_0$ between 300 and 2200 K. The data for the Nb-75\%Mo alloy lies in between those for Gr and NbC and ZrC . Clearly, a Nb-75\%Mo would be ideally suited to act as a compliant layer to accommodate any mismatch in the thermal strains between the Gr , and either the NbC or ZrC topcoat. Additionally, a Nb-75\%Mo compliant layer is unlikely to significantly affect the neutronics while being able to withstand the ultrahigh temperature environment of a NTP engine (Figure 2).

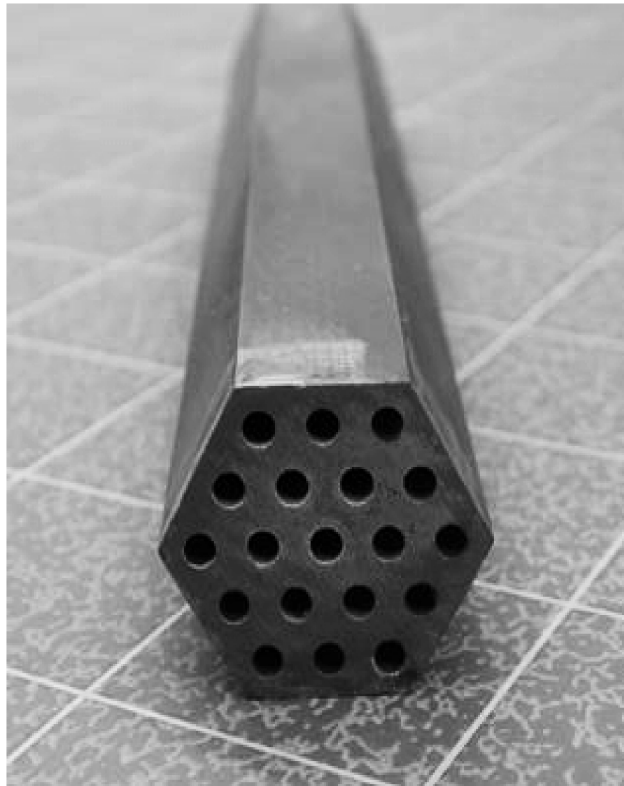
Figure 5.—Photograph of the Mersen 2160 hexagonal rod with 19 channels.

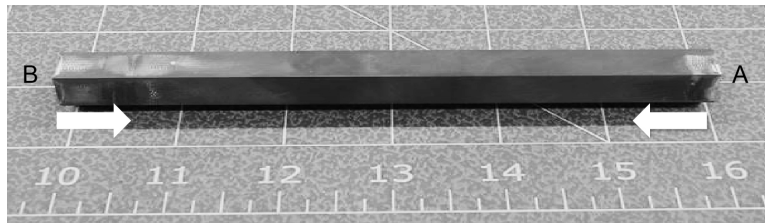
Figure 6.—Photograph showing the direction of the μ -CT scan from end faces, A and B, of the coated rod up to a distance of 25.4 mm as depicted by the arrows.

Micro-computed tomography (μ -CT) scans were conducted on the coated 152.4 mm long hexagonal coated Gr rod. Figure 6 shows the coated Gr rod with arrows showing the direction of the scans from end faces A and B. The scans were conducted from end faces A and B up to a distance of 25.4 mm at 10 μ m voxel intervals between scans. Since a large amount of data were generated, only images taken at locations 0, 6.35, 12.7, 19.1 and 25.4 mm from each face are included in the report.

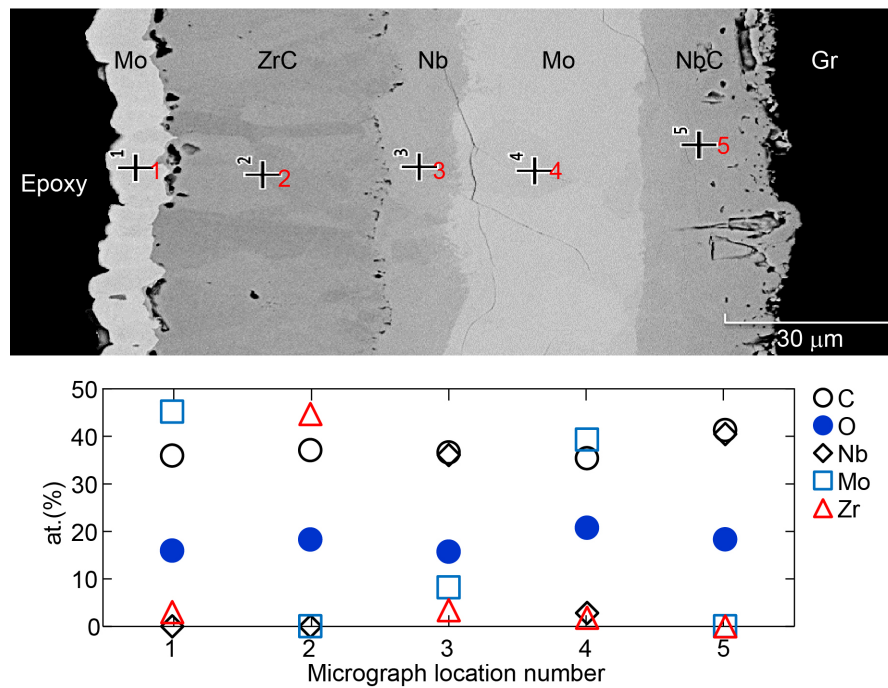
Figure 14.—Back scattered electron image of a region of the post-step thermal cycled specimen, DS-2, showing the locations in each coating layer at which the spot EDS data shown in the bottom graph were determined. The measured values of carbon are suspect as they could have been affected by hydrocarbon contamination in the SEM chamber. The source of oxygen appears to be due to moisture contamination of the vacuum furnace due to inadequate drying of the specimen prior to thermal cycling.

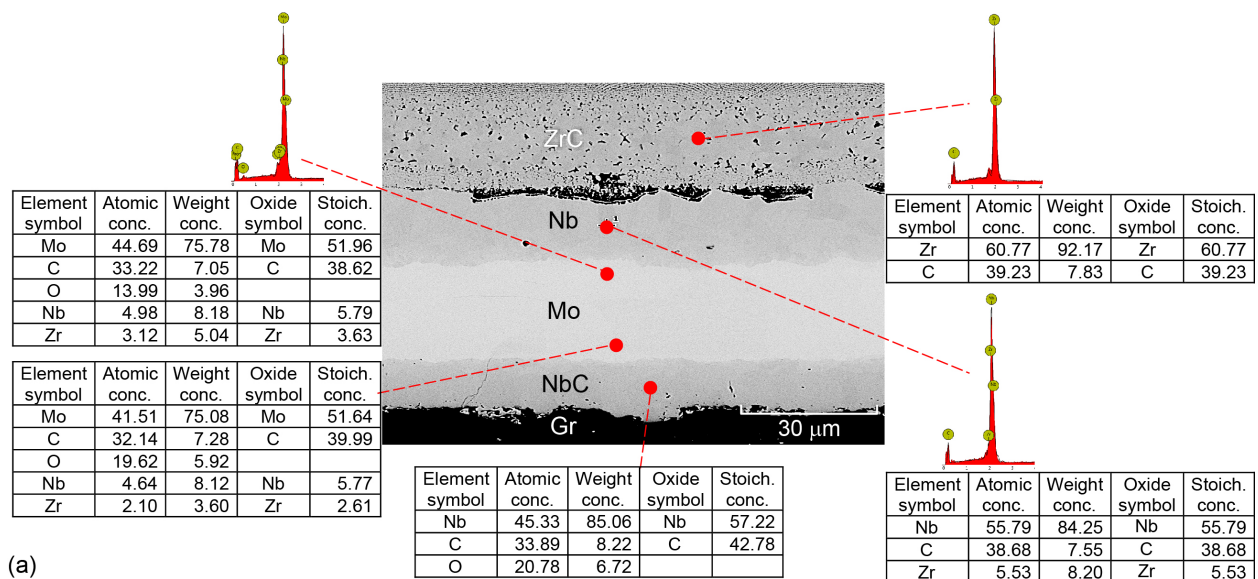
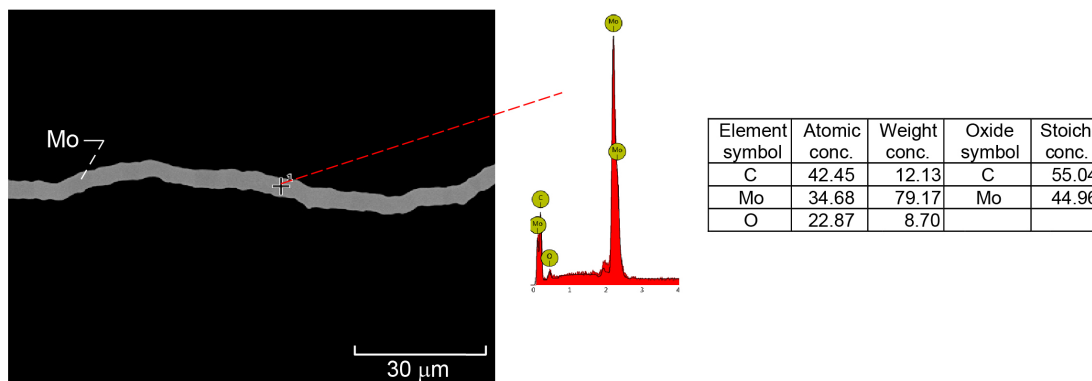
Figure 16.—Spot EDS data from the different coating layers in specimen, DS-1, after thermal cycling between ambient and 1900 K with a 1 h hold time for 20 cycles. The measured values of carbon are suspect as they could have been affected by hydrocarbon contamination in the SEM chamber. (a) General analysis of the different layers showing high values of oxygen in the Mo and the NbC layers as well as evidence of Zr diffusion into the Nb and the Mo layers. (b) High values of oxygen in the debonded Mo overlay layer. (c) Variations of C and Zr at seven locations in the ZrC layer from close to the Nb/ZrC interface to the ZrC/Mo overlay interface showing no significant spatial variations in the compositions of these two elements.

Figure 16(a) shows the post-thermal cycling spot EDS spectra and compositions determined at the red dots from the different coating layers for DS-1. Again, a high level of C varying between 32 and 39 at.% was observed in all the layers. A close examination of the data shows that Zr had preferentially diffused from the ZrC layer into the Nb and the Mo layers below. In this case, the Zr content varied from about 60.8 at.% in ZrC to 5.5 at.% in Nb to 2.1-3.1 at.% in Mo. The Nb-Zr binary phase diagram shows that the β -Nb and β -Zr phases⁶ are completely isomorphous at high temperatures and undergo a monotectoid reaction at and below 893 K to form a β -Nb + α -Zr dual phase microstructure [41]. The higher solid solubility of Zr in Nb and the lower solid solubility of Nb in Zr may qualitatively explain why Zr had preferentially diffused from the ZrC into the Nb layer during the thermal cycling test.

The compositions of the two spots in the Mo layer also revealed that Nb had diffused into this layer. Significantly, the compositions of O varied between 14.0 to 19.6 at.% close to the Nb and NbC diffusion layers, respectively. A spot EDS analysis of the Mo overlay also revealed a high O level of 22.9 at.% (Figure 16(b)). A high O level of 20.8 at.% was also observed in the NbC diffusion layer. Since the ZrC and the Nb layers did not contain significant amounts of O in the post-thermal cycled specimen, it is reasonable to conclude that the high levels of O observed in the Mo overlay, the Mo and the NbC layers were due to oxygen contamination of the CVD reactor chamber during the coating process. The fact that O peaks were not observed in the ZrC and the Nb layers suggests the possibility that the oxygen contamination is intimately connected with the deposition of Mo. Infrared spectral analyses of vaporized MoCl_5 salt at elevated temperatures revealed the presence of oxygen impurity in the form of MoOCl_3 [42]. It is likely that the source of the oxygen contamination was the CVD precursor MoCl_5 salt although the possibility of a leak in CVD system cannot be ruled out. The source of the O in the NbC layer is most likely from NbOCl_3 impurity present in the precursor NbCl_5 salt assuming that there was no air leakage in the CVD system [43]. As will be demonstrated later in the paper, high values of oxygen were observed quite often in the Mo layers. Similarly, high values of O were observed in the Mo layer in an earlier investigation [25].

Figure 16(c) shows the variations in the C and Zr compositions at seven locations in the ZrC layer varying from the Mo overlay/ZrC to the ZrC/Nb interfaces after thermal cycling. The compositional data are shown both in a graphical as well as in a tabular form. The observed C and Zr compositions varied between 36.9 and 46.8 at.%, and 53.2 and 63.2 at.%, respectively. There was no significant spatial variation in the compositions of these two elements. Unfortunately, as mentioned earlier, the observed C values were probably influenced by hydrocarbon contamination on the specimen surface so that the true C value is unknown. As noted earlier, the ZrC layers were probably deposited under CVD processing which resulted in a two-phase lamellar microstructure corresponding to either the $\text{ZrC} + \text{C} + \text{gas}$ or the $\text{ZrC} + \text{Zr} + \text{gas}$ regions of the CVD pseudo-binary phase diagrams [36]. On the basis of the Zr-C binary phase diagram [29], the expected microstructure for $\text{C} < 38.0$ at.% would be an $\alpha\text{-Zr} + \text{ZrC}$ lamellar eutectic microstructure at room temperature. Between $38.0 \leq \text{C} \leq 46.5$ at.%, the microstructure is expected to be a single phase Zr-rich ZrC_x microstructure. Referring to Figure 16(c), the average measured value of C is about 41.5 at.%. It is reasonable to assume that the actual average value of C would be less than 38.0 at.% after correcting for contributions from C deposits from hydrocarbon decomposition. This assumption is consistent with the observed lamellar eutectic microstructure (Figure 9(b) to (c) and Figure 16(c)) based on the Zr-C binary phase diagram [29] and the CVD pseudo-binary phase diagram [36].
