Down-Selection of Four Common Habitat Variants

Abstract— The Common Habitat is a large habitat that uses the Space Launch System core stage liquid oxygen tank as its primary structure. It has a gravity-independent internal architecture, such that identical units can be used on the lunar surface, Mars surface, and in microgravity. In developing the habitat, two key architectural questions emerged. Should the internal layout use a vertical or horizontal orientation of the tank? Should the crew size be four or eight? This led to the design of four variants: a four-crew horizontal, four-crew vertical, eight-crew horizontal, and eight-crew vertical. The primary consideration applied for down-selection was the crew experience living and working in the habitat, inclusive of crew productivity, well-being, and survivability. Based on this consideration, a series of seven assessments was performed to compare the four variants. A stowage assessment developed a standard logistics module and then considered the amounts of water to be stored in each variant. It then estimated how much stowage could be carried onboard each Common Habitat and how many logistics modules are required by each varian

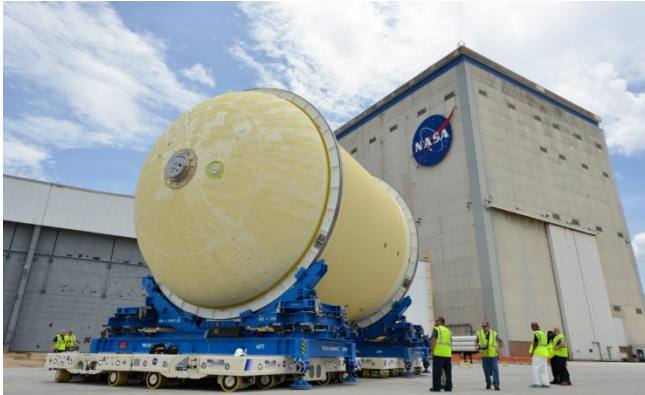
Figure 2. SLS LOX Tank

Figure 2 shows a manufactured SLS LOX tank and indicates the relative size of the tank as compared with the people next to it on the ground.

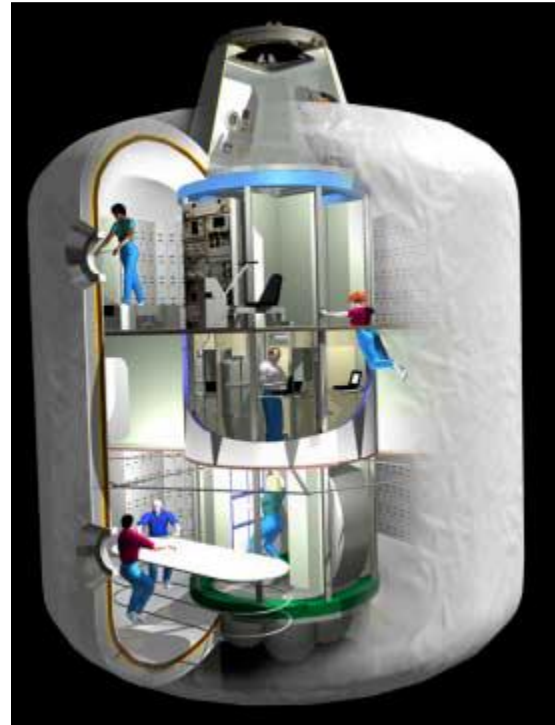
Figure 3. Vertical Orientation of TransHab

The first question is should the habitat have a vertical or horizontal internal orientation? An example of a vertical orientation is the NASA TransHab concept proposed by NASA in the 1990s, shown in Figure 3. [2] A vertical orientation is one such that the decks are parallel to a circular cross section of the pressure vessel.

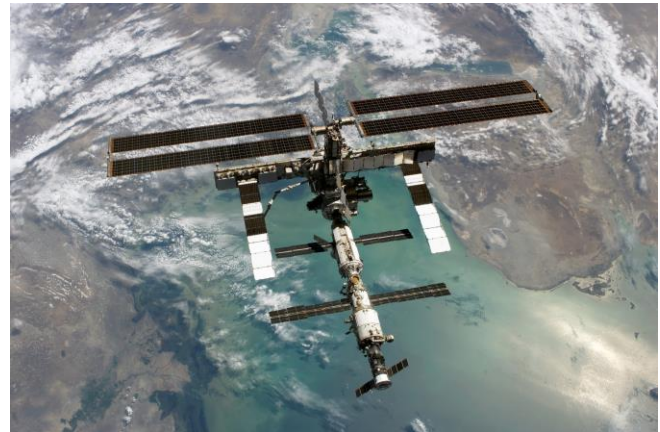
Figure 4. International Space Station

By comparison, a horizontal orientation is one such that the decks are perpendicular to a circular cross section of the pressure vessel. The International Space Station (ISS), shown in Figure 4, has a horizontal orientation within its pressurized crew modules. An internal view of the ISS is shown in Figure 5 where the horizontal orientation can be clearly seen.

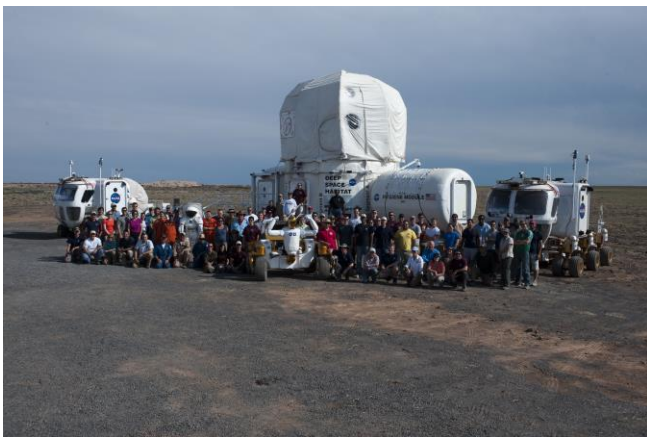
Figure 6. 2011 DRATS Test Team with the Habitat and Both Rovers in the Background

The second question concerns crew size. Many of the Mars Design Reference Missions often featured six-person crews. [3] But more recent reference missions have featured four crew or fewer. The Constellation program also planned for a crew size of four for the Moon. However, personal observation during NASA Desert Research and Technology Studies (DRATS) field expeditions from 2008-2011 and the Research and Technology Studies (RATS) mission operations test held at Johnson Space Center in 2012 has raised the question whether this crew size is sufficient. During these tests, NASA evaluated prototypes of surface and in-space variants of small pressurized rovers and long-duration habitats. Figure 6 shows the prototypes evaluated in 2011.

The two-person rovers were found to be most effective when employed in pairs and the habitat fully engaged a four-person crew. It would be challenging to efficiently utilize a habitat and two rovers at the same time with only four people available. Thus, this study has imposed the question should the crew size be four or eight?

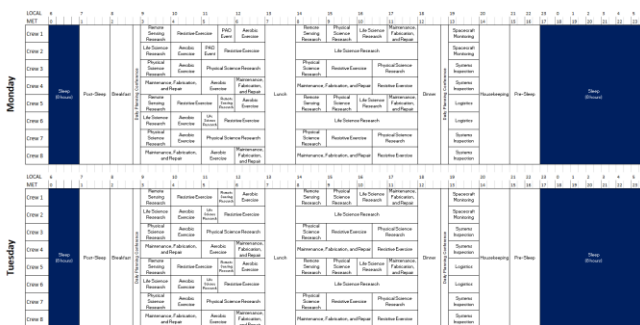
Figure 14. Monday and Tuesday Eight-Crew Schedules

These activities are then mapped onto a typical crew week. In this assessment, Monday, Wednesday, and Friday crew schedules are identical. Tuesday and Thursday crew days are identical. Mondays and Tuesdays are shown in Figure 14. Saturday and Sunday are both unique and shown in Figure 15.

These crew schedules track crew time in 15-minute increments during the day and in 30-minute increments at night. All eight crew are tracked individually.
