Results From the MISSE 6 Scattered Space Atomic Oxygen Experiment (SSAOE)

*Kim K. de Groh
Glenn Research Center, Cleveland, Ohio*

Polymers and other oxidizable materials used on the exterior of spacecraft in the low Earth orbit (LEO) space environment can be eroded away by reaction with atomic oxygen (AO). NASA Glenn Research Center developed an active flight experiment, called the Scattered Space Atomic Oxygen Experiment (SSAOE), to characterize AO scattering erosion in space. The SSAOE is comprised of three independent sub-experiments: A two part active experiment to measure both in-situ direct ram AO erosion and in-situ scattered AO erosion within an AO scatterometer; a passive AO scatterometer to measure the angular distribution of LEO AO scattered off an inclined angle; and passive samples for AO erosion yield (E_y) characterization. The SSAOE was originally flown on the Wake Shield Facility (WSF) during the STS-60 shuttle mission, and was later flown as part of the MISSE 6 mission on the exterior of the ISS. During the MISSE-6 mission the SSAOE was exposed to the space environment for 1.45 years. This paper provides an overview of the SSAOE, information on the flight missio

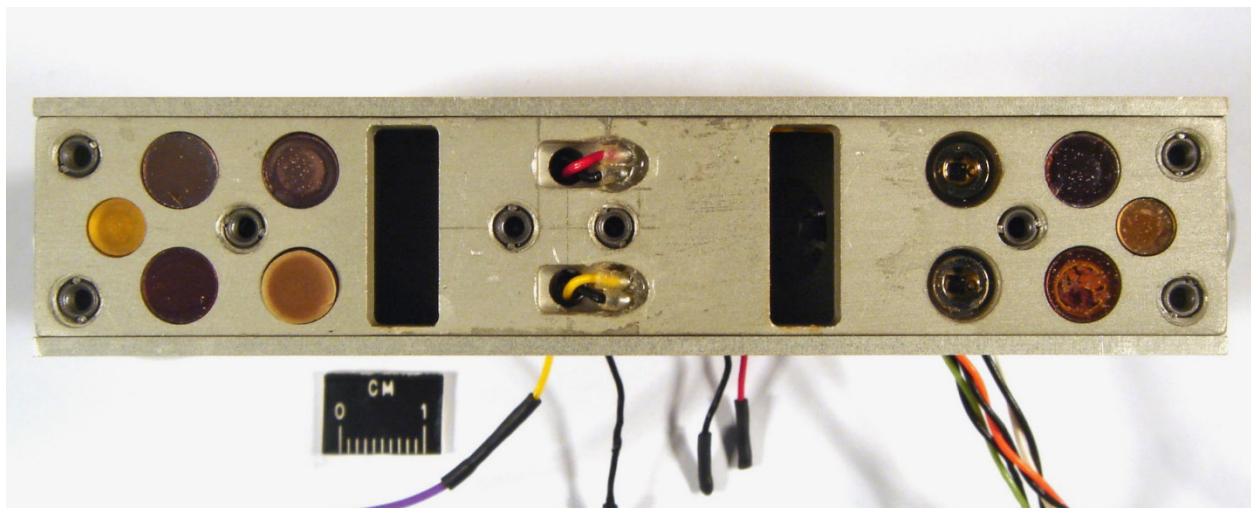
Figure 19. Post-flight photograph with the lid removed and the passive samples and ram facing photodiodes visible.

Figure 18 provides a post-flight photograph of the SSAOE after the MISSE 6 mission. Figure 19 shows a post-flight photograph of the SSAOE with the lid removed and the small passive samples and the ram facing photodiodes visible.

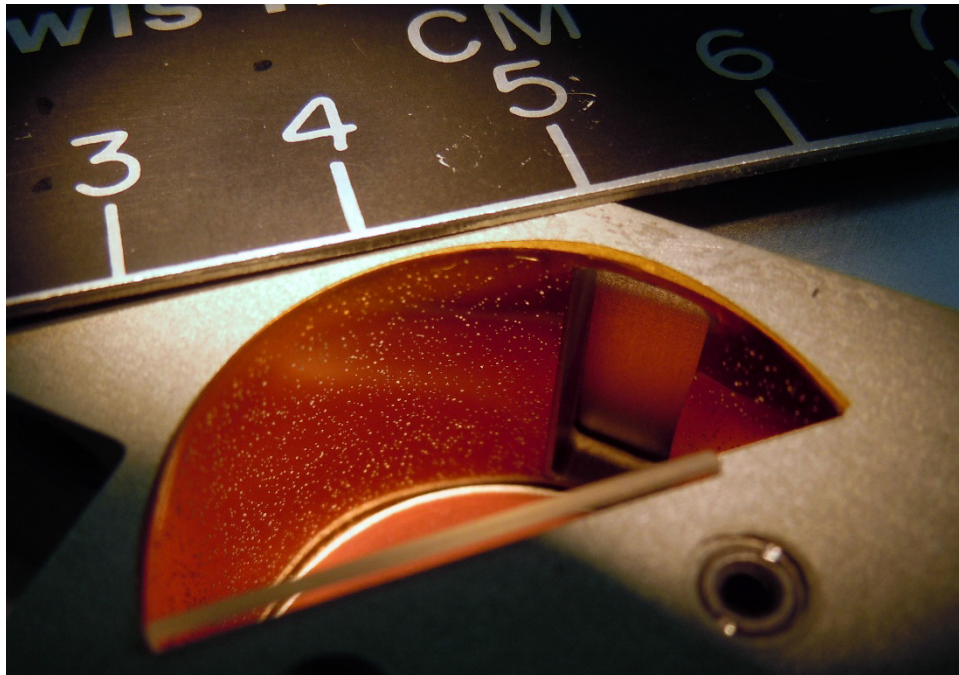
Figure 22. Post-flight photograph of the passive scatterometer chamber showing salt remaining on the Kapton liner.

Figure 21 and Figure 22 provide post-flight photographs with one of the SSAOE sides removed. Figure 21 shows the inside of both the active (right) and passive (left) scatterometer chambers and Figure 22 is a close-up of the passive scatterometer chamber showing the salt particles remaining on the Kapton liner. Figure 23 shows the passive scatterometer salt-sprayed Kapton liner removed from the scatterometer chamber and Figure 24 shows passive scatterometer salt-sprayed Kapton liner sample sectioned, and prepared for SEM imaging.

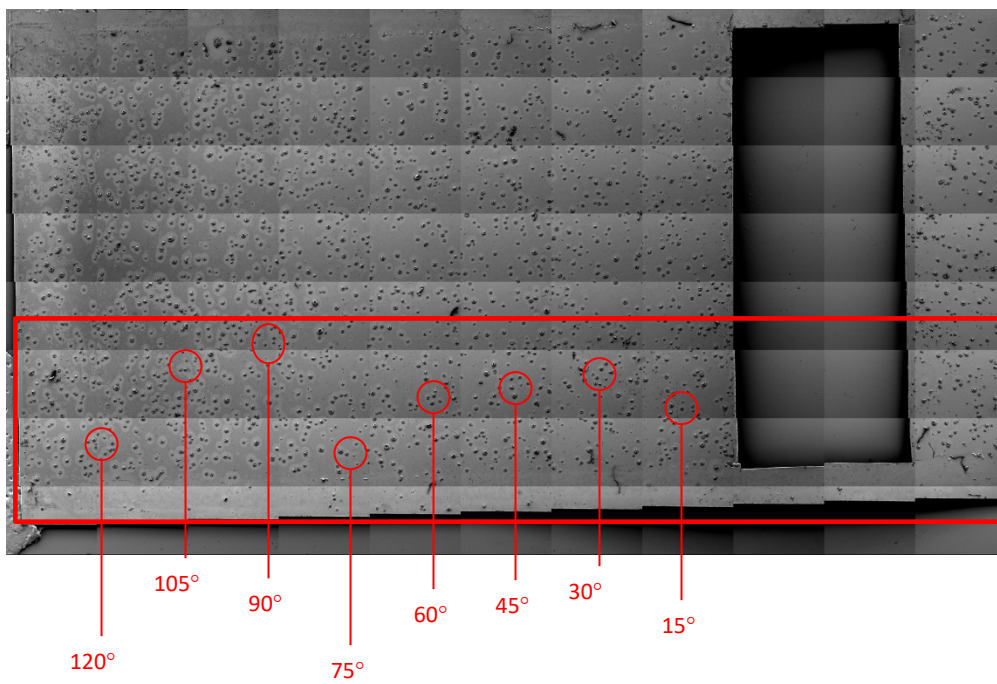
Figure 25. SEM composite image of the passive scatterometer salt-sprayed Kapton liner with sample and scatter angles highlighted for the FESEM images: (a) Sample angles (blue), and (b) Scatter angles (red).

Figure 25 is a SEM composite image, made up of many SEM images, showing the passive scatterometer Kapton liner with the salt-particles intact with the scatter angle locations defined. Figure 25a shows the **sample angles** and Figure 25b shows the **scatter angles**. As stated previously, the “sample angle” is not the same as the “scatter angle”. The 15° sample angle is for the 120° scatter angle, the 30° sample angle is for the 105° scatter angle, the 45° sample angle is for the 90° scatter angle, the 60° sample angle is for the 75° scatter angle, the 75° sample angle is for the 60° scatter angle, the 90° sample angle is for the 45° scatter angle, and the 120° sample angle is for the 15° scatter angle. This is clarified to avoid confusion because the **sample angles** are listed on the SEM images (i.e., SSAOE15). SEM images were obtained at each angle shown in Figure 25 except at a 105° scatter angle (30° sample angle). Figure 26 provides SEM images of the passive scatterometer salt-sprayed Kapton liner with the salt particles present. As can be seen, the salt particles appears to have dried formed in clusters.

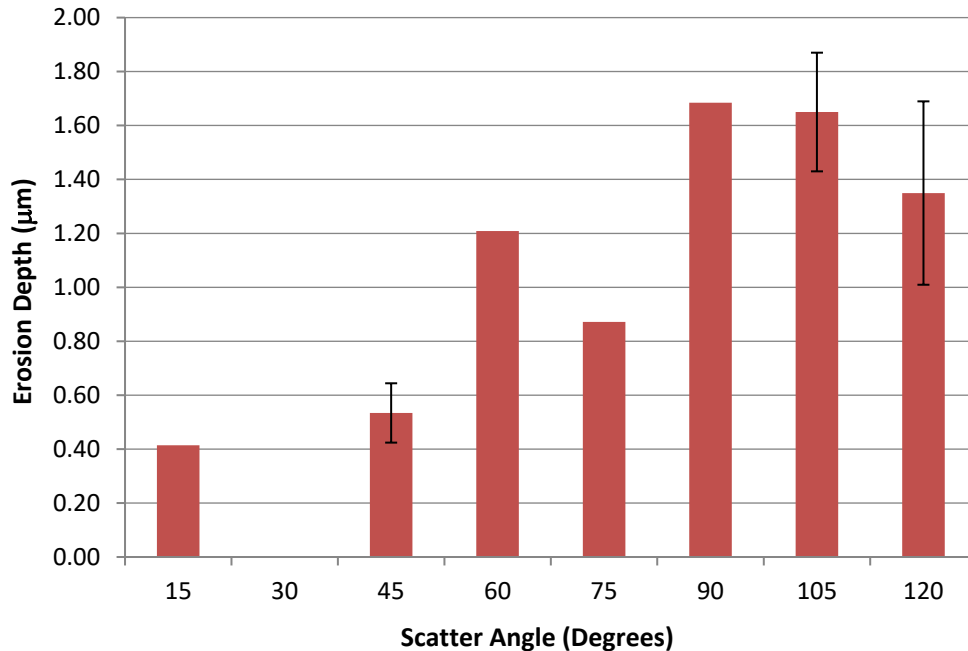
Figure 35. Bar graph showing the erosion depth versus the scatter angle.

Results of the erosion depth versus AO scatter angle are provided in Table 3 and are visually represented in the bar graph in Figure 35. As shown in the bar graph, the greatest erosion depth occurred at a 90° scatter angle. The images, such as Figure 28a, indicate that scattering within the scattering chamber caused slight AO undercutting of the Kapton that was covered with salt particles, as would be expected. The erosion depth versus scatter angle data indicates that there was only a slight increase in erosion due to flux scattered in a forward direction which indicates that the primary ejection of AO flux is normal to the scattering surface. This is different than the results by Banks et al. in Reference 16 where the primary ejection of AO within a MISSE 2 AO scattering chamber was at 45° off an aluminum target that was exposed to normal incidence LEO AO.
