# Challenges with Heat Flux Calorimeters used in Arc Jets

David M. Driver<sup>1</sup>, Imelda Terrazas<sup>2</sup>, Frank Hui<sup>3</sup>, Enrique Carballo<sup>4</sup>, My Au<sup>5</sup>, Myvan Nguyen<sup>6</sup>  
*NASA Ames Research Center, Moffett Field, California, 94035*

Occasionally large errors have occurred in some of the calorimeters used in the arc jet facilities. Some slug calorimeters would measure twice the expected heat flux and some Coaxial TC calorimeters would measure half the expected heat flux. While these errors in heat flux measurements are easy to identify and discard / dismiss, the concern is that less spectacular errors are difficult to detect. This inspired a critical look at the calorimetry used to measure stagnation heat flux in the NASA Ames Arc Jet facilities. Numerous sources of error were investigated, and the culprit in the case of slug calorimeters was determined to be leaks in the stagnation calorimeter assembly resulting in flow along the side of the slug. In the case of the coaxial TC calorimeter, it is hypothesized that in some calorimeters there is a partial electrical short circuit in the Coaxial TC sensor element somewhere in the middle of

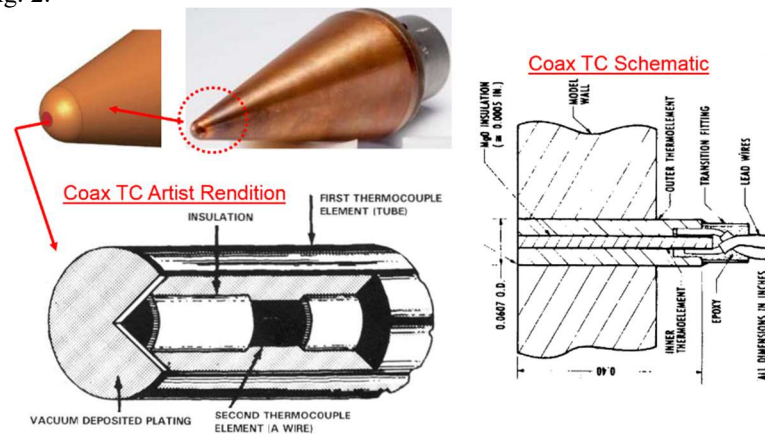
Coaxial thermocouple calorimeter (Coaxial TC) [6] are another tool for measuring heat flux. A thermocouple sensor, in the shape of a cylinder, is constructed by swaging a copper tube around a slender constantan pin (coaxial centered inside the tube) – the two elements (pin and tube) are separated (electrically) by a thin layer of insulation (MgO) sandwiched between them. One end of the cylinder (windward tip) is coated with copper (via vapor deposition) creating an electrical junction between the constantan pin and the outer copper tube. Constantan and copper lead wires are attached to the corresponding elements on the other end (backside) of the cylindrical tube. These sensors are commercially available from Medtherm [7] and Arnold Engineering Development Center (AEDC) [6] mounted them into copper bodies of various shapes and sizes. An example of this is the 9mm diameter sphere cone coaxial TC calorimeter shown in Fig. 2.

Fig 2. Coaxial TC Calorimeter built into a 9mm diameter sphere cone probe.

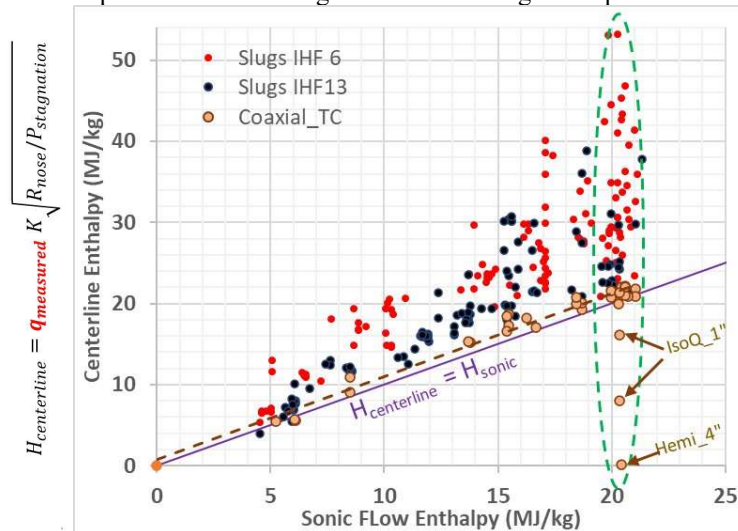
Fig. 3 Slug and Coaxial TC Calorimeter measurements in the IHF facility.

Tests were performed in the IHF 6" and IHF 13" nozzle at a large range of conditions. It appears that the problem of slugs measuring high occurs mainly in the 6" nozzle and to some extent in the 13" nozzle where the stagnation pressure is high. Repeatability is most egregious in the IHF 6" nozzle at the highest condition. It is interesting to note that the majority of measurements from the coaxial TC calorimeters agree well with the Fay-Riddell correlation, except for a few calorimeters. Also note that Coaxial TC calorimeters almost never measure higher than expected levels of heat flux. And slug calorimeters, almost never measure lower heat flux than predicted by Fay-Riddell. When the two instruments agree, then there is a high confidence in the measurement accuracy. To help understand the discrepancies between these instruments, a series of arc jet tests were conducted in the IHF 6" nozzle at the maximum condition (green oval in Fig 3.) Two objectives were pursued:

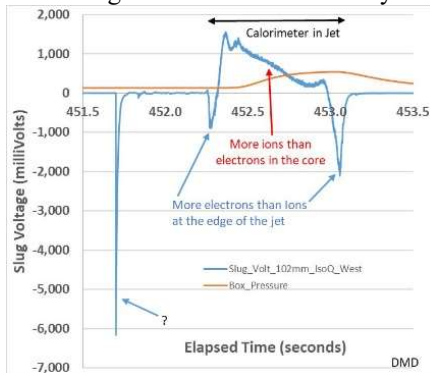
Electric arc attachment (joule heating) was considered and studied by measuring the voltage difference between the slug and the body of the calorimeter (which are electrically isolated from one another by non-conducting ruby balls). If charge particles from the plasma are electrically conducting back to the arc in the arc heater, one would expect to see a voltage difference between the slug and the calorimeter body (calorimeter body electrically grounded). Only small differences in voltage between the slug and the calorimeter body were seen (see Fig. 4).

Fig 4. Voltage difference between the slug and calorimeter body during insertion into the flow

The difference in voltage between the slug and the calorimeter body was less than 2 volts, which was miniscule relative to the voltage drop across the arc heater (6000 volts). In the absence of a short circuit between the slug and calorimeter body, this seems to indicate that the plasma was not significantly conducting between the arc in the heater and the slug.

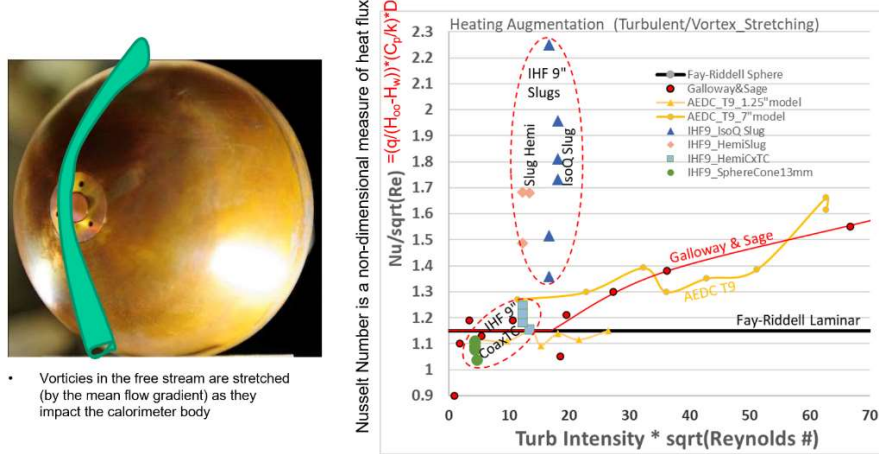
of the slug calorimeters far exceed the heating rates seen in the literature for comparable levels of turbulent Reynolds number. The figure implies that it unlikely that turbulence is the source of high heating seen by some of the slugs. Furthermore, why would turbulence effect only some calorimeters and not all calorimeters of the same size and shape.

Fig. 5 Free stream turbulence effects on stagnation heating of blunt bodies

The augmentation in heating rate (over laminar flow) associated with turbulent free stream is far greater in the present arc jet studies than has been seen in past studies published in the literature.

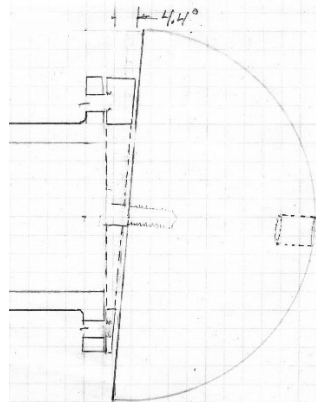
Fig. 6 Calorimeter deliberately pitched at angle of attack

This provides incentive for the flow to go into the gap at the stagnation point and out of the gap away from the stagnation point. Measurements were obtained for the case where the calorimeter was pitched relative to the centerline of the jet, followed by another run where the calorimeter axis of symmetry was aligned with the centerline of the jet. The resulting heat fluxes measured in these two cases was nearly identical. This result seemed to point to the gap not being the source of heating augmentation.

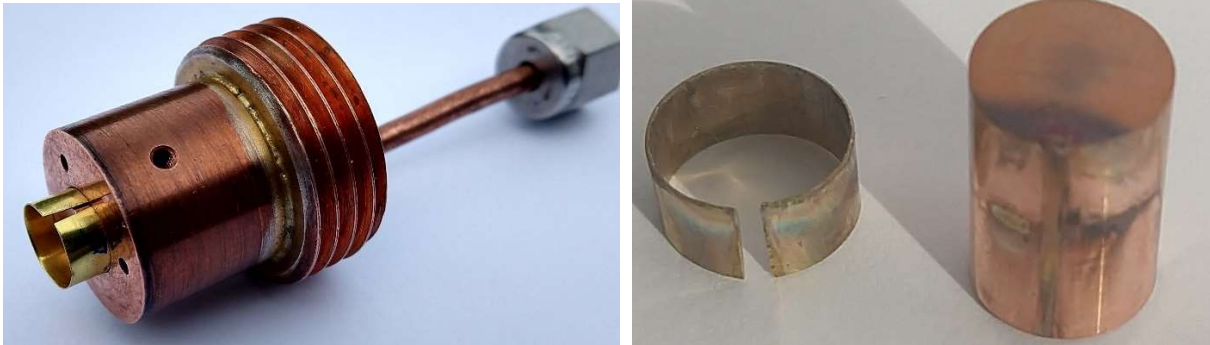
that makes a difference. The gap was plugged by sliding a hoop of brass shim stock into the gap so that it would occupy most of the gap, thus taking away some of the volume available to interact with the slug (see Fig. 7a). The modification was done without taking the calorimeter off the model traverse system, in the interest of not disturbing the existing setup and introducing any more variables into the problem. The figure shows an example of shim stock partially inserted into the gap.

Fig 7. a) Slug Calorimeter with brass shim stock partially inserted into the gap. b) post-test discoloration

After running in the arc jet, a streak of discoloration on the side of the slug where the two ends of the brass shim stock had not completely come together (see Fig. 7b). The streak appears to be evidence of local high heating (or oxidation) on the side of the slug where the shim stock was missing. Also, the resulting heat flux measurement was greatly reduced when the shim stock was installed (see Fig. 8). The measurements were repeated with other slug calorimeters that measured unreasonably high levels of heat flux and the result was the same. It was not obvious how or why the shim stock was producing lower heating. It was not due to enhanced conduction between the slug and the slug holder (by virtue of the shim) – losses measured after the calorimeter exposure to the flow were the usual 1 or 2%. All that could be said was that plugging the gap helped.

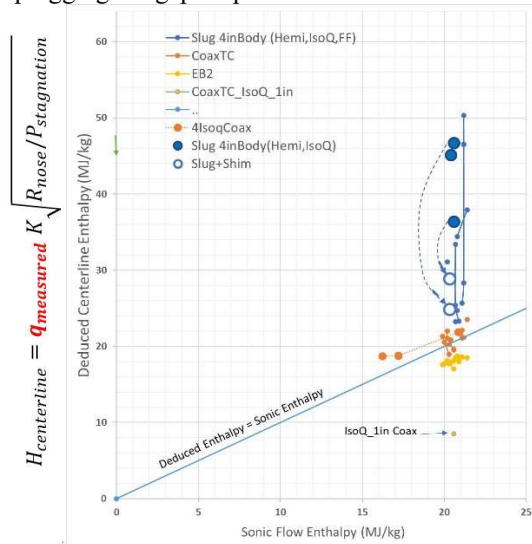
Fig. 8 Heat transfer of slug calorimeters with and without brass shim stock installed in the gap.

To be clear, we are not advocating that a shim stock be used to ameliorate the heating augmentation, this exercise (of plugging the gap) was merely a learning tool.

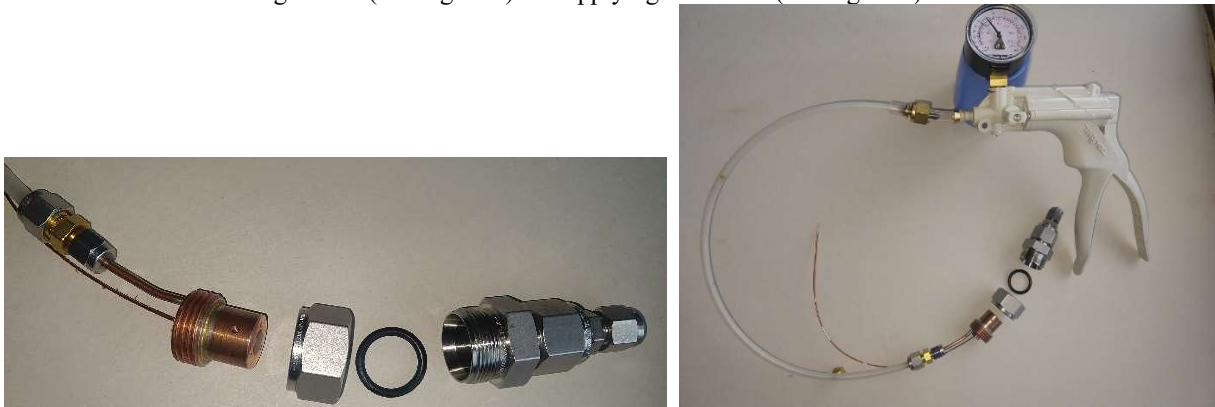
Checking calorimeters for leaks was accomplished by putting a vacuum on the face of the slug calorimeter body and see if the vacuum would hold (after valving off the slug cavity from the vacuum source). This involved capping off the front face of the slug holder (see Fig. 10a) and applying a vacuum (see Fig. 10b).

Fig. 10 Apparatus for capping off the slug holder so that it could be checked for leaks.

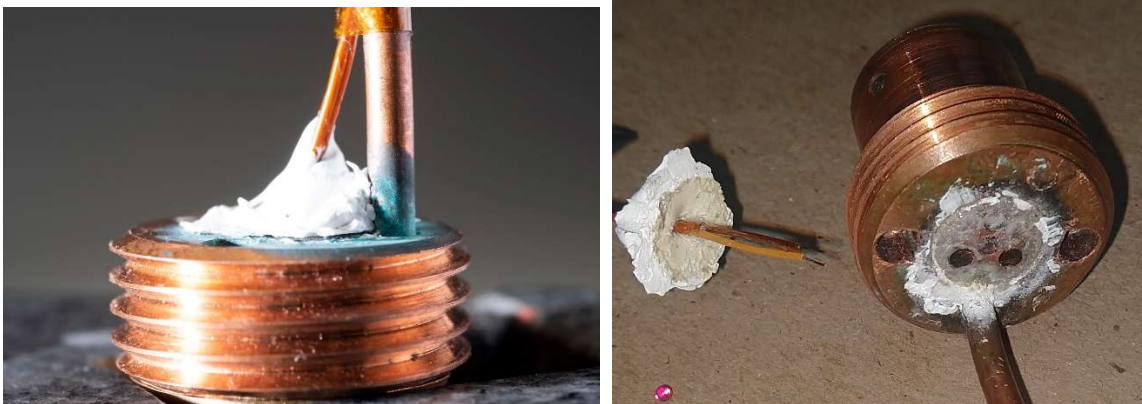
Leak checking revealed that several slug holders were leaking to various degrees. When examining the slug holders that leaked, it was apparent that the adhesive had debonded from the slug holder (see Fig. 11). The adhesive sealant was designed to seal the cavity in the slug holder (where the slug resides) from leaking hot plasma out the backside. In the absence of sealant, hot plasma (stagnating on the slug and cavity) would exhaust out the back through a hole designed to pass the thermocouple wires out of the cavity.

Fig. 11 Slug holder backside with Ceramabond sealant that has debonded

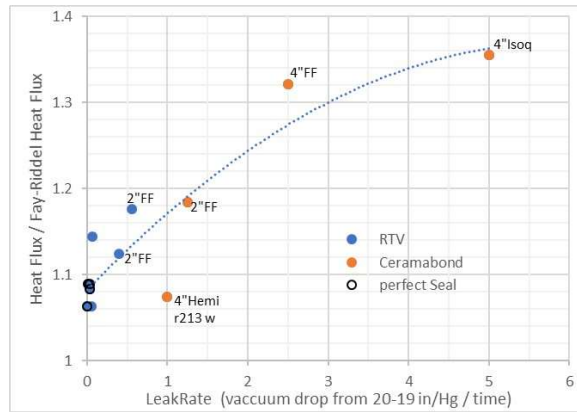
It was apparent that those slug calorimeters measuring high heat rates also showed cracks and debonds of the adhesive. Relative leak rates were quantified by measuring the rate at which the pressure would rise after valving off the vacuum source from the slug holder. Typically a vacuum of  $-20$  mm Hg was imposed on the slug followed by measuring the time for the pressure to rise to  $-19$  mm Hg. It was found that the measured heating rate correlated reasonable well with the leak rate (see Fig. 12).

Fig. 12 Correlation between leak rate and heat flux

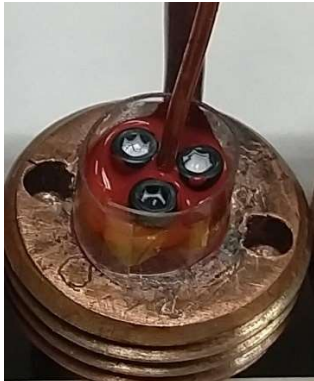
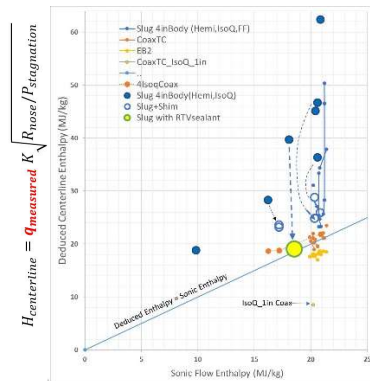
Fig. 13 a) Slug holder with RTV sealant b) Heat flux measurement with and without RTV

Keep in mind that no leaks are acceptable, and the goal is to eliminate all leaks. This involved adopting a different adhesive/sealant (RTV as opposed to ceramic adhesive) and developing a mechanical means of holding the RTV down so it would not inadvertently be pushed away from the slug holder causing a debond. Improvements to the design involved threading screws into the backside of the slug holder so that the heads of the screws could act to restrain the solidified pool of RTV (surrounding the TC wire), see Fig. 13a.

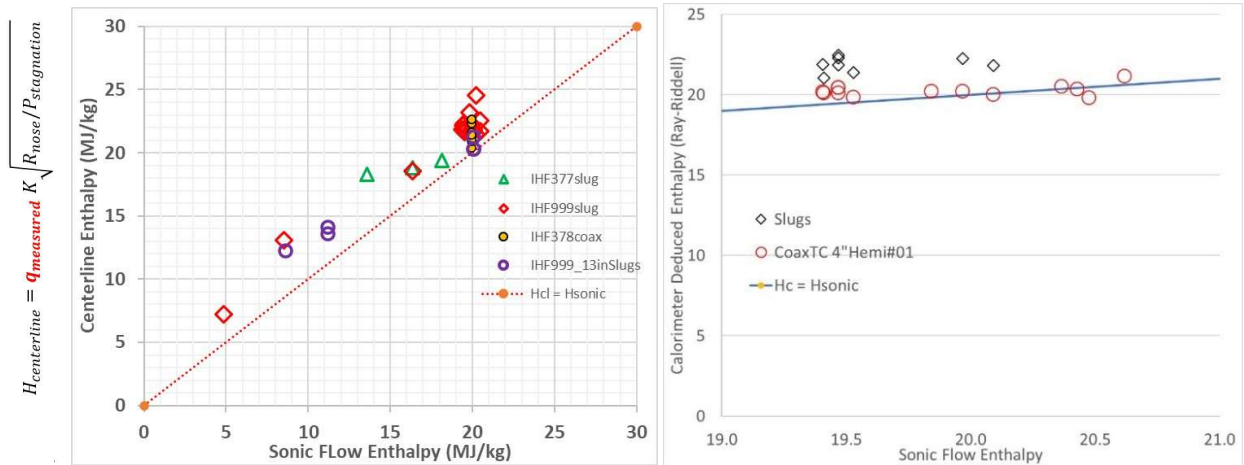
a) Variety of conditions in both IHF6'' and 13'' nozzles      b) close up of high condition in the IHF 6''nozzle  
 Fig. 14 Slug measurements after employing RTV to seal the backside of the slug holder

All data shown in Fig. 14 were obtained in the Interaction Heating Facility (IHF) [11]. Fig 14 a shows good repeatability over a variety of conditions and calorimeter shape and sizes. Fig 14b shows the repeatability for the maximum facility condition in the IHF 6'' nozzle. In Fig 14b, the small variation in heat flux measurements (enthalpy) are due to small changes in facility conditions from run to run.

Stagnation pressure on the front of the slug cavity is greater than the near vacuum on the backside of the calorimeter producing a pressure differential across the sealant that acts to push the sealant off the back side of the slug holder. The RTV design worked well (see Fig. 13 b) and has been added to the slug assembly procedure. The revised slug assembly procedure also requires that a vacuum and pressure test be performed on the slug holder before (and after) testing in the arc jet to verify no leaks are present. As a result, the slug calorimeters have been producing much more repeatable and reliable measurements of heat transfer (see Fig 14).

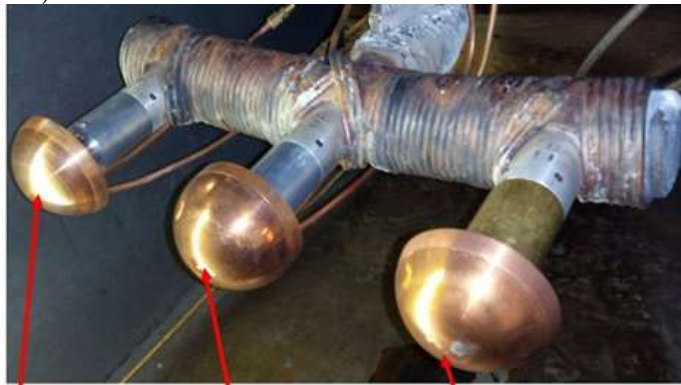
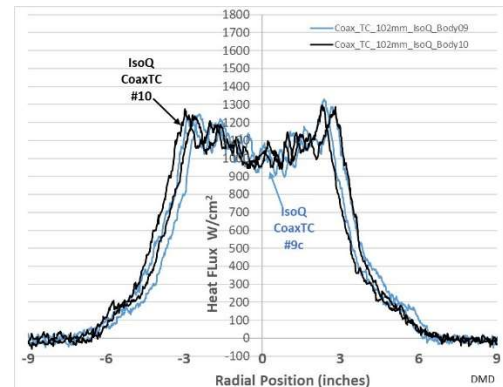
Coaxial TC calorimeters provide very valuable data about the flow uniformity across the jet (or lack thereof). For example three coaxial calorimeters mounted on a 3 prong probe holder (known as a trident) were simultaneously swung through the flow downstream of the nozzle exit (see Fig. 15a). Each probe measures heat flux as a function of distance from the centerline of the jet. These identical probes provided very good agreement with each other (see Fig. 15b).

Fig 15 a) Coaxial TC probes mounted on a trident      b) Radial distribution of heating measured by probes 9 & 10

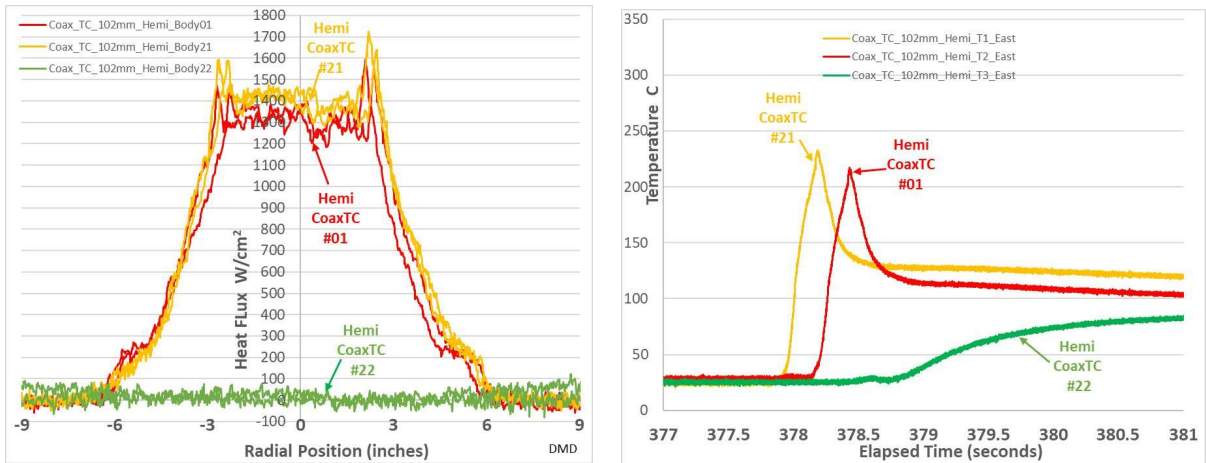
However, some identical coaxial TC calorimeters gave very different results from one another. One extreme example shown in Fig 16 shows the 4'' Hemispherical Calorimeters #01 and #21 agreeing with each other to about 6% while the 4'' Hemispherical calorimeter #22 appears to be dead. When comparing the thermocouple histories for each of the calorimeters, calorimeter #22 appears to show a more gradual rise in temperature than the others, and the rise in temperature occurs after the calorimeter has exited the flow.

Fig. 16 a) Heat Flux measured by Coaxial TC Calorimeters b) Temperature history of Coaxial TC calorimeters.

One thought is that the thermocouple was partially shorted at a location other than the tip of the sensor. There was not much that could be done to fix the problematic calorimeter (Coaxial TC #22), nor could the analysis be easily “adjusted” to correct the measured heat flux. Consequently, it was decided to conduct a test campaign in which problematic coaxial TC calorimeters could be identified and removed from service. This involved testing all coaxial TC calorimeters (various shapes and size bodies) at the same arc jet condition (facility max) see Fig 17a and b.

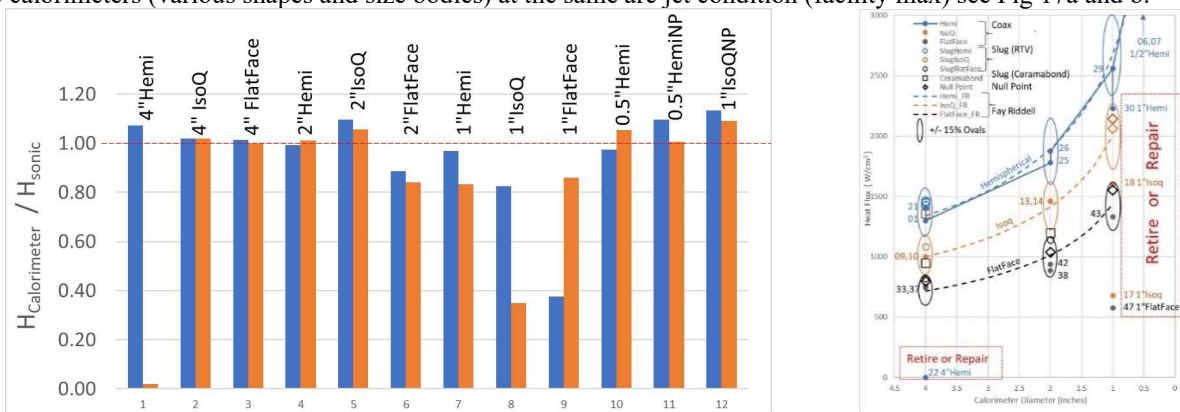
a) Bar graph showing comparison between identical pairs of calorimeters b) Same measurements as a function of  $R_{nose}$  Fig 17. Coaxial TC calorimeter measurements compared to each other and Fay Riddell

The pairs of bars (Blue and Brown) shown in Fig 17a. shows the agreement (or not) between the primary calorimeter (Blue) and its corresponding identical twin (Brown). Testing pairs of identical calorimeters helps to identify problem calorimeters.

Most coaxial TC calorimeters compared well with each other and the Fay Riddell estimate of heating. However several did not (4”Hemi#22, 1”IsoQ#17, 1”Isoq#22, 1”Hemi#30, 1”FlatFace#47). Those that did not were deemed to be unreliable and were taken out of service. Our current best theory is that these problematic coaxial TC calorimeters likely have a short internal to the sensor body, and that there is a secondary electrical junction somewhere other than at the tip of the sensor where the junction is designed to be.
