Finding and Fixing a Small Low Temperature Leak – A Case Study on XRISM/Resolve

Mike DiPirro for the
NASA/JAXA/SHI XRISM/Resolve Team

Nov. 15, 2021

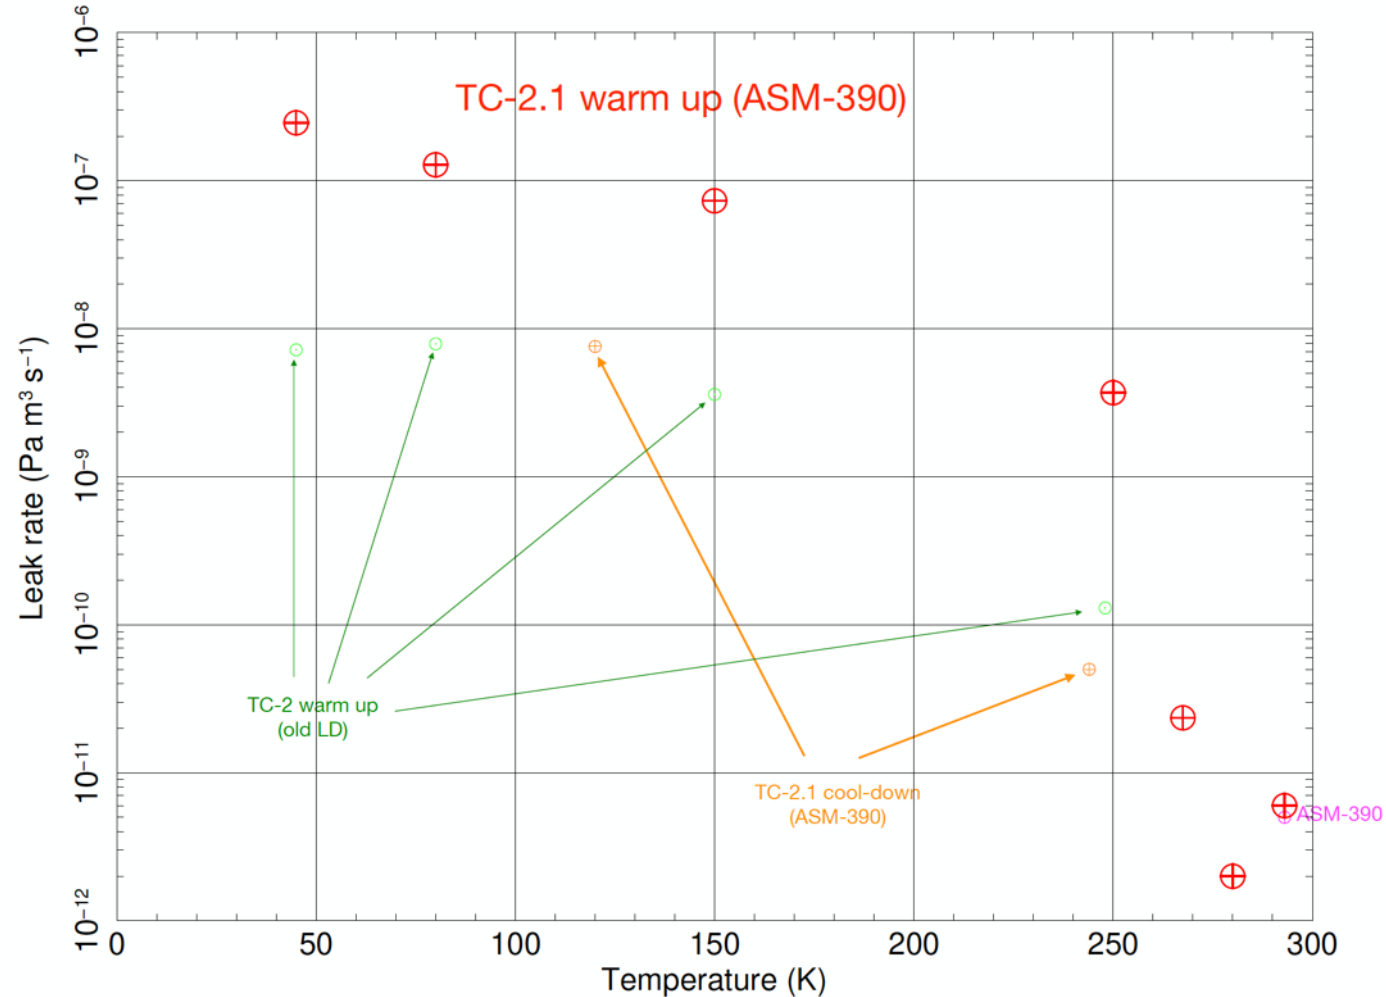
What does the leak look like vs. temperature?

- Laminar varies as gas density and inversely with viscosity
 - $T^{-1.67}$
- Molecular varies with gas density
 - T^{-1}
- Permeation varies exponentially with the inverse temperature
 - only one component identified with a non-metal seal – electrical feedthrough into the tank
- Constant hole size does not fit the data
 - Points to increasing hole size at low T caused by strain or differential contraction

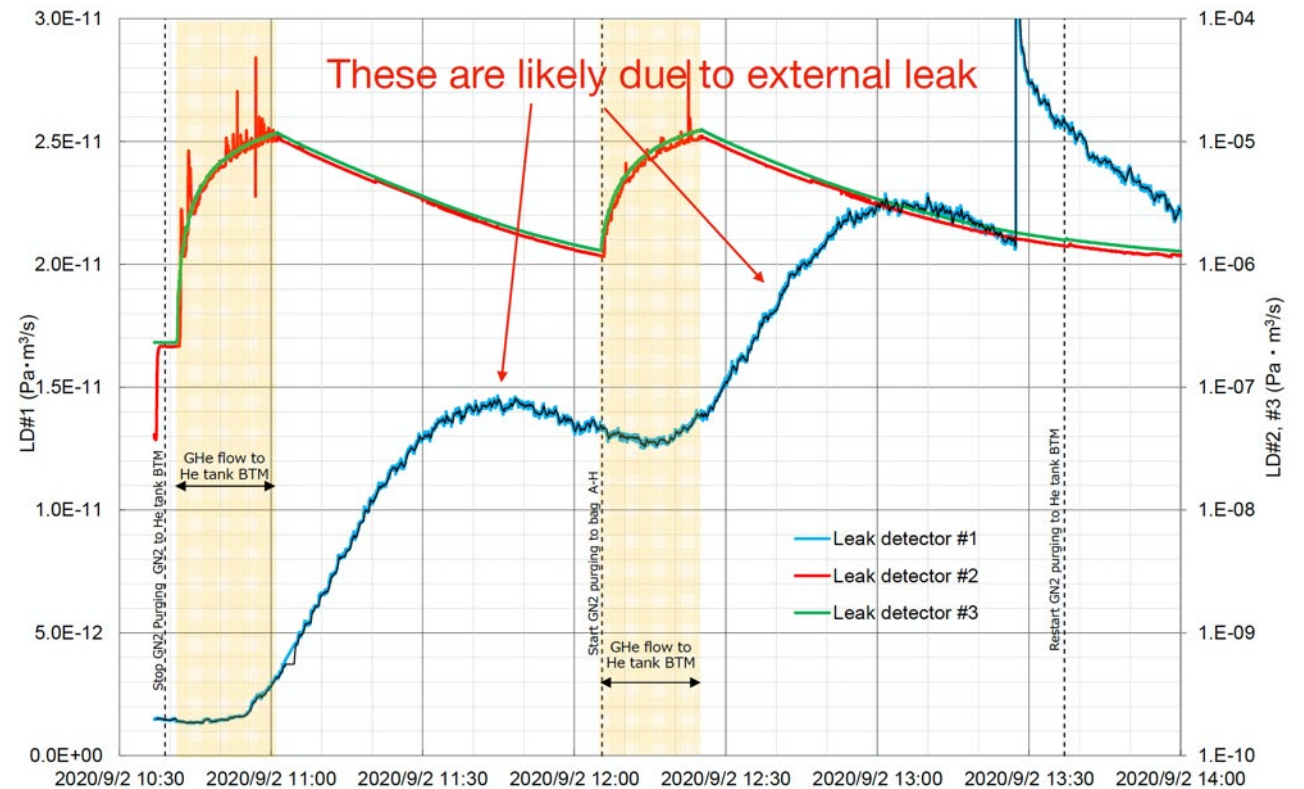
- Put a GN2 purged tent around LD1
- Used 2 additional Leak Detectors as sniffers
 - LD2 shows background near bags
 - LD3 shows background in room
- Effects are definitely seen with a time delay
- See Mark Kimball's presentation

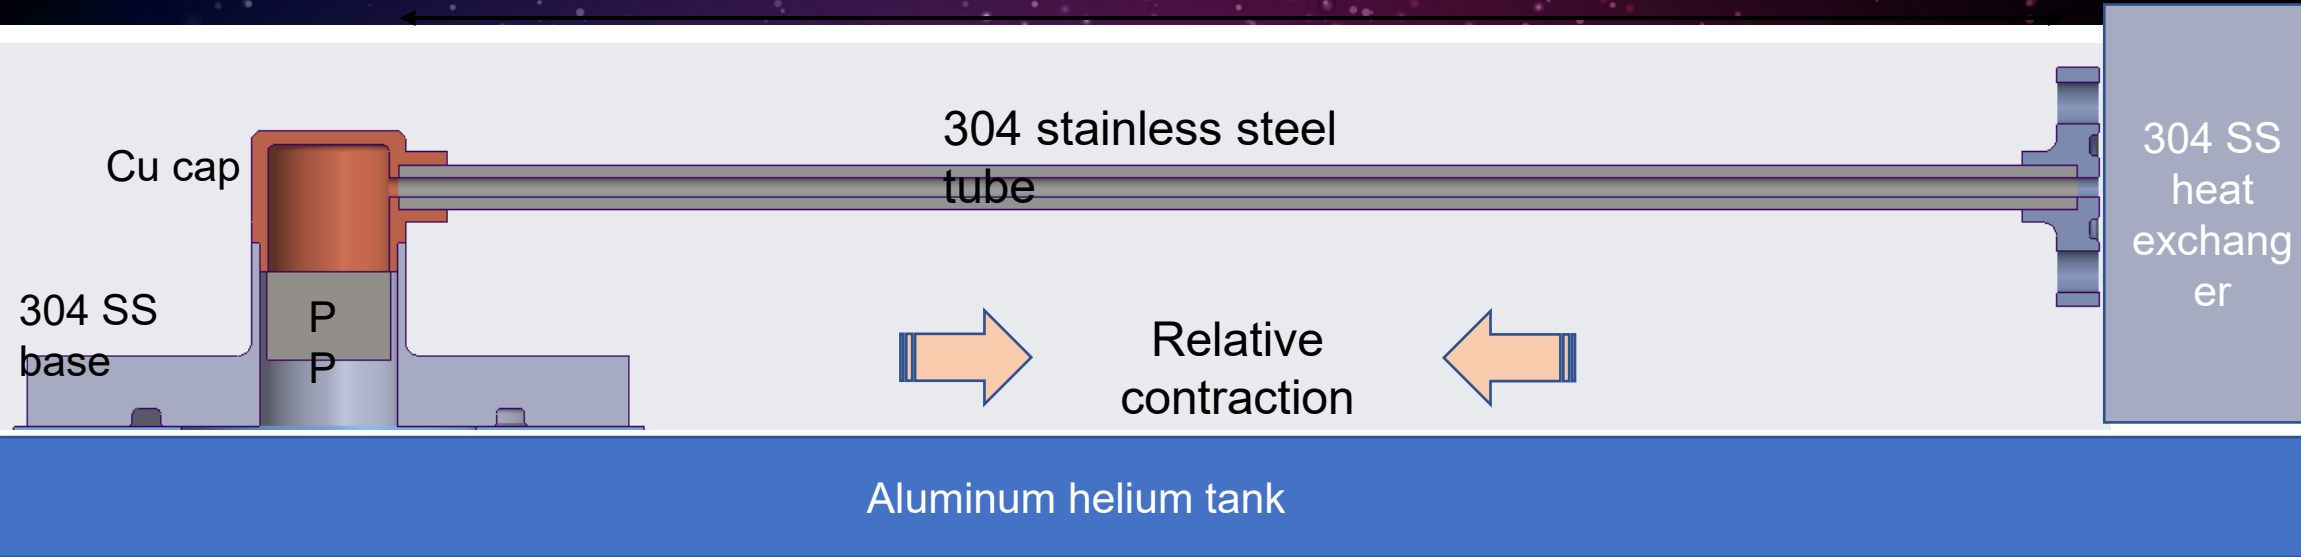
Finite element model

$$\Delta CTE_{AL6061 TO SS304} = 0.00118 \text{ mm/mm}_L$$

$$\text{Relative Thermal Contraction} = (0.00118)L_{TUBE}$$

$$\text{Relative Thermal Contraction} = (0.00118)(119.93 \text{ mm})$$

$$\text{Relative Thermal Contraction} = 0.14 \text{ mm (0.00557 in)}$$

- Porous plug capillary geometry was redesigned
 - Eliminates differential contraction stresses
 - [show schematic next page]
- More attention was paid to interface joints
 - Mini-conflat torques, bolt interference, cleanliness of surfaces, smoothness of surfaces
- During the post repair cooldown of complete system (TC-1A) more attention was paid to leak checking at each step in the process including intermediate cool down temperatures
- Neither TC-1A nor TC-2A showed any sign of a leak and accumulated leak check showed that the requirements were met.
