NASA/TM–20210024768

Buckling Test and Analysis of the
8-foot-diameter Sandwich Composite Cylinder
Test Article CTA8.3 as Part of the Shell
Buckling Knockdown Factor Project:
Test Dates 16–19 December 2019

*Kyongchan Song, Marc R. Schultz, Cyrus J. R. Kosztowny,
Adam Przekop, and Nathaniel W. Gardner
Langley Research Center, Hampton, Virginia*

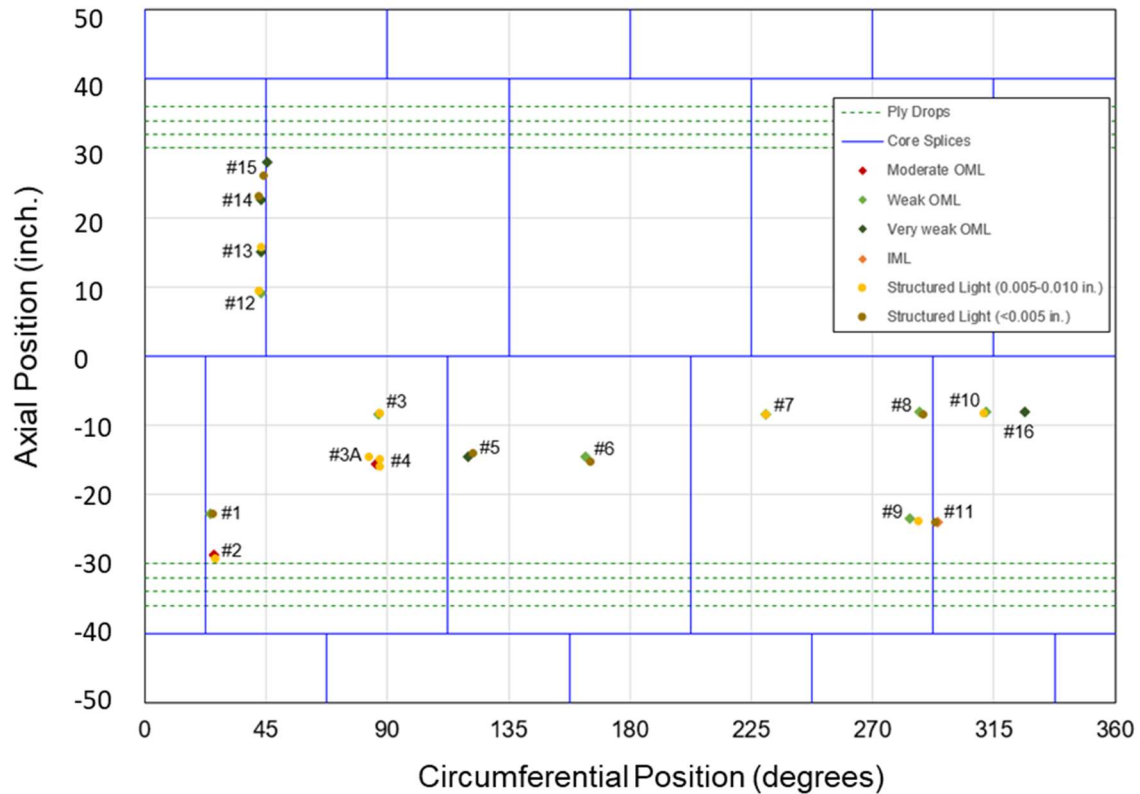
Figure 1. The map of anomalies of CTA 8.3 test article.

Prior to potting, nondestructive evaluation (NDE) was performed to inspect the test article by shearography and structured-light scanning. From the NDE of the test article, a total of 16 anomalies were detected and measured. The map of indication locations from the shearography and the structured-light scanning is shown in Figure 1 and the size of each anomaly in the form of h (axial) x w (circumferential) is listed in Table 4. A summary of the anomalies detected in CTA8.3 is given in the Shearography Inspection Report (Appendix B).

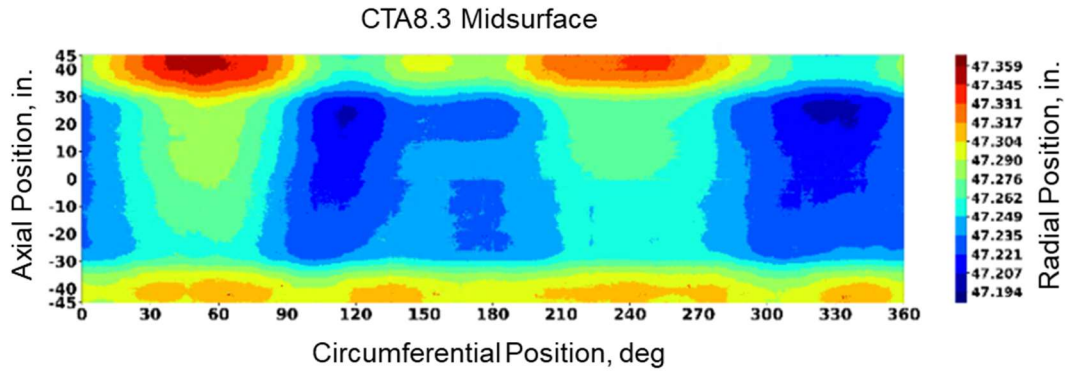
Figure 2. Unrolled image of midsurface radial position.

The structured-light scanning geometry measurements of OML and IML surfaces were used to determine the geometric imperfections of the test article, and later used in the development of the as-built finite element models (FEMs). These measurements were taken with the test article potted inside the attachment rings that interface with the test fixture, that is, the measurements were taken with the test article in the *as-manufactured* condition. The midsurface radial position of the test article was obtained by averaging the OML and IML radial measurements and is shown in Figure 2; the midsurface imperfection is indicated by the variation in the radial position. The thickness (and subsequently thickness imperfections) was obtained by taking the difference between the OML and IML radial imperfection measurements and is shown in Figure 3. When interpreting Figures 2 and 3, it is important to consider that both results include the presence of the padup plies at the axial coordinates below -30.0 in. and above $+30.0$ in., and do not show end sections that are potted within the metallic attachment rings. The midsurface imperfection indicated by Figure 2 shows a global radial pattern where the radius varies in a mostly circumferential pattern around the cylinder. However, a more axially localized region with smaller radial position can also be identified around the circumference at the axial coordinate of approximately 15.0 to 30.0 in. The thickness plot in Figure 3 shows the thicker padup sections at the top and bottom, but other than that does not show a pattern as obvious as that in the radial imperfection plot. Rather, only a few localized thickness variations, primarily along the axial direction between radial stations 300° and 340° and several other locations, are seen.

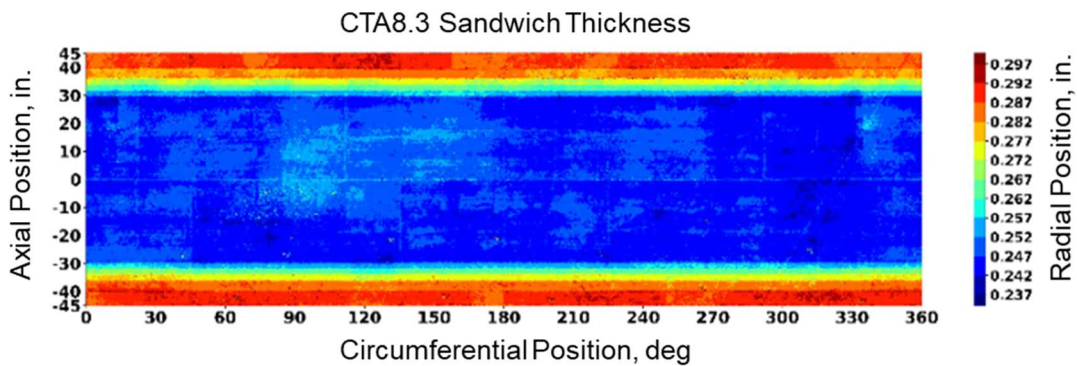
Figure 3. Unrolled image of the measured thickness.

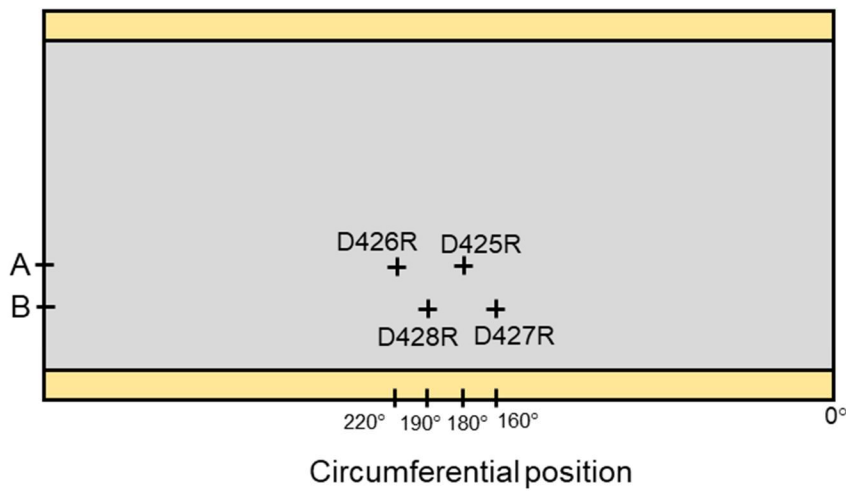
Figure 6. Locations of EDI displacements, unrolled view from IML.

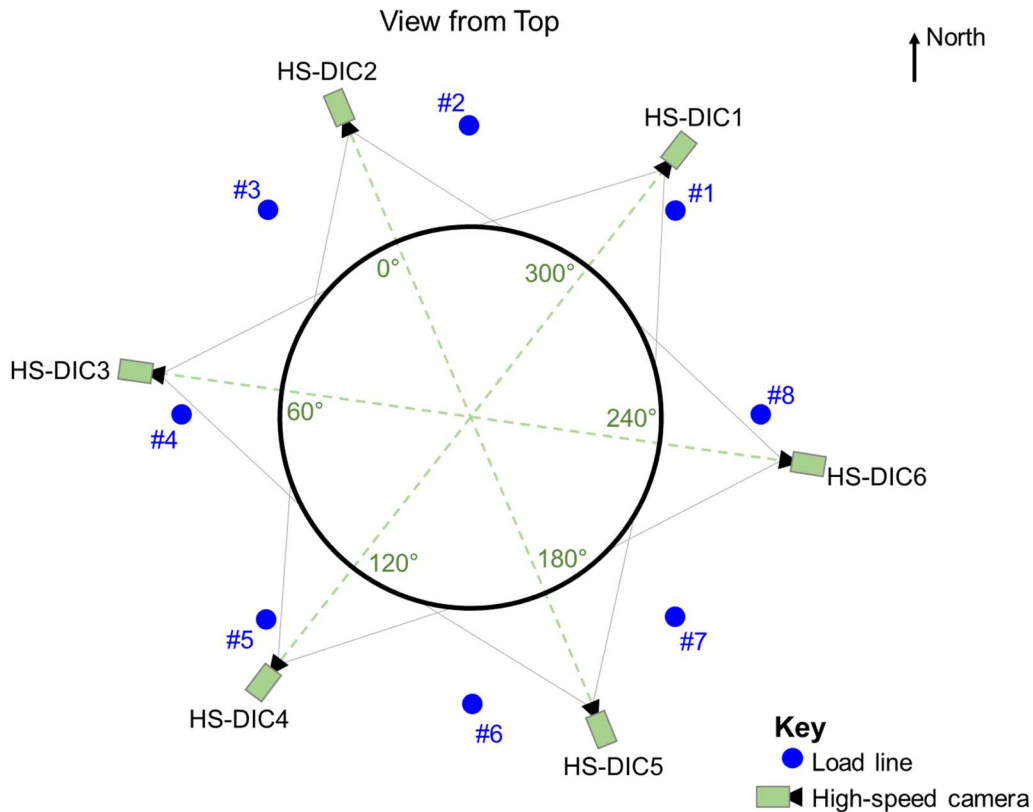
Figure 13. The high-speed DIC system.

A total of six high-speed camera pairs were set-up around the circumference of the OML, as shown in Figure 13, to continuously record at 10,000 frames per second (fps). Due to the number of camera pairs and the test stand (camera mounting locations), the camera systems were not equally spaced; however, they were still located in positions to allow for overlapping coverage between adjacent camera systems. The high-speed camera systems were available to measure the buckling displacement response of the entire OML during all load sequences, but were primarily used during the failure load sequence to capture the dynamic failure event and damage initiation and propagation. Due to the high frame rate (10,000 fps) and the limited resolution of the cameras, the optimal speckle size was larger than that of the low-speed systems, 0.45 to 0.65 in. In order to properly correlate over the entire field-of-view, and provide the best accuracy and data for all DIC systems (low-speed global and local), the speckle pattern of the global low-speed system was adjusted to be closer to the lower end of the optimal size for the global high speed, which is why a global speckle pattern of 0.3 to 0.5 in. was chosen for the entire acreage of the test article. The

cameras were synchronized with respect to each other and had a common, manual, post-trigger recording function (i.e., all data from before the trigger and no data after the trigger). The cameras were programmed to acquire images at a rate of 10,000 fps in a continuous write-overwrite loop, with a total recording time of approximately 2.55 sec, to each camera's buffer until the high-speed DIC operator triggered the manual post-trigger recording after the buckling or failure event.

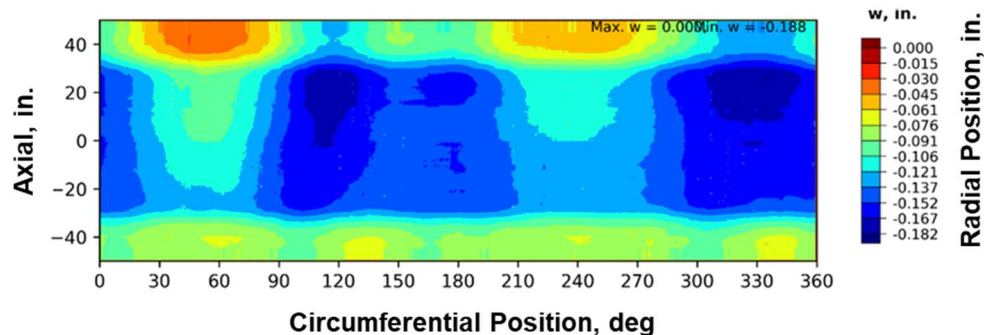
Figure 15. CTA8.3 as-manufactured imperfection contour plot contains combined radial and shell thickness imperfections.

For FEMs with radial imperfections, the as-measured geometric imperfections and shell-thickness variation were imposed on the global FEM. The Python script Py_TIGIRS [8] was used to modify the nominal geometry of the global FEM to implement both radial and shell thickness imperfections. The processed radial imperfection contour plot of CTA8.3 with the combined radial and shell thickness imperfection values calculated using Py_TIGIRS are shown in Figure 15. These as-manufactured imperfections can be compared with the measured radial imperfections of Figure 2. Including both the radial and thickness imperfections in numerical models has been demonstrated to improve the agreement between analysis predictions and the experimentally observed response in both prebuckling and buckling-initiation behavior [9, 10]. Nonlinear buckling analyses were performed on the FEM using a general static solver preload step followed by a transient dynamic step to capture buckling and postbuckled response.

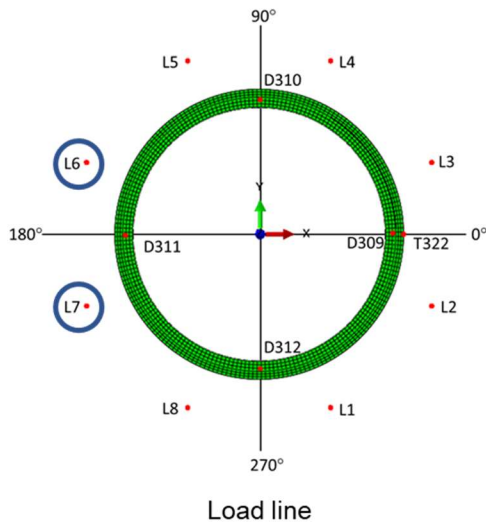
Figure 20. The predicted load versus end-shortening curves of FEM and test data (Load lines 6 and 7).

load observed from the test. The test and predicted total applied load versus end-shortening response of each pair of load lines with test data are shown in Figures 17 through 20. The dotted lines represent the test results and the solid lines represent FEM predictions obtained from the nonlinear transient dynamic analysis. As shown in these figures, the axial displacements of load lines 6 and 7 show the largest axial displacement and the axial displacements of load lines 2 and 3 show the smallest axial displacement as expected because the maximum compression load was applied to the test article at the 180° circumferential location.

From Figures 17 through 20, it can also be seen that as the test article was loaded, an anomalous nonlinear flattening response was observed in the axial displacement of each load line. This anomalous behavior in each load line continued until the middle of load step 1, which was to 10% of P_{cr}^{CL} . In other words, the associated displacement was not proportional to the applied load as expected. This nonlinearity may be attributed at least in part to the excess movement (slop) at lower load levels of the pins that connect the hydraulic jacks and load lines to the upper and lower spiders. After 10% of P_{cr}^{CL} , the excess slop in the test fixture may have been removed. The load versus end-shortening response of each pair of load lines shows a linear response for the rest of LS12 until the buckling failure of the test article. As seen in Figures 17 through 20, the finite-element-analysis-predicted total applied load versus end-shortening responses of each pair of load lines were linear and coincided with each other from the initial loading until the buckling event; the predicted and test-measured slopes were consistent after the anomalous response seen during load step 1 of the test.

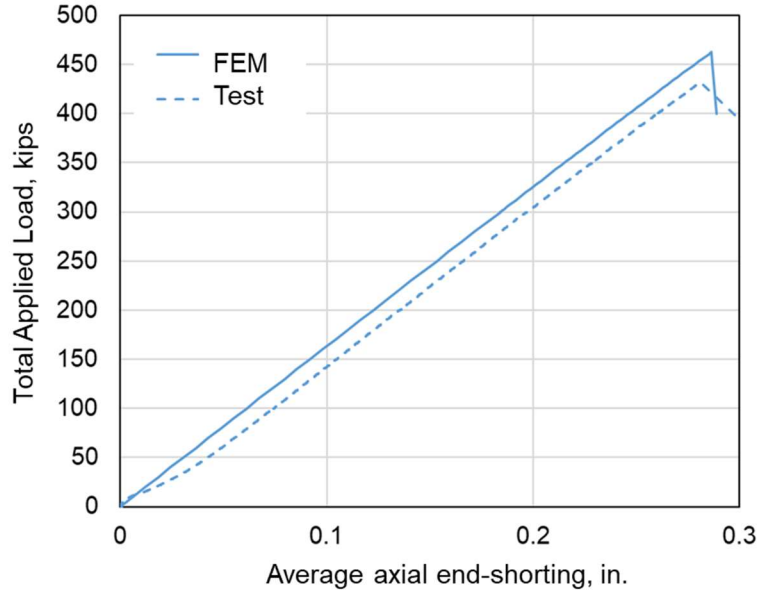
Figure 21. The tested and predicted total load versus average axial end-shortening measured at the attachment rings.

The predicted total applied load versus average axial end-shortening response of CTA8.3 (the average of δ_{D000A} , δ_{D090A} , δ_{D180A} , and δ_{D270A}) are shown in Figure 21. The average axial end-shortening response of CTA8.3 shows better agreement with test data compared to the end-shortening response of each load line, which suggests that the anomalous behavior of the upper test hardware and excess movement in the pins caused much of the discrepancy between the measured and predicted end-shortening response of each load line.

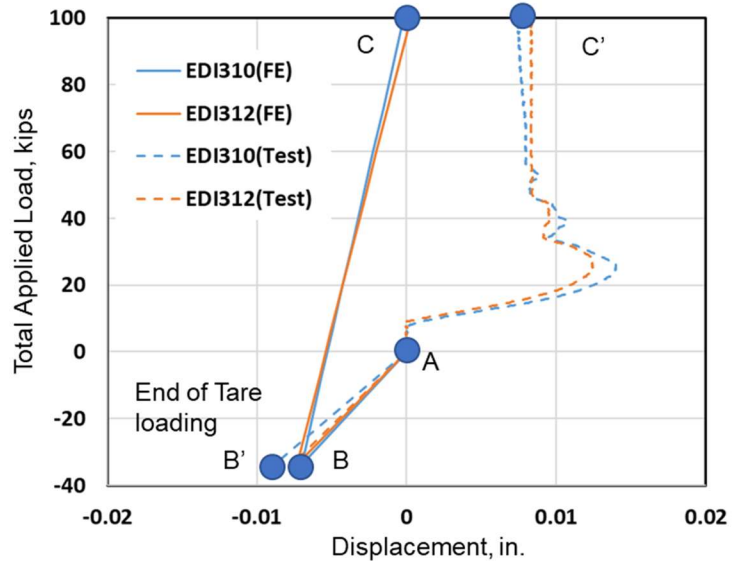
Figure 33. The predicted load versus radial displacement curves of EDI and test data (EDI 309 at 90° and EDI 311 at 270°).

In both Figures 32 and 33, the load lines were predicted to displace in a linear manner as the FEM simulates the ramp to tare load from point A to B. During the test, the paths to the end of tare load for L2 and L3 were also linear, but reached the end of tare load with different axial displacements, B'. As the second step of the analysis is executed with the combined axial and bending loading, the predicted load-line displacements track linearly some slight deviation from point B towards point C at 100.0 kips. At the end of the tare load during the test, all instrumentation (i.e., load cells and EDIs) are re-zeroed so the test data plotted proceeds from point A to C' during load step 1. At the beginning of load step 1, the load increases without any measurable displacement until nearly 10 kips. After this point, the load and displacements increase proportionally until approximately 20 kips, at which point the load increases but the displacement of each load line oscillates about -0.02 in. until approximately 60.0 kips. After approximately 60.0 kips, the loading behavior is linear. The FEM was unable to capture this observed behavior, and the addition of the rigid body motion in the FEM did improve model correlation with respect to the total applied load versus displacement.

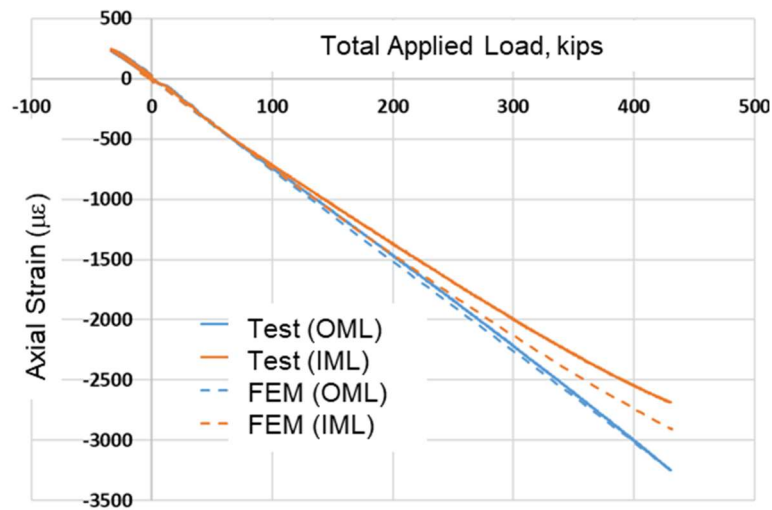
Figure 45. Predicted axial strain and test data of IML gage 72 and OML gage 71 (AFT 29-in. line).

The predicted back-to-back axial strains from the FEM and the measured axial strains are shown in Figures 44 through 47 where the predicted axial strain and test data of IML and OML gages 63, 64, 71, 72, 79, 80, 87 and 88 are presented. These gages are at the 90° circumferential location of AFT 38-in. line, AFT 29-in. line, FWD 29-in. line, and FWD 38-in. line regions and show good agreement between predicted and test axial strain data. The maximum deviation between the predicted and observed strains was 8%.

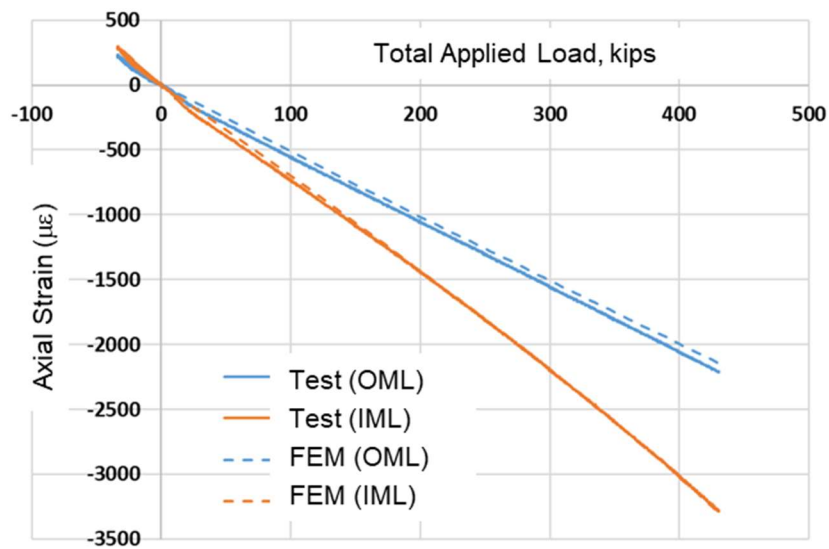
Figure 47. Predicted axial strain and test data of IML gage 88 and OML gage 87 (FWD 38-in. line).

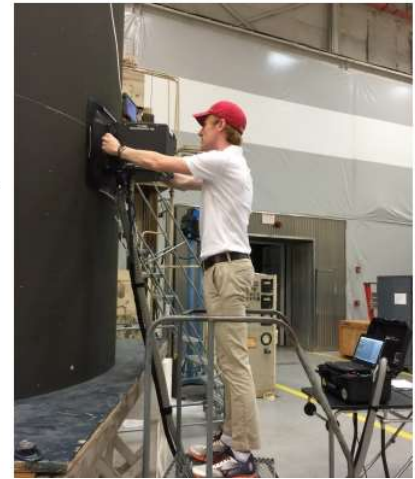
Indications were numbered sequentially as detected, measured and a piece of masking tape placed directly over the center of the tape. The positioning of the tape marker was verified by a vacuum re-test.

Map of Shearography Indication for Test Barrel Section s/n 001 (June 4/5, 2019)

The test procedure was to use vacuum shearography for scanning and both vacuum and thermal stress shearography if any anomaly was detected. A total of (16) anomalies were detected and measured. (15) were located on the Outer Mold Line (OML) also the bag side, and (1) weak indication (#11) was on the Inner Mold Line, also the Tool Side. #16 appeared with both thermal and vacuum tests. We recommend secondary NDT of this indication.

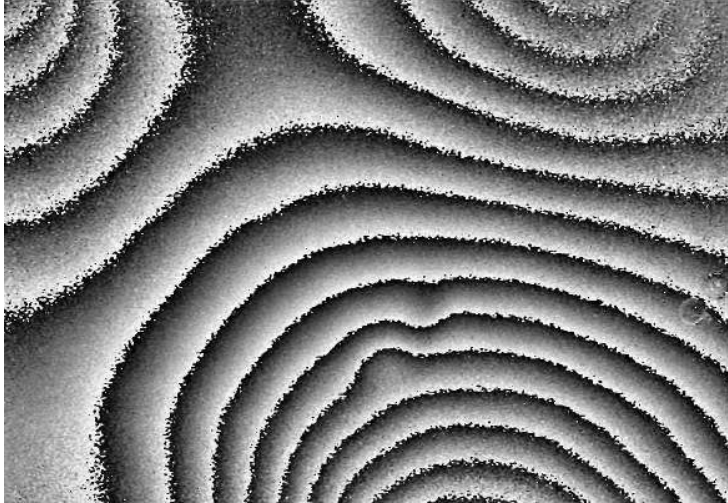
Location: AFT OML, TB0 (239.2, 42.0 in.)

Comments: probable core anomaly as opposed to a disbond.

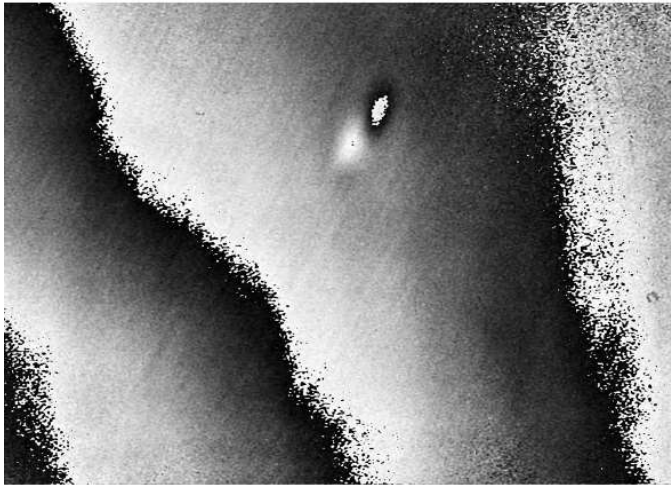
Location: AFT OML, TB3 (258.0, 42.0 in.)

Comments: A slight basin is seen, probable low velocity impact or core anomaly.

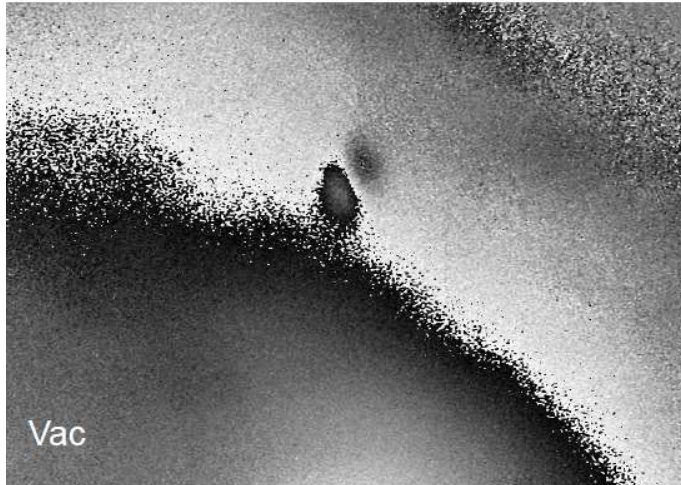
Location: FORWARD OML, TB0 (35.5, 59.0 in.)

Comments: Honeycomb core appears attached to the face sheet over the indication, suggesting a core anomaly as opposed to a disbond.
