# LUNAR DUST TOLERANCE TESTING OF REPRESENTATIVE SEALS FOR LUNAR SURFACE ASSET SEALS

N. Jimenez<sup>1</sup>, S. Gerdts<sup>1</sup>, P. H. Dunlap<sup>1</sup>, and J. Mather<sup>2</sup>

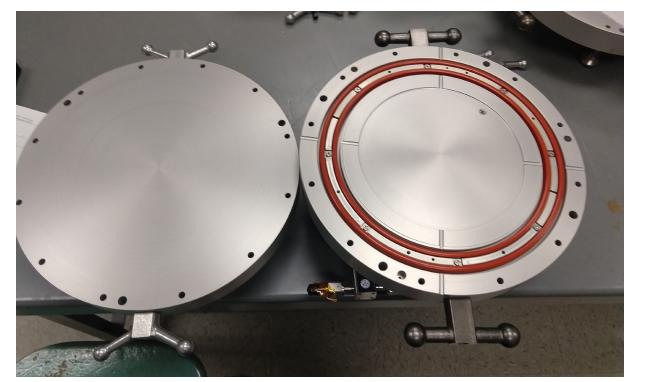
Figure (1): Leak test flow fixture with subscale NDS seal

For this testing, both seal geometries (NDS and docking hatch seal (DHS)) were installed in test fixtures with flight-representative grooves (Figures 1 and 2). These seals were 30 cm and 28.5 cm in diameter for NDS and DHS, respectively, and the cross sections were identical to the seals used on NASA's Low Impact Docking System and Lockheed Martin's Orion capsule. The seals were coated with Braycote<sup>™</sup> (Castrol Limited) 601 EF grease and a leak rate test was performed on the seals prior to dust loading to provide a baseline leak rate that could be compared against the leak rate of the contaminated seal.

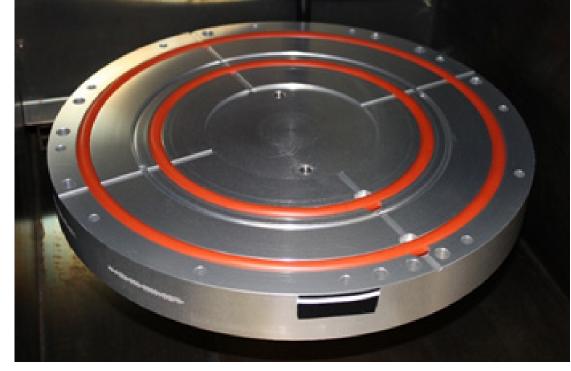
Figure (2): Leak test flow fixture with subscale DHS

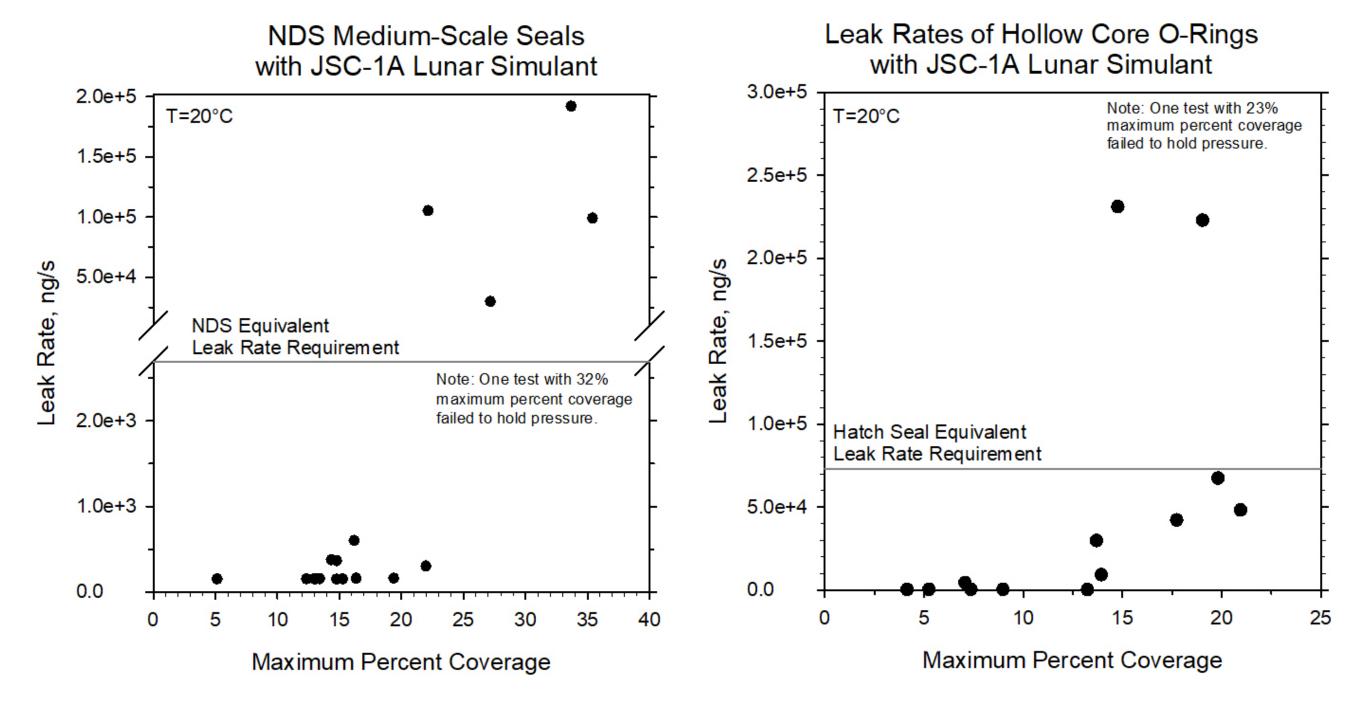
Figure (6): Maximum percent coverage vs. leak rate for NDS seals Figure (7): Maximum percent coverage vs. leak rate for DHS

The lighter maximum contamination levels of less than 14% for NDS and 10% for DHS represented between 1 and 2 times the increase in leak rates from the baseline. These lighter levels help quantify the levels of contamination that the two seal designs would be allowed to sustain without any dust mitigation efforts being needed. This quantification could be done via optical image analysis in situ on the lunar surface.

The median deposition ranges of 14 to 22% for the NDS and 10 to 14% for the DHS designs helped determine the breakthrough point. The upper bound of this range yielded the breakthrough point, which was approximately 22% for the NDS and 14% for the DHS designs. The transition from the passing contaminations past the breakthrough point was catastrophic in nature. The leak rates increased exponentially after their breakthrough points, resulting in leak rate orders of magnitude higher than their allowable requirements, as shown in Figures 6 and 7. A couple of test seals were evaluated above the breakthrough point in the heavy deposition range to confirm the behavioral trend.
