Response of Ablative Thermal Protection Materials to Degradation in Low Earth Orbit – Characterization of Specimens from MISSE-13

Peter Marshall¹

1: Analytical Mechanics Associates

2: NASA

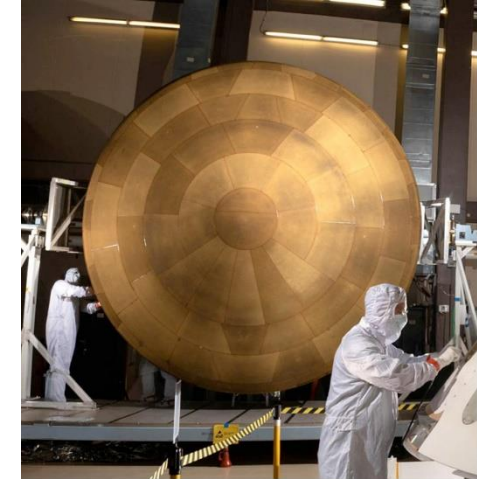
- TPS acreage materials
 - PICA-D: Phenolic Impregnated Carbon Ablator, Domestic raw materials
 - Very low density carbon foam infiltrated with low density/high surface area phenolic resin
 - Used on Stardust, Mars Science Laboratory, Mars2020, and others
 - HEEET: Heatshield for Extreme Entry Environment Technology
 - Mid-density material with woven carbon/phenolic fibers
 - Infiltrated with similar phenolic resin
 - Two layers: insulating layer (IL) and higher density, higher carbon layer for recession (RL)
- Seam – PICA-RTV sandwich
 - RTV560: silicone used in many tiled TPS joints and bonds
 - Flight heritage as seam in MSL and Mars2020
- Coatings – NuSil on HEEET IL
 - NuSil 1144-0: commercial low-volatility silicone coating for surface protection

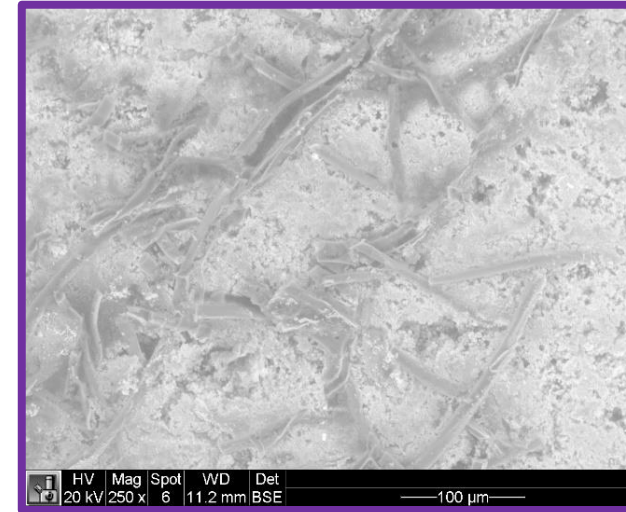
- Film more apparent in SEM
- Silica accumulation next to frame
- Low molecular weight silicone is most likely migrating species
 - Convert to silica film upon AO interaction
 - Is volatile silicone present everywhere or is AO/UV-C needed to generate?
- If red is iron, what species is mobile?

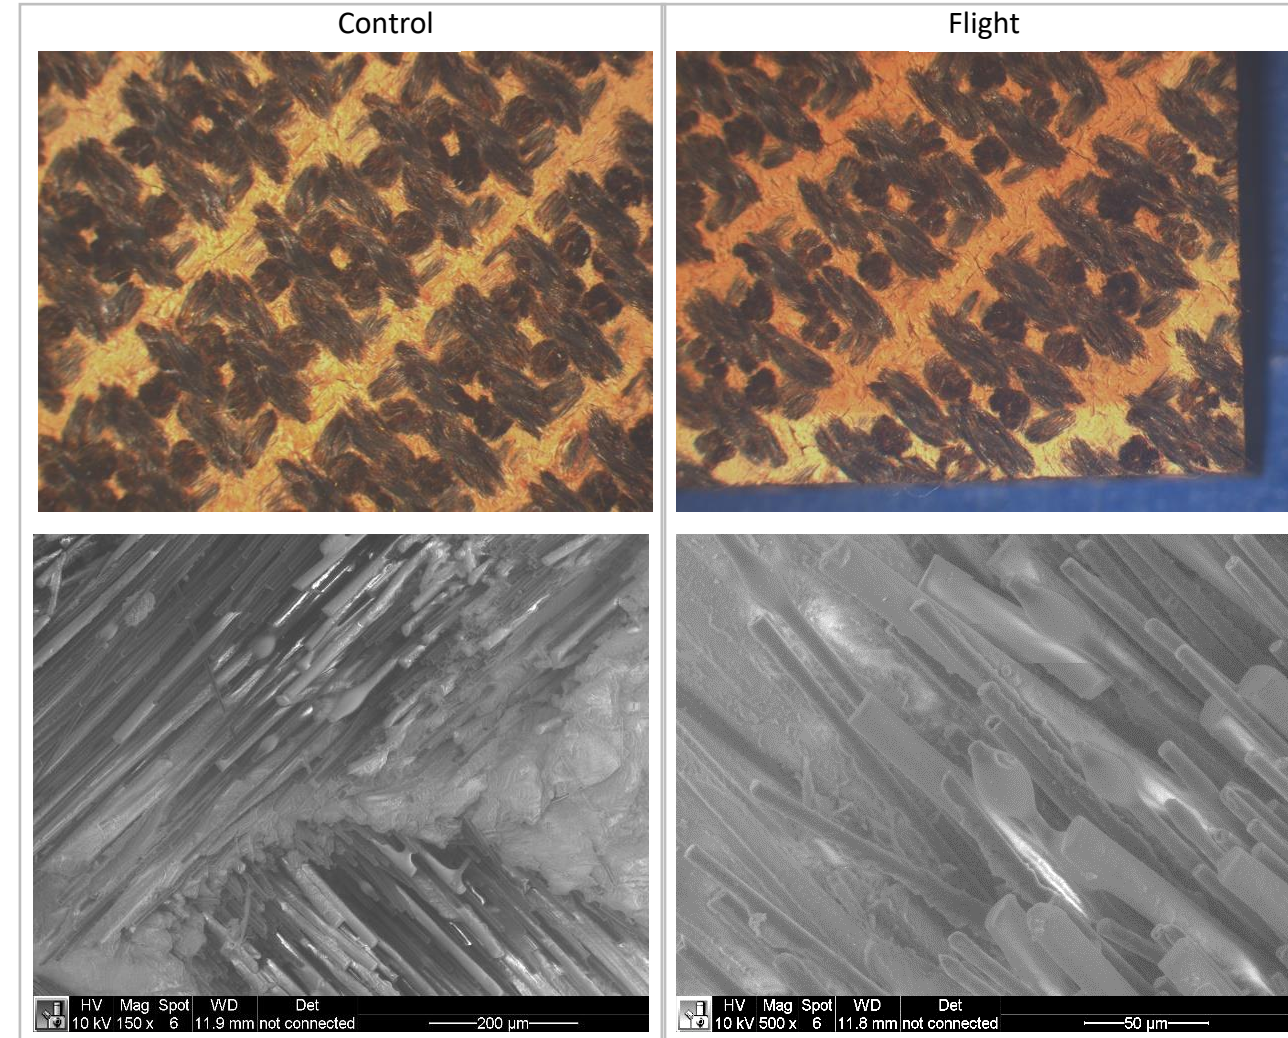
- Nusil 1144-0 is a silicone coating designed to provide AO protection and be low outgassing
- Initial interest was dust control
- Qualitatively less overall darkening than non-coated samples
- Less AO pitting on fibers
- Droplets on some fibers indicative of less-than-ideal wetting or excess application
 - No droplets/excess on phenolic matrix

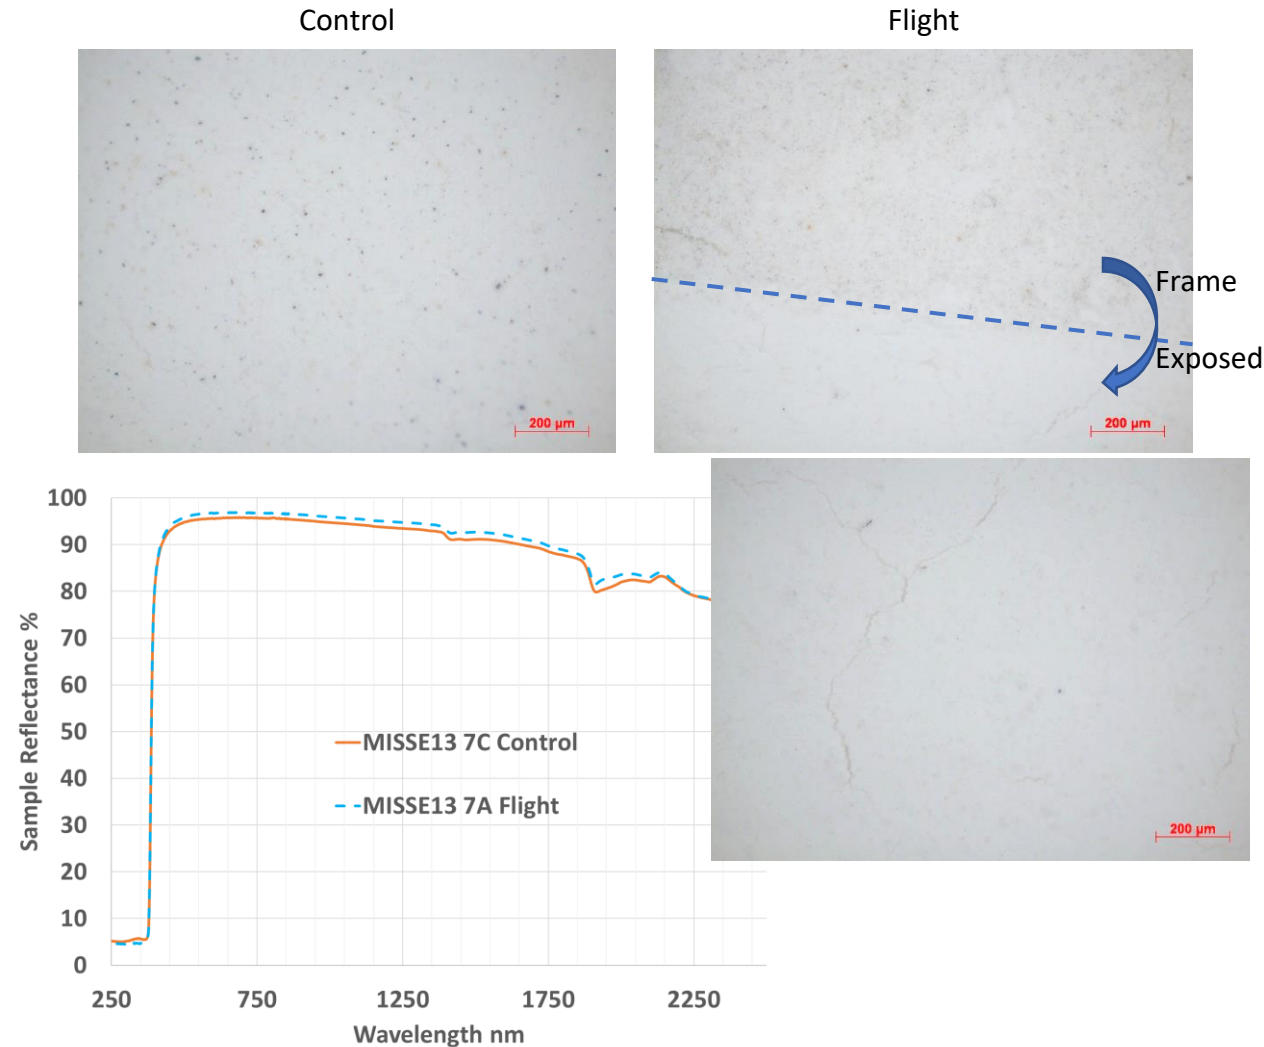
- AZ93 is a ZnO white pigment bonded with potassium silicate
 - Fully ceramic oxide system
- Slight darkening under frame
 - No Al detected by EDS
 - Likely in fact bleaching of exposed as appearance under the frame is similar to control
- Reflectance in UV-visible increased slightly on flight
- Fewer dark inclusions in flight than control
 - Could cause increased reflectance
 - Yet to be identified but organic contamination would be removed by AO
 - Possibly sourced from HEEET substrate
- Few cracks in flight surface which might be associated with damage from clamping in frame
