# **NASA Universal Waste Management System and Toilet Integration Hardware Operations on ISS – Issues, Modifications, and Accomplishments**

ICES-2022-073

# Universal Waste Management System (UWMS)

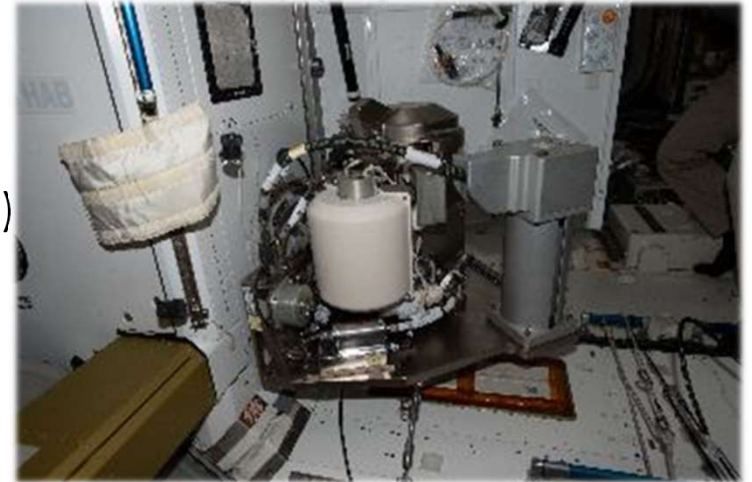
ISS UWMS installed in Node 3, ISS

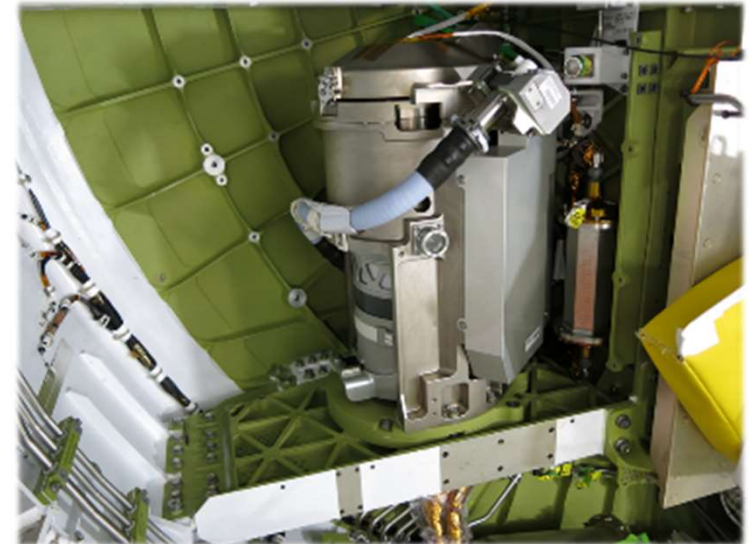
Orion UWMS installed in Artemis-2

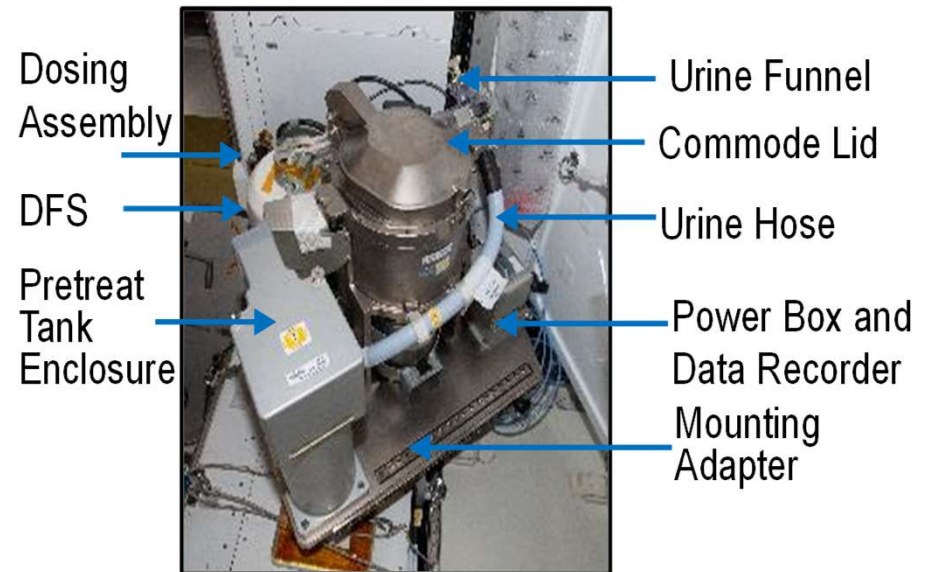
ISS UWMS installed in Node 3, ISS

- Designed for Orion launch/landing loads and electrical interface and adapted for ISS
- Dual Fan Separator (DFS)
  - Unit uses air to aid in capture of urine and deposit of fecal material
  - Single motor drives two fans and rotary urine separator
  - Fiberglass acoustic enclosure (internal to UWMS)
- Simple operations with no control panel
- Urine Collection
  - Pretreat solution pump and conductivity sensor
  - Uses Russian pretreat concentrate tank
- Fecal Containment
  - Individual fecal collection bags
  - Canister holds ~20 deposits
  - Canister cap provides odor control
  - Lifting mechanism ensures tight seal to prevent odor release
- Simultaneous Urination and Defecation
  - Redesigned urine funnels, and notched housing to improve female urination during simultaneous operations

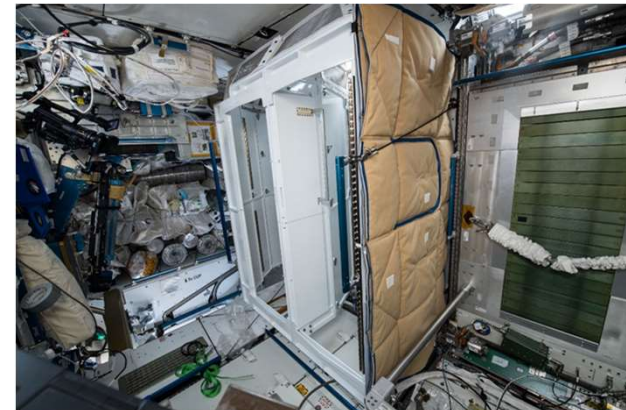
Toilet Integration Hardware Stall installed in Node 3, ISS

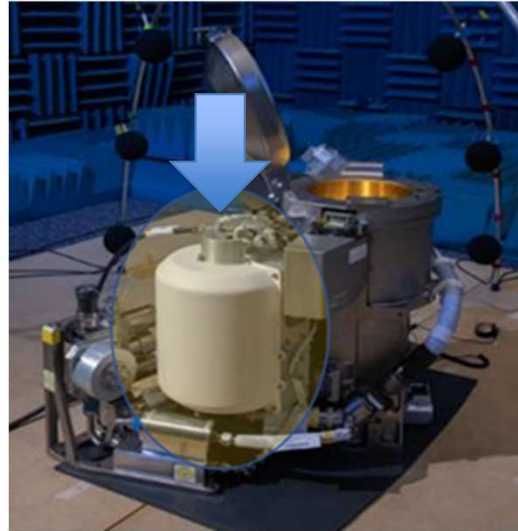
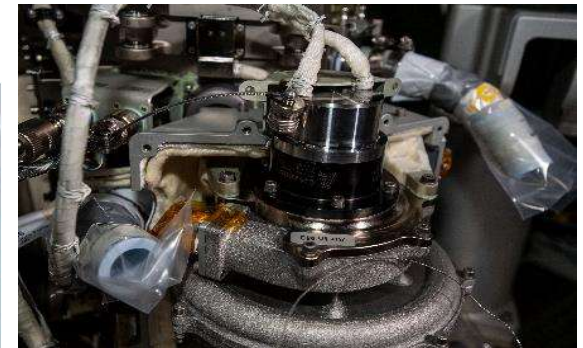
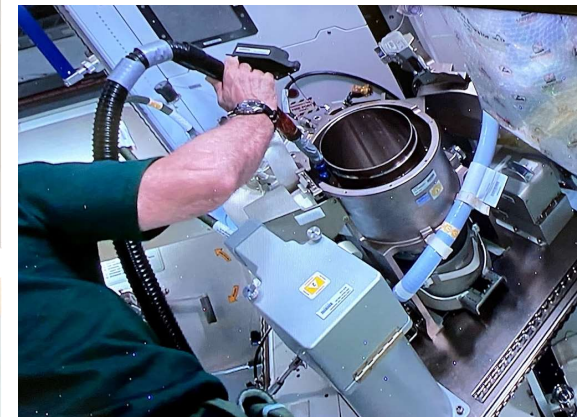
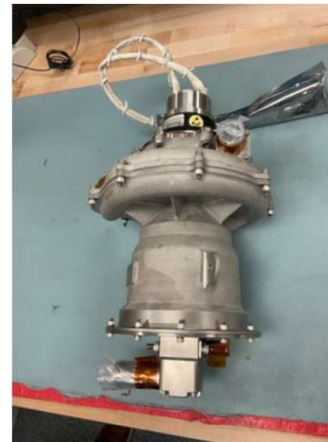
**ISS UWMS Dual Fan Separator (top images and left lower image) and attempt to move stuck separator with on-orbit vacuum cleaner (right lower image)**

- Originally installed DFS Failed to start during power up of UWMS
  - ❑ Locked Rotor Fault 5/26/21
- Attempts to free the unit with the on-board vacuum cleaner were unsuccessful
- Replaced with on-orbit spare 7/20/21
  - ❑ Ground investigation to determine root cause of on-orbit failure indicated failure due to off-nominal configuration of testing with pretreated urine in gravity environment: Ground handling & testing
  - ❑ Not a risk to spares fleet
  - ❑ Failed unit repair and refurbishment in-work for return as spare

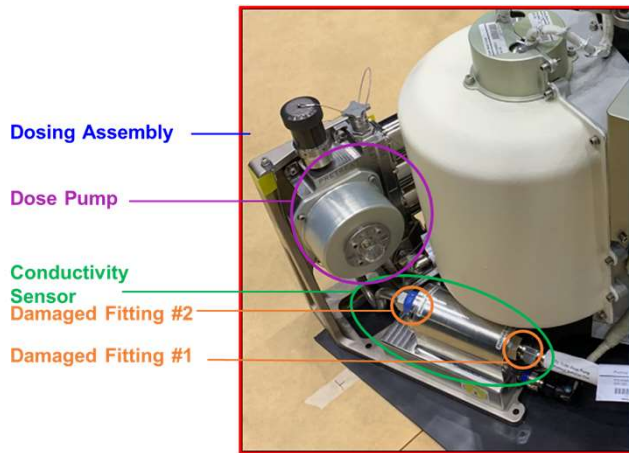
UWMS Dosing Assembly including Conductivity Sensor

- Low pH and strong oxidizing chemicals (pretreat) used to prevent microbial and fungal growth
- Dose pump dispenses metered volumes of concentrated pretreat and water for each urination

- Conductivity Sensor measures solution to provide a warning of incorrect pretreat concentration to protect downstream recycling systems which indicates pretreat volumes are appropriate to treat urine

- On-orbit unit and spare ground units failed to perform
- Samples of pretreat solution color change and analysis indicated dose dispensing occurred allowing further operations of UWMS to proceed

- UWMS pressure sensor data and ISS water bus data used to provide assurance of pretreat dispensing
- Sensor upgrades in work for on-orbit replacement
  - Updating materials in original sensor

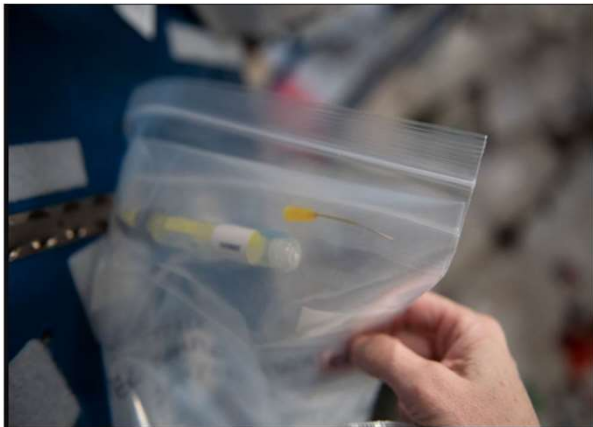
Syringe with pretreat sample for return and analysis

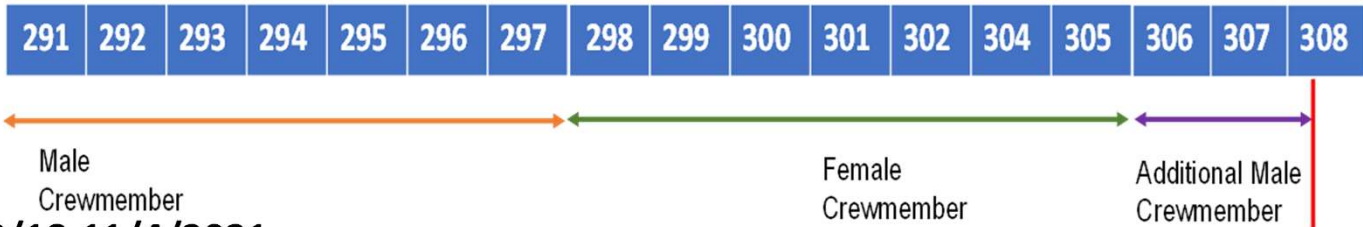
Pressure Sensor Fault  
UWMS shut down

- Pressure sensor hard fault at day 17

- Caused from organic debris occluding pitot tube

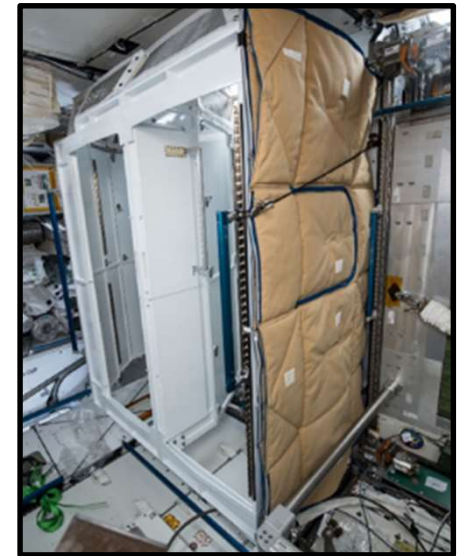
ISS UWMS and Toilet Stall in Node 3

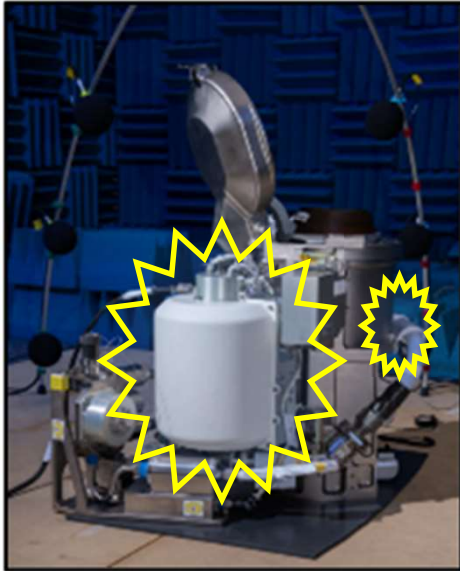
ISS UWMS in Acoustic Testing at JSC

- Acoustic exceedance known at time of Environmental Testing of ISS (11/2019) and Orion (10/2019) units
  - Average A weighted requirement is 68 dBA (log scale)
    - ISS - 72.9 dBA
    - Orion - 75.9 dBA
- Noise from Dual Fan Separator includes case radiated and duct born components
- On-orbit ISS crew complaints on noise levels; using headphones for mitigation
- Acoustic cover on ISS awaiting testing for reduction levels
  - Orion considering similar cover for Artemis-II
- Orion Artemis-II plan to use hearing protection; Artemis-III+ contract mods in work to update DFS design
- Root Cause – DFS design including gearbox, air flow, and speed

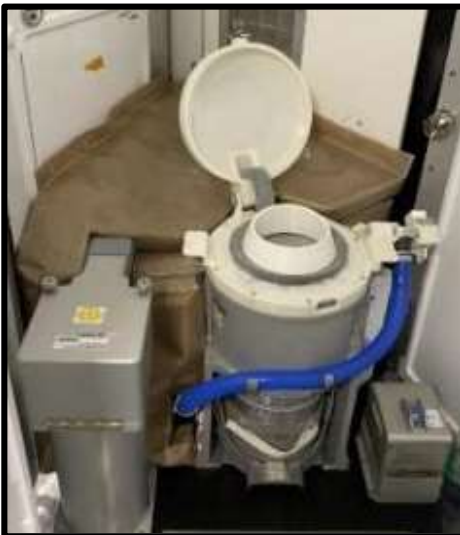
ISS UWMS Trainer at JSC with Acoustic Cover

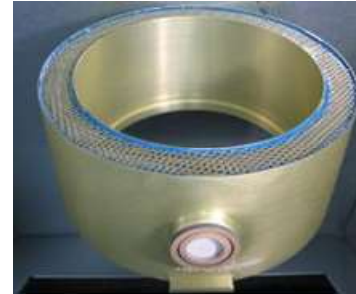
OBF unit

- Odor Bacteria Filter (OBF) does not meet requirement for 84 crew-day use based on original ground testing
- Validation of capacity/life on ISS key insight for Orion manifesting
- **Crew noted smells during UWMS use for both urination and defecation**
- OBF was of unknown capacity since it had been installed in UWMS in May 2021
- Seal at OBF inlet found to be folded over in off-nominal position which allowed an incomplete seal and release of odors
- Additional on-orbit testing is needed to confirm proper use and actual life/capacity of OBF units

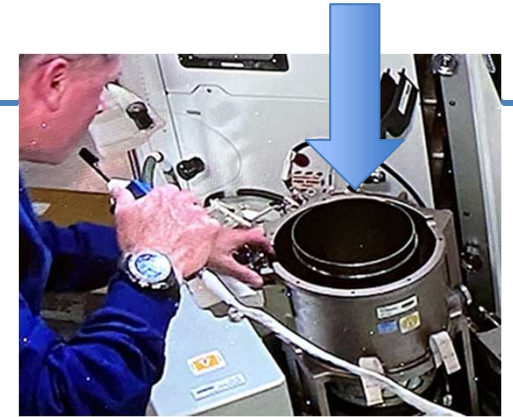
ISS UWMS showing location of OBF (not installed)

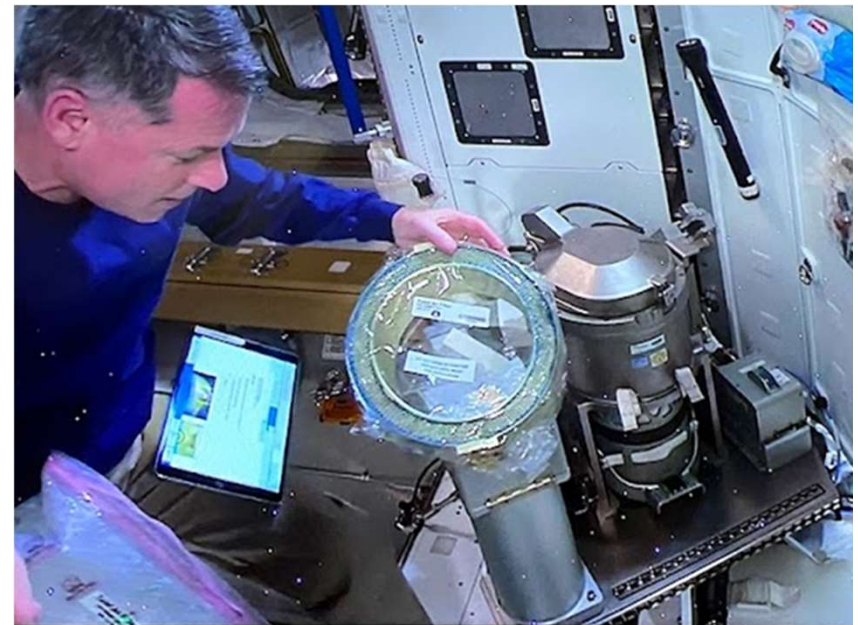
Crewmember with OBF and UWMS on ISS

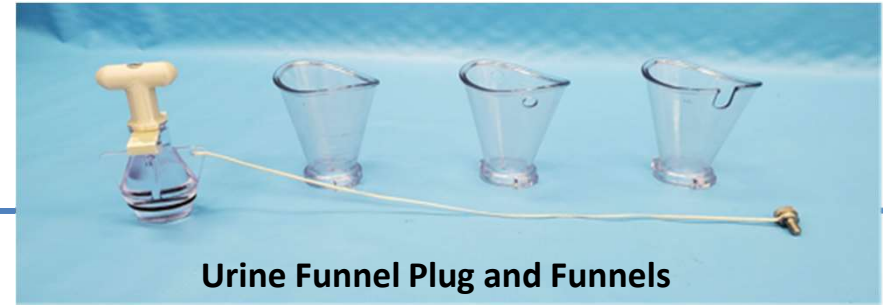
- Urine Funnels

- NASA updated urine collection with a urine funnel design optimized for female crew.
- Size and shape of funnel intended to improve simultaneous operations (urination and defecation) for female crew
- Numerous Crew evaluated and provided feedback which resulted in three designs
- On-orbit evaluation in the ISS Waste and Hygiene Compartment (WHC) influenced design changes
- Limited Checkout crew debriefs indicated that all urine funnels work with UWMS
  - Male crewmembers had no preference
  - Female crewmember preferred the notch option but indicated the plain funnel worked as well

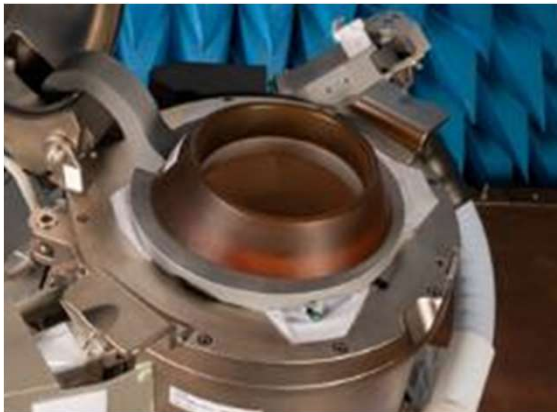
UWMS with 5" commode seat

- Seat size and shape optimized to work with the urine funnel and to improve placement of female crew
- Two sizes were flown for evaluation
  - Male crewmembers had no preference but noted the seat opening was too large; one male crewmember didn't use the seat
  - Female crewmember also noted the opening was too large and preferred the 4" seat since it is not as tall
