Operating and Maintaining the JWST Cleanroom attached to JSC's Chamber A during preparations for the OTIS Cryogenic Thermal Vacuum Test

Kelly A. Henderson-Nelson^a, Edwin W. Goldman^b, Joseph O. Ward^a, Jason E. Durner^a, Jason Brandon^a, Yingrui (Zao) Huang^c, Jonathan L. Homan^d

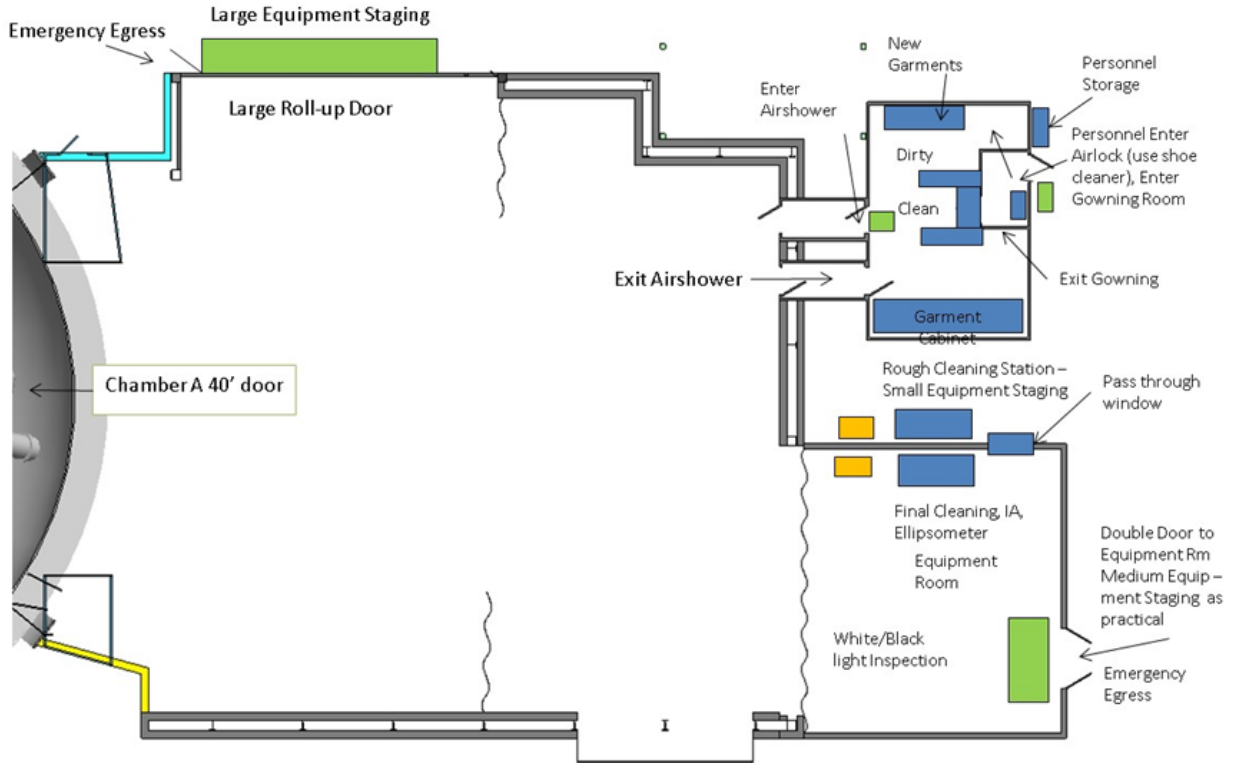
Cleanroom Floorplan/Hardware and Personnel Ingress & Egress - Despite being built within a pre-existing building, the JWST cleanroom contained 539 m² (5800 ft²) of controlled workspace with roughly 465 m² (5000 ft²) in the main high bay and approximately 74 m² (800 ft²) in equipment room (Figure 2). Big equipment was brought into the high bay by means of a large roll up door while the equipment room utilized a pass through for smaller items and tools. Personnel entered through a gowning room of approximately 37 m² (400 ft²). Once gowned, personnel stepped into an air shower before passing into the cleanroom. Personnel exiting the facility utilized a transfer hallway with double doors leading back into the gowning room.

Figure 2. Floorplan of JWST cleanroom attached to Chamber A.² (Drawing credit: NASA)

Cleanroom entry points for hardware are shown in Figure 2. The large roll-up door was used for large GSE and flight hardware, while medium and small pieces of hardware and equipment were sent into the cleanroom through the equipment room and pass through door respectively. There were two ISO 7¹ cleaning stations equipped with the necessary cleaning supplies for small piece parts and hardware: one cleaning station was located next to the pass through window and another was located in the truck lock. Any hardware cleaned within the cleaning stations was double bagged and hand carried to the pass through window for ingress into the cleanroom.

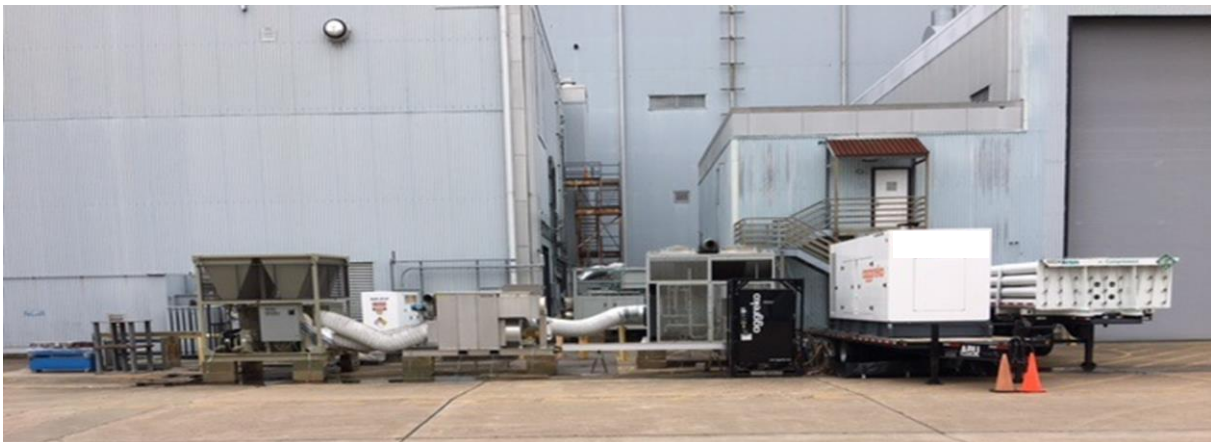
Cleanroom Environmental Control Redundancy – Instability in the critical utility delivery to cleanroom air handlers due to severe weather, necessitated the development of a stand-alone redundant system that could provide conditioned air in the event of equipment failure, utility disruption, or other system failure. To back up the cleanroom AFMS a large system (Figure 7) was acquired consisting of 4 direct expansion cooling units coupled with two mechanical dehumidifiers and a 65kw electric heater. Power was provided by a trailer mounted diesel generator with external fuel tank enabling approximately 12 hours of run time before refueling. The units were arranged in a serial configuration with the cooling unit feeding into the dehumidifier before entering the heater. From the heater, approximately 283,169 lpm (10,000 cfm) of airflow was ducted into a manifold which could be attached directly to the cleanroom MAU. When operating on the backup system the plant dampers were de-coupled from their motors and locked in the fully open position. The chilled and hot water valves were closed via the BAS software and the MAU fans remained active.

Figure 7. Cleanroom backup AFMS (Photo credit: NASA/Edwin Goldman)

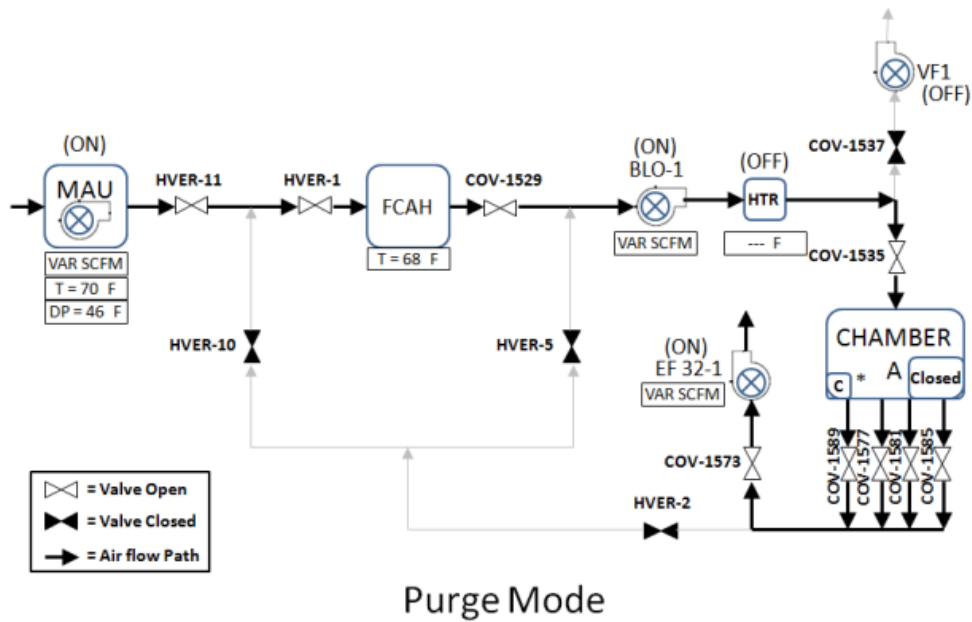
Lesson learned after OGSE-1 – Due to leaks in the recirculation segment of the AFMS ducting, high particle counts were observed after the OGSE-1 test while purging the chamber to remove nitrogen. To correct this issue, only the MAU (with no recirculation) in “purge mode” (Figure 11) was used to purge the chamber after re-pressurization in following tests. In addition, when the MAU shut down during a power outage caused by the 2015 thunderstorm, there was a slight negative pressure within the AFMS. It was discovered that when the MAU shuts down, the MAU intake louvers close immediately, while the blower fan downstream continues to rotate to a slow stop. This caused the negative pressure and a spike in the AFMS system particle counts.

Figure 11. Schematic of Chamber A AFMS in purge mode, and MAU, FCAH, blower, and gate valve locations.⁵ (Diagram credit: NASA)

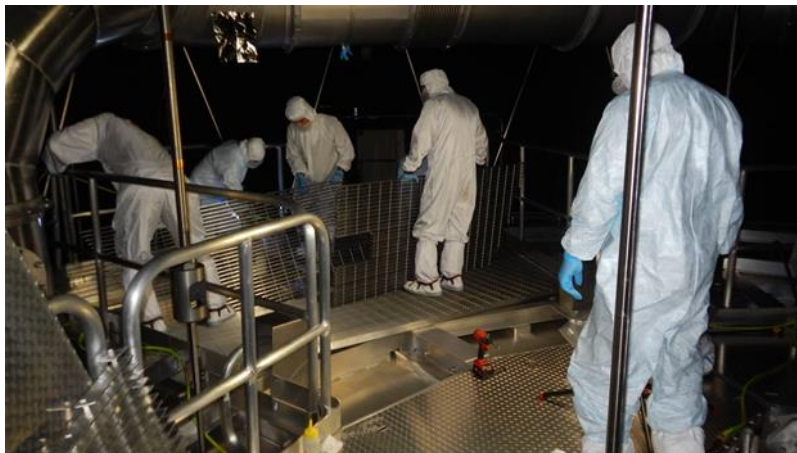
Figure 13. CC technicians cleaning areas under floor grating on level 5 (Photo credit: NASA/Joe Ward)

Major chamber cleaning was conducted two times, just before the first “mini-pumpdown,” and before the pre-OTIS CV vacuum functional test or “mini-pumpdown 2.” There were approximately 20 CC technicians that supported the effort each time. From the very top of the nitrogen shroud in the “circus tent,” to the bottom of the chamber in the plenum, technicians cleaned all of the interior chamber shell, as well as interior and exterior nitrogen and helium shroud surfaces. This included walls, floors, support structures, ledges, cable trays, and supply tubing. Steel plate floors and catwalk gratings were removed so surfaces underneath could be thoroughly cleaned (Figure 13). Technicians crawled into small and confined spaces (which required special training) while wearing full bunny suits and carrying cleaning equipment. During the cleaning process on all levels, CC technicians were responsible for repairing, sealing or removing, and cleaning peeling tape and damaged multi-layered insulation on support equipment and chamber supply tubing. They also inspected for peeling paint or any other potential source of contamination and reported it to the lead Contamination Control Engineer for resolution. During the cleaning, extra caution was exercised near installed optical alignment support equipment.

Cleaning tools included cleanroom mops, HEPA filtered vacuums, wipes and the 50/50 IPA and deionized water blend discussed in Section 1.3. Extension poles were designed and fabricated to bridge the gap between personnel catwalk platforms so that most of the interior and exterior of the nitrogen and helium shrouds could be reached. Surfaces were vacuumed first, followed by solvent wiping or mopping. After cleaning, surfaces were inspected with both white and ultraviolet flashlights. Maintenance cleaning of floors and accessible equipment continued to be performed on a daily basis on level 1, level 5, and in high traffic areas as was done for the cleanroom described in Section 1.3. Also, before each test, technicians were hoisted up inside the helium shroud on a man lift to inspect for and remove contamination and any indication of peeling paint, tape, or acrylic adhesive.

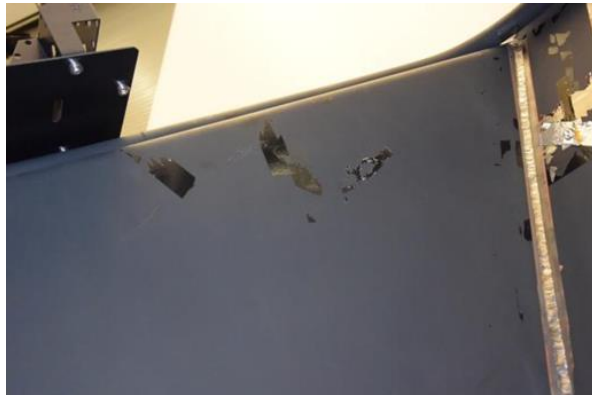
Figure 16. Tape backing completely delaminated from adhesive after exposure to cryogenic T in vacuum. (Photo credit: NASA/Joe Ward)

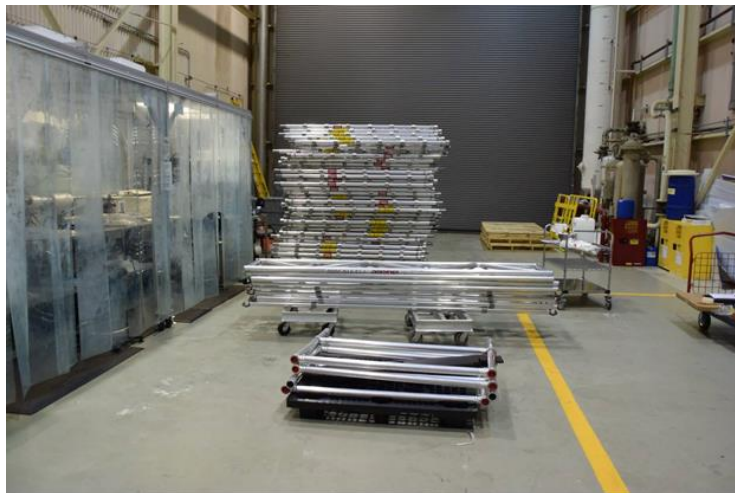
Figure 19. Scaffolding staged in truck lock before ingress into cleanroom and cleaning station on left. (Photo credit: NASA/Joe Ward)

Hardware and equipment to be brought into the cleanroom was staged in the space known as the truck lock (Fig 19), typically used for transition of hardware and equipment delivered to the building 32 into the vacuum test high bay. Because the truck lock was an uncontrolled area, special protocols were developed that included twice daily vacuuming of the floors and equipment. For hardware transitioning to the cleanroom, initial cleanliness inspections conducted in the truck lock included looking for evidence of dust, chipping paint, debris, uncured coatings, and disallowed materials. Once the initial inspection was complete, the hardware was rough cleaned following hardware provider instructions. Any hardware that was rough cleaned and not immediately brought into the cleanroom was covered and sealed. Final cleaning (also conducted per hardware provider procedures), VC-HS + UV inspections, and/or contamination sampling for quantitative measurements occurred after the hardware was moved into the cleanroom. Hardware delivered double bagged and pre-certified followed the standard protocol for exterior bagging to be removed in the truck lock and final bagging removed inside the cleanroom. Even hardware that was delivered with a cleanliness certification was inspected once inside the cleanroom due to random issues with bagging integrity, actual hardware cleanliness, and material usage.

Aluminum scaffolding – There was a significant amount of aluminum scaffolding used during I&T operations at JSC. Some was erected on Level 5 around the COCOA, in the cleanroom, and a significant amount around the PF installed on Level 1. Figure 19 shows a stack of scaffolding struts in the truck lock awaiting rough cleaning. Internal strut surfaces were cleaned by flushing or swabbing (using a large custom fabricated swab) with a solution of 80/20 deionized water and IPA, and all exterior surfaces were cleaned by vacuuming and wiping with the same 80/20 solution. Open ended struts that could not be cleaned in this manner were sealed with an approved plastic. Final cleaning and inspection occurred in the cleanroom. CC technicians stood by with a vacuum in order to remove any aluminum shavings generated during assembly and disassembly of the scaffolding. Due to limited space, scaffolding could not be stored in the cleanroom, and as a result, there were multiple iterations of this process.

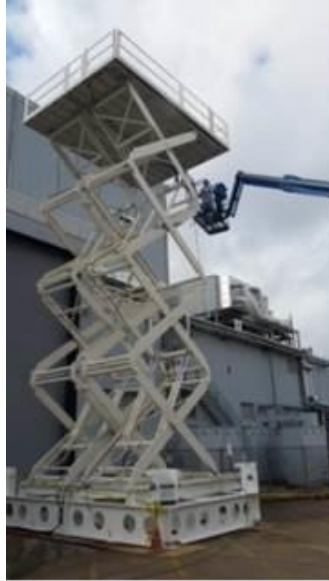
Figure 20. Pentalift inspection just outside the JSC building 32 truck lock (Photo credit: NASA/John Byard)

Pentalift – A 40ft scissor lift with a 12'x12' platform was custom fabricated to support installation of auto-collimating flat (ACF) mirrors to the helium shroud ceiling. Unfortunately the manufacturer did not have experience building cleanroom compatible equipment. It was delivered to JSC with paint chipping from all joints, mechanisms and recesses, along with metal debris, and hydraulic fluid contamination. Post-delivery adjustments to the structure required additional grinding and drilling. Insufficient ceiling height in the truck lock and cleanroom required it to be cleaned outdoors, so that it could be fully deployed for the cleaning (Figure 20). Once in the cleanroom, it was extended as high as possible and re-cleaned. Additional post fit test findings caused the Pentalift to be removed from the cleanroom, and re-cleaned again after additional modifications. Hydraulic leaks continued to be a challenge, but were closely monitored and well contained by CC technicians using approved plastic and special “diapering” techniques.

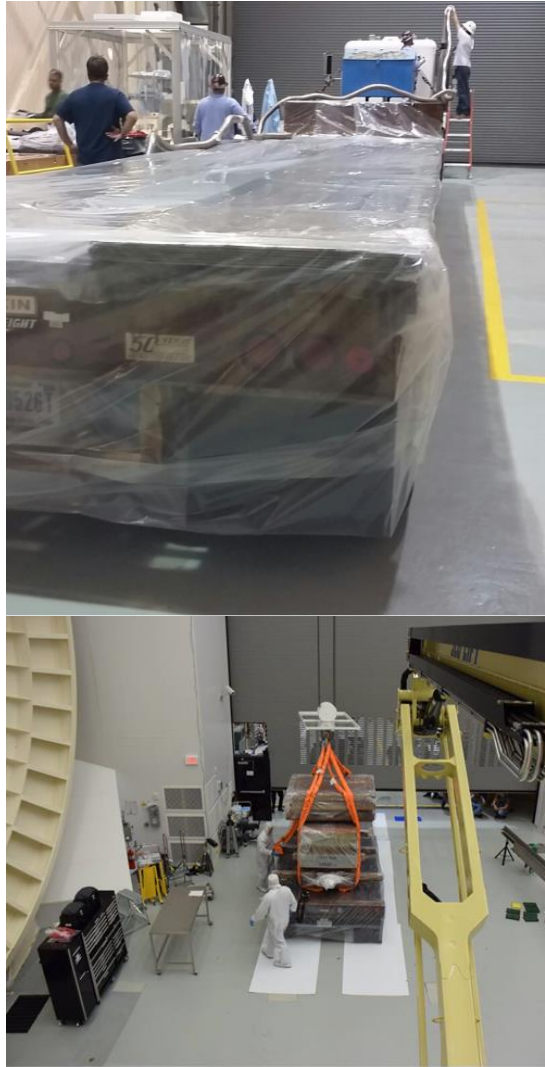
Figure 21. Truck trailer being prepared in truck lock then backed into cleanroom with crane load test weights (*Photo credit: NASA/Joe Ward, Chris Gunn*)

Crane load testing – Load testing of the cleanroom crane was conducted prior to the arrival of OTIS. In order to perform this test, steel weights were delivered to building 32 from an outdoor storage facility on a flatbed truck. While there is a crane in the truck lock and in the cleanroom, neither could be used to transition heavy equipment through the truck lock into the cleanroom. This made it necessary to use the flatbed to move the weights inside the cleanroom. Initially, outside the truck lock, the weights were lifted off the flatbed trailer with a heavy duty forklift, then the trailer was washed with a high-pressure sprayer. Approved bagging material was placed on the flatbed and then weights were placed back on the flatbed, on top of the plastic. Each weight was then completely covered and sealed to the flatbed plastic. Once this was complete, the trailer was backed into the truck lock (Figure 21) and all packaging material installed outside was solvent wiped. In addition, all sides of the flatbed were wrapped with plastic from the top of the flatbed to the floor. Next, ducting was connected to the truck's exhaust pipe and sealed so that engine fumes could be vented outside via a building exhaust fan port. In parallel, the inside of the cleanroom was prepared for the flatbed: all critical hardware was covered, a particle counter and a hydrocarbon monitor were placed within 5 feet of critical hardware, and contamination samples were deployed. Also, approved plastic corrugated sheeting was placed on the floor where the truck wheels were to be rolled over the cleanroom floor. A final, full inspection was conducted to ensure the weights and trailer were visibly clean and sealed well, and then particle counters and hydrocarbon monitors were started. Floors were mopped outside and inside the cleanroom, and just before the roll up door was opened, the cleanroom MAU plant air supply dampers were opened 100% as described in Section 4. After the roll up door was opened, the Chamber A AFMS (with 40' door open) was also ramped up. A technician was stationed at the pressure panel to monitor pressure, while in communication with the AFMS operator to ensure the pressure did not exceed 0.2 inches w.c. during this process. At this point, the trailer was backed into the cleanroom, and the roll up door was lowered as much as possible over the top of the trailer. The truck engine remained running during the load test to avoid a brake pressure release that could potentially push dirty air back into the cleanroom. Particle counts inside spiked temporarily when the roll up door was opened but quickly settled down to below ISO 7¹ level during the load test. Typically, the load testing took 20-30 minutes to complete before the truck rolled back out of the cleanroom.

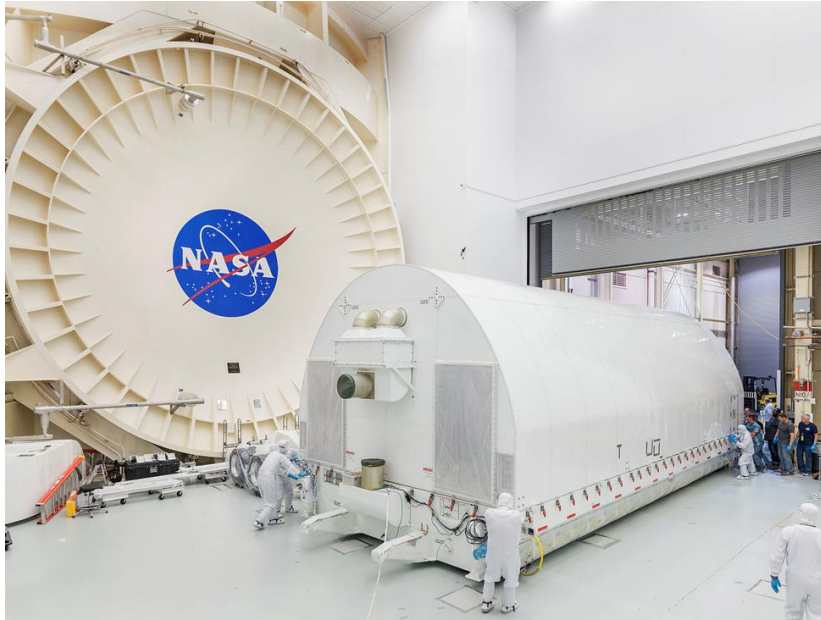
Figure 22. OTIS within the STTARS shipping container as it was delivered to JSC (Photo credit Chris Gunn, NASA)

STTARS - The Space Telescope Transporter for Air Road and Sea (STTARS) shipping container was used for transport of OTIS from GSFC to JSC and JSC to Northrop Grumman in a C5A aircraft. The shipping container is 4.6 m (15 ft) wide, 5.2 m (17 ft) tall, by 33.5 m (110 ft) long, and it weighs almost 75,000 kg (165,000 lbs). It is comprised of the pallet, tent frame and the exterior lid. It was designed, fabricated, and built to be cleanroom and space flight hardware compatible, with the interior capable of maintaining ISO 7¹ or better air cleanliness.

Because the inside of the STTARS container was maintained to ISO 7¹ cleanliness conditions, the interior remained very clean during shipments. Airborne particle counts during transport operations were < ISO 6¹. Witness samples installed outside and inside the tent frame for the transport from GSFC to JSC and JSC to GSFC indicated a ≤ 0.002 PAC or less and < 5 angstroms NVR.

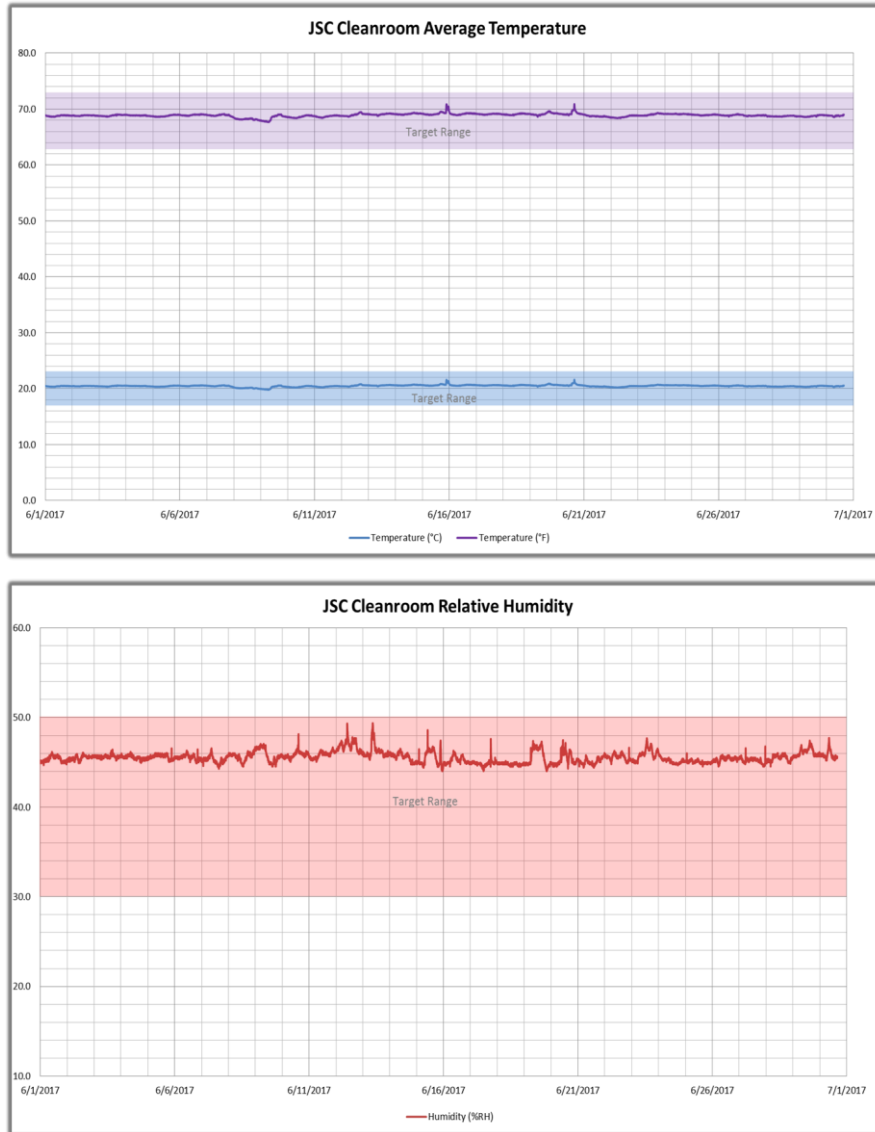
Environmental Control - The biggest challenge for this cleanroom was the weather. The demand for chilled water onsite at JSC was highest during hot humid weather, and the cleanroom was one of many facilities onsite that required it. Updates to the control software provided warnings if chilled water T and/or flow parameters became unstable, and even shut down the MAU in the event that chilled water could not be quickly returned to nominal operation. Logs were kept of conditions that would impact chilled water performance, providing additional insight to impending issues. In addition, after the weather event experienced in 2015, spare parts were procured for any component that was vulnerable to an electrical storm. The back-up environmental control system provided the necessary redundancy to keep cleanroom T and RH levels within specification under any circumstance. Monitoring data from the tracking and alarm system enabled informed management teams of JSC and GSFC to ensure out-of-spec conditions were minimized. Figure 23 includes T and RH plots for June 2017, while OTIS was being prepared for its cryogenic test. In summary, by the time OTIS had arrived at JSC for its cryogenic thermal vacuum test, the environmental control system, its alarms, and back-up systems were reliable and fully operational.

Figure 23. T and RH plots for the JSC Cleanroom June 2017⁸

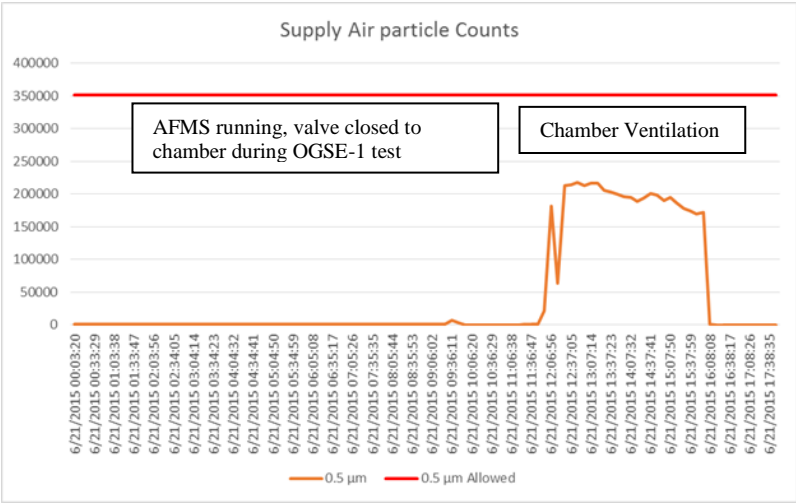
Figure 25. Chamber supply particle counts (0.5 micron) post-test ventilation OGSE-1 June 2015⁹

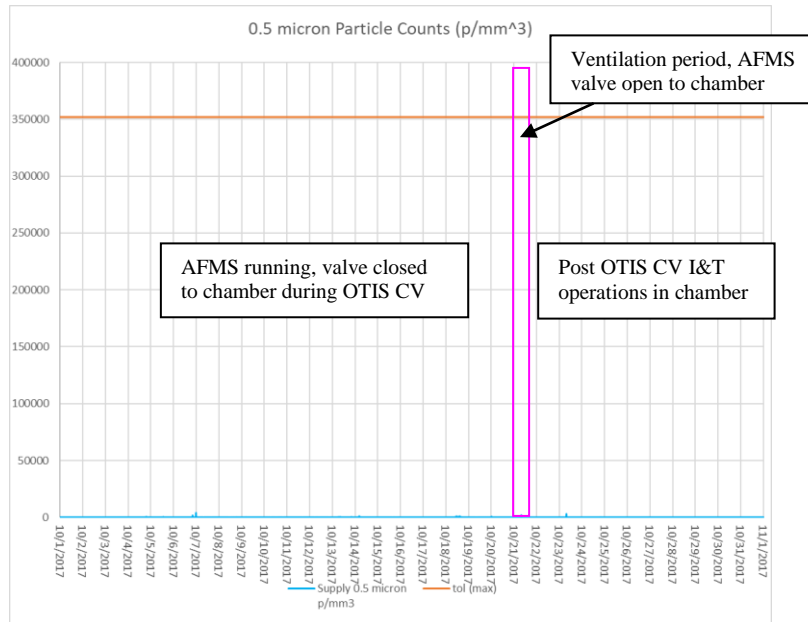
Figure 26. Chamber supply particle counts (0.5 micron) post-test ventilation and ambient OTIS CV operations¹⁰

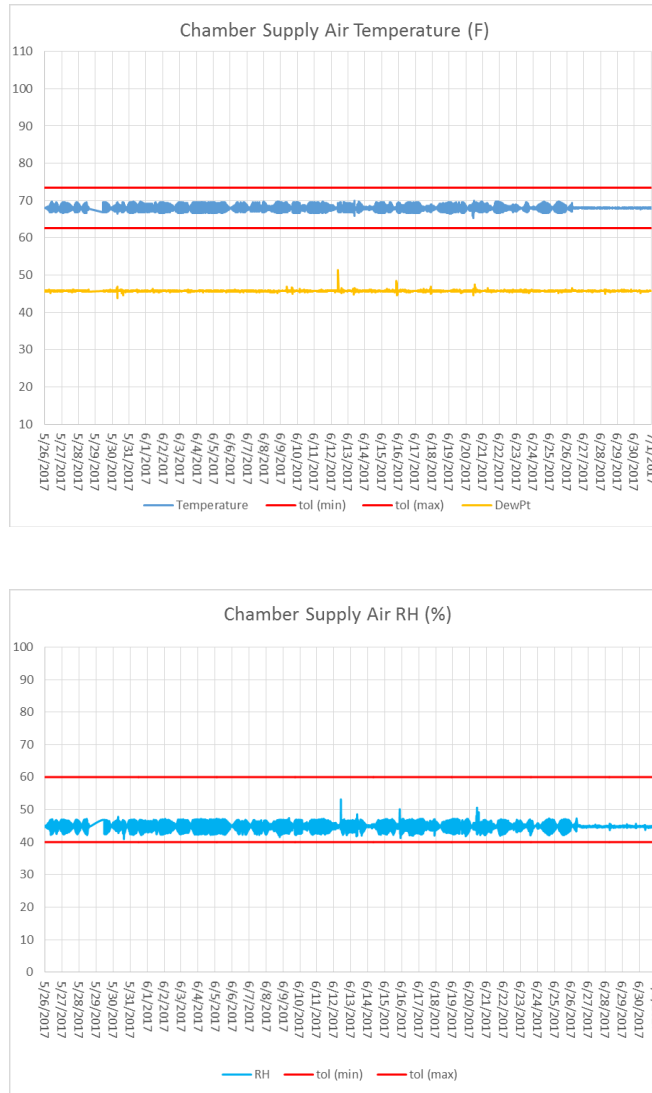
Figure 27 shows the plots for T and RH for the Chamber in June 2017 during OTIS CV test preparation operations. The plots show that T and RH levels in Chamber A were well controlled.

Figure 27. T and RH plots for Chamber A June 2017⁸
