# Precious Cargo: Transporting contamination-sensitive instruments & optics

## ABSTRACT

The James Webb Space Telescope (JWST) is a multi-national program with Instruments and hardware supplied by companies all over the world and numerous states in the United States. In order to transport larger assemblies, like the Optical Telescope Element / Integrated Science Instrument Module (OTIS), and ultimately JWST, the Space Telescope Transporter for Air, Road and Sea (STTARS) was designed and constructed. STTARS is a massive mobile cleanroom (longer than 2 semi-trailers) that provides an ISO class 7 payload environment while being transported by road, airborne and marine vehicles. Temperature, humidity and particle counts are controlled and continuously tracked, with fallout and NVR witness samples for confirmation. Instruments or sensitive hardware may be purged continuously during transport. STTARS has 5 main components: the upper tent frame, lower tent frame, pallet, strong back and lid. After transporting OTIS to Northrup Grumman (NG), STTARS was modified to increase its height to house the JWST Observatory on its voyage to French Guiana. This new configuration was designated Observ

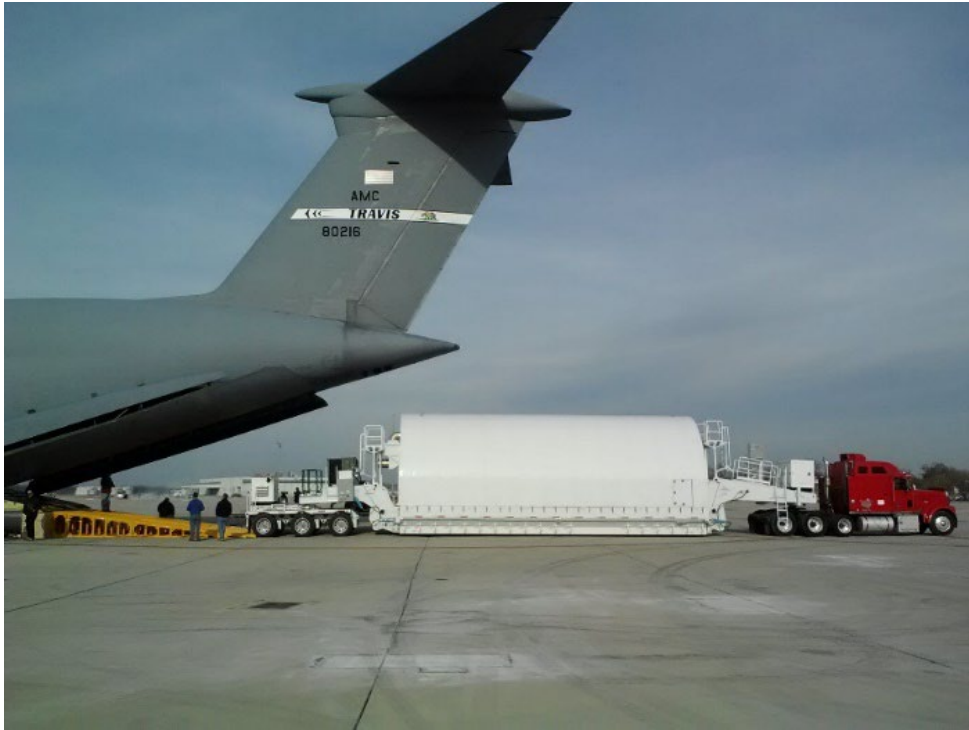
Figure 1. STTARS preparing to load onto the C-5C space cargo modified (SCM) in November 2012 at Wright-Patterson Air Force Base. (Credit: USAF Photo/John Andersen)

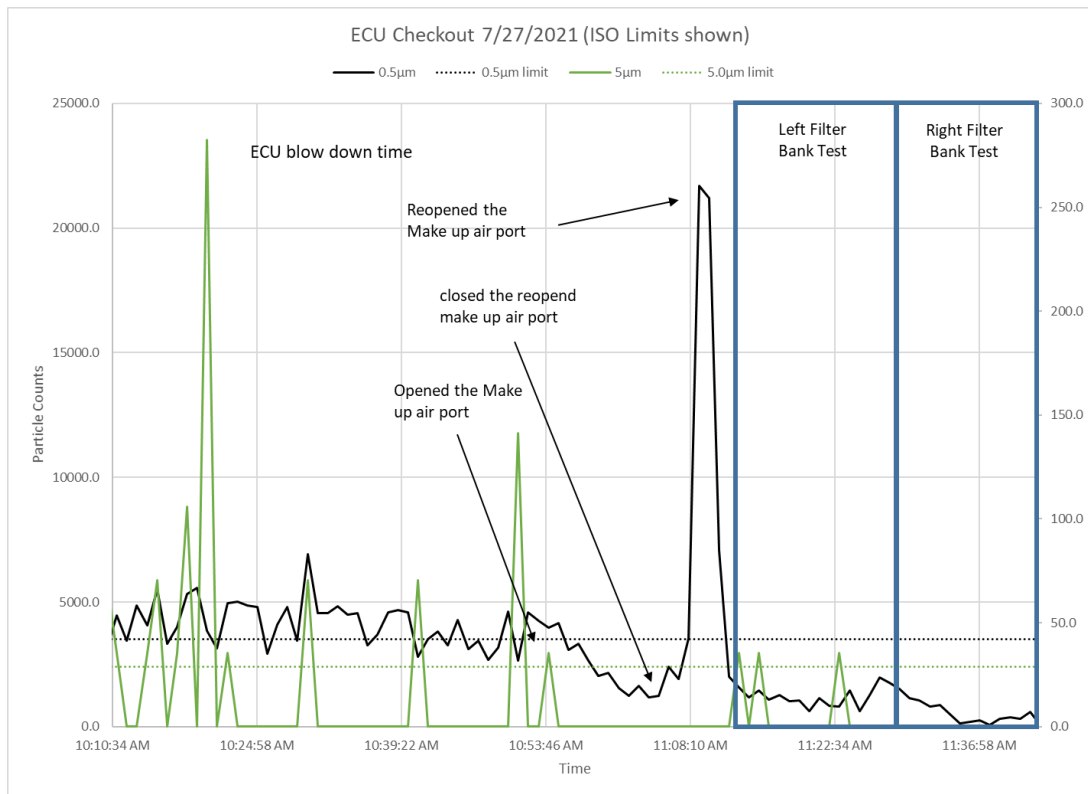
Figure 5. 7/27/2021 ECU checkout particle count results (Credit: NASA/GSFC)

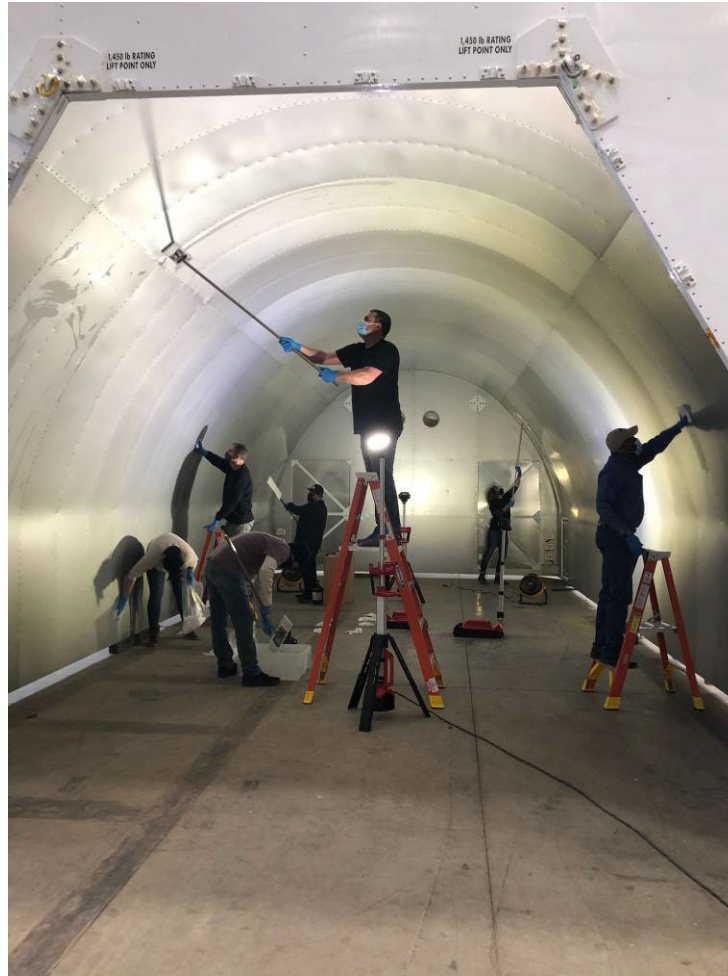
Figure 6. Rough cleaning of the inside of the OSTTARS cover at Nelson Manufacturing (*Credit: NASA/GSFC*)

The newly designed upper and lower tent frames have direct line-of-sight exposure to the observatory and required extensive cleaning and verification prior to loading of the JWST. The rough clean was performed at Nelson, the manufacturing facility in Ottawa, Ohio (Figure 6) during the week of February 22<sup>nd</sup> 2021. A team of seven engineers and technicians spent five days performing the rough cleaning. To start, the tent frames were lifted by crane and placed on cribbing. The upper tent frame interior and exterior surfaces were fully accessible for cleaning, but the lower tent frame was not designed to allow personnel to walk on it, so a crane and rigging crew were required to flip the lower frame upside down to allow access to its interior surfaces (see Figure 7).

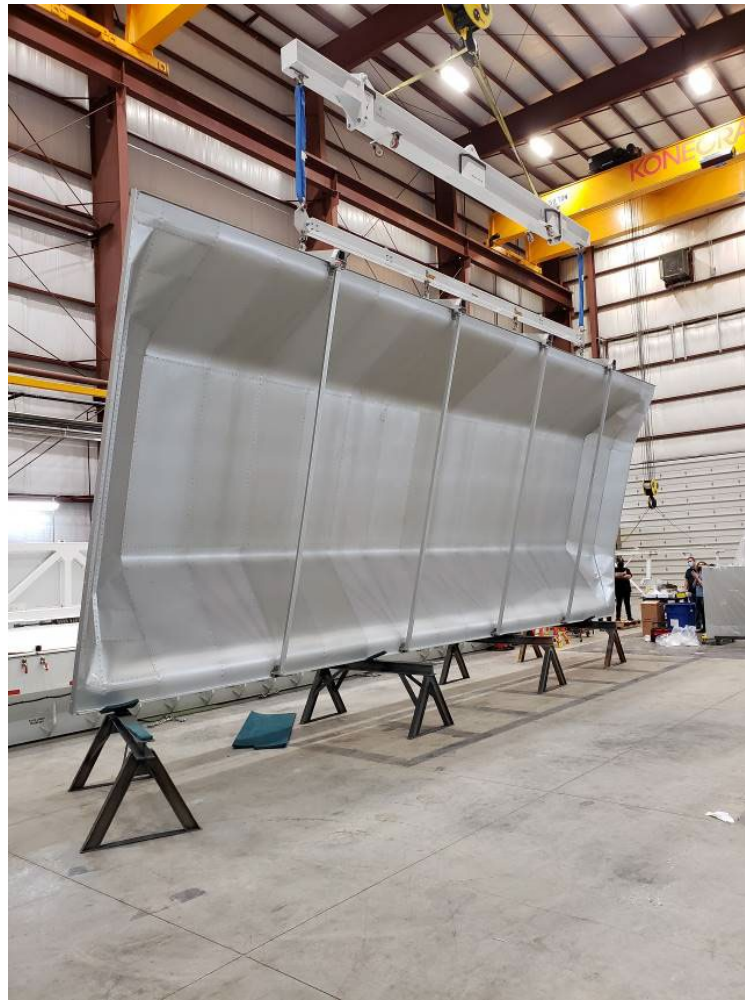
Figure 7. Rotating the lower tent frame for cleaning access (*Credit: NASA/GSFC*)

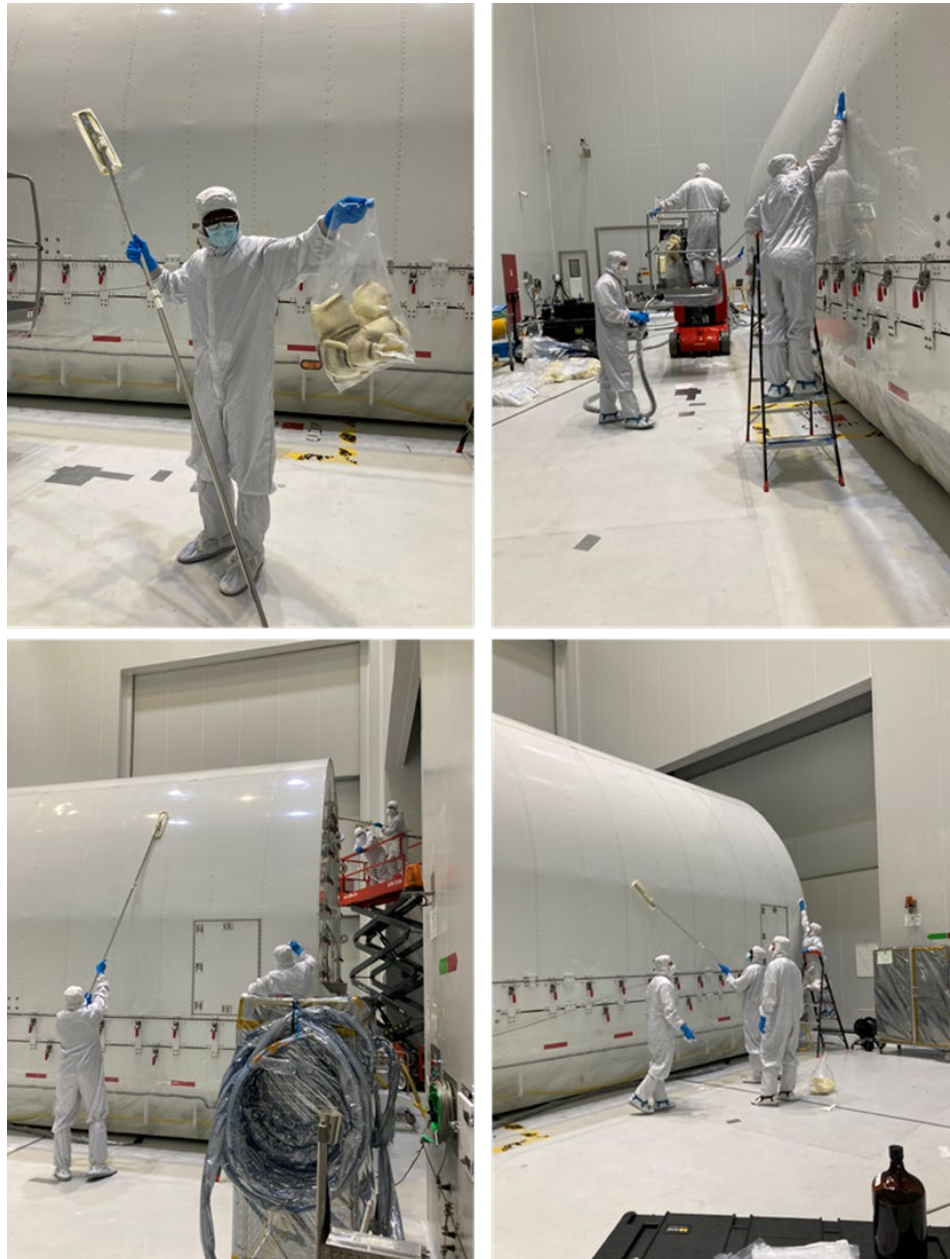
Scissor lifts were needed to enable the team to reach the apex of the arched cover, which held significant particulate fallout. With OSTTARS rising roughly 5.5 meters (18 feet) in height, the scissor lifts were required to extend roughly 7.6 meters (25 feet) into the air to enable a downward angle that would allow sufficient access and downward pressure to clean the area. . Despite the access afforded by using scissor lifts, the team on lifts still needed cleanroom mops on long telescoping handles to reach all surfaces and remove the contamination. One manlift would be positioned on each side of the container, stocked with multiple packs of dry cleanroom mop heads and poly bags containing mop heads pre-soaked with IPA. Contamination present at the top of the lid was heavy enough to require multiple passes with dry mop heads to minimize streams of dirty IPA cascading down the sides of the container. Upon completing a few passes with dry mop heads a transition to pre-soaked IPA mop heads was made.

Riveted, overlapping metal panels were used to form the lid and each seam exhibited an increased amount of contamination due to the mechanics of the removal process. The seam interfaces and associated rivets caused pooling of IPA which, in turn, could redistribute the contamination and form a film once the IPA evaporated. To combat this, the team would alter the amount of IPA used for the presoaked mop heads when spot cleaning around the panel interface seams. Essentially a mop head with a greater amount of IPA would be used for the initial post dry wipe cleaning and be followed by another pass with lightly dampened mop heads with emphasis on the seamed interfaces (Figure 8). The process required hours of awkward reaching, extending, and performing of exaggerated mopping motions which required honest self-assessment of fatigue by all in the team to avoid injury, all while maneuvering scissor lifts within inches of the OSTTARS shipping container at roughly 7.6 meters (25 feet) in the air.

Figure 8. Exterior cleaning of OSTTARS. (Credit: NASA/GSFC)

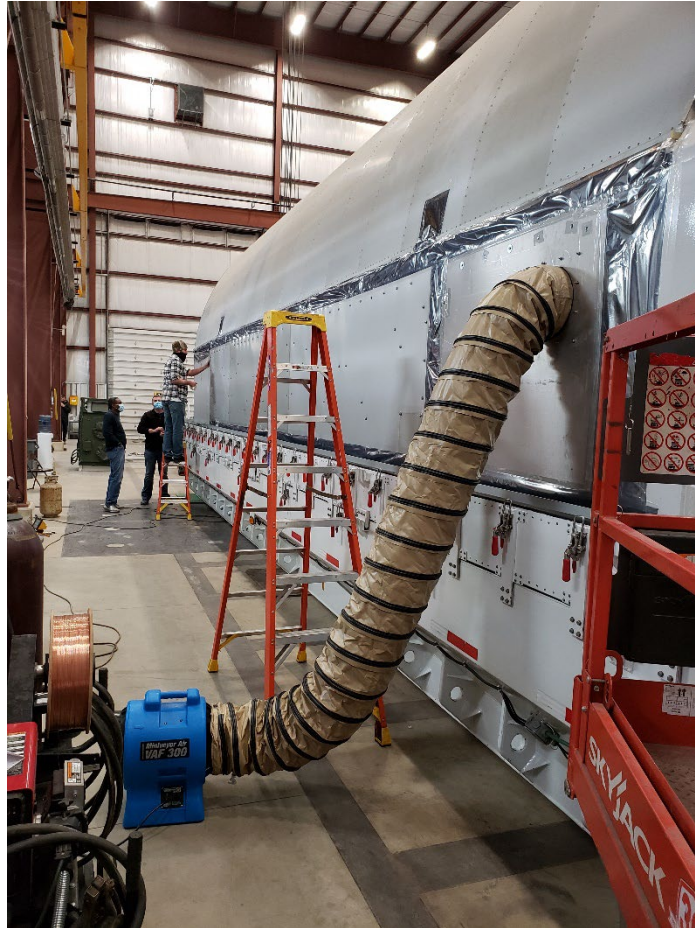
and close outs became critical due to the strict humidity requirements of the onboard science instruments and exposed optical surfaces. Upon completion of OSTTARS modifications, temperature/humidity stability tests were run to validate the environmental control unit's ability to properly maintain the conditions within the tent frames. This testing allowed contamination control engineers a chance to evaluate the effectiveness of planned closeout techniques. The tent frames were closed out as if the telescope was inside. To test the close outs, the tent frame volume had a blower connected to it and turned on (Figure 9). This provided a high positive pressure and allowed the team to search for leaks and make adjustments to the close outs as necessary. This proved very effective in finding leak paths that were not easily identifiable.

Figure 9. Leak testing the closeouts at Nelson Manufacturing. *(Credit: Joseph Ward)*

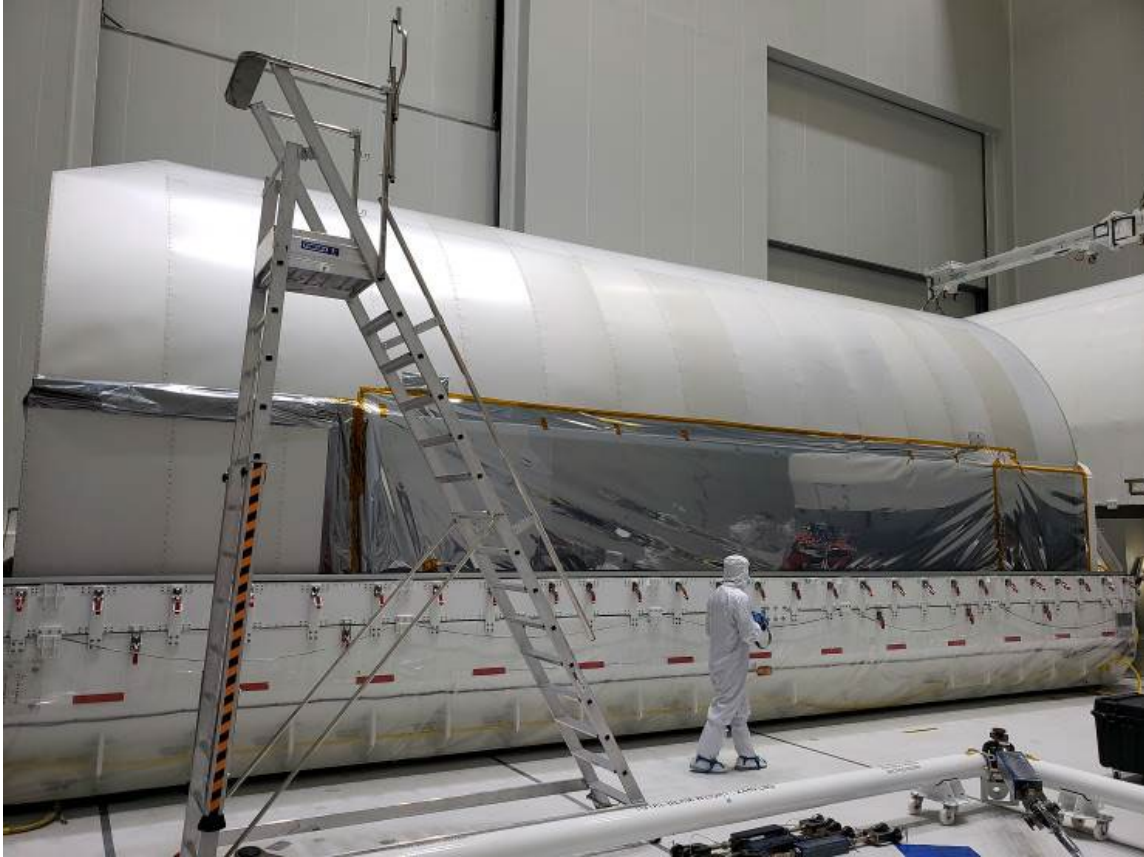
Figure 10. OSTTARS final closeouts around the upper and lower tent frames. (Credit: NASA/GSFC)

Additional team members worked to seal out seams and gaps at the end gate opposite the tombstone. By design a large gap was present vertically along each side of the end gate/arm interface. This gap was sealed with 12-inch ESD compliant tube stock with care given to allow enough slack for potential movement and any pressurization present from the purge system and environmental control unit. A smaller gap was present along the upper edge of the interface of the end gate and upper tent frame which received the same mitigation efforts utilizing ESD compliant tube stock taped in place with allowances for independent movement of each structure. (Figure 10)

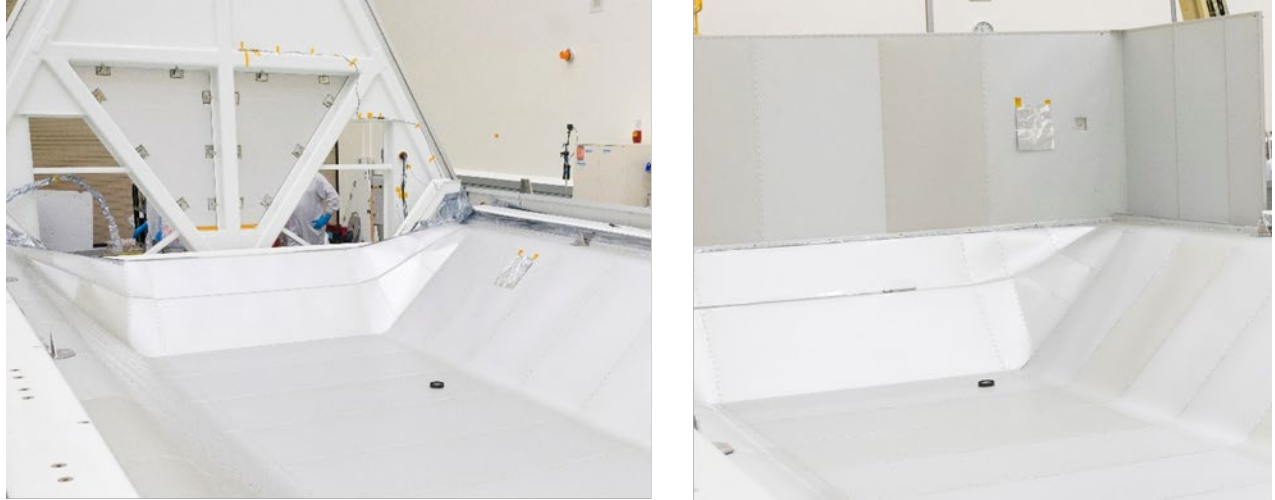
Figure 12. Contamination samples NVE 2 and Wafer A on the left and NVR 1 and Wafer B on the right inside OSTTARS. (Photo credits: Chris Gunn)

OSTTARS transport of Webb followed the same monitoring processes as the previous transports. The particle counters were set to automatically start counting when power was supplied to the units. The counters were handheld units with a 0.1 cfm pump. The counter inside the tent frame volume was mounted on an arm using a bracket made for the counter. The counter outside the tent frame measuring the cover volume, was taped in place. Both counters were set to sample for 10 minutes with no hold or delay between samples. This allowed for complete monitoring of the transport. Prior to the cover installation power was connected to OSTTARS and all instrumentation was checked to verify functionality. Figure 11 shows the approximate locations of the fallout wafers, NVR foils and the particle counters placed inside OSTTARS. Each location was photographed (Figure 12) after deployment of the samples.

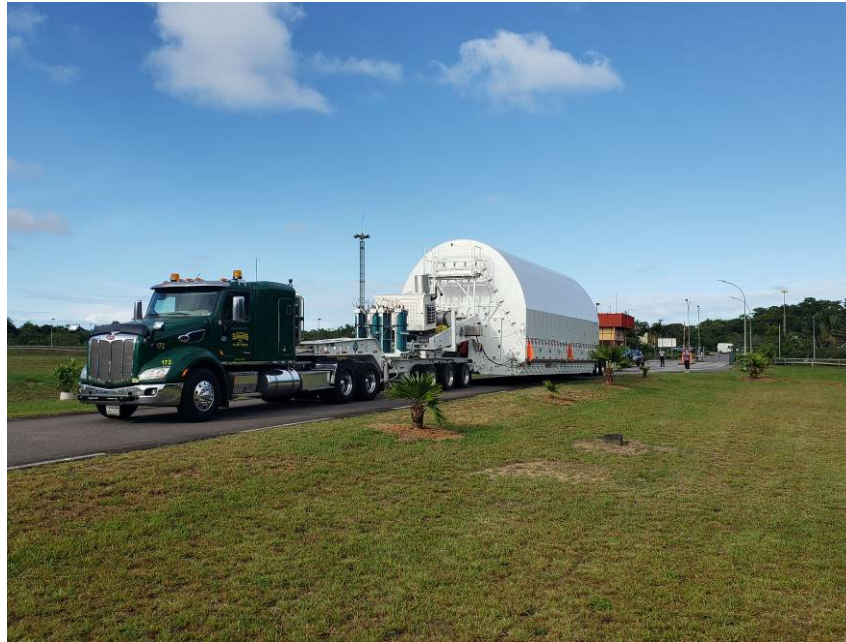
Figure 13. October 12, 2021 Webb arrives at CSG in French Guiana. (Credit: Joseph Ward)

With the safe arrival of OSTTARS at the launch site in French Guiana, the precious cargo was unloaded and continued its amazing journey, while the job of OSTTARS came to an end (Figure 13). Following the removal of the container cover, the external fallout wafers and NVR foils were collected. Total exposure time of the contamination samples outside the tent frame was 22 days (9/21/2021 to 10/13/2021). Following collection of the external contamination samples, the closeout material was removed to allow the lift of Webb out of the container. With the closeout bagging material removed, the first look at Webb was possible (Figure 14). The secondary mirror was just visible through openings between the tent frames. A couple of days later, once Webb was lifted out of OSTTARS, the samples inside the tent frame were collected. Total exposure time for those samples was 24 days (9/20/2021 to 10/14/2021).

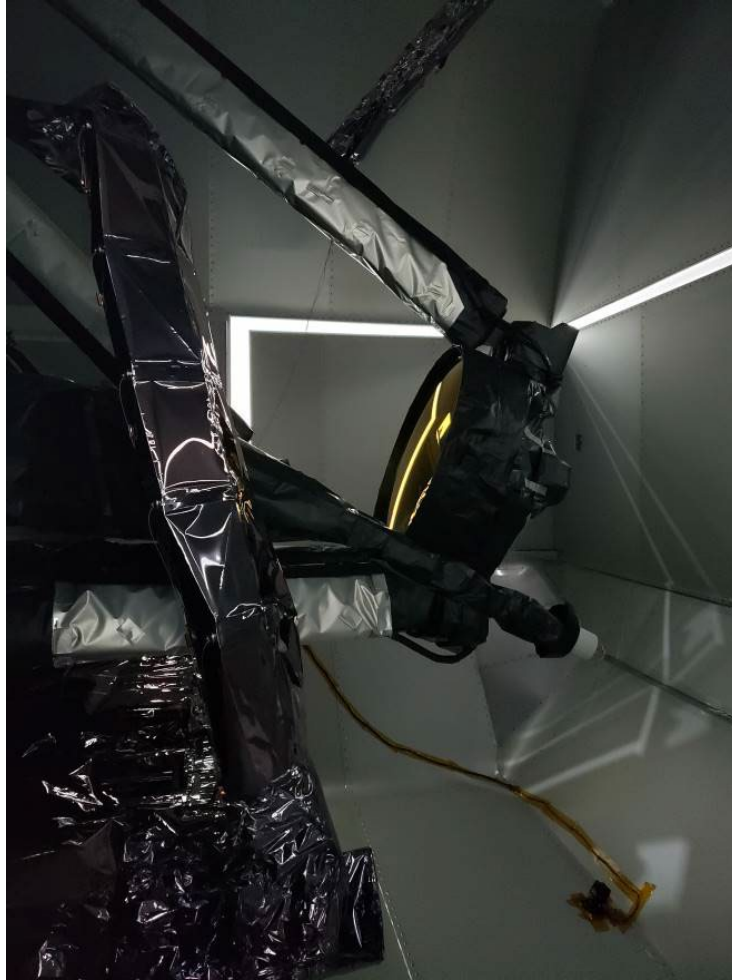
Figure 14. The secondary mirror was the first view of Webb inside OSTTARS at the launch site. *(Credit: Joseph Ward)*

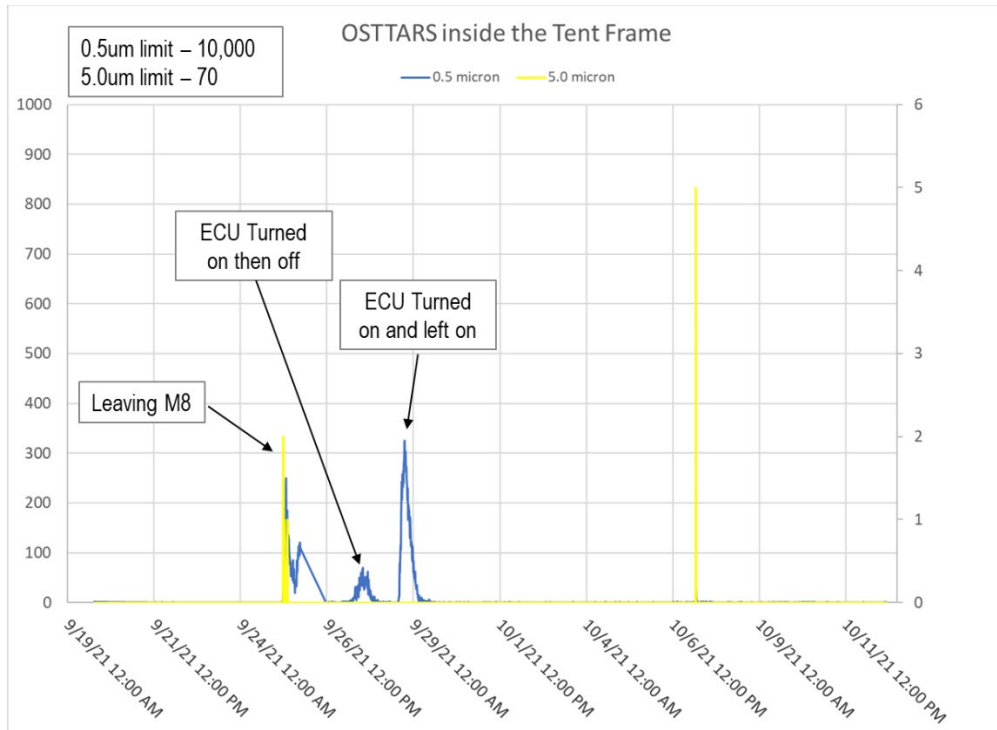
Figure 15. Particle count data inside the tent frame during the JWST transport to CSG. (Credit: NASA/GSFC)

Though the wafers were able to be analyzed at the launch site, the NVR samples were sent back to Goddard Space Flight Center for analysis. The total PAC inside the tent frame during the transportation of Webb to the launch site was 0.003 and the NVR was 0.02 mg/sqft, both exceeding their requirements and allocation. The particle count data inside the tent frame easily met the ISO Class 7 requirement (Figure 15). It is unknown what caused the unidentified 0.5 micron spike around 10/6/2021. Even so, the counts were well below requirement. When OSTTARS left California it was headed to an environment that it had never experienced before, with high temperatures and oppressive humidity. The CC team was confident with the closeouts and the plan for the ECU and purge. The temperature and relative humidity was monitored during the entire journey. In the end, the relative humidity inside the tent frame (Figure 16) maintained an average of just under 20% and the temperature inside the tent frame (Figure 17) averaged just over 70° F for the journey.

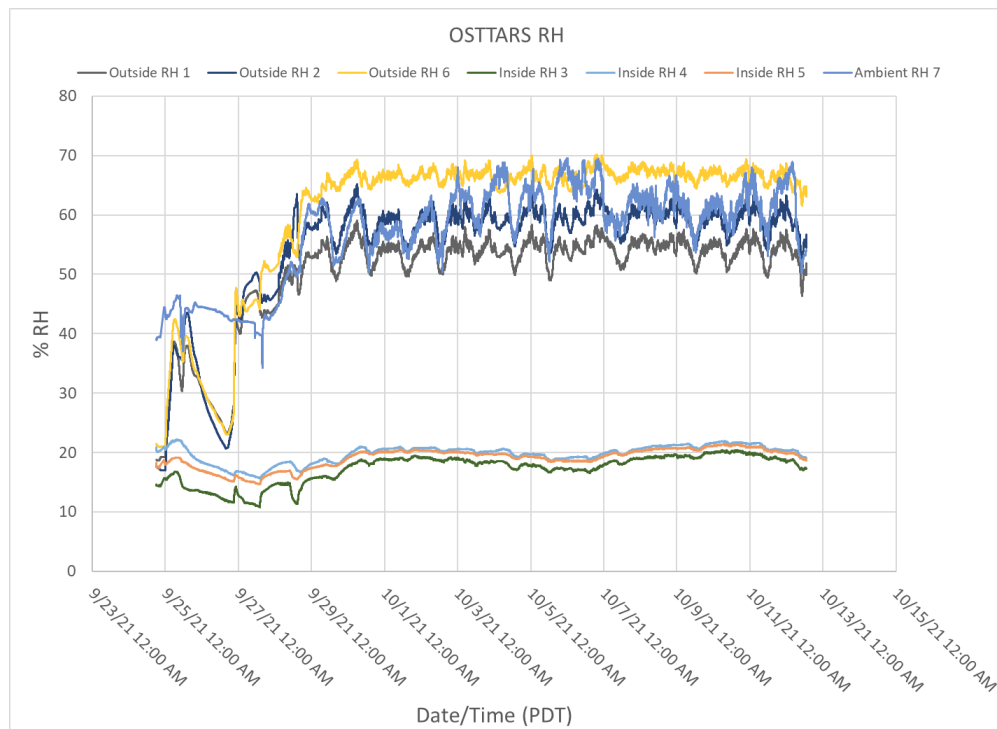
Figure 16. OSTTARS relative humidity data for the JWST transport to CSG. TF in the legend refers to the tent frame. (Credit: NASA/GSFC)

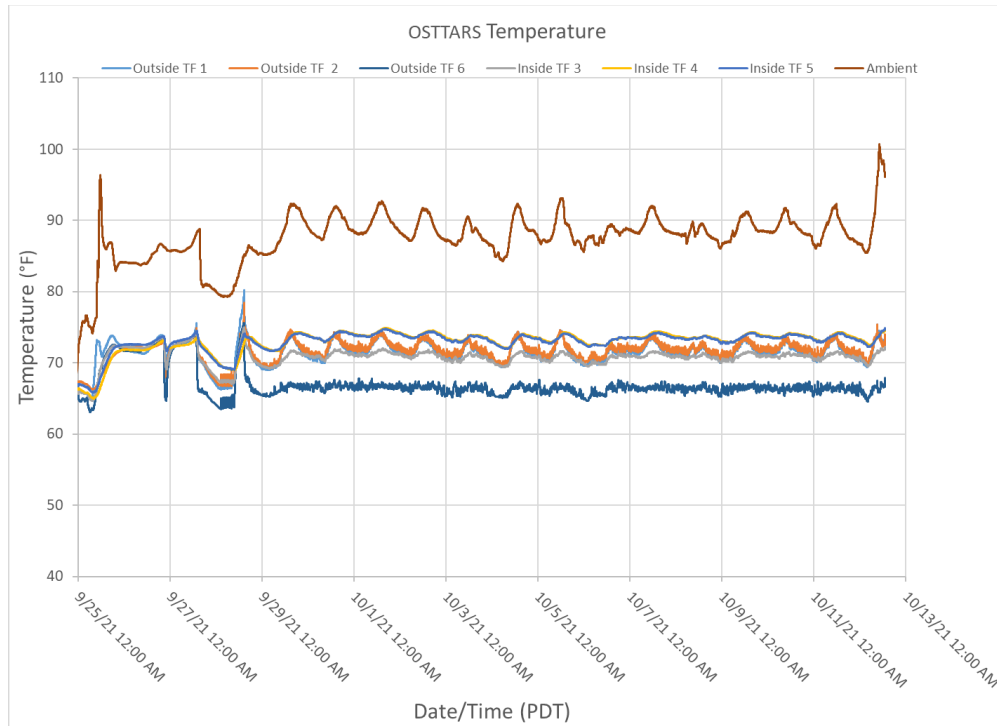
Figure 17. OSTTARS temperature data for the JWST transport to CSG. TF in the legend refers to the tent frame. (Credit: NASA/GSFC)
