Operating and maintaining the JWST Cleanroom attached to JSC's Chamber A during preparations for the OTIS Cryogenic Thermal Vacuum Test

**SPIE Optics+Photonics Meeting
23 August 2022**

Introduction

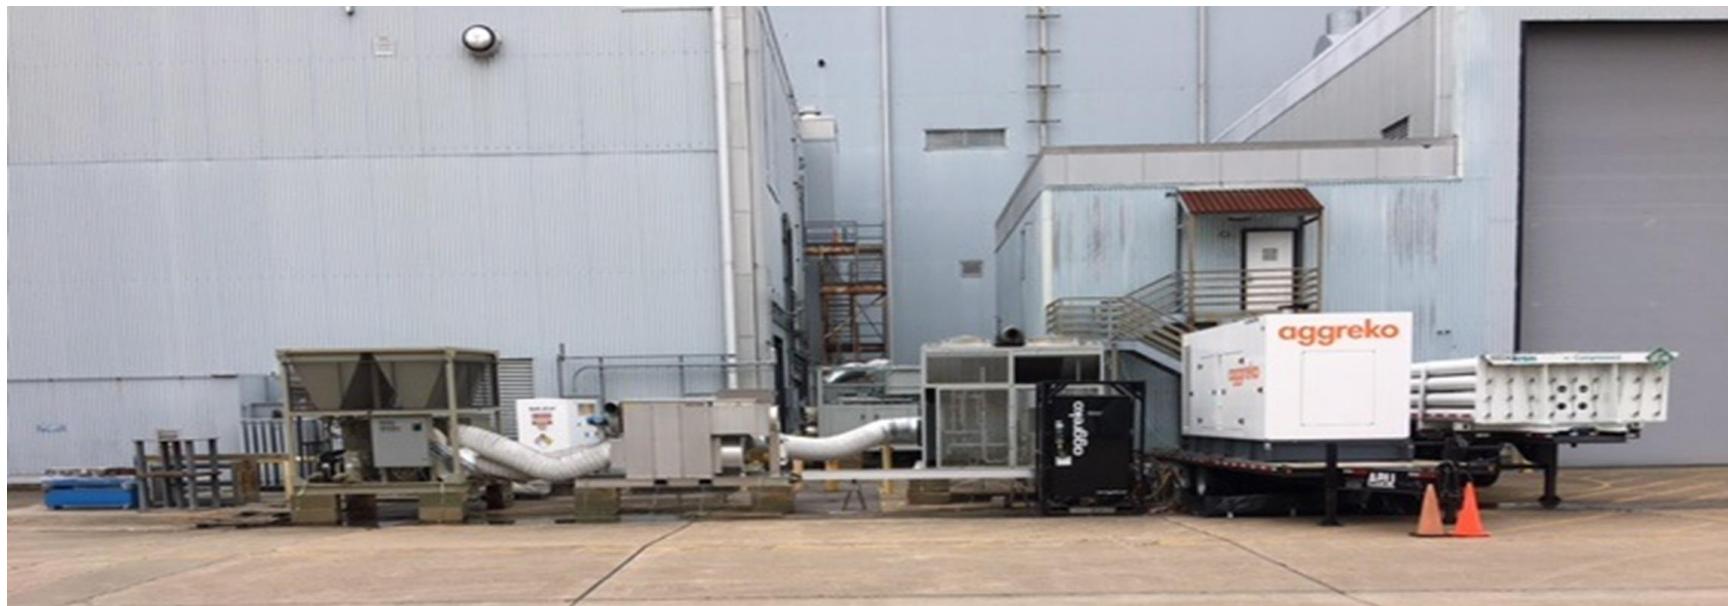
- Instability in the critical utility delivery to cleanroom air handlers due to severe weather prompted the development of a stand-alone redundant system that could provide conditioned air in the event of equipment failure, utility disruption, or other system failure.
 - The back up system was located just outside the building housing Chamber A and was connected directly to the cleanroom MAU intake when needed.

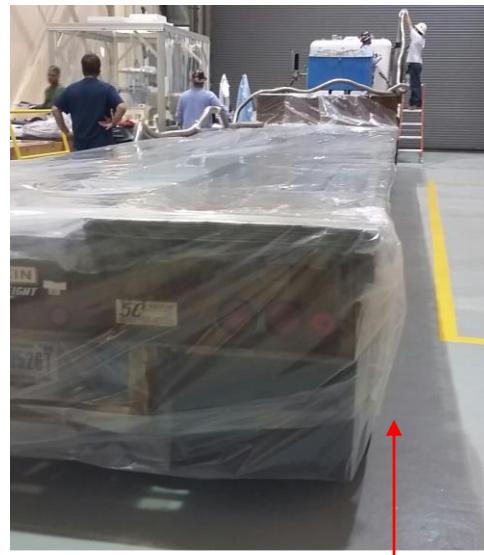
The 40 ft Pentalift! Too large to be cleaned inside building and not designed for cleanroom use!

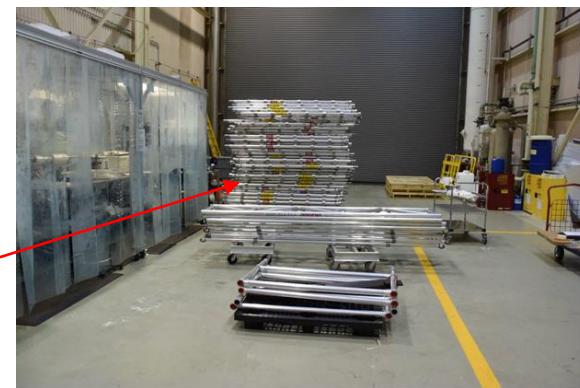
Tons of scaffolding – each pole cleaned inside and outside
