# Habitability Insights from Selected NASA Habitat Mockup Testing Campaigns

**In 2004, President Bush announced his Vision for Space Exploration, causing NASA to look beyond Low Earth Orbit. While the resulting Constellation Program was cancelled, a focus on expanding beyond LEO has continued to this day. Since 2005, multiple habitat concepts have been developed for the Moon, Mars, or deep space. Some of these concepts were mocked up in virtual or physical form and used in habitability testing campaigns. This paper provides an understanding of the value of two decades of habitability testing and highlights key insights obtainable only through human interaction with a vehicle concept design. The focus of this paper will be limited to primarily habitation work conducted primarily at or by the Johnson Space Center in support of active space habitat development programs or studies and is further limited to fixed habitats and will not discuss mobile habitats such as pressurized rovers.**

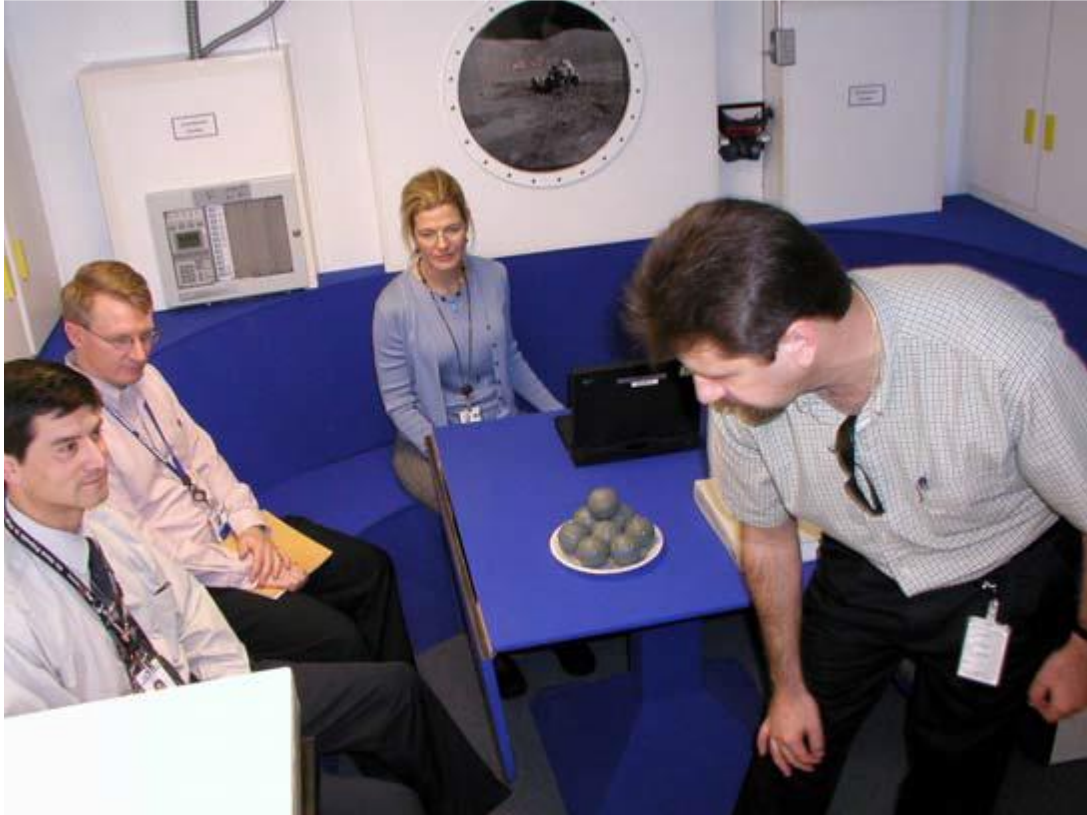
disciplines. An evaluation of the wardroom area is shown in Figure 1. A challenge with walkthrough evaluations, particularly with low-fidelity mockups, is it can be difficult to know what is in or out of scope for the evaluation. For instance, does the absence of environmental control and life support system (ECLSS) ducting mean that it was too low fidelity to include and should not be evaluated, or that the mockup designers forgot to account for air flow, indicating likely volume/layout deficiencies?

**Fig. 1 Evaluation of the Wardroom Area in the Horizontal Axis Lunar Habitat Mockup**

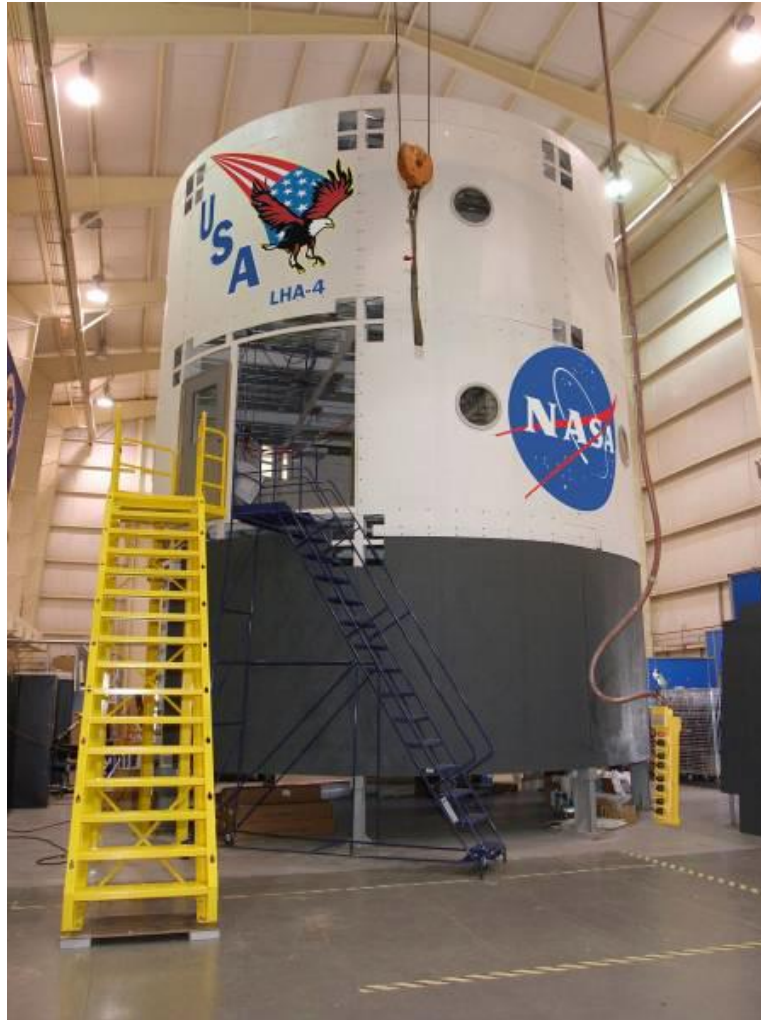
A vertical mockup followed immediately after the horizontal habitat evaluation, based on using the large diameter of the Ares V rocket to accommodate a 7.5-meter-diameter habitat with two decks. Shown in Figure 2, the structure appears to be three decks, but the lowermost section notionally represents a descent engine and propellant tanks with only the upper two levels intended as habitable volumes. Work began in 2005 and continued until 2006. Incorporating lessons learned from the horizontal habitat, separate volumes were allocated to biological science, physical science, EVA repair, and maintenance. Unfortunately, the project was defunded as the Constellation Program became further organized, with funding being terminated as soon as the empty shell of the mockup was completed. The mockup shell sat idle until 2008.

**Fig. 2 Vertical Axis Lunar Habitat Mockup**

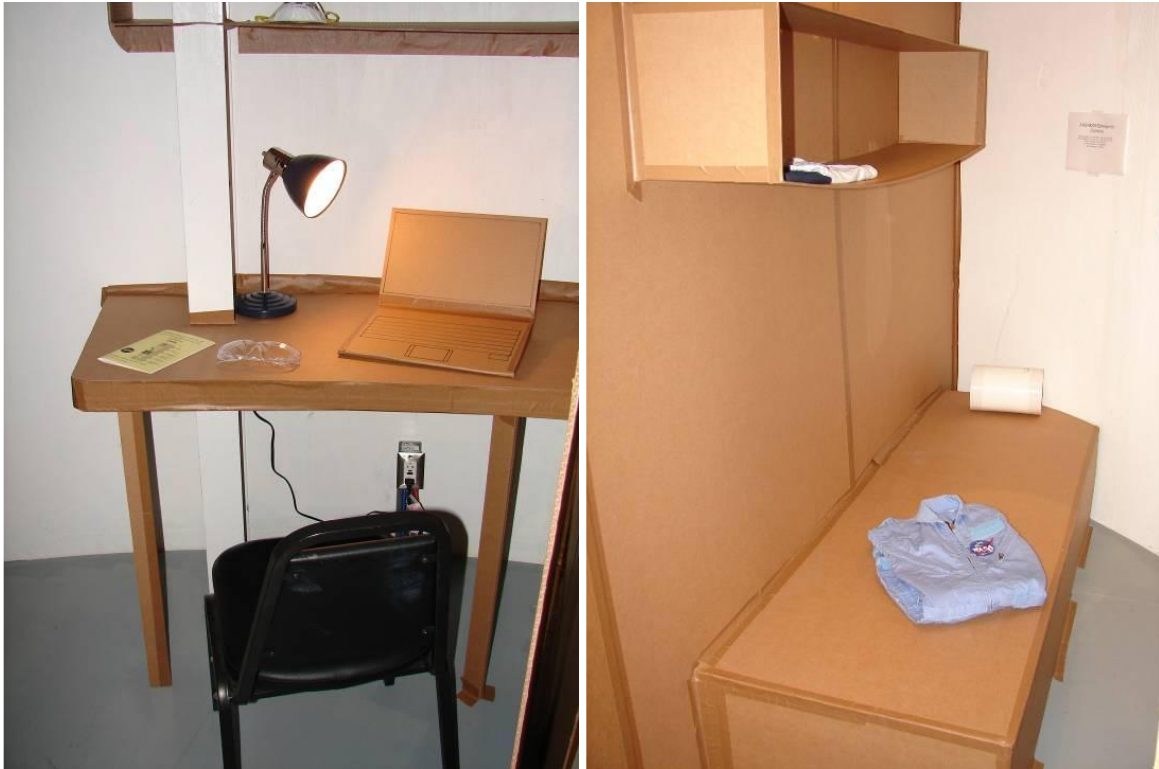
Functional areas of the mockup were built using cardboard and approximated workstation functional volumes as per architectural designs. These areas provided enough strength to support actual or mockup equipment such as tools and laptops. The habitat (HAB) deck contained crew quarters, a waste containment system (WCS), exercise area, and medical bay. The crew quarters can be seen in Figure 3 and the medical bay in Figure 4. The laboratory (LAB) deck contained the galley, a WCS, biological and physical science station, general maintenance and EVA suit maintenance areas, several of which are visible in Figure 5.

**Fig. 3 Cardboard Outfitting in Crew Quarters**

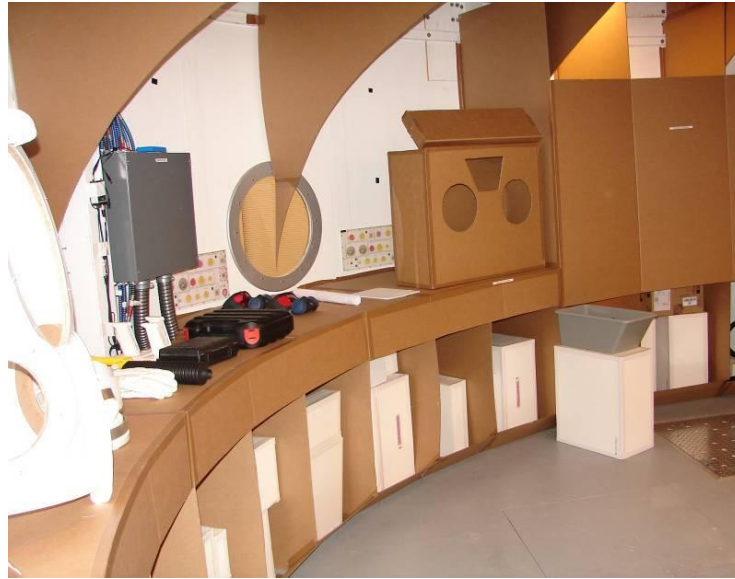
**Fig. 5 VALHM EVA Suit Repair, Maintenance, and Physical Science Stations**

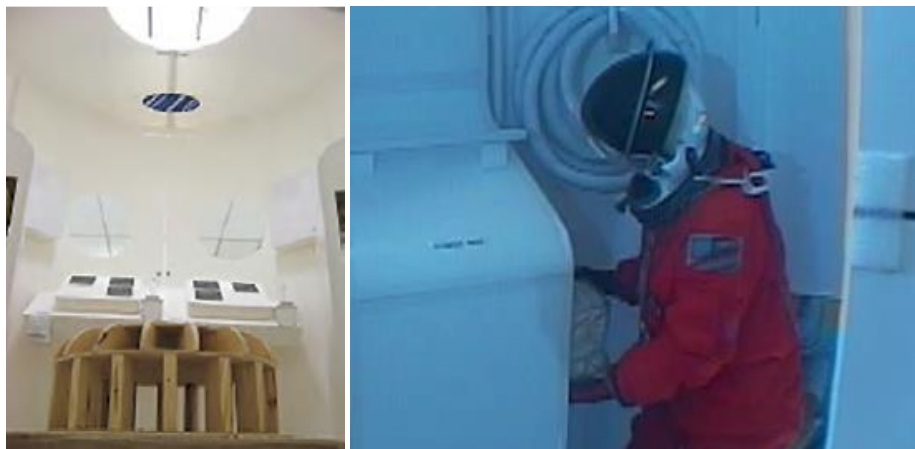
Ascent cabin testing utilized a pressurized Mark III spacesuit and an Advanced Crew Escape Space Suit System (ACES) suit. The smaller ACES suit, shown in Figure 12, experienced no significant issues. The ACES subject was able to easily maneuver from front to back across the engine, conduct umbilical operations, operate flight controls, and translate through the rear hatch.

**Fig. 12 Ascent Cabin Mockup (left), Subject in ACES Suit Accesses Ascent Cabin Rock Box Stowage Area (right)**

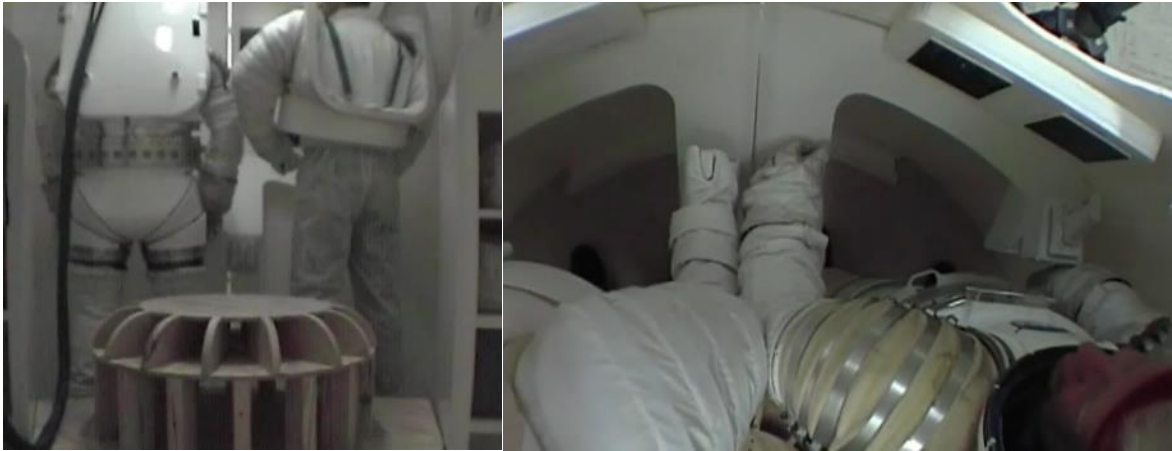
Operations were more difficult for the larger Mark III suit, shown in Figure 13. Collisions between the suit and vehicle structure or equipment was noted when translating from front to back across the engine and when accessing the rock box. The test subject chose to not attempt to translate through the rear hatch. The subject maintained that no issues existed with operation of flight controls even with the addition of a person wearing a mockup Mark III suit. However, this was a low fidelity mockup, and no manipulation of controls were possible. Given the image showing physical contact between the two crew members, it likely would not have been possible to conduct dynamic flight controller operation with the other crew member present, but this level of assessment requires a higher fidelity mockup than was available. Arguably, a motion base platform may also be important to verify minimum volume acceptability.

**Fig. 13 Subject in Mark III Suit Evaluates Operation of Controls Next to Person Wearing Mockup Mark III Suit**

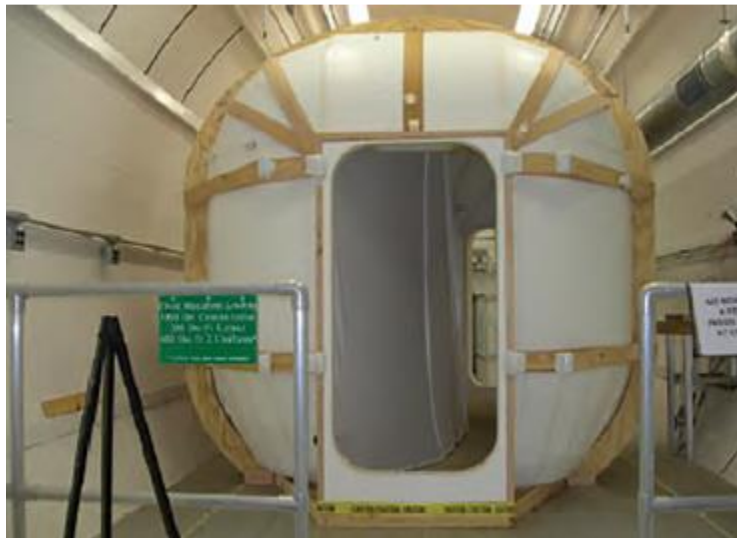
A partial mockup of one of the propellant tanks had been constructed, shown in Figure 14, in a fast turnaround time of less than three weeks [3], but was not fully outfitted at the point when the Lunar Lander Preparatory Study ended and thus no HITL evaluation was conducted for the propellant tank, which was to have been outfitted as a crew quarters.

**Fig. 14 HabiTank Crew Quarters Module (right) Mockups**

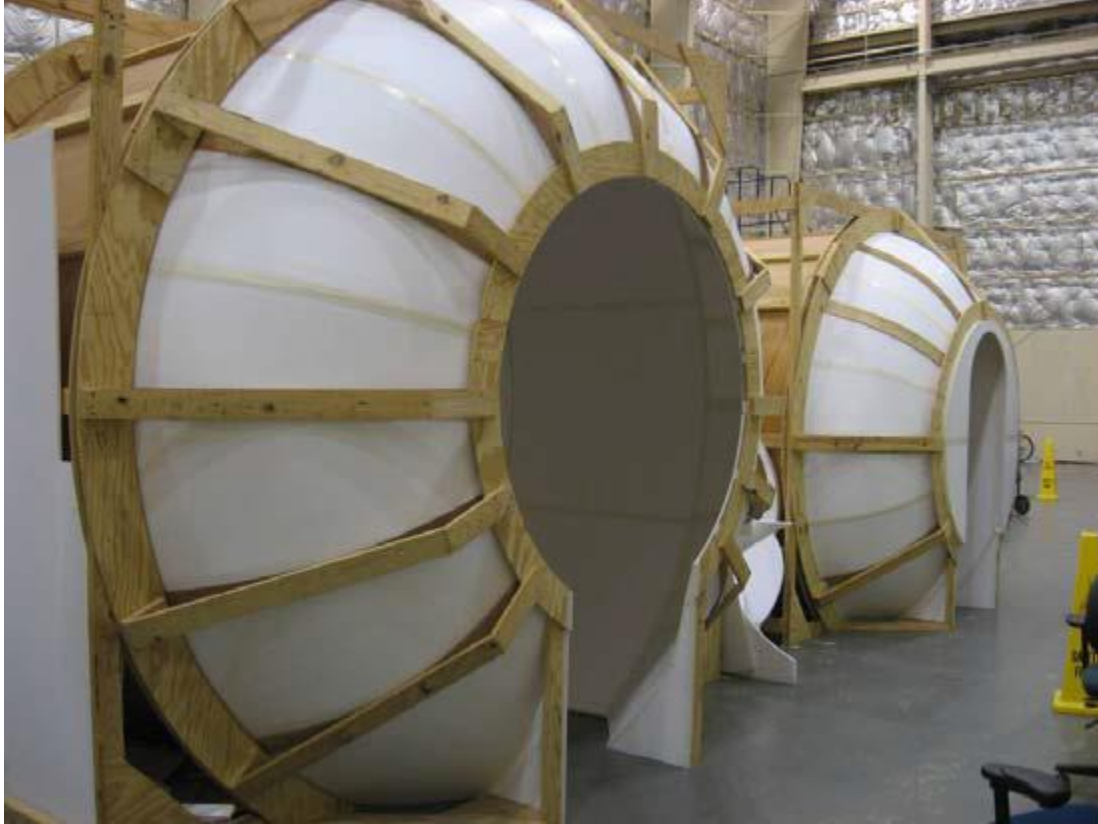
Consequently, a diameter test was conducted using 3-meter and 3.5-meter-diameter low fidelity mockups, pictured in Figure 17. Functional areas of the mockup were built using foam core and represented accurate measurements as per architectural designs

**Fig. 17 3.0-meter and 3.5-meter Habitat Mockups**

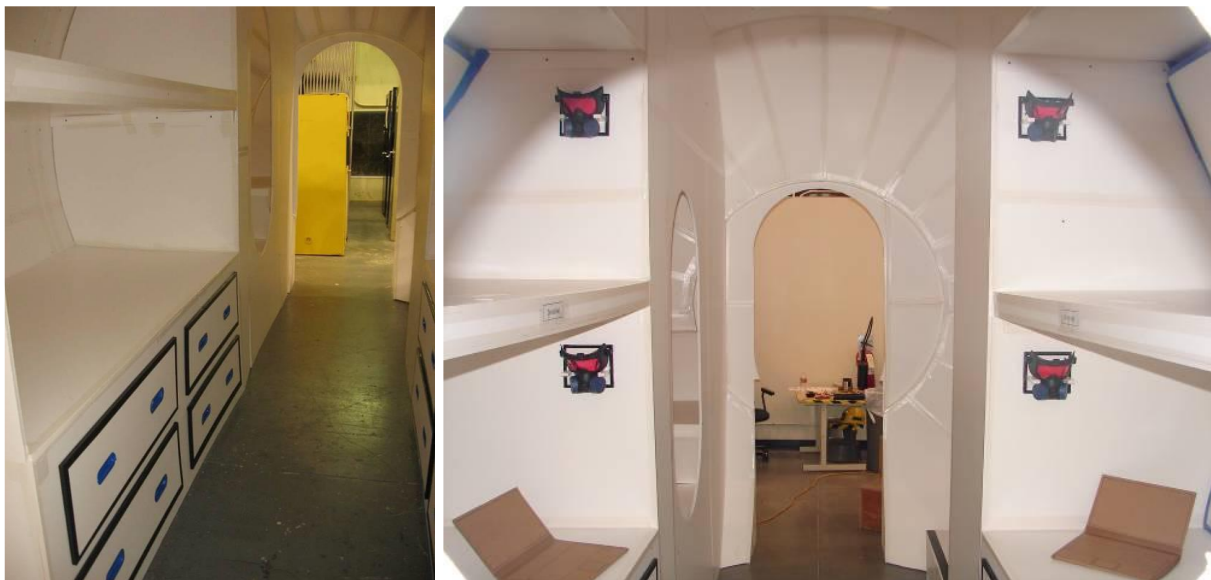
**Fig. 18 Crew Bunks**

However, only a single module of each diameter was constructed and therefore did not represent all of the functionality needed on the lunar surface. Outfitting was limited to four sleep bunks, clothing storage, a system monitoring station, and waste containment system (WCS), representing a crew quarters module, as shown in Figure 18 and Figure 19. This outfitting provided enough strength to support equipment such as mockup tools and laptops.

Additional results of this evaluation included a redesign of the bunk layout in both modules would allow for more comfort, privacy, workspace, and stowage; and a reconfiguration to eliminate the all-in-one bathroom area. Future assessments of the displays and controls in the operations area is recommended with increased fidelity.

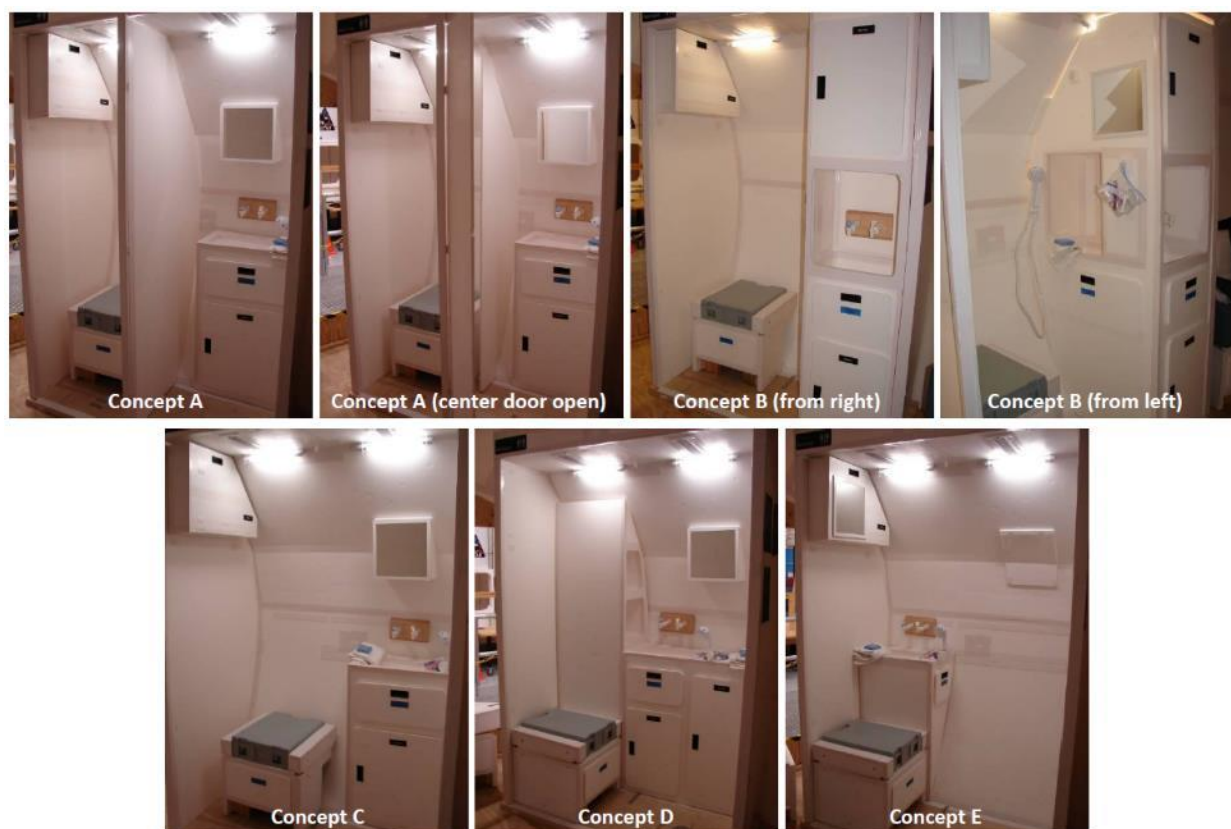
Each of the five designs was created so that various aspects of the wet bath were more prominent than others. For example, concept E was low on internal stowage, but high on internal usable volume, while concept D was high on internal stowage, but low on internal usable volume. Doing so, allowed the participants to rate the stowage and usable volume based on comparison. In addition, some of the concepts allowed for limited maintenance access based on their interior design. Thus, ratings for maintenance access were collected. One feature that was not incorporated was the external doors. Participants were told where the doors would be located and asked not to extend outside the interior wet-bath volume. The decision not to include external doors was based on the ability to view and communicate with the participants during the evaluation.

**Fig. 25 Wet-Bath Concepts**

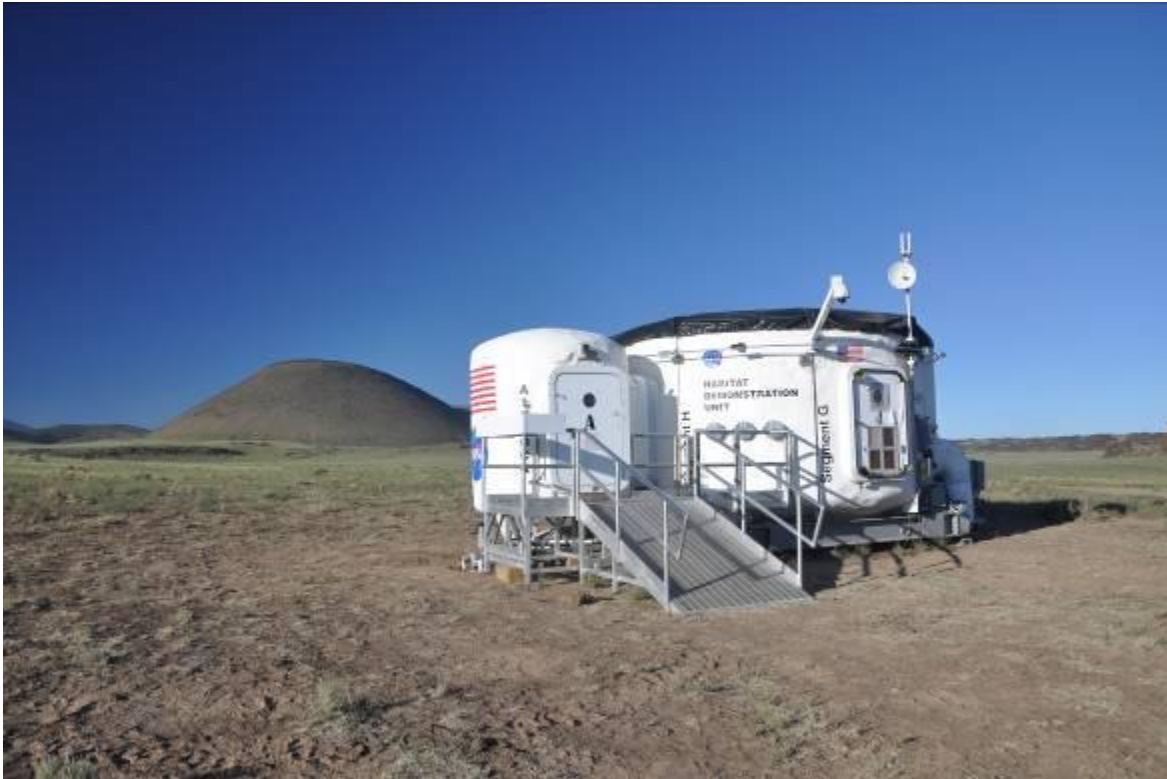
**Fig. 33 HDU at the 2010 Desert RATS**

The HDU was mocked up to represent the PEM at the 2010 DRATS, shown in the Arizona desert in Figure 33. As shown in Figure 34, the PEM includes only laboratory facilities and has no crew habitation facilities. In Lunabago mode, all crew habitation occurs within the rovers and the PEM provides laboratory, medical. The PEM has a diameter of 5 meters and a total height of 3.3 meters, with 2.0 meters constituting the height of the barrel section.

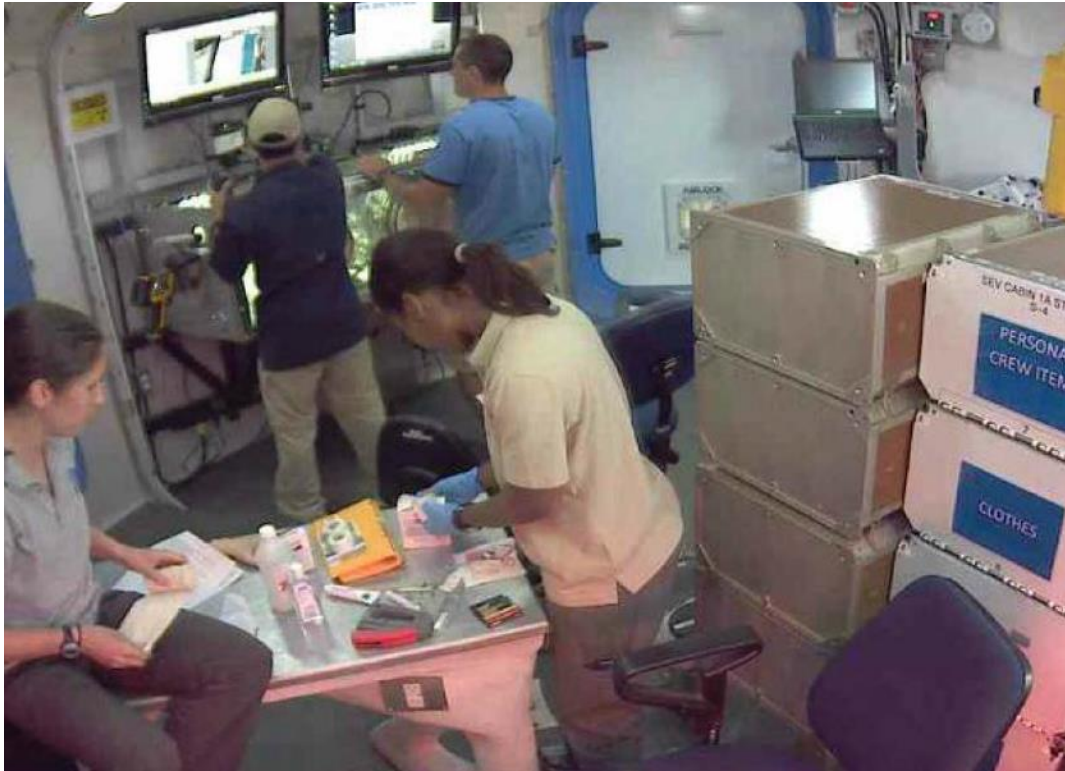
**Fig. 35 DRATS Crew Performing Workstation Tasks Inside the PEM**

NASA Human factors engineers recorded approximately 96 hours of crew task performance with two different operations (vehicle setup and resupply) and four workstations (medical, general maintenance, suit maintenance, and geology lab science) while in the field by using standard human factors measures collecting data on volume acceptability, workload, and 89 functional design elements. Figure 35 shows the crew performing tasks inside the PEM.

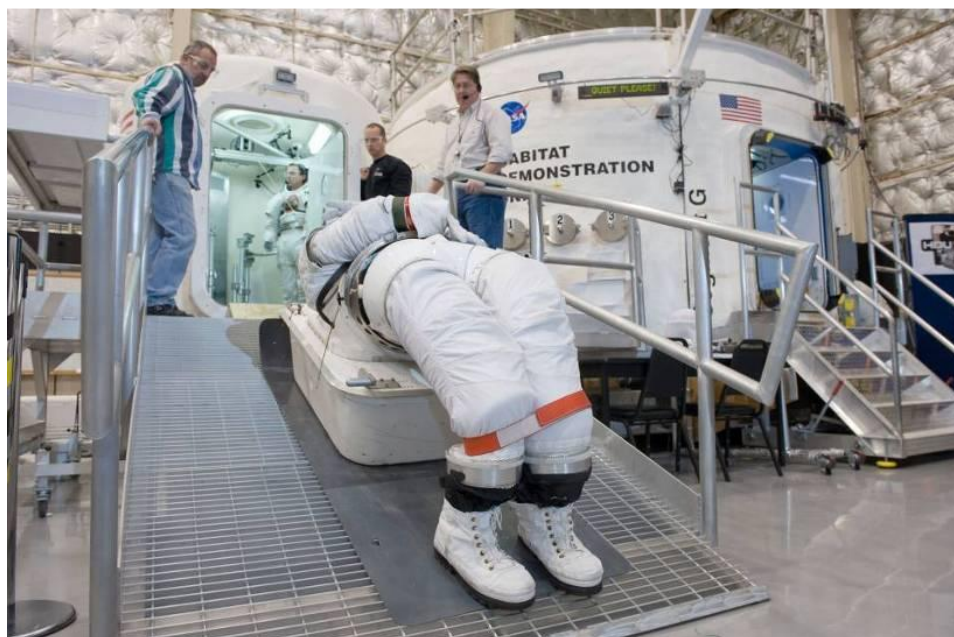
**Fig. 38 HDU Airlock Operations and Incapacitated Crew Member Evaluation**

An airlock operations and incapacitated crew member test was conducted at JSC as the final test under the Constellation Program. Using the HDU airlock within the context of the PEM configuration, investigators conducted an Extravehicular Activity (EVA) suit donning/doffing evaluation and an EVA crew medical emergency simulation to obtain preliminary human-in-the-loop performance data to apply to further enhance the habitat's capabilities for forward designs. Shown in Figure 38, the airlock connected to the HDU is 2.21 m (7.21 ft) in diameter with a cylinder height of 2.06 m (6.75 ft) and the end dome being 0.39 m (1.3 ft) (total height is 2.45 m (8.04 ft)). The approximate volume of the airlock is 8.64 m<sup>3</sup> (305 ft<sup>3</sup>). Placed within the airlock were two non-flight like suit stands constructed of 80/20 aluminum with overhead and side grab bars. Also used for the study was a hoist/cable device with wired remote control with the ability to lift 680.4 kg (1500 lbs.). Mannequins were used to simulate the incapacitated crew member as shown in Figure 39. The objectives for the evaluation were:

1. To evaluate the volumetric acceptability of the HDU airlock for two crew members to don and doff the Global Effects MK-III Mockup planetary EVA suits while using suit stands, seats, side grab bars, and overhead grab bars.
2. To evaluate the volumetric acceptability of the airlock for assisting a suited incapacitated crew member into the airlock from outside the habitat; positioning them into a suit stand; or transferring the incapacitated crew member into the habitat's medical operations station.
3. To evaluate the feasibility of transferring an incapacitated crew member by using a litter into the HDU's airlock without damaging either the airlock hatch seals or the EVA suit.

The testing generated copious amounts of preliminary qualitative and quantitative data on human performance under simulated emergency conditions as well as nominal EVA conditions. Data collected was examined for any developing trends that may need to be addressed and brought forward to improve the HDU habitat. Investigators examined the volumetric acceptability of the airlock for crew donning and doffing of space suits; translation paths and volumetric acceptability during incapacitated crew situations; translation paths of incapacitated crew into the habitat; and volume within the medical operations station to conduct off-nominal procedures for an injured crew member. This was the first comparison of airlock usability under both nominal and contingency conditions, giving the vehicle designer insights into early system acceptability, usability, and functionality.

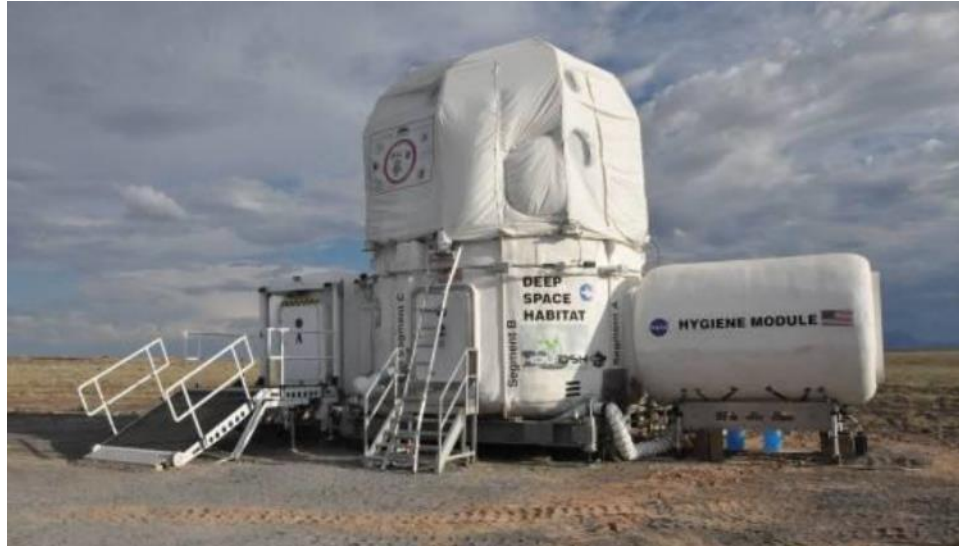
cut short due to hazardous weather. The HDU was modified as shown in Figure 43 to serve as a DSH by the addition of an inflatable section shown in Figure 44 that included a habitation (or HAB) deck with crew bunks, exercise, and galley, and the addition of a hygiene module containing waste and hygiene facilities. The lower deck (what had been the PEM under Constellation) became known as the LAB deck, which saw the former suit maintenance workstation replaced with a tele-robotic workstation. A combination ladder / elevator was added to the center of the habitat to enable translation between the HAB and LAB decks.

**Fig. 43 HDU in the Deep Space Habitat Configuration**

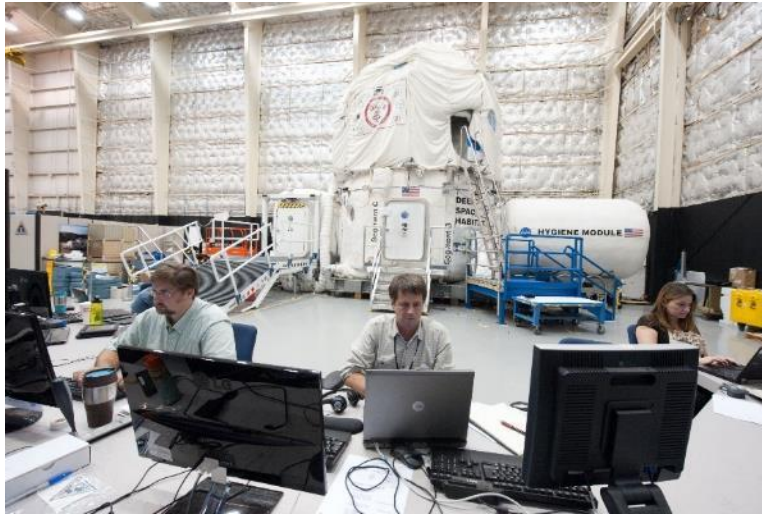
**Fig. 47 2012 Mission Operations Test at NASA Johnson Space Center**

The following year, a final Mission Operations Test was conducted at JSC, with the HDU located in Building 220, shown in Figure 47, once again configured as the Deep Space Habitat. This ten-day test was the most sophisticated habitat test conducted up to that point, though all funding was terminated at the end of the test and the test habitability data was never compiled into a test report. The 2012 test simulated two portions of the timeline associated with a 400-day mission to a Near Earth Asteroid (NEA). The first five days simulated the mission phase where the DSH is in proximity to the NEA. The remainder of the test simulated five days near the end of the Earth inbound cruise, where the crew is preparing the DSH for their departure. The test was conducted only on weekdays, with the crew living in the habitat during the week but leaving the mockup to go home for the weekend after the first five-day sequence.

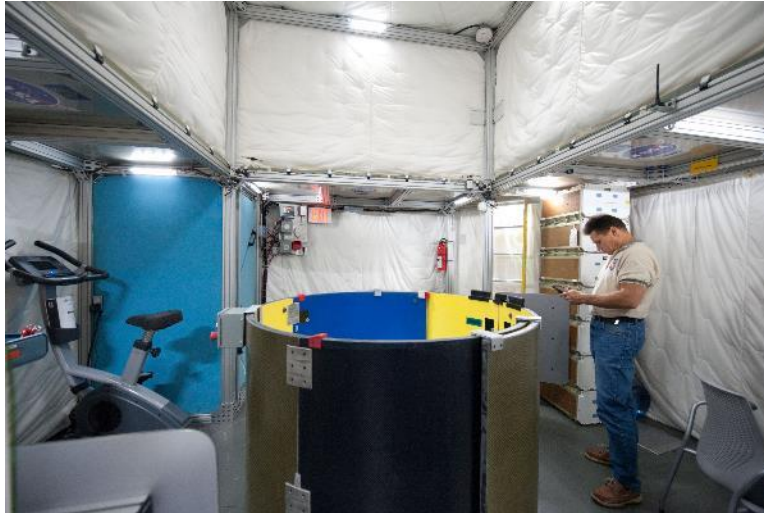
The Hab Deck was completely rebuilt following the 2011 Desert RATS test, resulting in significant changes to the interior layout as can be seen in Figure 48, Figure 49, and Figure 50. The Hab Deck was more clearly divided into two levels, with Level 2 containing the galley, wardroom, aerobic and resistive exercise, and logistics and stowage, most of which are collectively visible in Figure 49 and Figure 50. Level 3 was dedicated to four private crew quarters, three of which are visible in Figure 49.

**Fig. 49 Remodeled Hab Deck Showing Aerobic Exercise Device and Stowage on Level 2 with Walls of Three Level 3 Crew Quarters Visible**

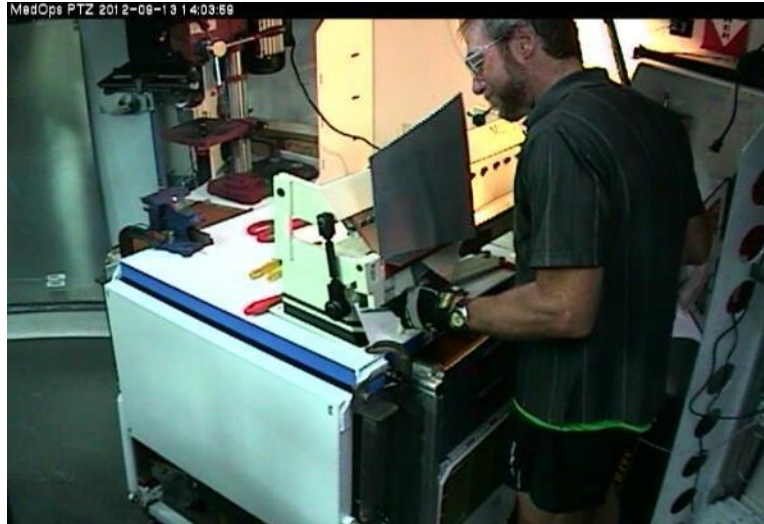
**Fig. 51 Maintenance Activity in the HDU – Deep Space Habitat During the 2012 Mission Operations Test**

Effectively the 10-day mission was divided into two 5-day missions. As previously mentioned, the crew left the mockup at the end of the first five days. During the course of the missions, the crew conducted activities that both simulated the NEA mission and exercised the capabilities of the various workstations and crew stations inside the habitat. Figure 51 shows a crew member conducting one of several hardware fabrication activities in the General Maintenance Workstation and Figure 52 shows a crew member performing resistive exercise.

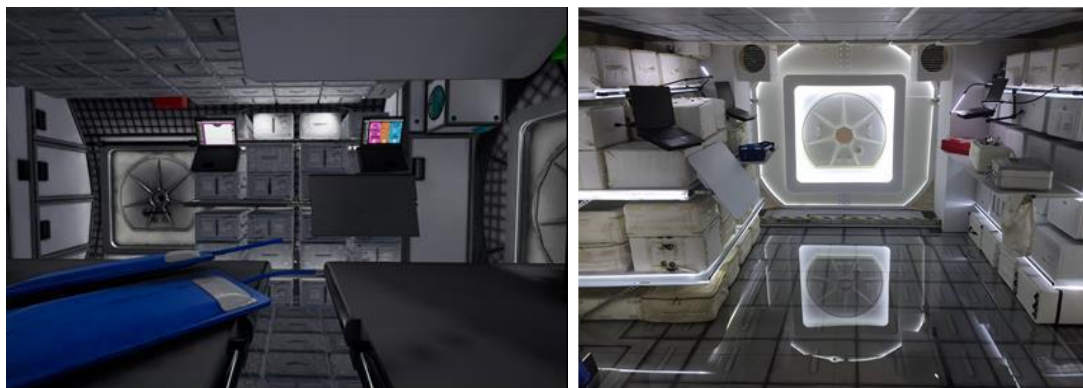
The Gateway tests also piloted the use of Virtual Reality. The NASA test team created a virtual copy of the second-generation NASA reference configuration of the Gateway US Habitat low fidelity mockup, shown in Figure 57 along with a photograph of the physical mockup. The team matched the fidelity of the two environments as closely as possible. Nonfunctional volumetric representations of subsystems and devices were accomplished in both mediums. Eight of fifteen areas of functionality represented in the mockups were tested by performing a walkthrough evaluation.

**Fig. 57 Virtual Reality (left) and Physical (right) Low Fidelity Mockups of the Gateway US Hab NASA Reference Configuration**
