# NASA Astronauts Install the Ninth Wi-Fi® Access Point outside Space Station

November xx, 2022 by Chatwin Lansdowne

**This Access Point (AP) is the first to be installed on the International Space Station's port truss.**

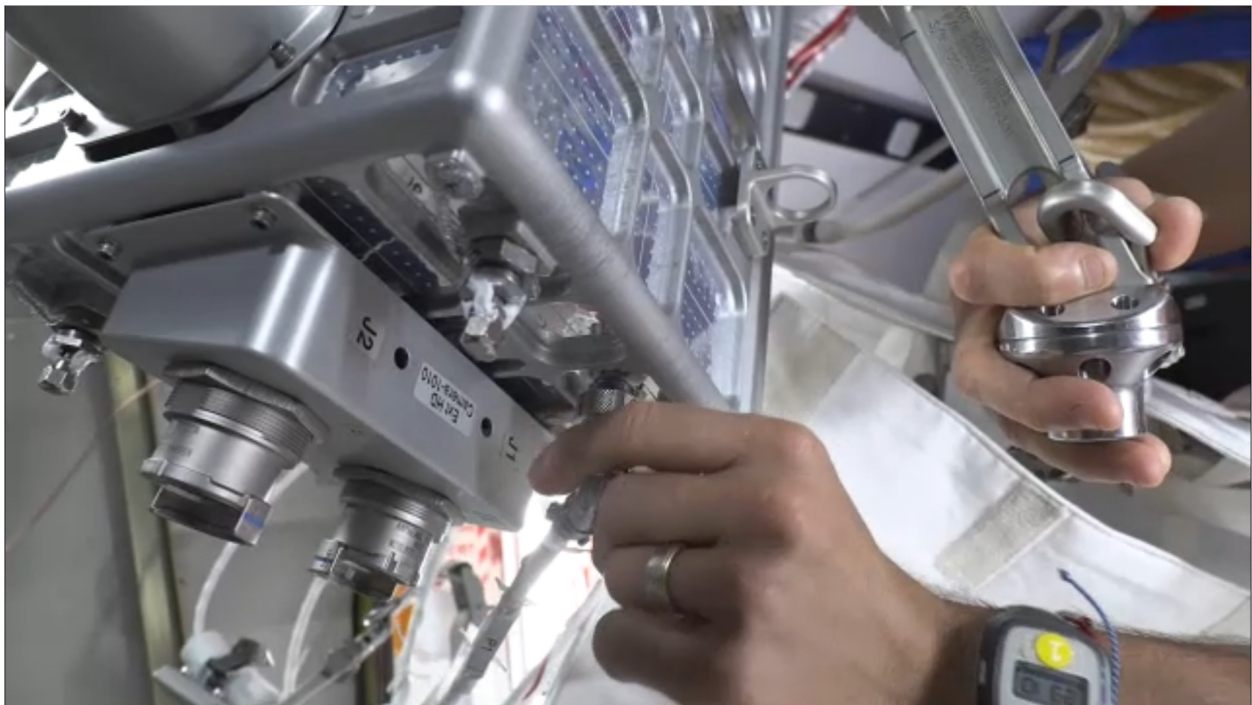
*Figure 2: NASA astronaut Raja Chari double-checks the Ethernet connection to the replacement camera's test port on March 17th. (Source: NASA)*

Because the access point is packaged with a high-definition camera, it replaced the existing external high-definition camera (EHDC) on the external television camera group (ETVCG). Chari and Maurer connected an Ethernet cable that was routed a year earlier on March 13, 2021 by NASA astronauts [Victor Glover](#) and [Michael Hopkins](#), who were already working in the area. Working among the solar panels at the end of the port truss, the Wi-Fi coverage for Hopkins and Glover's helmet cameras were challenged by distance and blockages to the nearest access point. Hopkins and Glover did not connect the Ethernet to the high-definition wireless camera at the Camera Port number 8 (CP8) camera at the time because the Ethernet connector is difficult to manipulate while wearing gloves. Originally the camera assembly was designed to connect wirelessly, and the Ethernet connection on the camera was intended as a service connector for logistics on the ground. Before moving the replacement camera into the airlock, Chari and Maurer fitted a pigtail to the replacement camera to allow them to easily connect the Ethernet during the spacewalk.

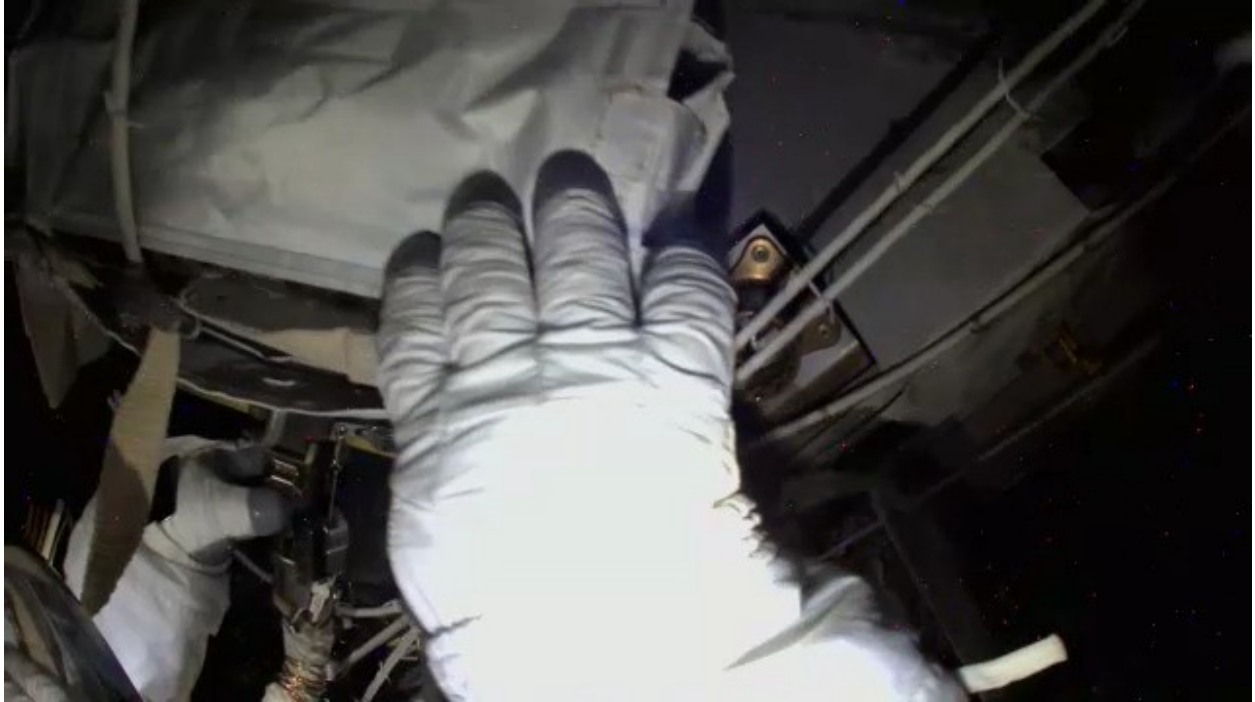
*Figure 3: After routing a pair of Ethernet cables along the port truss out to the Camera Port 8 on the International Space Station, NASA astronaut Michael Hopkins leaves a bag over the end of the cable in March 2021. ( Source: NASA)*

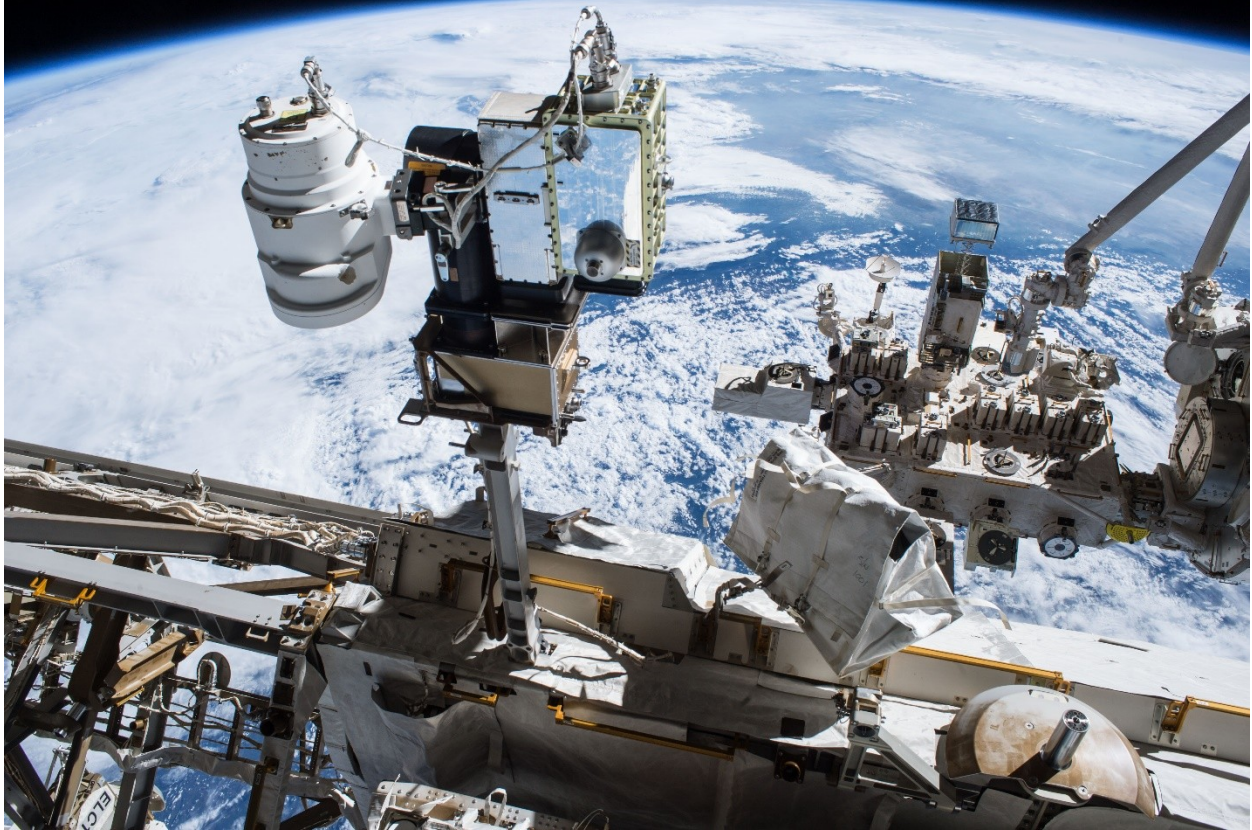
Figure 4: The External Television Camera Group (ETVCG) is comprised (left to right) of a luminaire, a motorized pan-and-tilt positioner, and standard-definition camera. In 2016, space walkers mounted a high-definition digital camera (EHDC) beside the analog camera and re-routed luminaire power to pass through the digital camera assembly. The digital camera connected wirelessly as a Wi-Fi client. Close-out photo of Camera Port 8 EHDC installation taken by astronaut Jeff Williams. (Source: NASA)

The high-definition camera at CP8 was originally installed during a spacewalk in [September of 2016](#) by Commander [Jeff Williams](#) and astronaut [Kate Rubins](#). Digital camera image sensors accumulate “dead pixels” and periodically need to be replaced. At that time before the ethernet cable was installed, the camera connected as a wireless client.
