# High Energy Dynamic Impact Testing of APC AS4D/PEKK-FC and TC1225 LMPAEK T700G Thermoplastic Composite Materials

**High energy dynamic impact tests were conducted on Solvay APC AS4D/PEKK-FC and Toray TC1225 LMPAEK T700G thermoplastic composite laminates. The primary objective was to provide data for evaluation of computational composite impact models. Empirical results indicate an approximately 50% increase in penetration threshold velocity and over 100% increase in penetration energy threshold for the TC1225 LMPAEK T700G composite compared to the APC AS4D/PEKK-FC composite. The velocity required to produce NDE-detectable delamination in the TC1225 LMPAEK T700G composite was roughly twice that for the APC AS4D/PEKK-FC composite. Comparison of the normalized energy absorption showed similar results for the APC AS4D/PEKK-FC system compared to a previously studied IM7/8552 composite material. The TC1225 LMPAEK T700G system absorbed approximately twice that of the other two systems when normalized by areal weight.**

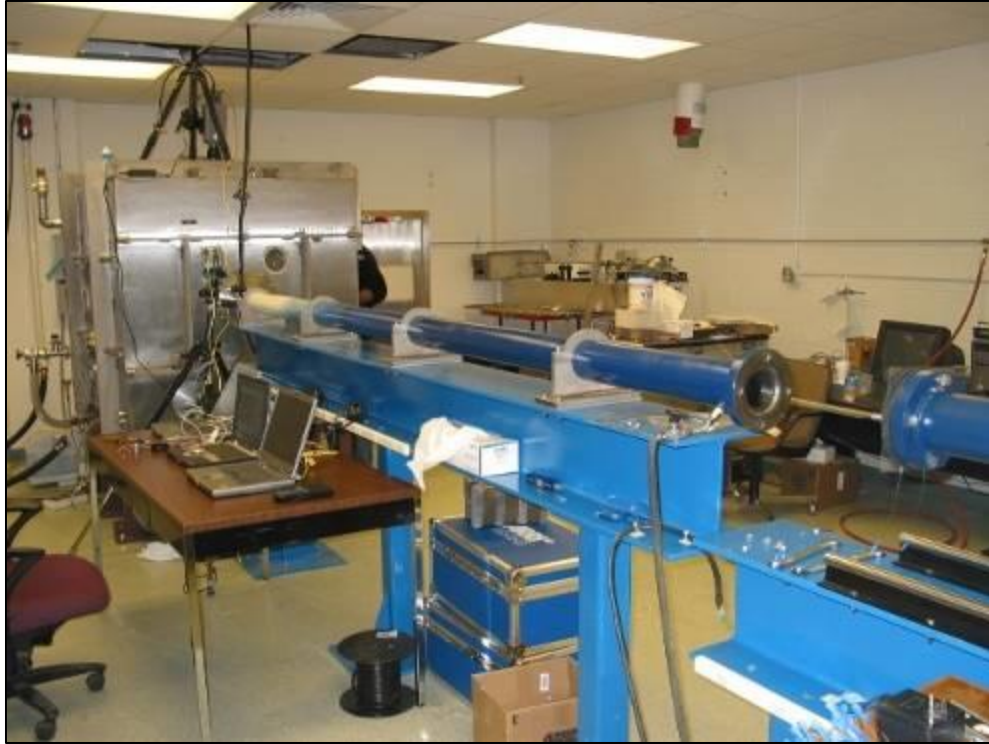
Figure 3. Gas gun connected to the vacuum chamber.

The projectiles were accelerated with a single stage gas gun connected to a vacuum chamber, shown in figure 3, using compressed nitrogen as the propellant. The gun barrel had a length of 7.1-m (23.3-feet) and a bore of 50.8 mm (2.0 inches). The projectile fit freely in the bore of the gun barrel and was accelerated without the use of a sabot. The pressure vessel was made up of sections as shown in figure 4, with a total volume of 31-L (1900-in<sup>3</sup>). The gun barrel protruded into the vacuum chamber which held the fixture for the specimens. For this series of tests, the test chamber was maintained at normal atmospheric pressure.

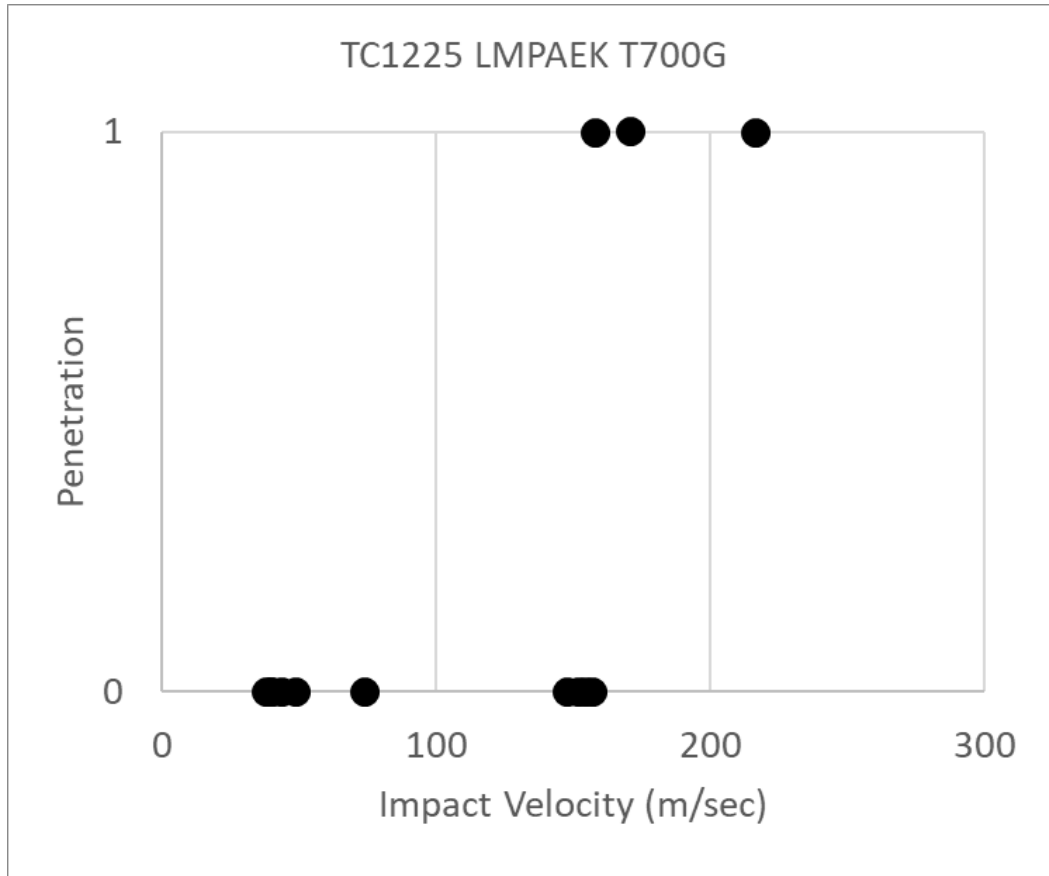
Figure 5. Penetration results for TC1225 LMPAEK T700G Panels.

Figure 5 shows the impact results with the impact velocity on the abscissa and the penetration value on the ordinate, the values 0 and 1 corresponding to no-penetration and penetration respectively.

For this material the onset of ultrasonically detectable delamination occurred between impact velocities of 39.5 and 43.8 m/sec.

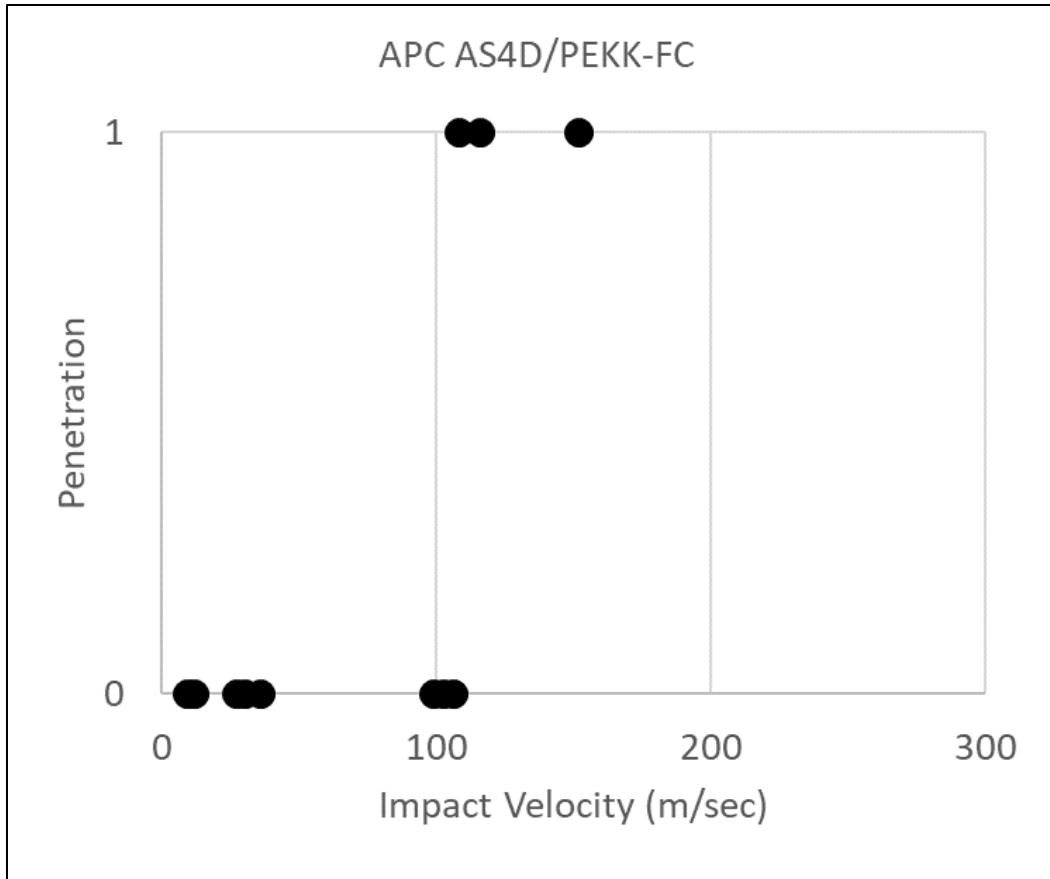
Figure 9. Penetration results for APC AS4D/PEKK-FC Panels.

Figure 9 shows the impact results with the impact kinetic energy on the abscissa, with the same scale as figure 5, and the penetration value on the ordinate. The values 0 and 1 on the ordinate correspond to no-penetration and penetration respectively. For this material the onset of NDE-detectable delamination occurred between impact velocities of 14.5 and 27.1 m/sec.

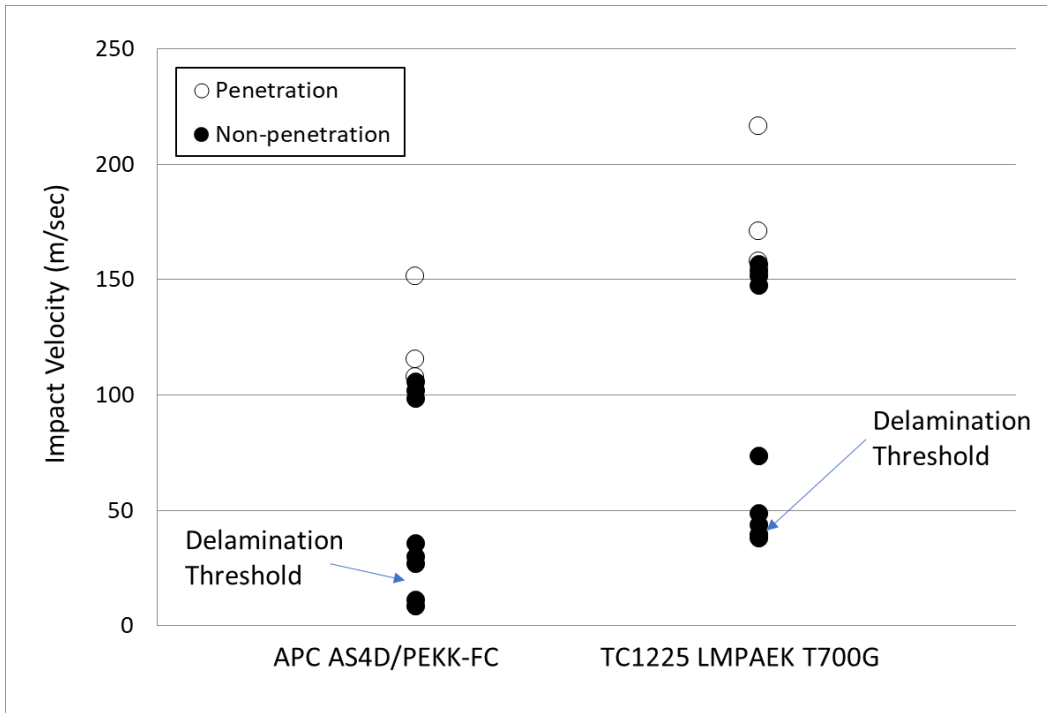
Figure 13. Impact test results for the APC AS4D/PEKK-FC and TC1225 LMPAEK T700G materials showing the relative velocity penetration thresholds and onset of NDE-detectable delamination.

A comparison of the summary impact results for the two materials tested in this study is shown in figure 13. For cases such as this where there is no overlap between the velocities of the tests in which penetration occurred and those where no penetration occurred, the penetration velocity threshold is calculated from the average of the highest non-penetration velocity and the lowest penetration velocity. For the TC1225 LMPAEK T700G material the penetration velocity threshold was 157.6 m/sec, yielding a penetration energy threshold of 1143 J. For the APC AS4D/PEKK-FC material the penetration velocity threshold was 106.8 m/sec, yielding a penetration energy threshold of 524.7 J. The impact velocities resulting in the onset of NDE-detectable delamination for the two materials are shown graphically in figure 14.

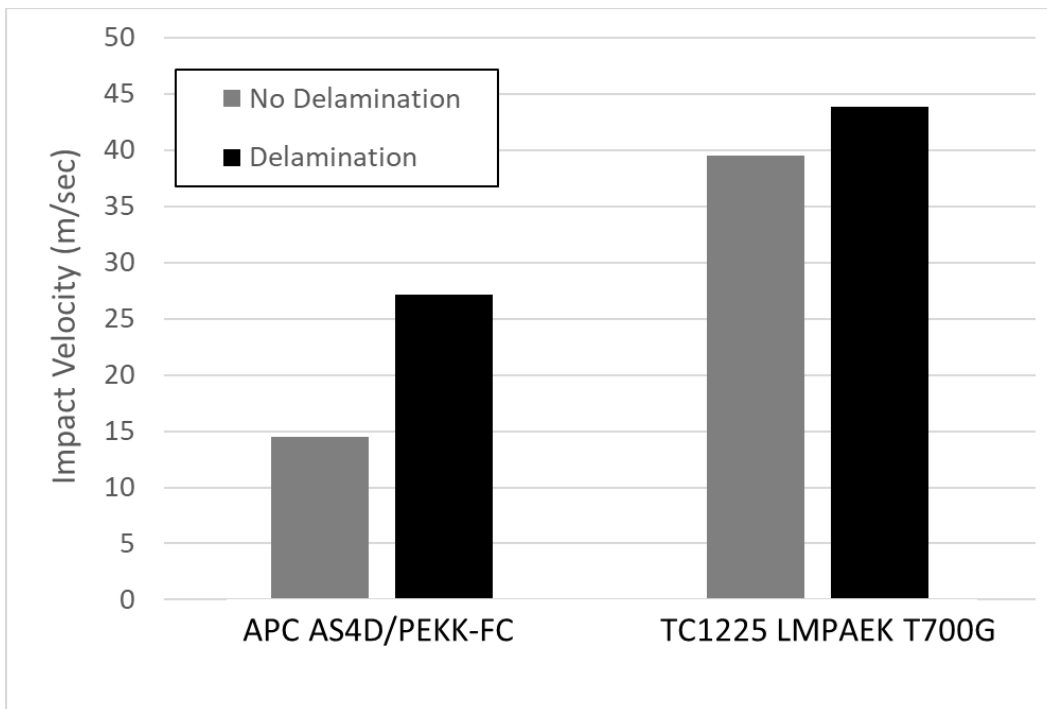
Figure 14. Impact velocities for tests near the onset of NDE-detectable delamination for the APC AS4D/PEKK-FC and TC1225 LMPAEK T700G materials
