# A Summary of Test Results from a NASA Lift + Cruise eVTOL Crash Test

## ABSTRACT

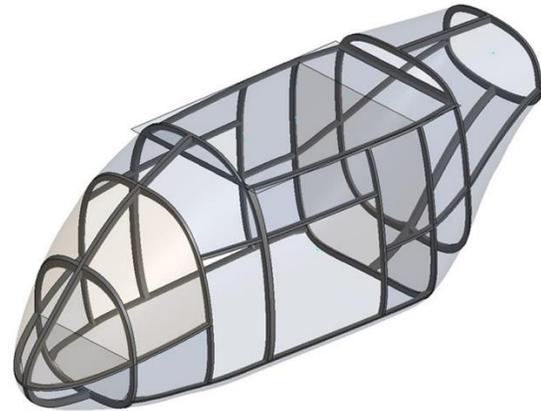
Figure 1 - Structural components of the LPC test article.

The skin and frame components were composed of layers of 3k-70-PW carbon fabric infused with INF-114 room temperature cure Epoxy resin, and vacuum bagged using large molds. The skin was built in four sections and assembled with post-cure bond lines on the top, belly, port, and starboard centerlines of the structure. The skin and frame stiffeners were composed of six and eight layers, respectively, and in a  $[0^{\circ}/45^{\circ}]$  repeating layup. There was no keel beam and no lateral subfloor shear webs. The subfloor energy absorbing concepts were fabricated and integrated during the test buildup to act as load paths within the subfloor structure. An illustration of the LPC test article main structure is shown in Figure 1.

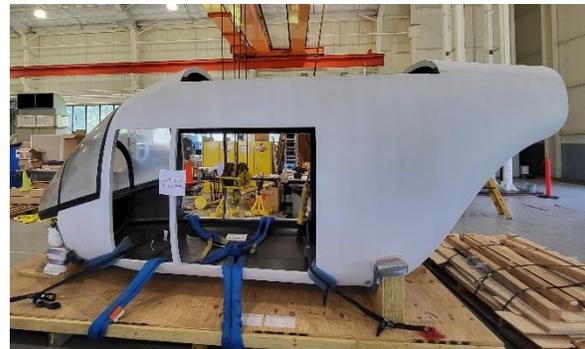
Figure 2 - Empty Lift + Cruise section.

A windscreen was developed from 0.125-inch acrylic sheet and was intended to provide additional structural rigidity. The doors were not added to the structure as they were thought to not add structural rigidity. A picture of the empty as-built LPC cabin section, prior to test build-up, is shown in Figure 2.

The section did not include a nose component, nor any subfloor structure. A nose was originally a variable intended to be designed and fabricated to various geometries to study the effects of scooping and plowing for some expected test cases. The actual nose used for the test was a rounded design that was more blunt than the original LPC geometry.

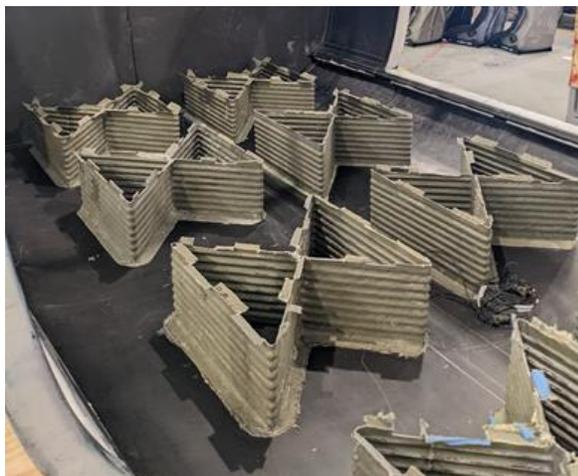
Figure 3 - Energy absorbing subfloor components.

The development of the EA concepts began in 2020 and have continued to evolve through a series of tests documented in [8-9]. The EAs were a modular design, each comprised of a cruciform section with added longitudinal bracing, which made them resemble an enclosed cross. The sections were fabricated out of hybrid carbon/Aramid plain weave fabric oriented at 45 degrees, vacuum bag and cured at room temperature with Epon 828 resin. Four-layer cruciform subfloors were positioned directly under each seat, while five-layer configurations were placed under the data acquisition systems, which were also located on the floor in between the rows of seats. In all, there were nine cruciforms present for the test. Each cruciform was riveted to the belly of the airframe through a bottom flange, while the top was notched, bent, and glued to the floor sections. The six aft cruciforms are shown in Figure 3.

The energy absorbing (EA) subfloor concepts used were of a modular type and intended to represent a crushable structure under each individual seat rather than a beam/frame system which would be utilized for the entire cabin section. The original intent was to develop optimized EAs under each seat/ATD configuration; however, it was later decided that because there was no subfloor keel beam, longitudinal stability must be provided by continuous seat rails and the seat rails would not be sectioned into smaller pieces for each individual energy absorbing component. The drawback of keeping the seat rails as one long continuous beam was possible load path transfer from one seat position to the others. Therefore, EAs were not optimized to individual occupant weights.

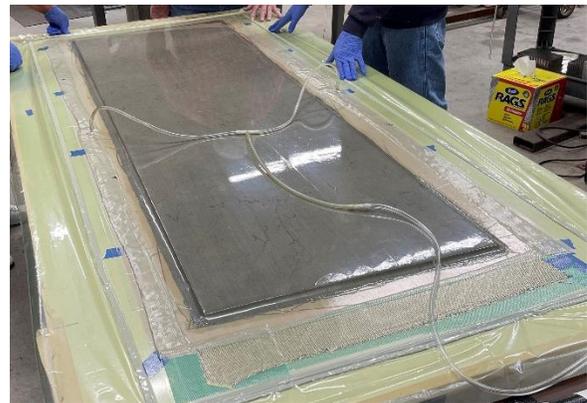
Figure 4 - Composite floor fabrication.

The floors were a sandwich composite composed with four layers of carbon fiber face sheets and a closed cell rigid polyurethane foam core cured using a room temperature cure resin. Tests were conducted to represent the bending stiffness of an aircraft cabin floor and were performed to ensure that floors were representative of a composite floor design. The floors were fabricated in two-foot lengths and meant to sit above a single row of the modular EA subfloors. A composite floor, shown under vacuum bag during fabrication, is shown in Figure 4.

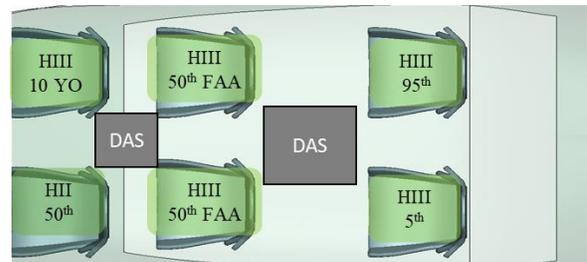
Figure 5 - ATD configuration for test (forward on left).

Six ATDs were utilized on the test seated in a combination of energy absorbing and rigid seats. The test configuration is shown in Figure 5, noting that forward is to the left. The ATD sizes ranged from a small 10-year-old (YO) sized Hybrid III (HIII) to a large 95<sup>th</sup> percentile HIII. There were three 50<sup>th</sup> percentile ATDs, two of which were HIII's utilizing the straight spine configuration, labeled "FAA", while the third was a Hybrid II (HII) build.

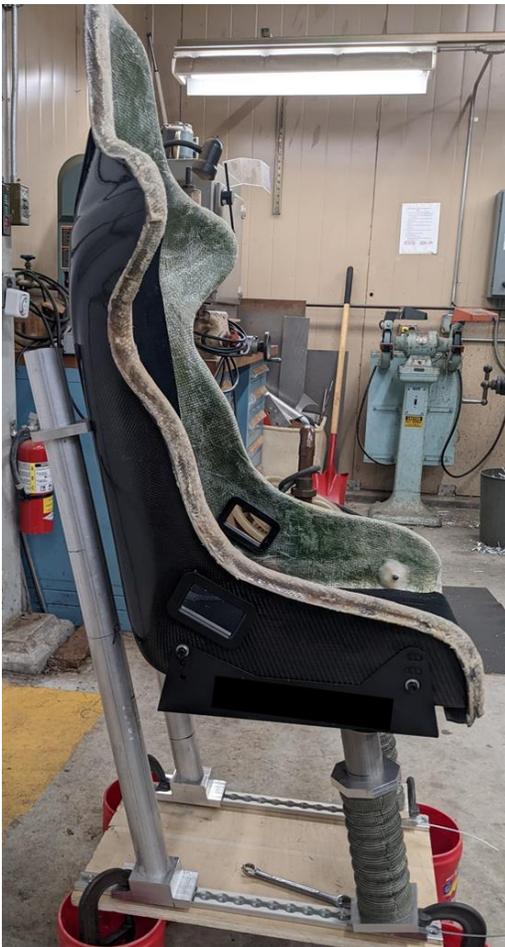
Figure 6 - NASA developed EA seat.

The design for NASA energy absorbing seat was first proposed in [8] and analyzed in [4]. The EA design itself is of a tube with accordion shaped walls designed to fold and crush in a stable and predictable manner.

In order to implement the design into the test, hardware was built to accommodate two of the accordion shaped EAs integrated into the front seat legs. The rear seat legs provided support, but mainly acted as guides for the rear portion for the seat to follow during the crush. Brackets attached to the seat back were allowed to travel along the rear tubes allowing the seat to freely crush on the front EAs. The EAs were oriented at a nominal 10-degree angle to the vertical based on predictions of the expected forward loads. A composite seat bucket was used for the seat itself, and an aircraft certified three-point harness was used as the restraint. The NASA developed energy absorbing seat is shown in Figure 6.

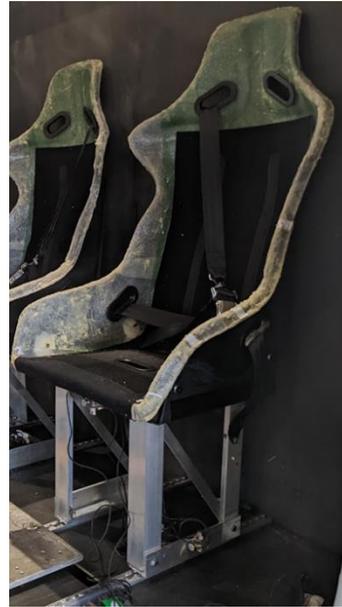
Figure 7 - Composite rigid seat design.

The other rigid seats were also designed and assembled in-house at NASA LaRC. Two of the three other rigid seats utilized carbon fiber seat buckets, while the rigid seat for the HIII 10 YO was an aluminum bucket. All rigid seats utilized rigid aluminum seat legs and attached directly into the seat

track. All rigid seats utilized aircraft certified three-point harnesses. The rigid composite seat design is shown in Figure 7.

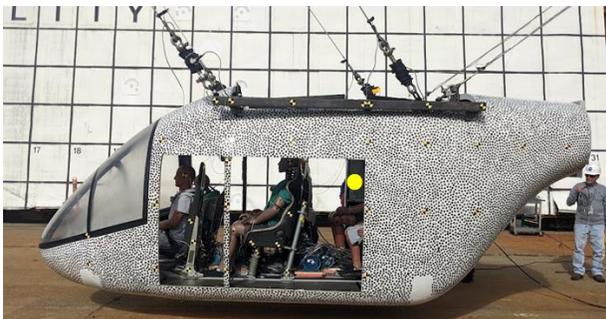
Figure 9 - Pre-test configuration for LPC test article.

The final weight of the test article including all additions was 3,450 lb. The longitudinal center of gravity (CG) was at station 127.5 and vertical CG was approximately 48 inches above the belly. The port side of the test article was painted in a stochastic black and white speckle pattern to generate data on surface deformations through digital image correlation methods, and tracking markers were placed on areas of specific interest in order to generate discrete tracking data. The final, pre-test configuration of the LPC test article is shown in Figure 9 with the CG location represented by the yellow circle located near the aft and top of the opening.

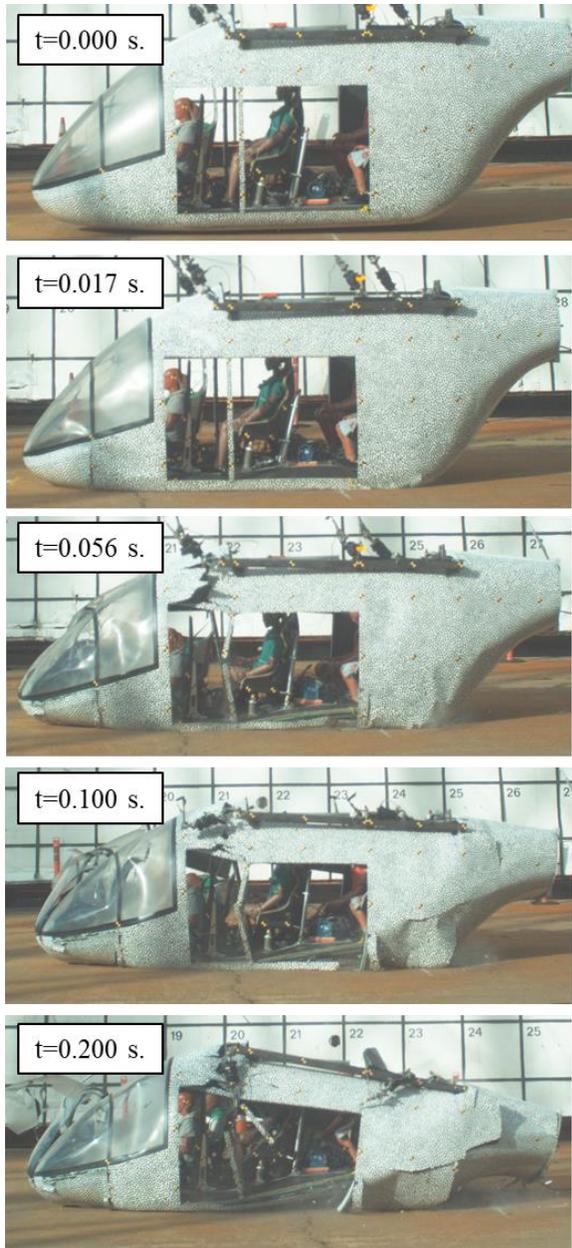
Figure 10 - Test image sequence.

The test was conducted on November 9, 2022. The test article impacted the ground with velocities of 38.1 ft/s horizontal and 31.4 ft/s vertical at a 0.6-degree nose down pitch and an approximate 2-degree yaw. A test image sequence taken from the port side is shown in Figure 10 using visual indicators captured from notable events.

The sequence in Figure 10 shows five notable times during the impact event. The top image depicts the test article just as it has contacted ground at  $t=0$  s. Immediately after impact, the EA components in the subfloors began to stroke. The upper middle image in Figure 10 shows the time in which the NASA EA seat stroke began to occur, which was approximately 17 milliseconds (ms) after initial ground contact. During this time, the overhead mass compressed the test article frame stiffeners, however there were no failures visible. The middle image depicts the test article at

56 ms after impact, which was the time of maximum stroke on the NASA EA seat. There were visible failures located in the forward cabin area. While not depicted in the image sequence, the first visible signs of failure in the vertical frame stiffeners began to occur approximately 36 ms after impact.

The fourth picture in Figure 10 shows the test article at 100 ms after impact where the b- and c-pillars have failed leading to the overhead mass to sink further. However, because the frame section around the nose on the port side had not failed, the mass began to tilt at an upward angle. The further compression of the aft end of the mass continued for the next 100 ms, until approximately 200 ms after the impact. Shortly after 200 ms post-impact, the overhead mass reached its maximum crush depth, and vertical motion of the overhead mass stopped. However, the test article continued to slide out for 2.4 seconds. The test article came to rest in its post-test configuration approximately 2.65 seconds after initial impact. Post-test inspections of the test article started immediately after the test article had come to rest. The port side damage is first shown in Figure 11.

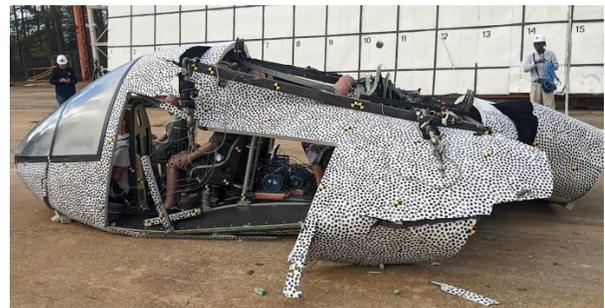
Figure 11 - Post-test damage in the port side.

Post-test inspections of the port side of the test article revealed both the b- and -c pillar failures leading to the overhead collapse. The frame section in the nose was largely undamaged which allowed for the forward portion of the cabin to retain its internal volume.

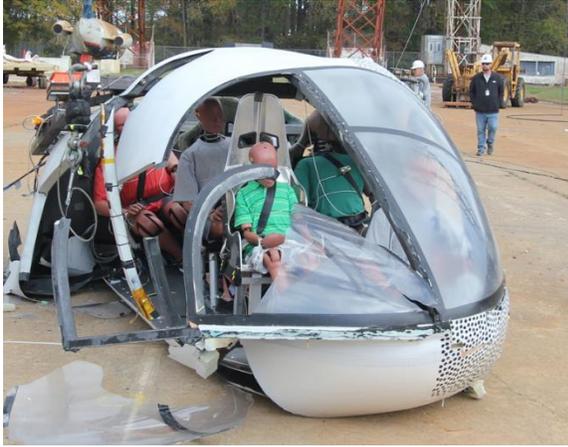
Figure 12 - Post-test damage in the nose section.

As shown in Figure 12, large amounts of damage and failures occurred in the nose portion of the test article. The forwardmost frame section broke away from the center longitudinal stiffener on the starboard side, shattering the starboard windscreen. The additional lower frame section on the starboard side also began to separate from the nose, but was still attached in the center of the nose, restraining it from breaking apart entirely. The starboard side is next shown in Figure 13.

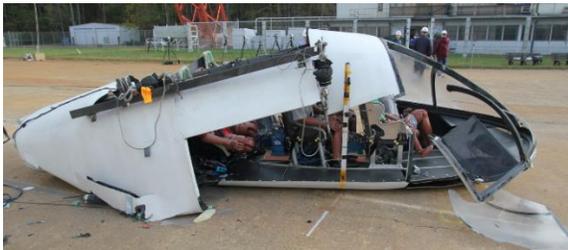
Figure 13 - Post-test damage in the starboard side.

Post-test inspections of the starboard side of the test article revealed both the a-, b- and -c pillar failures leading to the overhead collapse. Since the a-pillar collapsed on the starboard side, the roof vertical motion was higher than that on the port side. Finally, the floor structure was examined. The port side floor for the second and third row of seats is shown next in Figure 14.

Roof collapse began with the vertical stiffeners began to fail approximately 36 ms after impact. Failures of the a-, b- and c-pillars on the starboard side and the b-, and c-pillars on the port side led to large amounts of compression and vertical motion at the aft end of the cabin section. The collapse occurred between the initial failures at 36 ms to approximately 200 ms after impact.

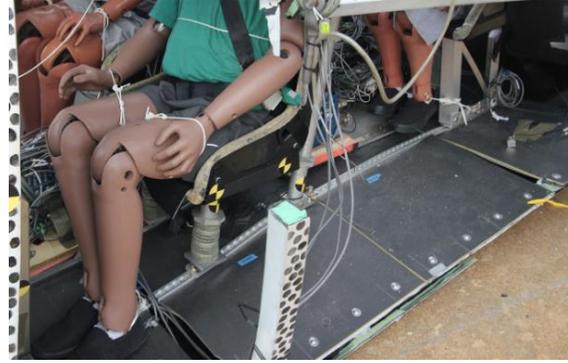
Figure 14 - Port side floor for second and third row.

There was a large amount of warpage on the floor and seat tracks, which was due to the compression of the subfloor EA structures. However, the floors stayed attached to the longitudinal stiffeners on both sides of the test article and the seat tracks remained attached to the floor, indicating the stiffness was sufficient to ensure that the EA structures would be able to produce the intended crush forces and be utilized as intended. Note the failed b-pillar column is visible in the foreground of Figure 14.

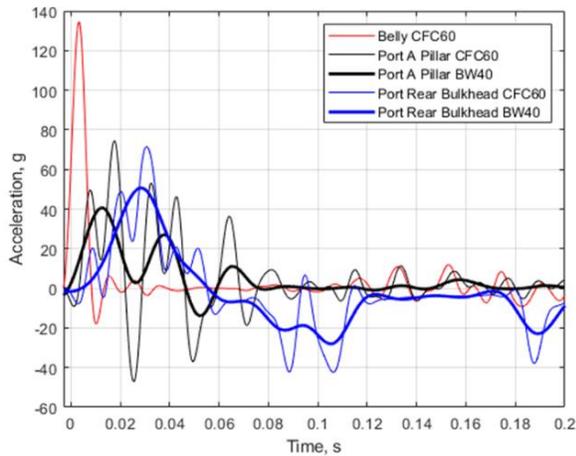
Figure 15 - Port side floor level acceleration.

Accelerations were acquired at various locations around the test article. All accelerations were filtered in accordance with SAE-J211 [13]. Comparisons to additional filter values are also provided in order to study the structural loads within the test article. Starting with the airframe floor/frame junction data, the starboard side experienced periodic data dropout leading to anomalous data at particular times, so the port side data is presented instead. The underlying data filtered in accordance with SAE J211 still showed significant oscillations, so additional low-pass filtering was used to determine the underlying pulse shape at the floor. Acceleration on the airframe on the belly and at the floor level is shown in Figure 15.

Using the SAE J211 filtering criteria, the peak airframe belly accelerations were 135 g, which only occurred for a duration of 8 ms. This short duration pulse represented a shock load on the test article at first contact with the ground and is not representative of the load imparted to the occupant compartment. When examining the floor accelerations, the belly impact was attenuated primarily through the airframe deformation and the overall subfloor crushing. When examining the SAE J211 filtered data for the port side frames, the accelerations indicated peak values of 74.3 g and 71.1 g for the a-pillar and rear bulkhead, respectively. However, there were significant oscillations present, due to the compliance of the test article, so additional filtering of a Butterworth (BW) 4-pole 40 Hz lowpass filter was applied. With the oscillations removed, the peak accelerations reached 40.6 g for the forward a-pillar, and 50.7 g for the rear bulkhead. Both pulses were triangular in shape and lasted for approximately 60 ms for the a-pillar location and 55 ms for the rear bulkhead. These times were generally in line with the time needed for EA crushing, appearing slightly longer since the measurements were not directly over the EA components.

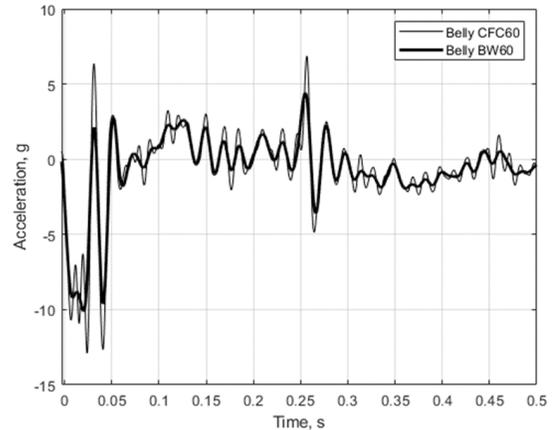
Figure 16 - Airframe horizontal acceleration.

The horizontal accelerations filtered in accordance with SAE J211 also showed oscillations similar to the vertical direction, so an additional lower BW 60Hz lowpass filter was used. The acceleration response with the highest magnitudes occurred for approximately the first 50 ms after impact. The acceleration pulse resembled a trapezoid in shape with peak values less than 10 g for the 60 Hz filter. Integrating the belly acceleration for the first 50 ms after impact produced a velocity delta of 9.7 ft/s. After this first 50 ms, there was no significant acceleration recorded prior to the test article coming to rest. It took an additional 2.635 seconds after the initial acceleration for the test article to come rest, leading to an average acceleration value of 0.4 g in the late time history of the post-test response. The relatively low friction between the concrete surface and the test article belly allowed for this large slide out distance to occur.

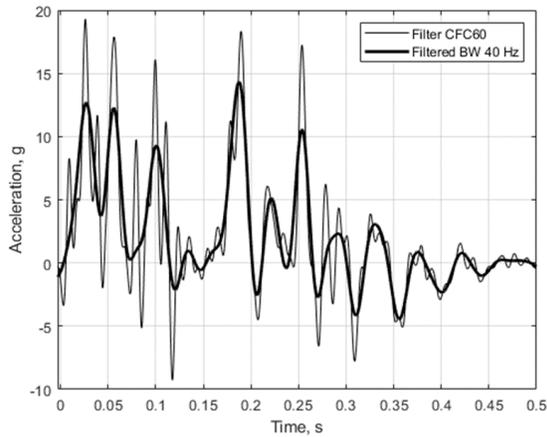
Figure 17 - Aft starboard side overhead mass acceleration.

Both the CFC60 filter and the lower BW40 filters did not change the underlying pulse shape in the overhead mass location, however the lower BW40 did change magnitudes. The overhead mass experienced two main pulses during the test. The first occurred during the first 100 ms and showed sustained positive acceleration values (when examining the BW40 curve) that occurred during the time of support frame section compression and failure. There is a second group of spikes that occurred starting at approximately 166 ms and lasting until 265 ms. This acceleration did not appear to be sustained at a positive value, but rather the effect of potentially two discrete events which occurred at 188 ms and 253 ms. It cannot be determined what caused the first spike, however an accelerometer located on the tail points to evidence that the second spike was a result of the tail strike. There were no other significant events to take place after the tail strike occurred. Additional evidence is captured from the video which showed after this time the major crushing has occurred and the vehicle experienced only post-impact slide-out. The tail vertical acceleration was next examined and is shown in Figure 18.

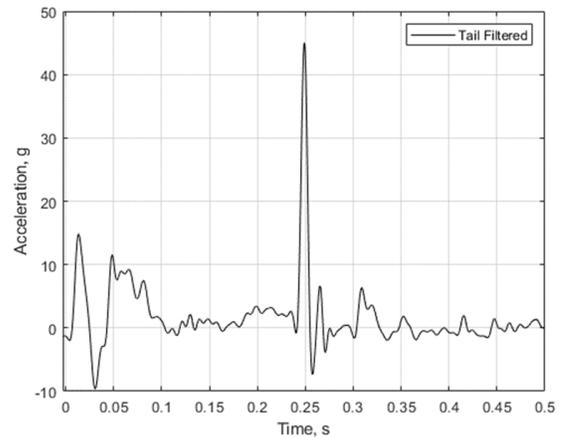
Figure 18 - Tail acceleration.

The tail accelerations indicated an initial spike of approximately 14.8 g before shifting to a -9.5 g during the first 30 ms after impact. However, after this initial oscillation, the tail experienced sustained acceleration of less than 10 g for the next 50 ms, which was caused by the roof collapse event happening during this time. The large spike occurring approximately 250 ms after impact was when the tail strike onto the impact surface occurred.

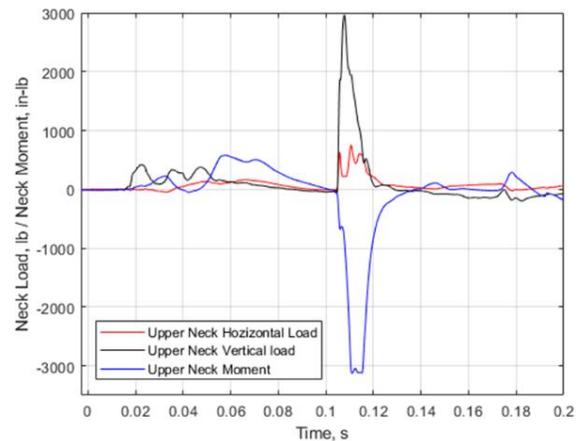
Figure 19 - HIII 95th upper neck loads and moment.

The 95<sup>th</sup> ATD was out of family with the other values, so the values at the neck were plotted for further examination. The neck loads and moment are plotted in Figure 19.

The data from the HIII 95<sup>th</sup> upper neck show a large event that occurred 110 ms after impact. The likely event that has occurred at this time is the overhead mass contacting the ATD head. The videos obtained are not able to confirm this event, however, the accelerations measured at the rear starboard mass location do show a spike at this time also.

The roof collapse, leading to the intrusion of the overhead mass, likely affected the rear row and specifically the 95<sup>th</sup> ATD, which showed high values of neck loads. The results obtained showed items that were not predicted from pre-test predictions, but nonetheless provide valuable insight into the nature of failure modes, energy absorbing structures and occupant response.

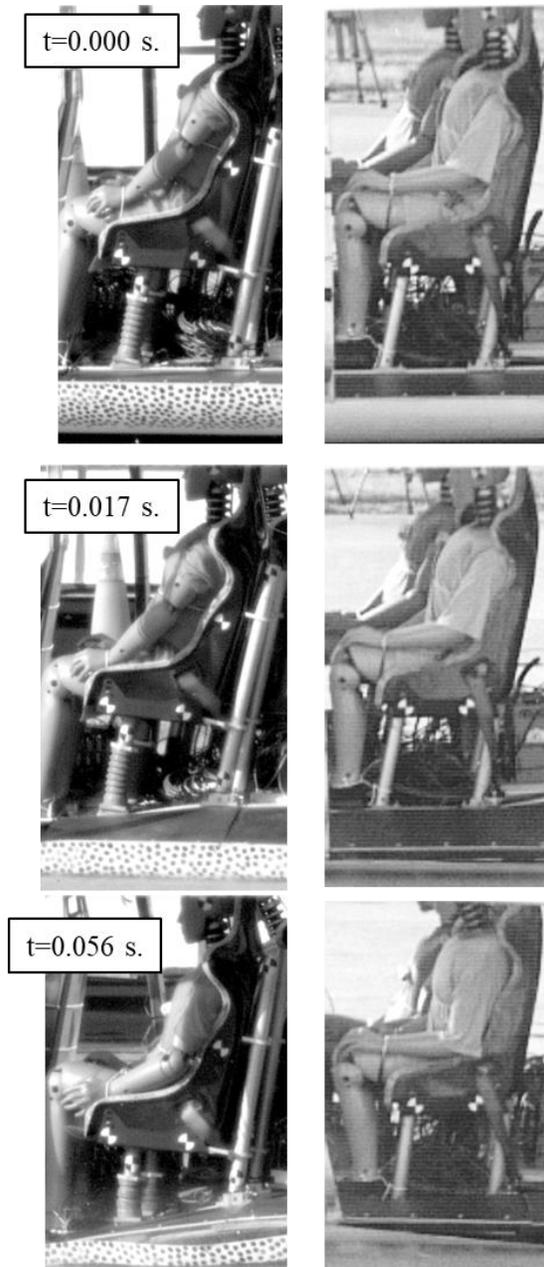
Figure 20 - NASA EA stroking (left) vs. rigid (right) seat responses.

The effect of seat energy absorption was studied by comparing the adjacent HIII 50<sup>th</sup> FAA ATDs in the NASA EA (seat four) and rigid seat (seat three). The effect of the seat stroke and subfloor EA on ATD response was determined through comparison of these matching ATDs in the same row. An image series showing significant notable events during the EA seat stroking is shown in Figure 20. The NASA EA stroking seat is on the left while the rigid seat is on the right. The rigid seat images have been mirrored such that direct observations can be made.

The top set of images in Figure 20 show the ATDs seated in their respective seats at the time of ground impact. The second set of images show the ATDs in their seat after a large portion of subfloor EA cruciform stroke has completed and prior to the seat EA engaging. The bottom set of images show the ATDs after the seat stroke had occurred. It should be noted that up until the seat EA engaged, the responses looked largely the same. The seat stroke time history was captured and is shown in Figure 21. The stroking

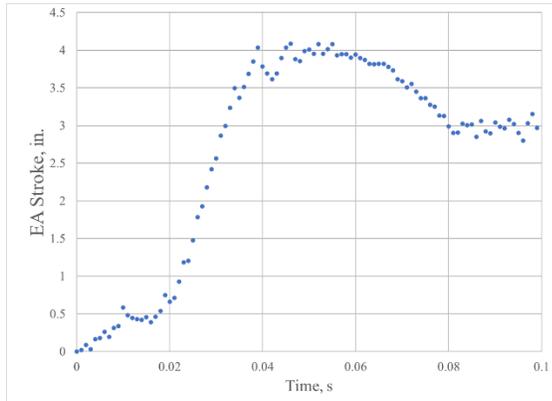
Figure 21 - Energy absorbing seat stroke displacement.

The stroking data presented in Figure 21 follows the trends seen in Figure 20. The stroke did not initiate until 17 ms after impact, and then continues for the next 30 ms after which a maximum stroke value of approximately 4 inches was achieved. There is a slight rebound in the seat/ATD after which the EA exhibited a permanent stroke of approximately 3 inches.

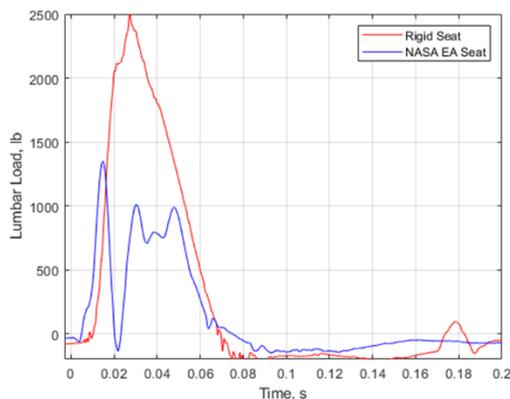
Figure 22 - Lumbar load comparisons between NASA EA and rigid seat.

During the first 17 ms of the impact, the ATD lumbar load values in the NASA EA and rigid seats were tracking approximately the same upward trends. The EA seat began to stroke at approximately 17 ms, and

at this point the ATD experienced a dynamic unload due to the now downward motion of the seat. As the seat EA crushed the lumbar load profile of the ATD resembled a trapezoid at a plateau value of less than 1,000 lb. In contrast, the lumbar load values in the ATD in the rigid seat continued to increase to a peak of approximately 2,500 lb which occurred 28 ms after impact. The full duration of the load was defined as the duration from initial rise to the load crossing the y-axis, and determined as approximately 70 ms for both ATDs.

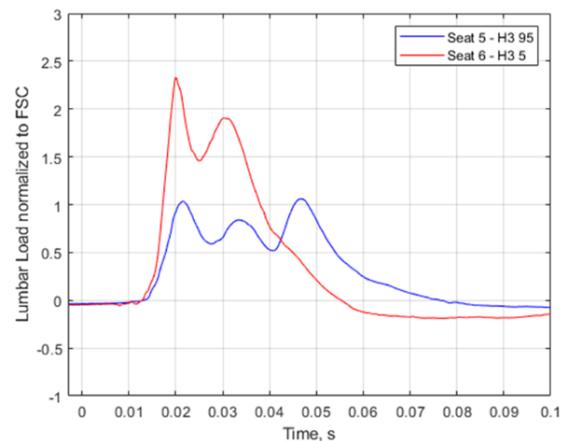
Figure 23 - Normalized lumbar load values of the 5<sup>th</sup> and 95<sup>th</sup> ATDs.

Lumbar loads from the 95<sup>th</sup> and 5<sup>th</sup> ATDs are also included in Table 3, even though these values are not used in the regulations. There is some documentation of lumbar load limits presented in a Full Spectrum Crashworthiness (FSC) Criteria for Rotorcraft [16] that discusses limits for non-standard sized ATDs such as the 5<sup>th</sup> (limit of 933 lb.) and 95<sup>th</sup> (limit of 1,757 lb.). Using those limits, a normalized lumbar load plot is shown in Figure 23.

Perhaps counterintuitively, the 95<sup>th</sup> ATD data showed a lower normalized value, only very slightly above the limit value at 1.1, whereas the 5<sup>th</sup> sized ATD normalized lumbar load value was significantly higher at 2.3. However, further investigations into the subfloor structure revealed the source behind this behavior. By examining the post-test shapes of the cruciforms that were located under these two ATDs, it was found that that cruciform subfloor under the 95<sup>th</sup> ATD crushed more efficiently than for the 5<sup>th</sup>. The finding is supported by examining the shape of the plots in Figure 23. The 95<sup>th</sup> ATD has a lower overall peak value and is trapezoidal shaped with a defined

region approximating a plateau. This region of sustained lumbar load was largely below the threshold with only a slight overage during the onset and toward the end of the response. The 5<sup>th</sup> ATD data, in contrast, was of much shorter duration and higher in magnitude, suggesting less crushing of the cruciform. While the 5<sup>th</sup> ATD lumbar load data did exhibit a slightly trapezoidal pulse, the EA subfloor was not efficient enough to keep the lumbar load values below the normalized limits. While it was difficult to determine the maximum amount of crush of the subfloor cruciform during the test since there were no measuring devices on the cruciforms themselves, the cruciforms were measured post-test after being extracted from the test article. The cruciform underneath the 5<sup>th</sup> ATD experienced a permanent post-test crush depth of between ½ inch and 1 inch. In contrast, the cruciform underneath the 95<sup>th</sup> percentile ATD experienced a post-test permanent crush depth of between 1 inch and 2 inches. A picture of the two EA cruciforms in the test article, prior to extraction, are shown in Figure 24.

Additional consideration should be given to the optimization of the subfloor structures. When examining the data, it appeared that the subfloors were most efficient for the heavier occupants such as the 95<sup>th</sup> ATD. While the subfloors did crush under all of the occupants during the test to varying degrees, the amount of loading into the occupant was most limited in the 95<sup>th</sup> ATD. In addition, the loads will be most reduced when an energy absorbing subfloor and energy absorbing seat work together as a system. NASA will continue to optimize the EA components both in the subfloors and in the seats using the results from this test to further reduce injury risk for the onboard occupants.

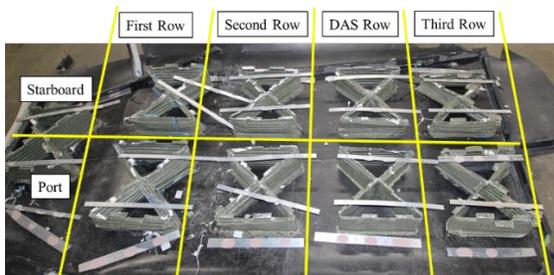
Figure 25 - Subfloor EA cruciforms post-test.

Post-test examinations of the tested EA cruciforms revealed several notable items. The first was the EAs themselves, while in various states of crush, did not

show signs of buckling or collapse, indicating robustness toward the longitudinal forces induced from the forward deceleration of the test article at impact. The second was that there was indication of crush on all specimens, indicating that they did accomplish their required goal of absorbing impact energy of the test. The post-test measured delta lengths of the specimen, as measured in the middle of and the edges of each specimen, are shown in Table 4. Note these values do not represent the maximum crush experienced during the test, but rather a permanently deformed condition extracted from the test article post-test. It is intended to give a relative measure for comparative purposes and will be used in additional post-test inspections and for further EA optimization.
