SERFE PLSS Component Lessons Learned from ISS

Chane Sladek,¹ Alicia Contreras-Baker,²
Jacobs Technology, Houston, TX, 77058

and David Westheimer,³
NASA Johnson Space Center, Houston, TX, 77058

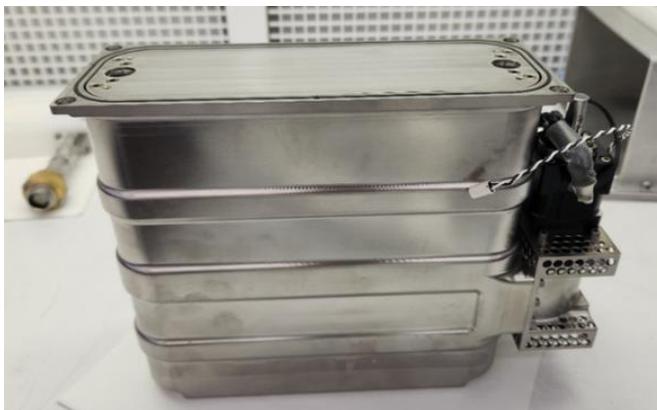
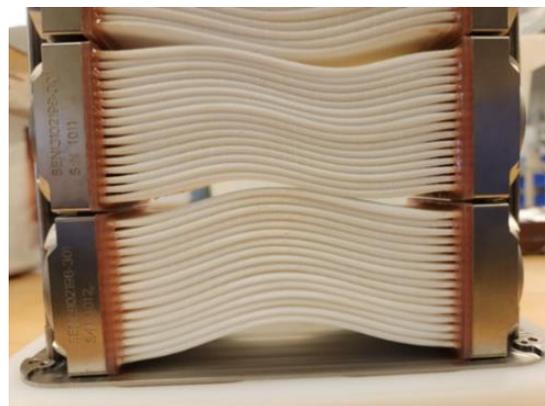
tests at the full assembly level and the individual cartridge level. The full assembly and cartridge stack are shown in Figure 5.

Figure 5. HX-440 assembly (left) and fiber cartridge stack (right).

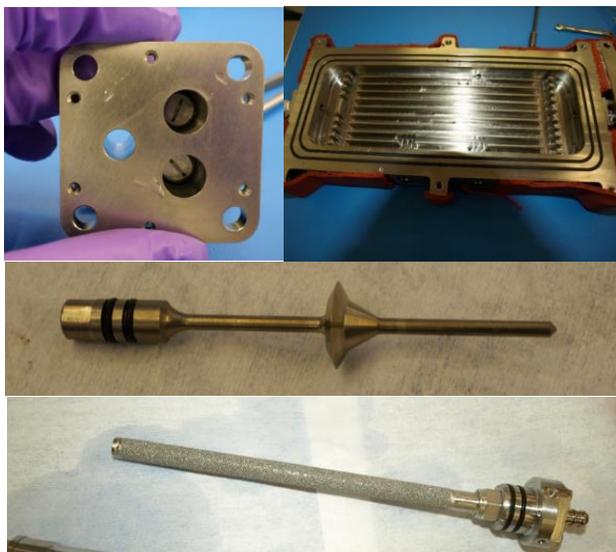
Figure 7. Various SERFE components following removal, including RV-424A/B (top-left), heater assembly (top-right), TCV-421 shuttle (middle), and F-2048 (bottom).

Most of the SERFE Flight unit titanium parts looked pristine during posttest inspections, Figure 7. Disassembly of the TCV (thermal control valve) provided observations that the wetted titanium components held up well during the SERFE mission and the shuttle inside of the valve did not show significant wear. Relief Valves RV-424A/B appeared to be in excellent condition when they were removed from the MiniPLSS. Component disassembly also showed that the wetted titanium

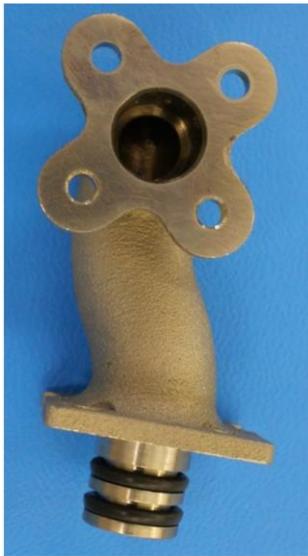
Figure 9. Presumed rust spots on secondary pump manifold.

PMP-422 also worked well and did not have any issues during testing operations. Some materials and processing issues were noticed during assembly of the pumps, which included rust spots on the 3-D printed titanium manifolds and “tarnishing” of the nitrided (gold colored) titanium pump body parts. The pump manifold can be seen in Figure 9. This pump was disassembled and inspected. During disassembly from the Mini-PLSS, the pump inlet filter (422C) was examined for contamination. Similarly to the inlet filter on PMP-423, it was examined at 50x magnification and did not contain any FOD (foreign object debris). Pump Check Valve (CKV-427) at the outlet looked good.
