# NASA Exploration Toilet On-orbit Results and Impact on Future Missions

***The Universal Waste Management System (UWMS), which has the ISS operational nomenclature “Toilet”, was initially installed on the International Space Station (ISS) in 2020 with final installation completed in 2021. Technical progress continued to be made with each on-orbit operation that culminated in additional crew use of the UWMS on ISS. Subsequent problems were evaluated during troubleshooting and testing with the UWMS hardware using water and pretreat to simulate crew use. This paper summarizes the additional testing, troubleshooting and the results, characterizes the additional data obtained, and summarizes the interpretation of the data to characterize the hardware’s operational nuances. Use of the hardware by crew is planned and will also be summarized. The paper will also describe the additional portions of the technology demonstration that were completed and the data that inform the Orion-installed UWMS unit and future manifesting of consumables for both Orion and ISS.***

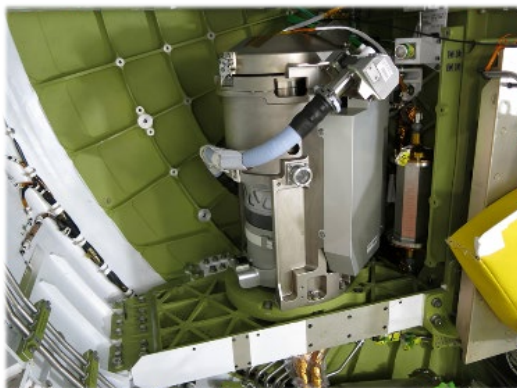
**Fig. 1. Orion UWMS installed in Artemis-II Vehicle**

The UWMS project's two toilet units have key goals for a reduction in mass and volume over previous toilets used in space vehicles. The ISS UWMS (Toilet) is 65% smaller and 40% lighter than the current ISS toilet used by US crew in the Waste and Hygiene Compartment (WHC.) The Orion UWMS (WMS) is 61% smaller than the toilet used on Shuttle missions. Air flow to aid in the collection of urine and fecal material is provided by a dual fan separator (DFS) which also serves to remove air from the urine/pretreat stream. Combining the two fans used in previous toilet designs into a motor arrangement with a single fan housing (separate impellers) provided much of the resultant reduction in mass and volume. The unit provides a simple startup operation with no need for an external control panel that turns on the unit either with removal of the urine funnel or lifting the commode lid. Pretreatment of the urine is performed in both units to stabilize the urine for processing on ISS or venting on Orion. A Conductivity Sensor provides measurement of the concentration of pretreat dispensed for the ISS unit. Fecal deposits and consumables such as wipes, and gloves are contained in a hard-sided fecal canister. More details can be found in a previous paper<sup>1</sup>.

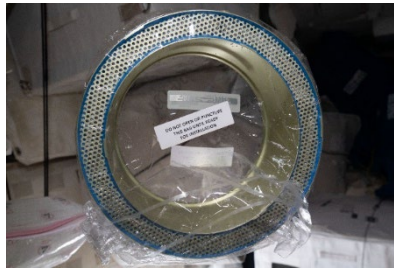
**Figure 5. Toilet Air Filter in packaging on ISS (Odor Bacteria Filter (OBF))**

The first R&R of the Toilet Air Filter (TAF) – prior to limited crew use in 2021 – allowed small carbon particles to escape into the cabin. These particles are the adsorbent within the filter bed used for odor control. The filter outlet utilizes a pleated membrane filter that prevents any dusting or particles from escaping, but the inlet to the filter has no such membrane. The beds are held by a coarse stainless wire mesh. The unidirectional air flow during operation generally sets and maintains the bed from the inlet side. On the other hand, ground packaging includes a plug that installs in the inlet to retain any free particles inside the filter during processing and handling. The whole TAF is then double bagged for flight, see Figure 5.

After the particle release, all the air filters on ISS were inspected inside their packaging. Of the 12 filters on orbit, 6 (half) had no evidence of particles in the packaging, 4 has very few particles and 2 had many particles. A procedure update was developed to minimize risk of particle escape and protect the crew during the R&R. Appropriate PPE was added to protect crew from any inhalation hazard and a vacuum would be used to safely collect any particles inside the bag before removing the filter. Incidentally, one of the two filters with the highest number of particles was chosen and used in the new filter R&R procedure in March of 2022 and showed successful particle collection/containment and crew protection. Thus, at this time, the team believes the procedure updates have adequately put controls in place for managing this risk/issue.

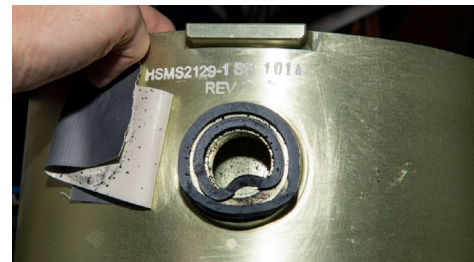
**Figure 6. Toilet Air Filter inlet seals after improper installation.**

A separate issue was noted during the second filter R&R – after limited crew operations in 2021. The crew had not fully opened the filter access door during the first filter R&R which led to the face seals on the TAF to be scrunched and folded. Figure 6 shows at least one of the two seals was fully compromised and the second seal may also have been compromised during the 16 days of crew operation. This might explain the crew complaint of odor *during* UWMS use (i.e., when air was flowing). Further testing is needed to verify. The crew procedure was updated to give a caution note and explicitly direct the crew to open the filter access door to the *open* and *locked* position. Recurrence of the filter seal issue has not yet been seen.

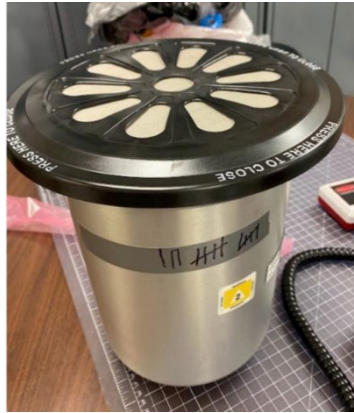
**Figure 8. Returned Fecal Canister**

A single fecal canister was returned from the ISS for evaluation by the engineering team as seen in Figure 7. This canister was examined externally for damage, odor, and weight before opening and showed that although the canister was in good physical shape, there was odor coming from the assembly of the Fecal Canister and Lid. Further study revealed that the gasket material between the two components was an open-cell foam which allowed odor to escape. Additional evaluation, testing and redesign of the gasket material are currently in work. See Figure 8 for Fecal Canister and Lid Assembly.

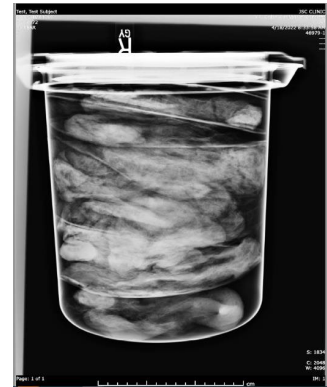
**Figure 9. Fecal Canister X-ray and Lid Assembly**

The Fecal Canister was x-rayed before it was opened, Figure 9. Compaction efficiency studies have been performed using ground prototypes and fecal simulants to estimate the quantity of fecal deposits that could be expected in the fecal canister volume. Validation of this ground testing with actual micro-gravity cases was needed. The returned fecal canister provided the first insight into the ability of the crewmembers to compact deposits and also how actual fecal material, flight fecal bags and use of on-orbit available wipes and gloves impacted the number of deposits contained in the canister. The x-ray showed good fecal compaction, however, more compaction plates than expected were seen.
