Exploration Helmet Permanent Anti-Fog Study

Kristine Davis¹

NASA Johnson Space Center, Houston, TX, 77058

Greg Trude²

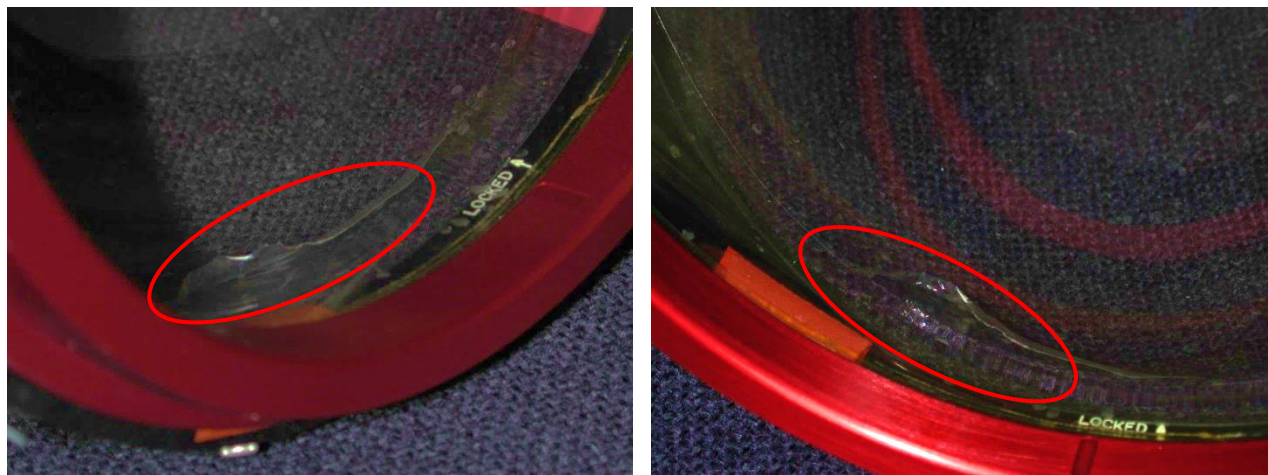
Figure 1: Delamination of the HTAF-308 coating after NBL testing.

Pictures from NBL DR WF433401 [4]

Due to the poor HITL test results, HTAF-308 was not incorporated into the EMU helmet design. There were a few contributing factors that were believed to have caused the delamination failure. First, the helmets coated were not new, pristine helmet assemblies. Ideally, the coating would be applied prior to the helmet ring being bonded to the polycarbonate. This would allow for the "seam line" to be covered by the helmet ring. Since the seam between the uncoated and coated polycarbonate was right at the subject's chin, it was more sensitive to losing adhesion and peeling

due to physical abrasion of the subject's chin especially if they had facial hair. This is also where the Valsalva device is typically placed which was also blamed for the delamination in the case of the NBL helmets. The polycarbonate itself might have also had residual oils left from subject's face during HITL testing or the currently used wipe on anti-fog that was not sufficiently removed before the coating was applied. Finally, the HTAF-308 itself was no longer deemed a "permanent" coating by Exxene Corporation.

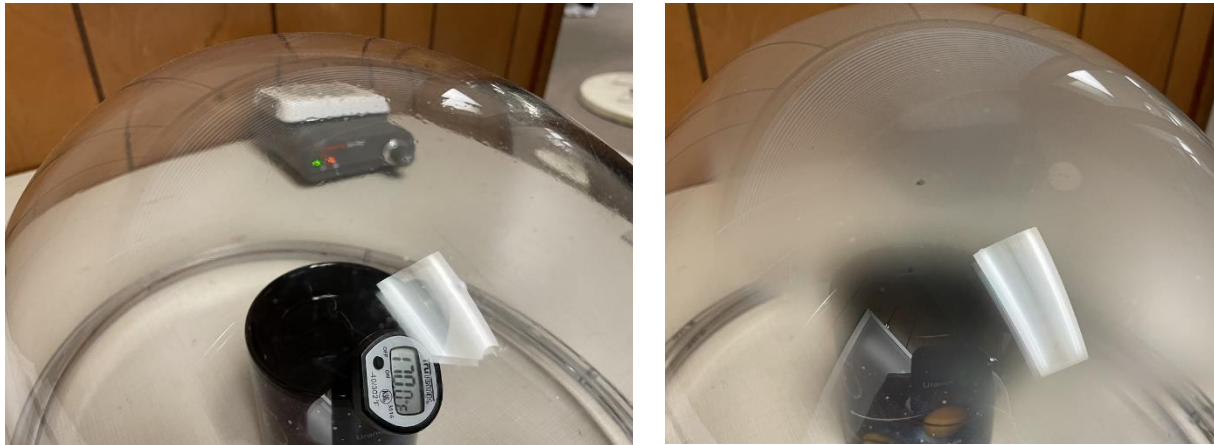
Figure 10: Visgard (Left) versus HCF-100 (Right) when exposed to 170 deg F hot water While the HCF-100 fogs more to the 170 deg F water, the Visgard develops an orange peel texture that starts to streak. This could be a concern for eye irritation.

While working with the coated samples, it was noticed that the materials, when wet from condensation or cleaning agents, seemed to have a different texture to them. The Visgard 106-94 was slippery and would be tacky for a short time after being wiped dry. By comparison, the Exxene HCF-100 presented no differently than a bare piece of polycarbonate plastic after wetting. As seen in Figure 10, the Visgard performs better to fogging than the HCF-100 when exposed to 170° F hot water. However, it starts to have an orange peel type texture. When left to dry, other differences appear. The Exxene HCF-100 will return to its pre-test state, with no visual evidence of any fogging or condensation remaining. For the Visgard 106-94, each of the droplets that ran down have dried and appear as a run (with thickness). This indicates some dissolution and re-deposition of the coating. This raises a significant concern the coating is rewetting and could potentially become droplets that could impact the crew member during a spacewalk.
