# A Summary of Test Results from a NASA Lift+Cruise eVTOL Crash Test

**Justin Littell Ph.D.**  
Research Aerospace Engineer  
NASA Langley Research Center  
Structural Dynamics Branch (D322)

# Test Objectives

# Test Article – NASA Lift + Cruise Reference Vehicle

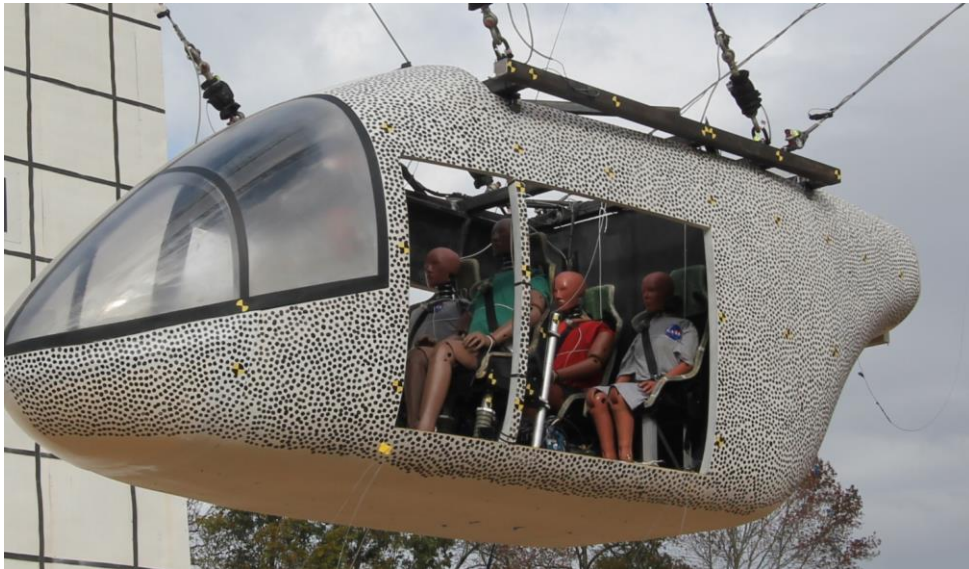
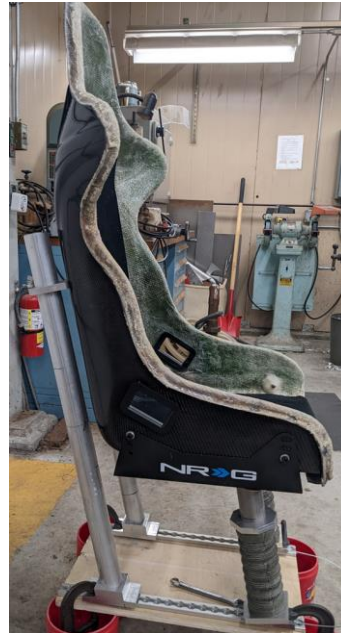
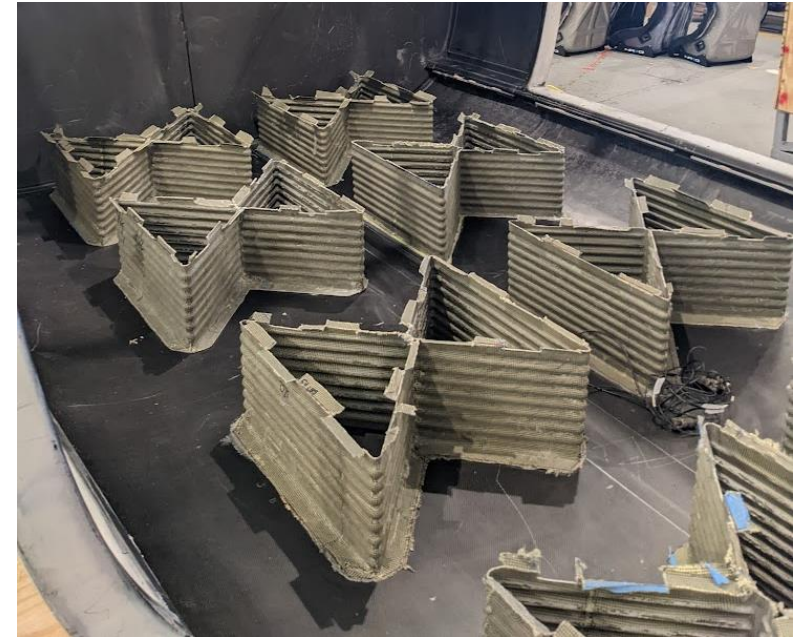
- Reference
  - Silva et al. *VTOL Urban Air Mobility Concept Vehicles for Technology Development*. 2018 Aviation Technology Integration and Operations Conference
- Test Article Specifications
  - Dimensions: 18 ft. x 6 ft. x 7 ft.
  - Total weight: 3450 lb.
  - Seats: 6 passenger
  - Wing Type: High wing
  - All composite design with skin and foam fill frame sections
- Structural components sized to maintain survivable volume under load
  - 12 g static vertical load
  - 30 ft/s dynamic vertical impact
  - Non-structural components replaced with mounted mass

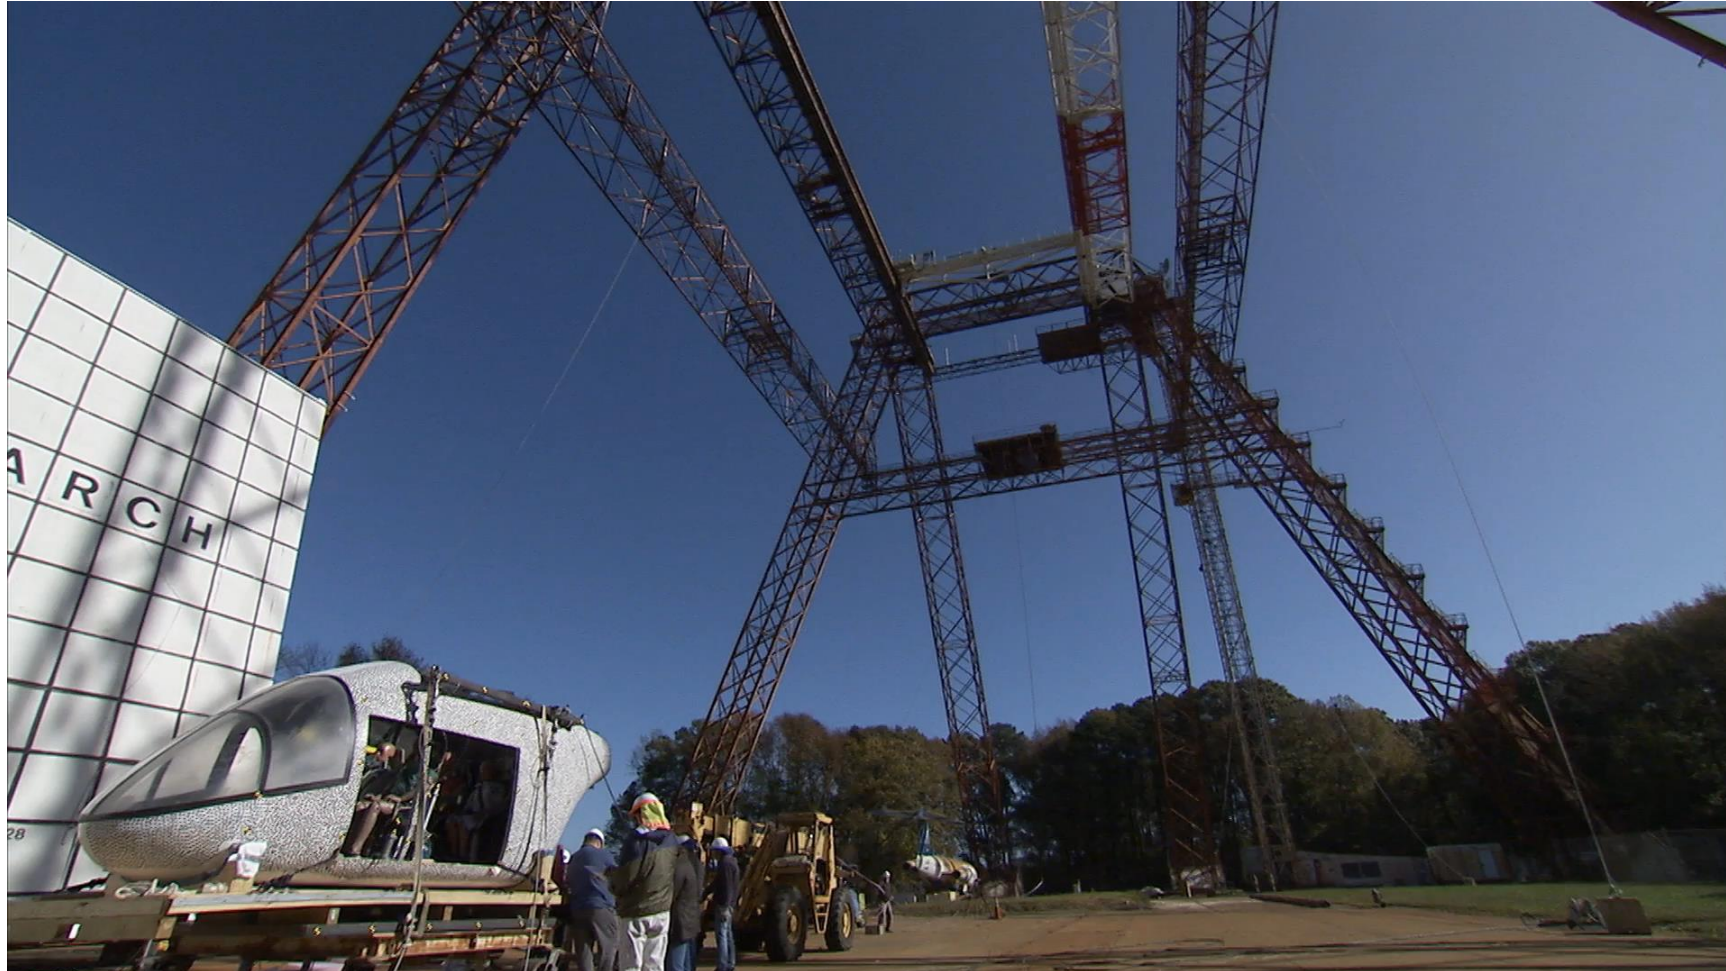
# Test Video

- Horizontal Velocity = 38.1 ft/s, Vertical Velocity = 31.4 ft/s
- Pitch 0.6 degrees nose down, 2 degrees yaw

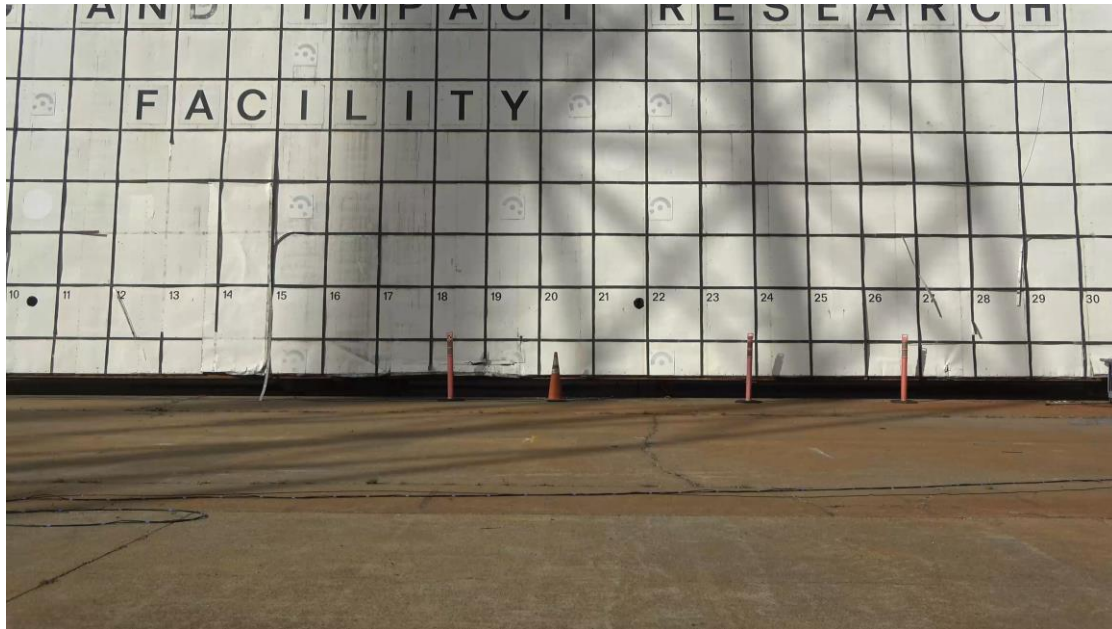
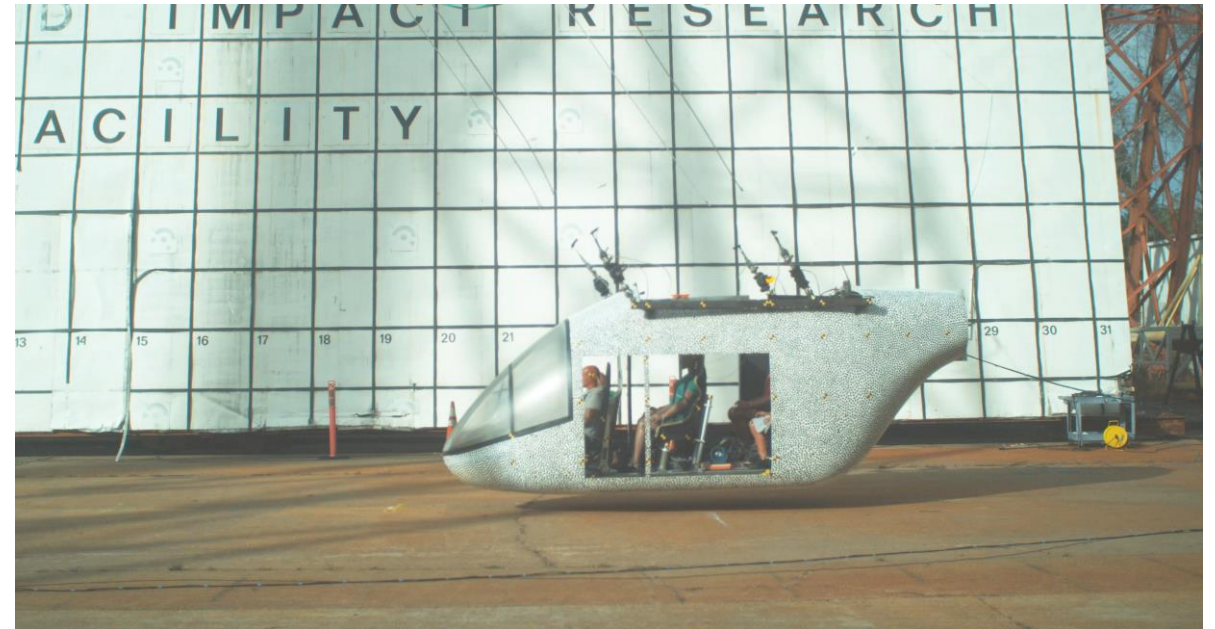
# Video: $t=0$ to $t + 0.050$ s

- $t=0$  to  $t+0.040-0.050$  s - primary time of energy absorbers crushing and start of cabin failures
- $t+0.050$  s to  $t+0.200$  ms – collapse of the overhead structure

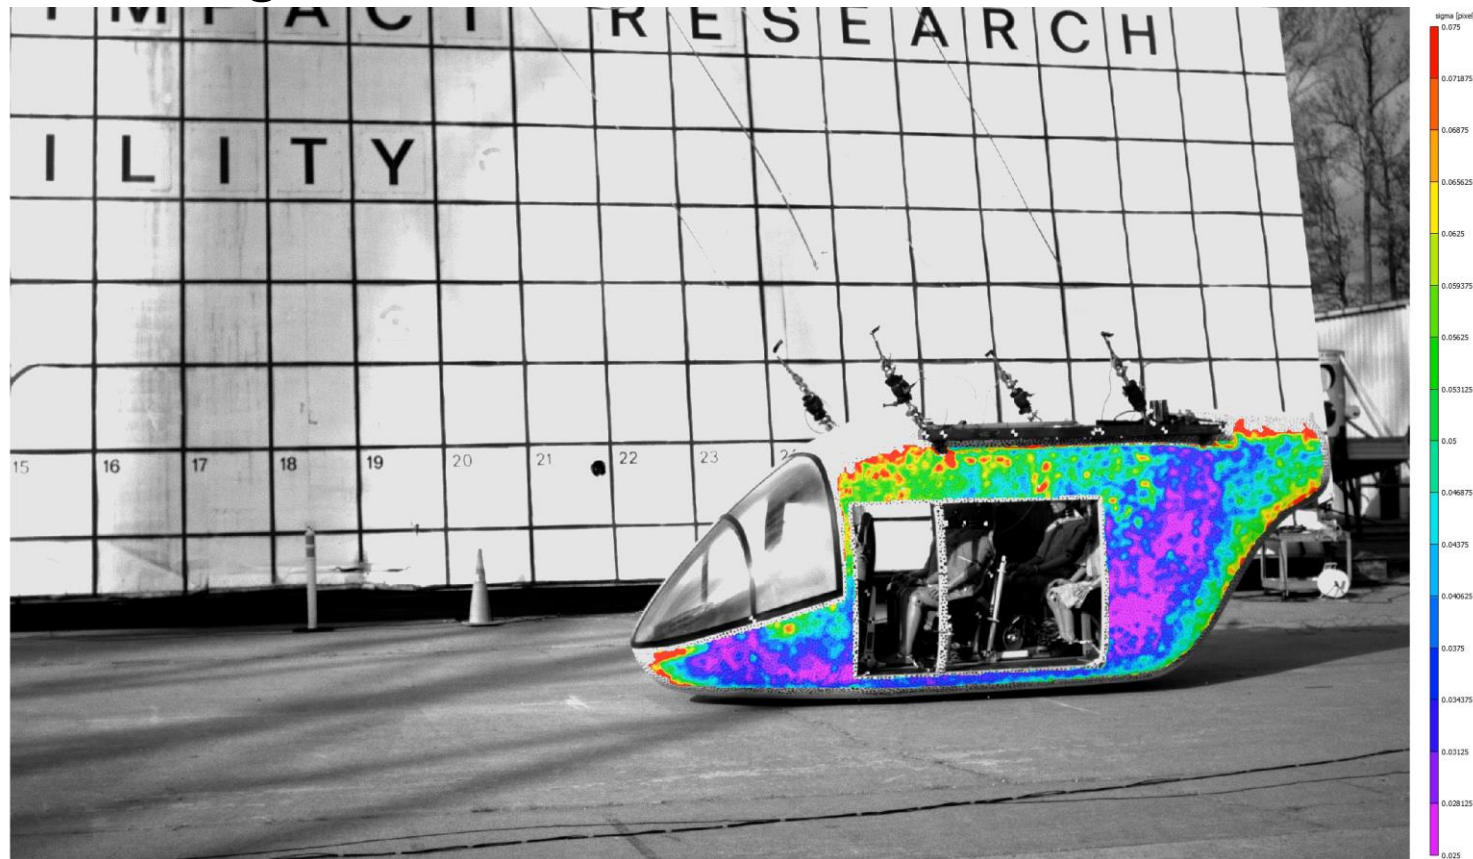
# Photogrammetry Analysis

- Plotting Sigma which is pixel deviation from reference.
  - High Sigma values indicate failure locations
- Video goes through the first 0.150 seconds

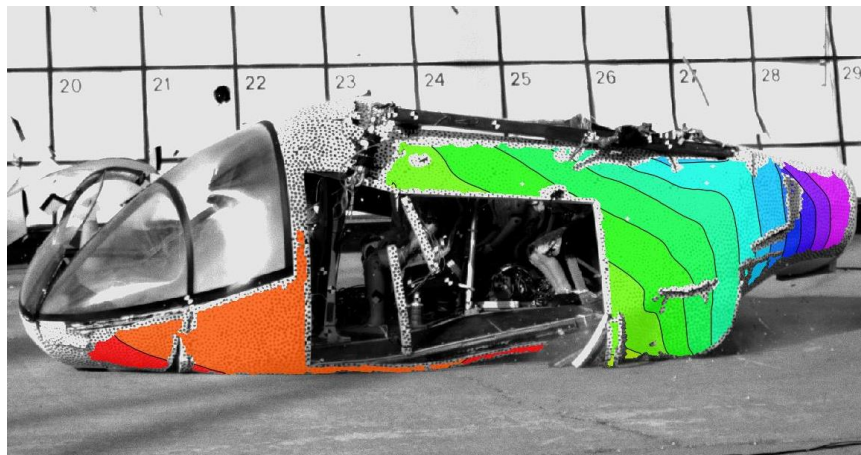
$t + 0.150$  seconds

- Plotting vertical deformation to determine items such as cabin intrusion
  - Data shows deformation from reference, which needs to be proceeded to determine the delta between ceiling and floor
- Plotting lateral (out of plane) deformation to determine skin buckling and additional failure locations
  - Data will be used for computational modelling

5.4" 33.6"
