International Space Station (ISS) Environmental Control and Life Support (ECLS) System Overview of Events 2022

Nov 20th, 2022 marks the 24th anniversary of the beginning of construction of the International Space Station (ISS). The ECLS system is constantly changing to meet the needs of current missions and future exploration. The ISS has become the laboratory that was always envisioned, allowing for an ever-growing class of exploration level technologies that will propel the stage forward as humanity advances beyond Low Earth Orbit (LEO). This paper will review the past year and look towards the future for each U.S. ECLS subsystem. The impacts, challenges, and successes related to the intermingling of incumbent and cutting-edge technologies are summarily discussed in this paper.

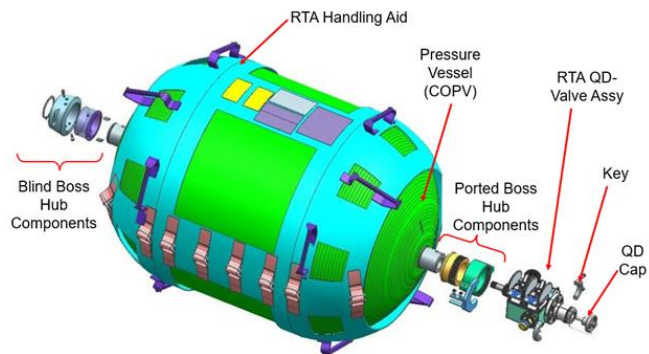
Figure 1. Nitrogen/Oxygen Recharge System Recharge Tank Assembly

COPVs provide a low mass means for gas storage and transportation but are known to be susceptible to damage resulting from handling, tool drop impacts, or impacts from other objects (e.g. fork lift, shackles, etc). NORS RTAs consist of a COPV and Quick Disconnect (QD)-Valve Assembly. RTAs are pressurized with nitrogen (N₂) and oxygen (O₂) on the ground to about 6,000 psi for use in the ISS N₂ and O₂ pressure systems. RTAs are also pressurized with air to about 3,000 psi for use during an ISS ammonia emergency. The NORS RTA Pressure Vessel Damage Control Plan establishes a plan to mitigate damage to the NORS / Commercial Crew Vehicle (CCV) Emergency Breathing Air Assembly (CEBAA) RTA COPV throughout its life cycle. Part of the Damage Control Plan (DCP) is a ground inspection of the NORS RTA before servicing and upon return from ISS. The DCP describes damage that should and should not be documented in a Discrepancy Report/Non-Conformance.

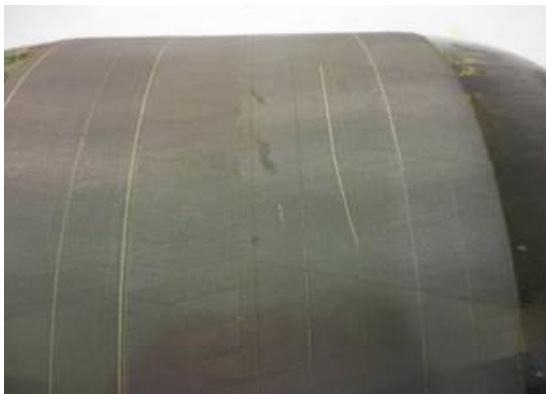
Figure 2. COPV Scratches

Two separate tanks were noticed to have marks on the COPV portion of the NORS RTA during 2022. A Non-

Conformance was written on each tank to document and further inspect the damage. For both tanks, visual inspections found no impact cracks in the resin and no broken fibers on the COPV. Both Boeing and NASA Fracture Control/Pressure Vessel (FC/PV) experts agreed that the damage was superficial and there are no constraints to

continue to use both tanks. The marks on the RTAs have driven a reevaluation of ground handling procedures to ensure the RTAs are being handled properly at all time.

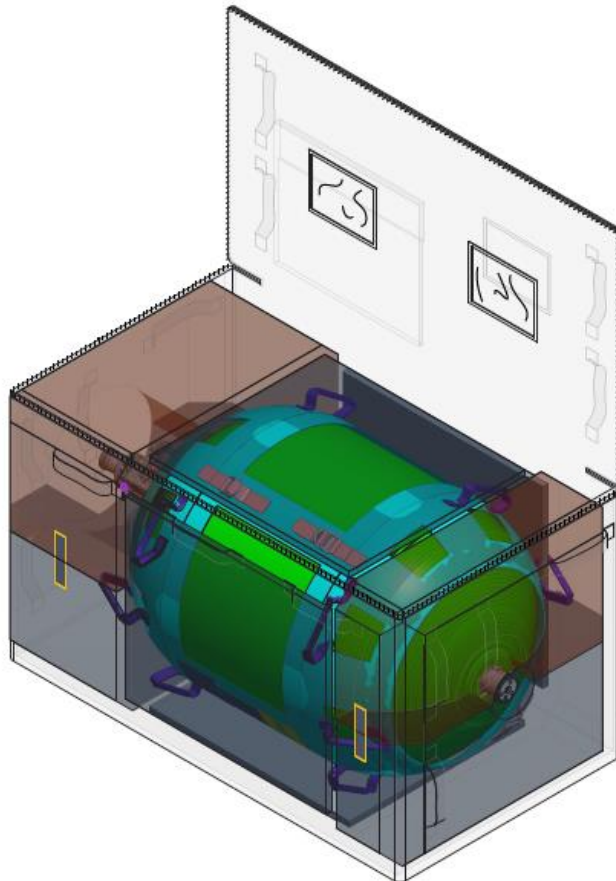
Figure 6. Modified Vehicle Interface
Assembly

NORS Tanks have been launched and returned from ISS inside Vehicle Interface Assemblies (VIA), modified M-01 sized bags, starting with the Orbital-4 launch in 2016. The VIA includes the four (4) pieces of foam to protect the NORS Recharge Tank Assembly (RTA) and the VIA Bag. NORS RTAs have been difficult to return due to the size of the NORS VIA footprint, 21 x 35.3 x 32.2 inches. At the beginning of 2022 there were a total of ten (10) O₂ and N₂ NORS tanks on ISS, eight (8) of which were empty and waiting to be returned to ground.

Ground teams began to look at ways to return more tanks to alleviate on-orbit stowage issues. The VIA would not fit on Crew return flights so a smaller, more compact option was considered. The new design used a modified, bulging 4.0 CTB, 37.5 x 20.0 x 20.25 inches. This design has two (2) foam end caps and four (4) thin side foam pieces to help protect the tank. This 4.0 CTB configuration has been used to return one (1) NORS RTA on Axiom-1 (April 2022) and two (2) NORS RTAs on Boeing OFT-2 (May 2022). This configuration is going to be used for future NORS RTA returns on Crew vehicles starting with Crew-5. Currently there are six (6) O₂ and N₂ NORS RTAs on ISS.

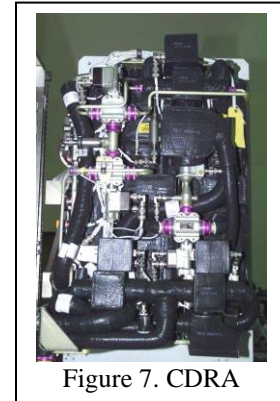
Figure 7. CDRA

Performance for Lab and Node 3 CDRA's this year were nominal. NASA Technical Demonstrations are run preferentially in place of CDRA, according to availability. Thermal Amine System (TAS) failure has forced CDRA into active duty, where it has been nominally. Additionally, the Lab CDRA also has had the check valve reach its certified end of life without failure and is still going strong. It is unlikely any of the beds will need replacement in the near term.

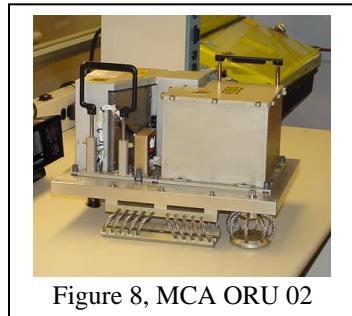
Figure 8. MCA ORU 02

The Lab MCA ORU 02 F0001 reached its end of life after receiving Error Code 36: 'Electrometer OP PBIT'. The ORU 02 was Removed and Replaced (R&R) with F0006. During a zero calibration in preparations for an EVA, the Lab MCA experienced Error Code 62: 'Both Filaments Failed'. The data showed that the filaments were receiving voltage and current which indicated that there was an issue in the control circuitry and it was not a failure of the filaments. The ORU 02 F0006 will be R&R'd with F0008 and further bench tested on the ground to better understand this anomaly.

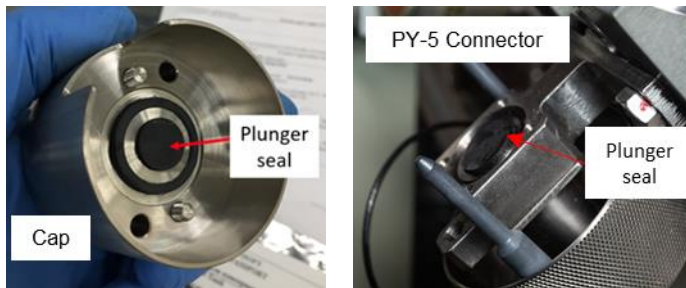
Figure 9. WHC Cap and Plunger Seal

In May 2022, WHC maintenance was conducted. This included the concurrent R&R (Removal and Replacement) of the Dose Pump and Pretreat Tank. This also included replacement of the EK Hose. During the checkout procedure, which included a functional check, the WHC control panel Pretreat Bad Quality (PTBQ) light annunciated. Crew executed several manual doses, which is a standard documented countermeasure. However, the PTBQ light persisted.

In addition, Crew reported only the portion of the EK Hose on the Pretreat Tank side showed the color indicative of containing Pretreat, while the other half (on the Dose Pump side) remained clear. Nominally, this entire hose should contain Pretreat, a dark red / maroon fluid. Suspecting either an infant failure of the Dose Pump, which had already reached Shelf Life and Wetted Life certifications, or a misconfiguration of the Pretreat Tank connections, the next troubleshooting steps included R&R of each component serially to isolate the failure. The Pretreat Tank was R&R'd first, and crew was instructed to inspect and verify all connections. This Pretreat Tank was a new variant which does not fly with an EK hose attached and instead has a cap, which contains a center rubber seal on the Pretreat Tank side of the PY-5 handwheel connector. During the second attempt at activation, there was still no fluid movement seen in the EK hose. Next, the Dose Pump was R&R'd with a newer Dose Pump as well as a new EK hose, but this still resulted in no movement of pretreat through the EK hose. Ground teams decided to reinstall the original Dose Pump, which had started showing signs of failure (the original reason behind the R&R) but was still functional. The rationale being, since root cause was still not identified, to use the degraded Dose Pump for further troubleshooting to identify root cause. This was to avoid risking damage to the last pristine spare Dose Pump on orbit. Crew was asked to de-mate all connections and photo document to help identify the root cause. Finally, when Crew de-mated the PY-5 handwheel connector, a crew member noticed the seal had come off of the cap, and was stuck on the PY-5 handwheel connector side. This is an off nominal condition. This seal had prevented pretreat from flowing into the EK hose, thereby deadheading the second Dose Pump. This resulted in requiring installation of the last remaining USOS on-orbit Dose Pump to return WHC to nominal function.

WHC maintenance procedures have since been updated to instruct to Crew verify the seals remain in the caps and not stuck to the handwheel connector. It was also suggested, as a standard practice, to perform functional checks in between the removal and replacement of each hardware component. This is because neglecting the functional check can lead to indeterminate troubleshooting. Lastly, after discussion with Russian WHC counterparts, a new cap design was implemented to better secure the seal and prevent a

recurrence of this issue in the future.

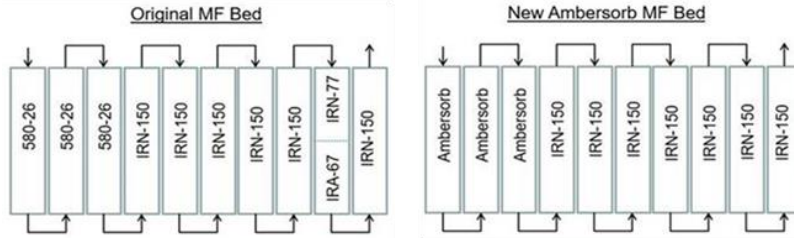
Figure 10. Original and Updated MF Bed Design

The Multifiltration Bed (MF Bed) has operated over a series of configuration changes over the lifetime of Water Processing Assembly (WPA), including a change from dual series bed operations to single bed in 2019, and change from the -1 legacy design to current -2 configuration in 2020. The new -2 design incorporates Ambersorb® 4652 in place of obsolete 580-26 charcoal media, and replacement of separate IRN-77 and IRA-67 media with all IRN-150 in Cylinder 9 to eliminate leachate issues and enable running beyond acetate breakthrough.

Effluent water samples were taken from previously installed MF Beds S/N 16 and 17 (dual beds in series), returned and analyzed after the first, second and third (for the first bed, S/N 16) ionic breakthroughs. Samples from the second ionic breakthrough contained compounds that challenge the catalyst in the

not at a level expected to harm the Reactor or present conductivity excursions too high for WPA reprocessing to handle. The Reactor installed at this time operated 4 months following the second breakthrough and returned to ground for testing, which confirmed exposure to these compounds did not result in performance degradation. It was thusly agreed in October 2021 to run the currently installed MF Bed S/N 7 past the second ionic breakthrough and plan for removal and replacement (R&R) after the third ionic break through.

In April 2022, the MF Bed reached the third ionic breakthrough and was R&R'd, after the first breakthrough in April 2021 at approximately 9000 lbs. of throughput and second breakthrough in October 2021 at approximately 16,000 lbs. This marked the first time a single bed had been allowed to operate past the second breakthrough, allowing an additional approximately 11,000 lbs. of throughput and 6 months of operational run time before reaching required R&R levels of conductivity. Total Organic Carbon (TOC) levels remained in family and no other indications of Reactor catalyst degradation have been observed. The new MF Bed S/N 11 (installed April 2022) is planned to run in the same configuration and through the third breakthrough.

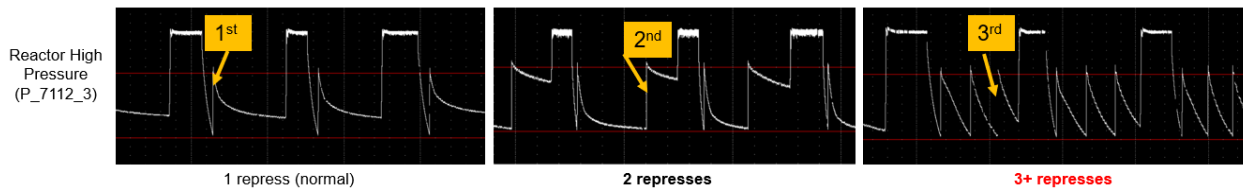
Figure 12. Water Processor Assmbeley Repressurization Cycles

The typical failure mode for Catalytic Reactors is leaking of the Hot Item Assembly elastomeric seals, which are subject to wear from oxidation and thermal cycling during WPA processing. Reactor High Pressure sensor P_7112_3 is used to monitor the start and progression of a potential seal leak. In nominal operations, a single repressurization follows a process cycle due to thermal cooldown following the previous process cycle. A second repressurization is possible with extended time in standby due to nominal Reactor seal leakage, or due to either an internal (through a pressure regulator or check valve) or a small external leak. Three or more repressurizations is not common in nominal processing operations, and indicative of degraded elastomeric seals in the Cat Reactor no longer holding pressure.

Catalytic Reactor S/N 5 demonstrated signs of significant leakage (three or more repressurizations) and was R&R'd in June 2022, after an expected number of cycles based on historical averages of prior Reactors operating at the same temperature and pressure. Typically, in the current operating configuration, the second repressurization starts at approximately 300-400 process cycles. S/N 5, however, first started showing this second repressurization sooner than expected, at around 150 cycles. Because this second repressurization was seen sooner than average but the Reactor still reached average life before gross leak occurred, it is suspected that there was a premature internal leak in either the

inlet check valve [0165-1], inlet isolation valve [1126-1], or pressure regulator [1115]. S/N 5 returned on SpX-26 and will be investigated to assess valve performance and identify root cause of failure
