MAINTENANCE CHALLENGES IN AGING TEST FACILITIES

NASA's Propulsion Systems Laboratory

TETWoG 109

Clint Shrewsbury, Mechanical Facility Engineer

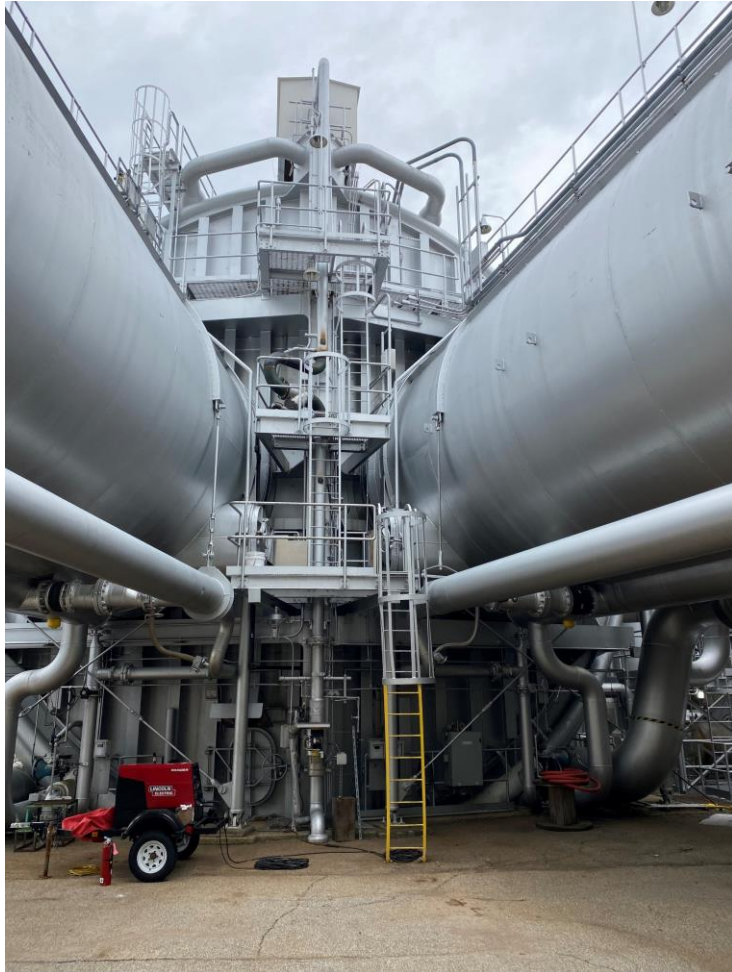
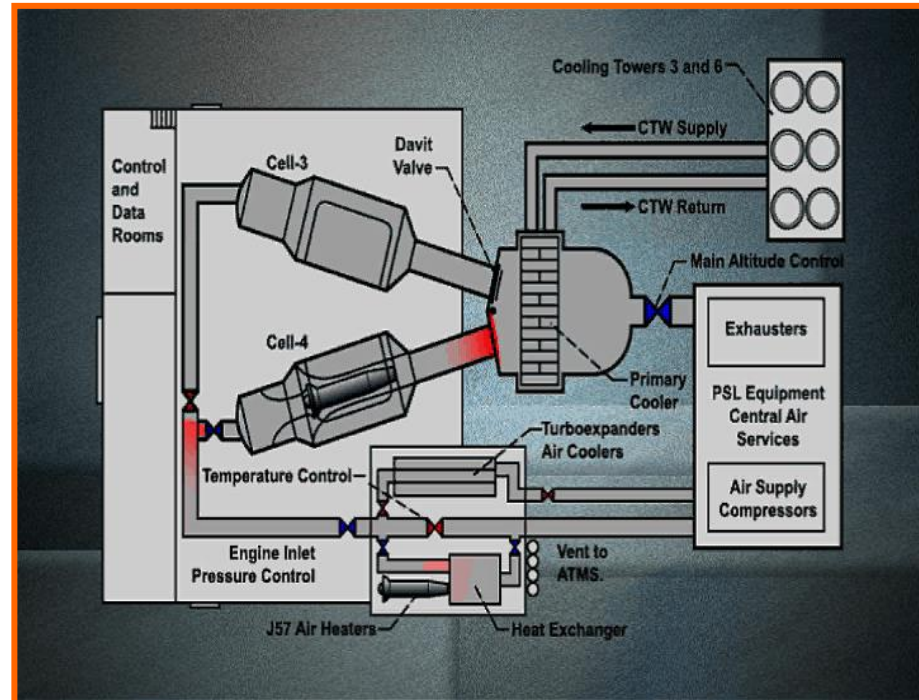
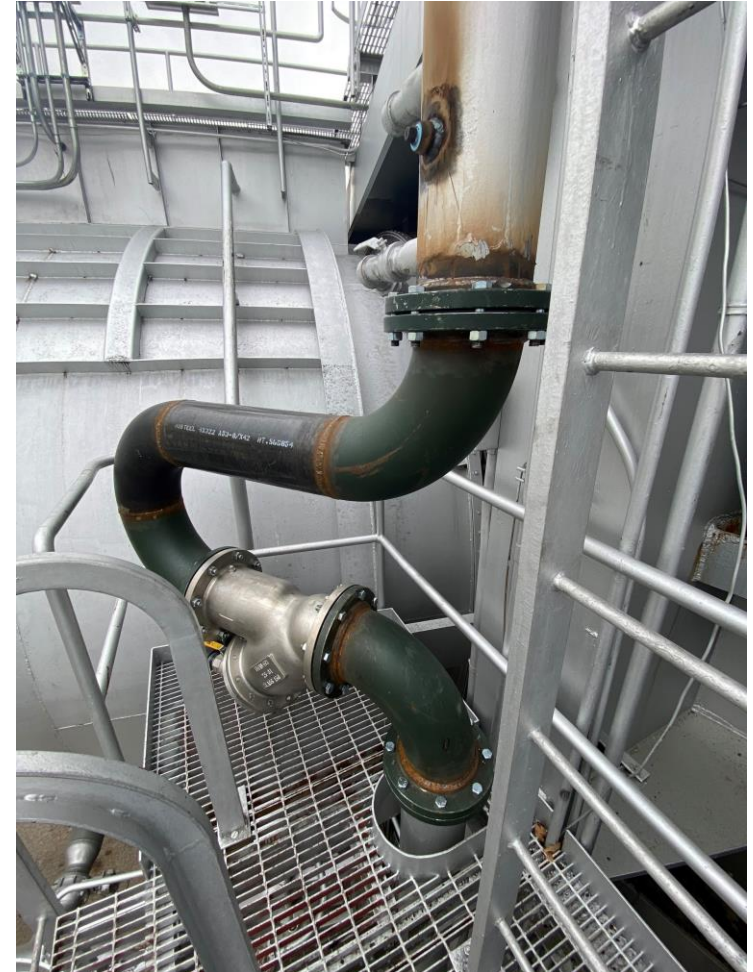
Example 1

- Issue:
 - 18' valve used to protect unused test cell from hot engine exhaust experiences water spray clogging.
- Result:
 - Clogged sprays result in additional maintenance for the facility technicians. Approximately 200 additional man hours per year of extra work.
- Solution:
 - Install a y-strainer in the supply line for the water sprays to prevent clogging.

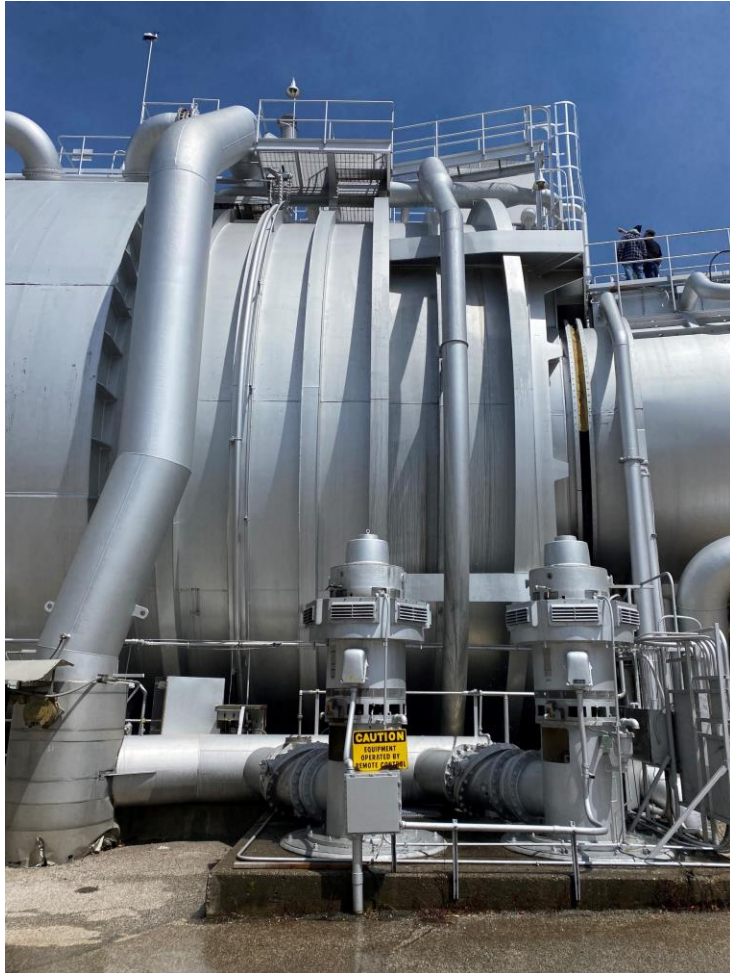
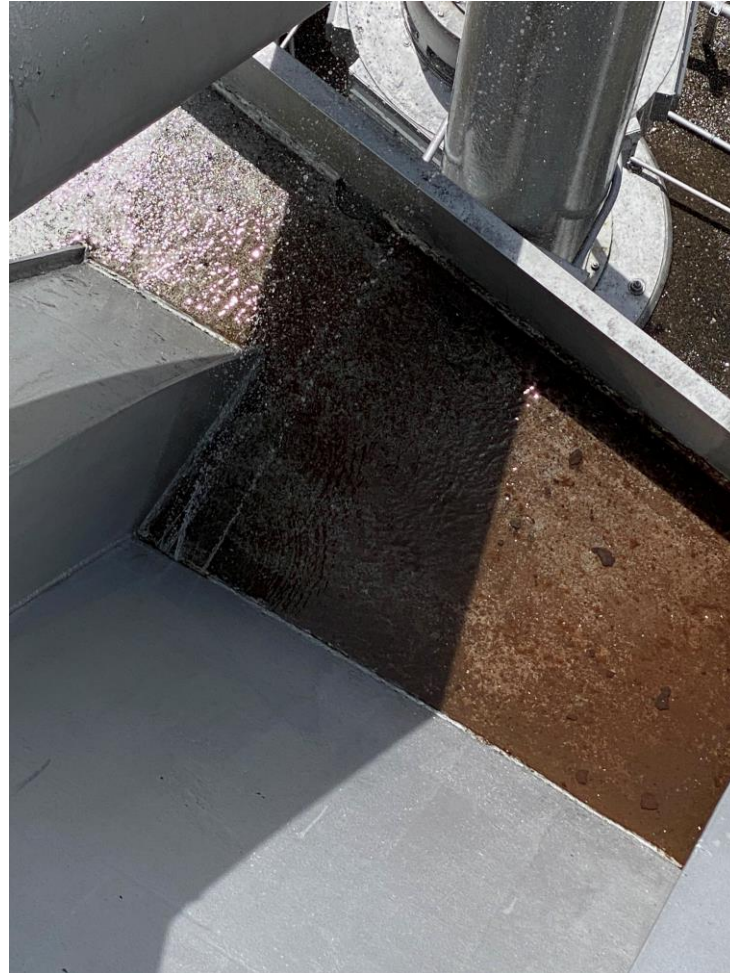
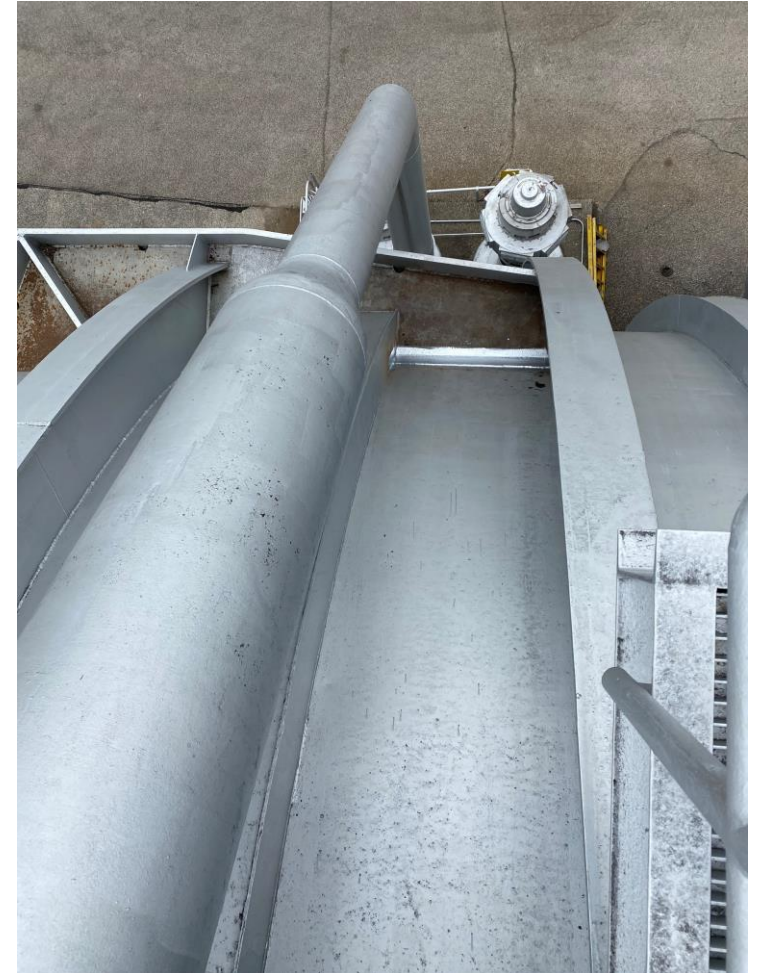
Example 2

- Issue:
 - PSL primary cooler water jacket spraying water on to facility pumps needed for operation.
- Result:
 - Early spotting of leak through maintenance inspections prevented damage to PSL pumps.
- Solution:
 - Leak was repaired by qualified welders and is no longer leaking.
