Establishing Standardized Test Methods for Evaluating Space Suit Gloves

ICES-2023-37

*International Conference on
Environmental Systems*

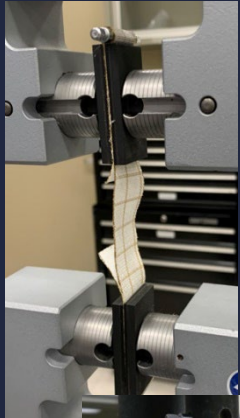
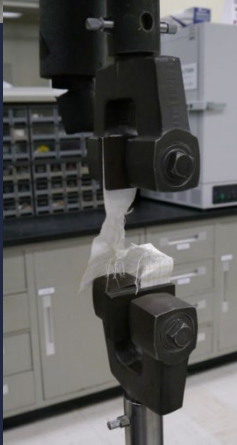
Tensile strength test (upper left). Tear strength test (lower left). Puncture strength test (upper right). Cut resistance test (two in lower right). Image Credit: NASA

- Tensile Strength (ASTM D5035)
- Puncture Strength (ASTM F1342)
- Tear Strength (ASTM D2261)
- Cut Resistance (ASTM F2992)
- Thermal Conductivity (ASTM C 177)
- Abrasion Resistance (ASMT D4966)
- Emissivity (ASTM C1371)
- Air Permeability (ASTM D737)
- Stiffness (ASTM D1388)

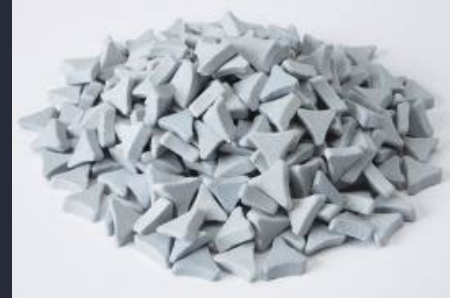
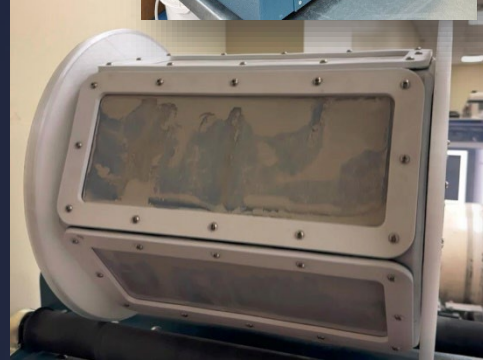
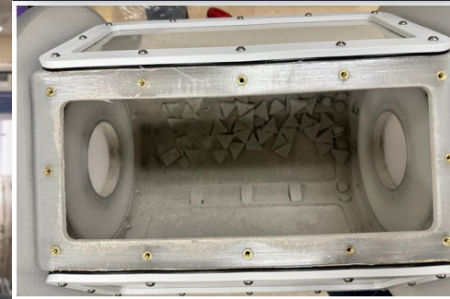
Tumbler apparatus (upper left). Commercially available tumbler media (upper right). Tumbler with dust shown migrating through material (lower left). Tumbler with panel removed to show internals of tumbler after tumbling with Lunar regolith simulant and tumbler media (lower right). Image Credit: NASA

- ASTM representatives were included on the team and bring insight from industry and experience in fabric testing; they document the new standard
- Emphasis on establishing a defined procedure for
 - Preparation of fabric panels
 - Quantifying metrics
 - Cleaning the fabric to prepare it for post abrasion strength testing
- Enhancements were made to improve functionality of test
 - Longer fabric panels are captured in 6 removeable frames
 - Tumbler frames with clear, polycarbonate windows for viewing dust penetration/holes
- Exploratory Testing - Controllable variables were identified and defined
 - Type/quantity of lunar simulant and rock media defined
 - Speed of rotation of tumbler
 - Duration of the test
- Validation Testing - Consistency and Repeatability
 - Performed using Ortho Fabric, Cotton, and Kevlar as reference fabrics

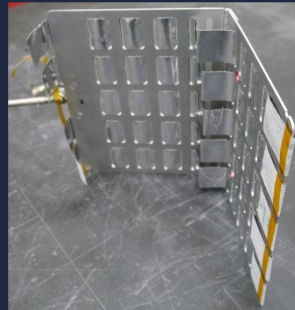
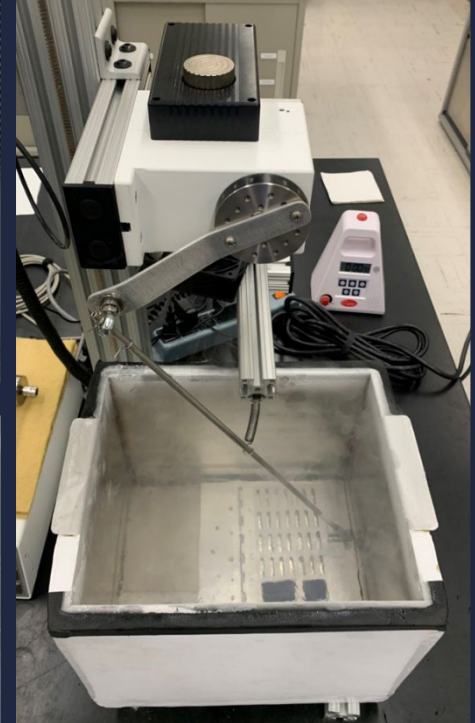
Instron strength test apparatus in LN2 chamber (upper left). Folding apparatus (lower left). LN2 bath with folding apparatus motor and interfaces (right). Image Credit: NASA

- Determine if fabrics degrade from exposure to cryogenic temperatures
 - Not commonly tested
- Limited research available to understand total effect
- Three separate tests included to compare LN2 effects
 - Pre-screen pass-or-fail fold test
 - Completed on a subset fabrics – all fabrics “passed”
 - Instron strength testing with LN2 chamber (tensile, tear, puncture)
 - Not completed due to technical issues
 - NASA developed LN2 folding apparatus with post tensile test
 - Completed on a subset of fabrics

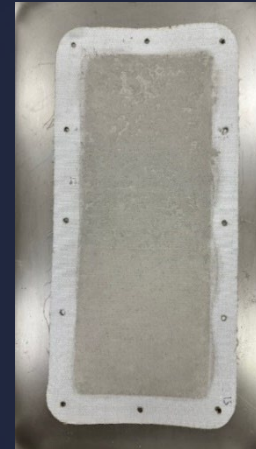
Fabric panel showing remaining lunar simulant after being removed from tumbler (left); Fabric panel showing strips cut for tensile testing (right) Image Credit: NASA

- The fabric test plan is extensive and only a subset was completed for this effort
- Pre-screen cryo crack testing
 - All fabrics “passed” visual inspection
- Abrasion Exposure (Tumbler Test)
 - Baseline data gathered (tensile, tear, cut, puncture, thickness, mass, air permeability, stiffness)
 - Panels of fabric were abraded for 8 hours using lunar simulant and rocks
 - Post abrasion strength data collected

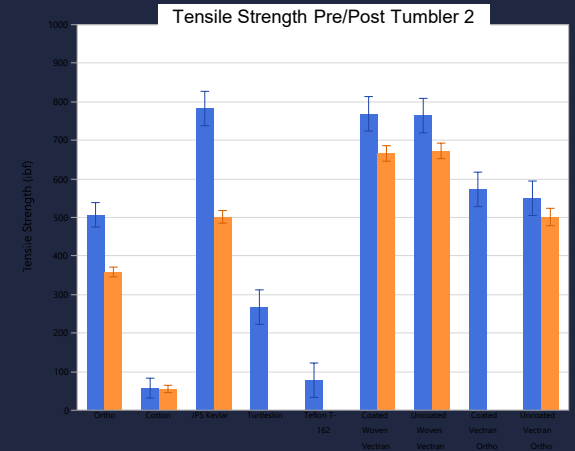
Tensile Results

- What is the variability of the tumbler abrasion test?
- Fabrics were run in 2 unique tumbler drums
- P-Value analysis is being conducted to determine 95% confidence interval of results
- Initial analysis to determine if mean tensile strength is determined by fabric type
- Hypothesis 0: The mean tensile strength is equivalent for all fabrics
- Hypothesis 1: The mean tensile strength is not equivalent for all fabrics

- Baseline: Kevlar, Coated Woven Vectran, Uncoated Woven Vectran > Coated Vectran Ortho, Uncoated Vectran Ortho, Ortho > Turtleskin > Teflon T-162 and Cotton
- Tumbler 1: Coated Vectran Ortho > Kevlar > Ortho > Turtleskin > Cotton and Teflon T-162
- Tumbler 2: Uncoated Woven Vectran, Coated Woven Vectran > Kevlar, Uncoated Vectran Ortho > Ortho > Cotton

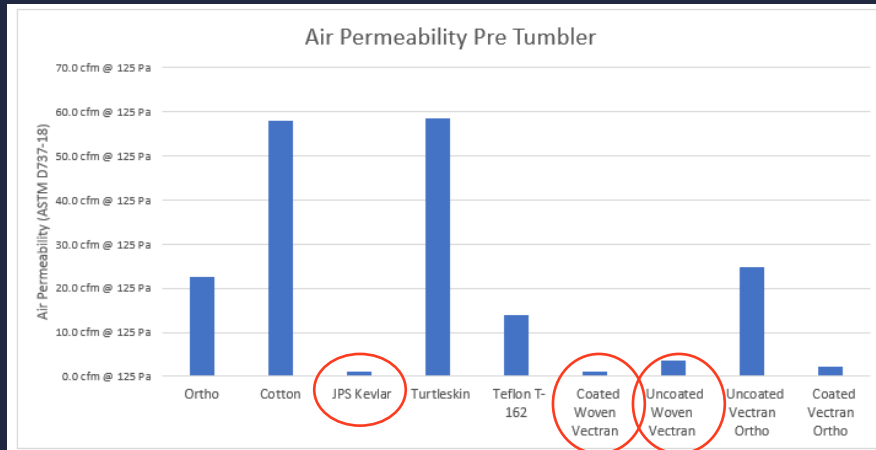
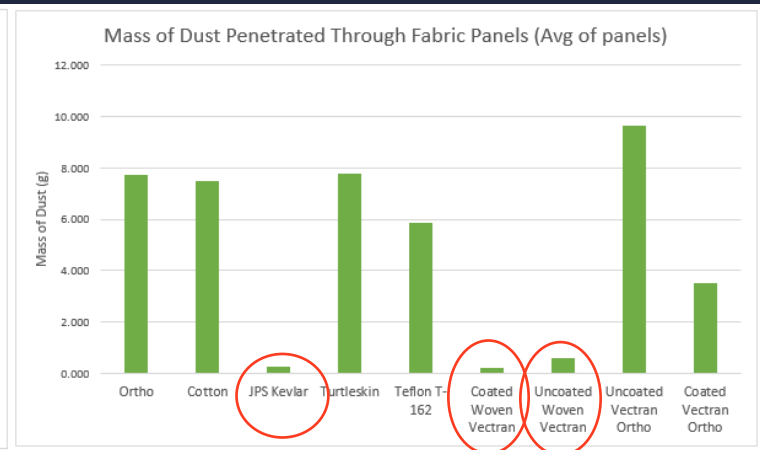
Air Permeability and Dust Penetration Analysis

- Correlation found between fabrics with **low** air permeability/plain weave and amount of dust penetrated
 - Kevlar, Uncoated and Coated Woven Vectran
- Correlation not as strong for fabrics with high air permeability
 - Ortho Fabric, Turtleskin, Teflon, Uncoated Vectran Ortho Fabric

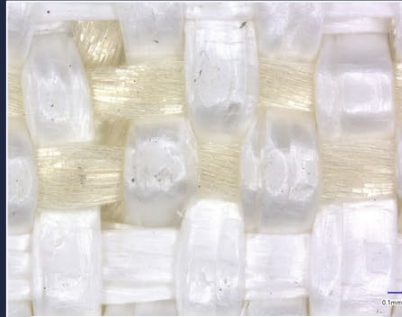
100X Uncoated Vectran Ortho Pre-Tumbler

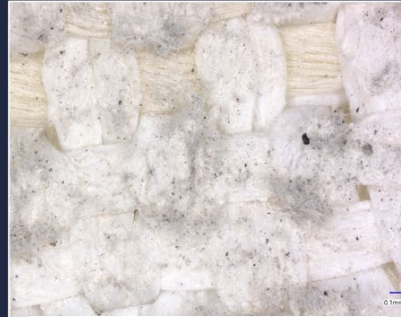
100X Uncoated Vectran Ortho Post-Tumbler

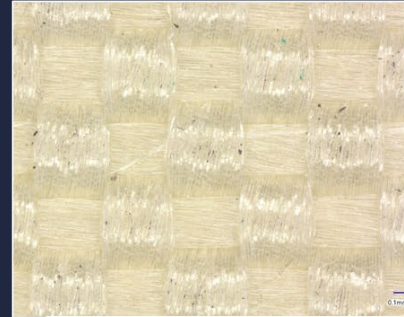
100X Uncoated Woven Vectran Pre-Tumbler

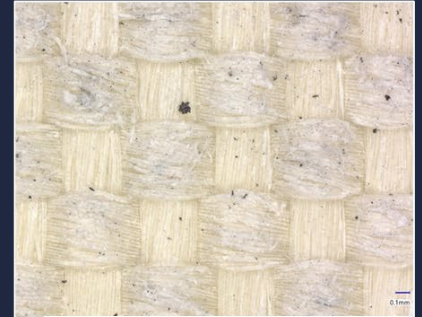
100X Uncoated Woven Vectran Post-Tumbler

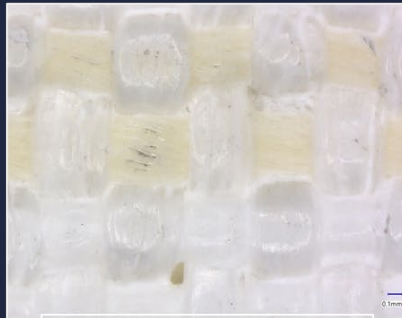
100X Coated Vectran Ortho Pre-Tumbler

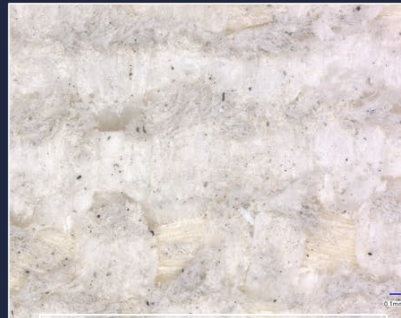
100X Coated Vectran Ortho Post-Tumbler

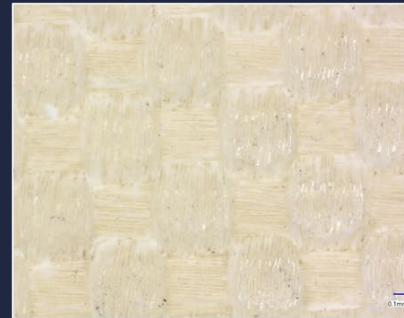
100X Coated Woven Vectran Pre-Tumbler

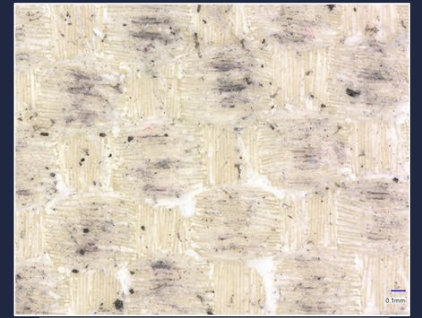
100X Coated Woven Vectran Post-Tumbler
