Surge Current Withstanding Resistor Replacement for ER Carbon Composition

Jacob Hobaugh, Space Systems LLC/GSFC
Kellan McCarthy, Space Systems LLC/GSFC
Bruce Meinhold, SSAI/GSFC
Timothy Mondy, GSFC
Marialena Troia, Space Systems LLC/GSFC

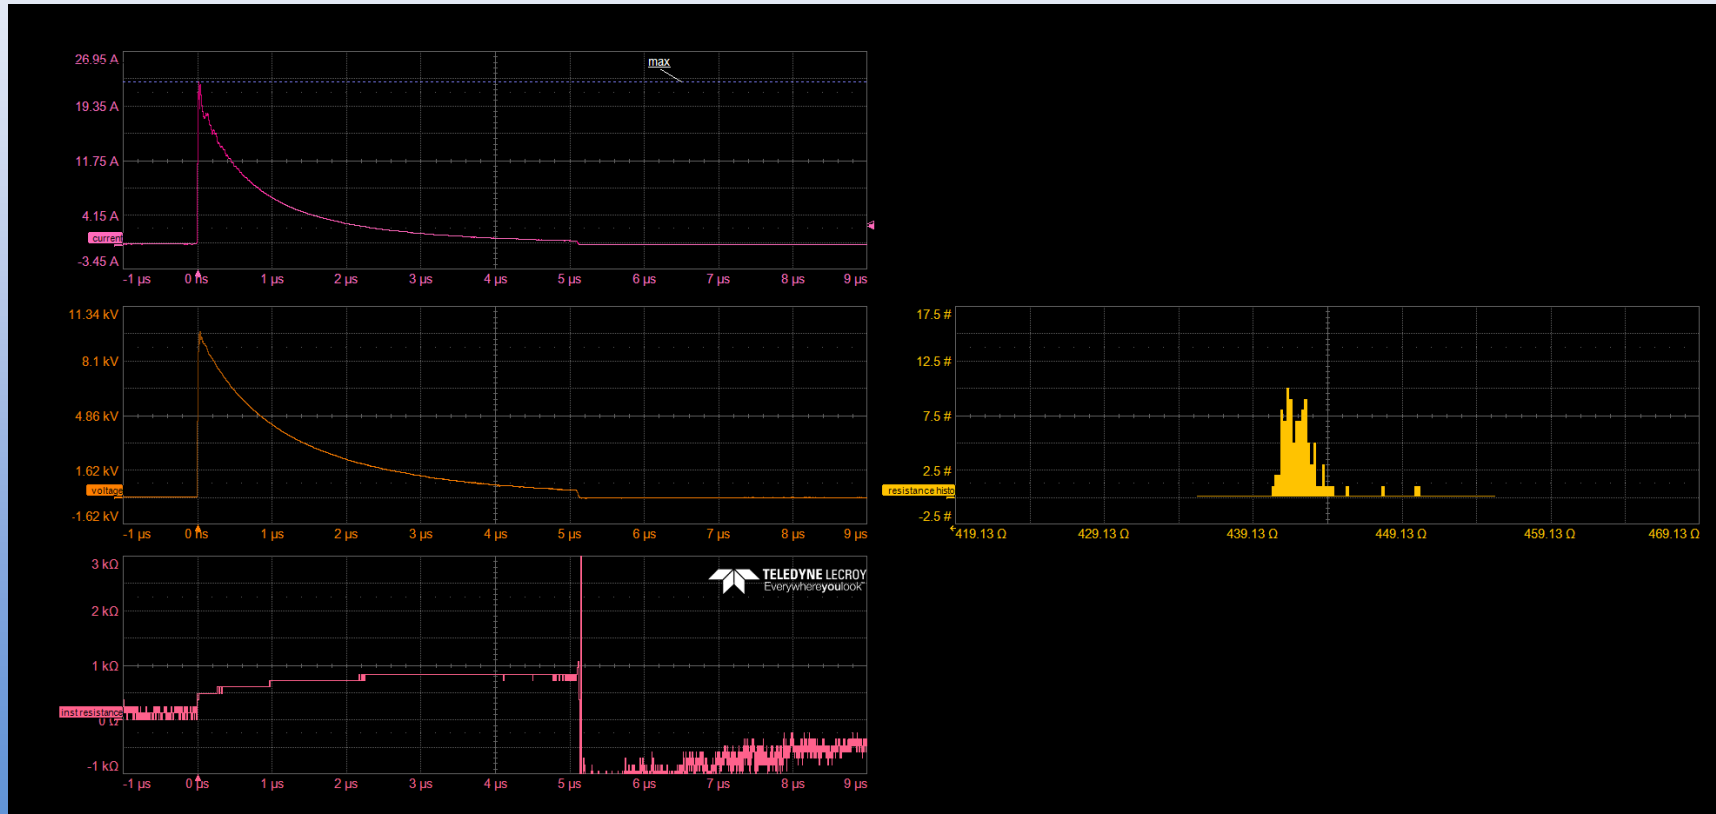
Pulse Shape

- Manufacturer H, 1k Ω , SN3

- The following testing was performed on all samples (except controls)
 - 2,000V, 10 pulses; 4,000V, 50 pulses; 10,000V, 20 pulses; 10,000V, 100 pulses
 - Testing performed by Jacob Hobaugh, Marialena Troia, Kellan McCarthy
- Note that the joule energy per pulse was calculated using

$$Energy = \frac{1}{2} C \times V^2$$

- 2,000V, $Energy \approx \frac{1}{2} (.002 \mu F) \times (2000 V)^2 = 4 mJ / pulse$
- 4,000V, $Energy \approx 16 mJ / pulse$
- 10,000V, $Energy \approx 100 mJ / pulse$
- Total Energy pulsed into each resistor = 12.840J

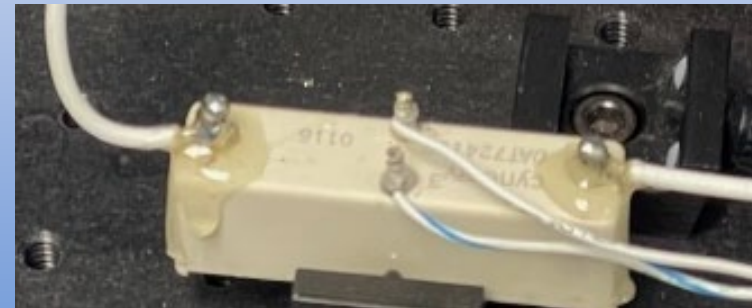
Test Fixture - Modified

- After several thousand pulses, the ball bearing “pulser” began to weld on contact and testing had to be halted.
 - Ball bearing pulse mechanism was replaced with relay

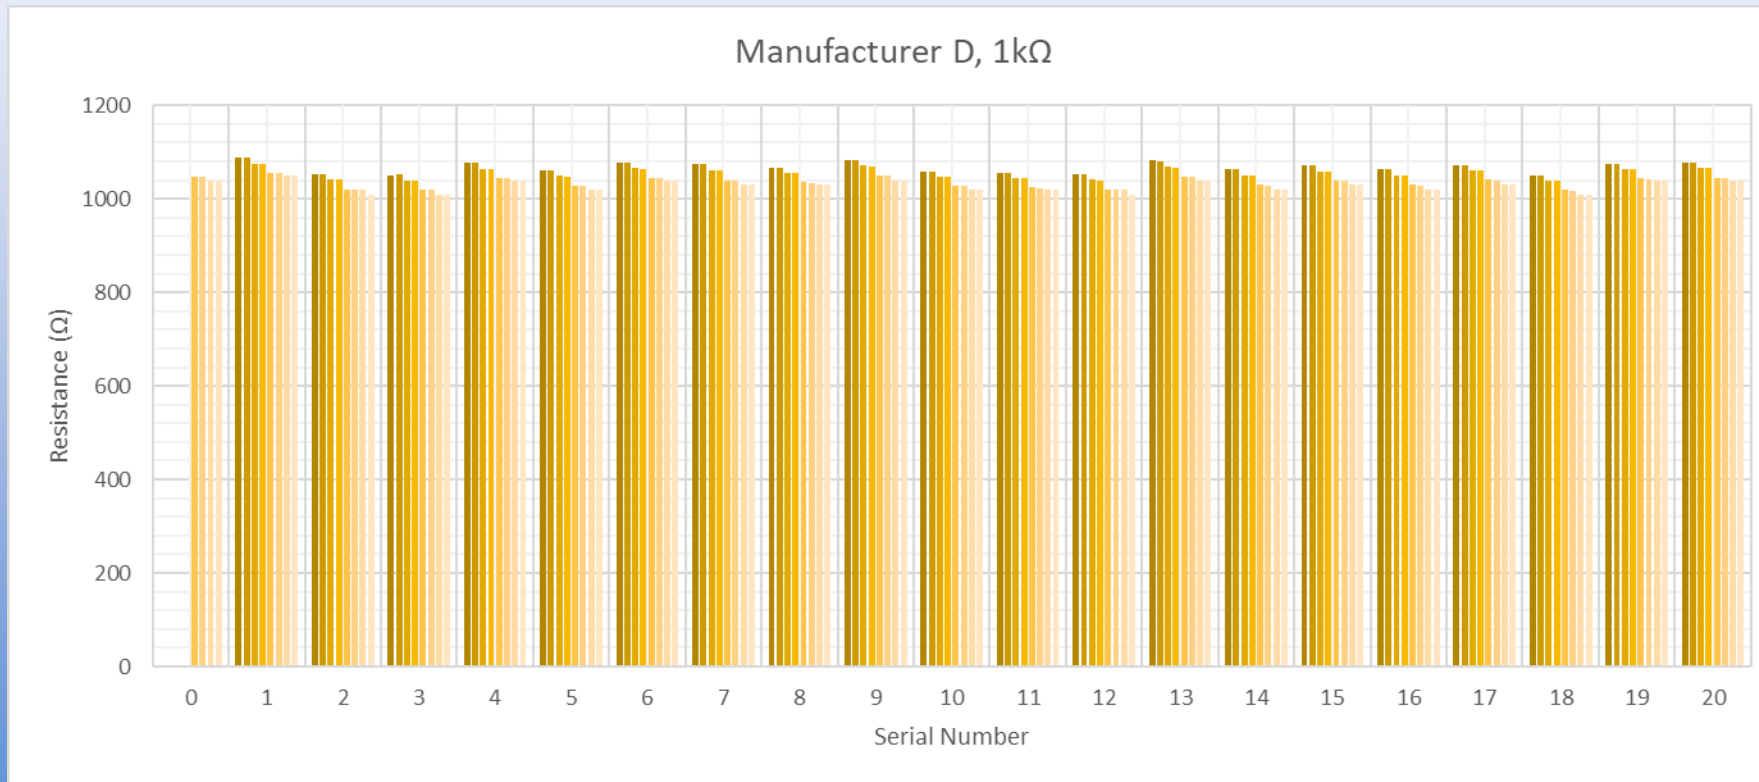
Sample Data - Typical Resistance Degradation Over Pulse Testing

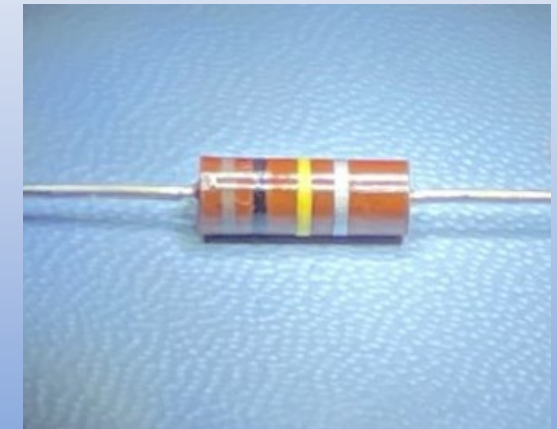
Sample Data – Catastrophic Resistance Degradation Across Pulse Testing

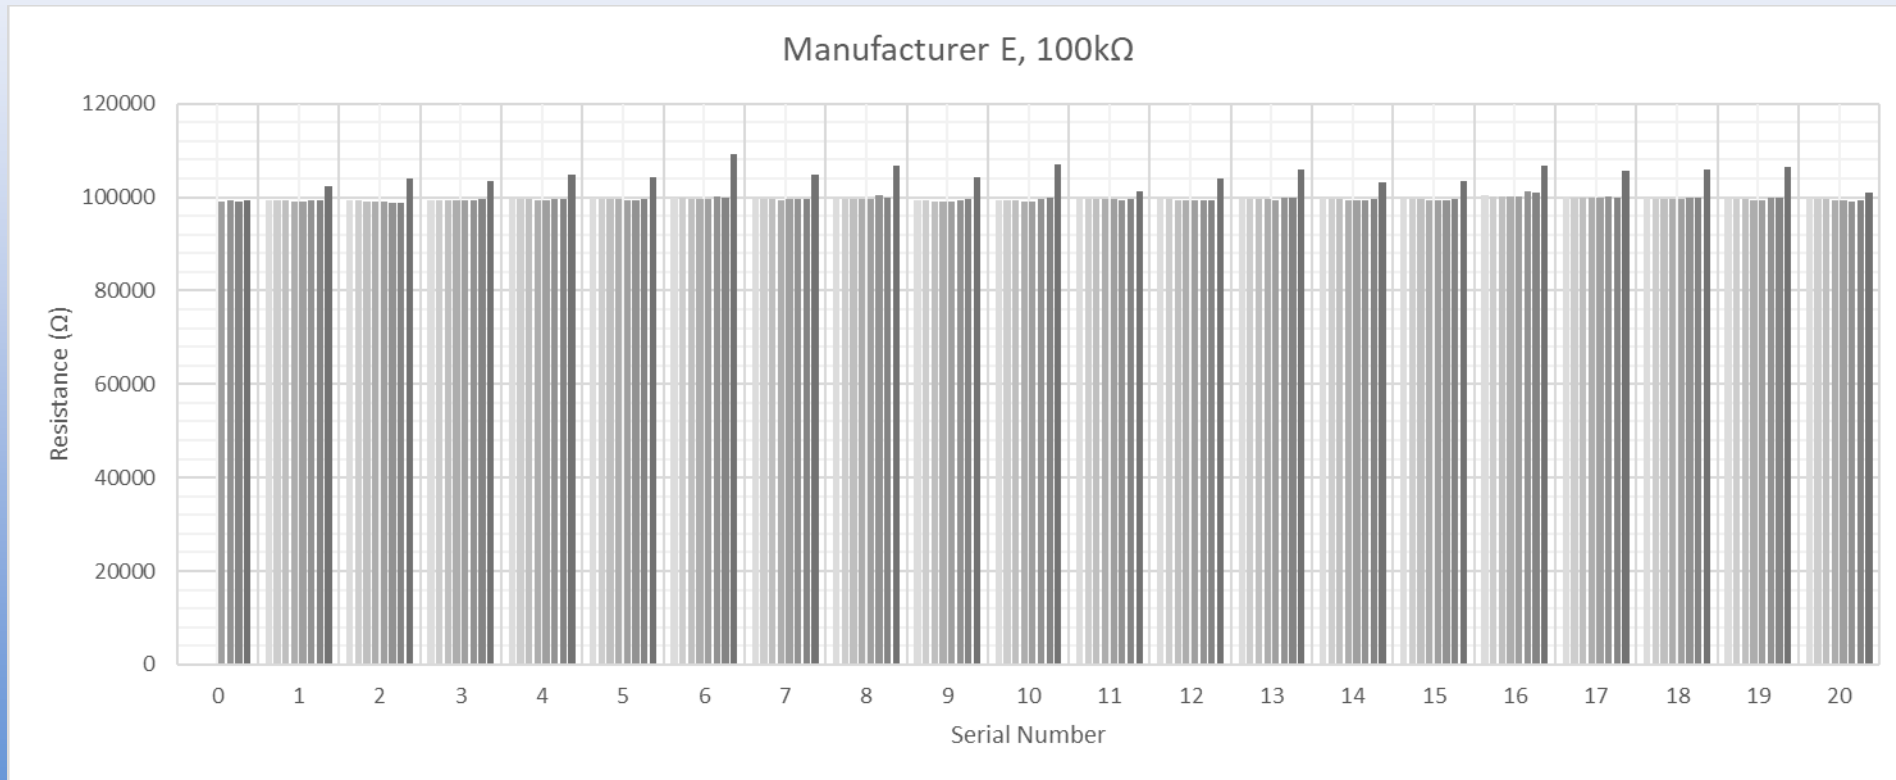
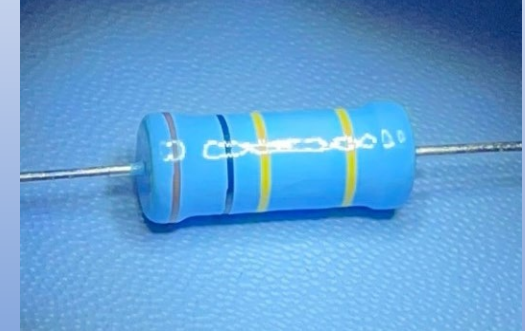
Sample Data – Outlier Resistance Increase

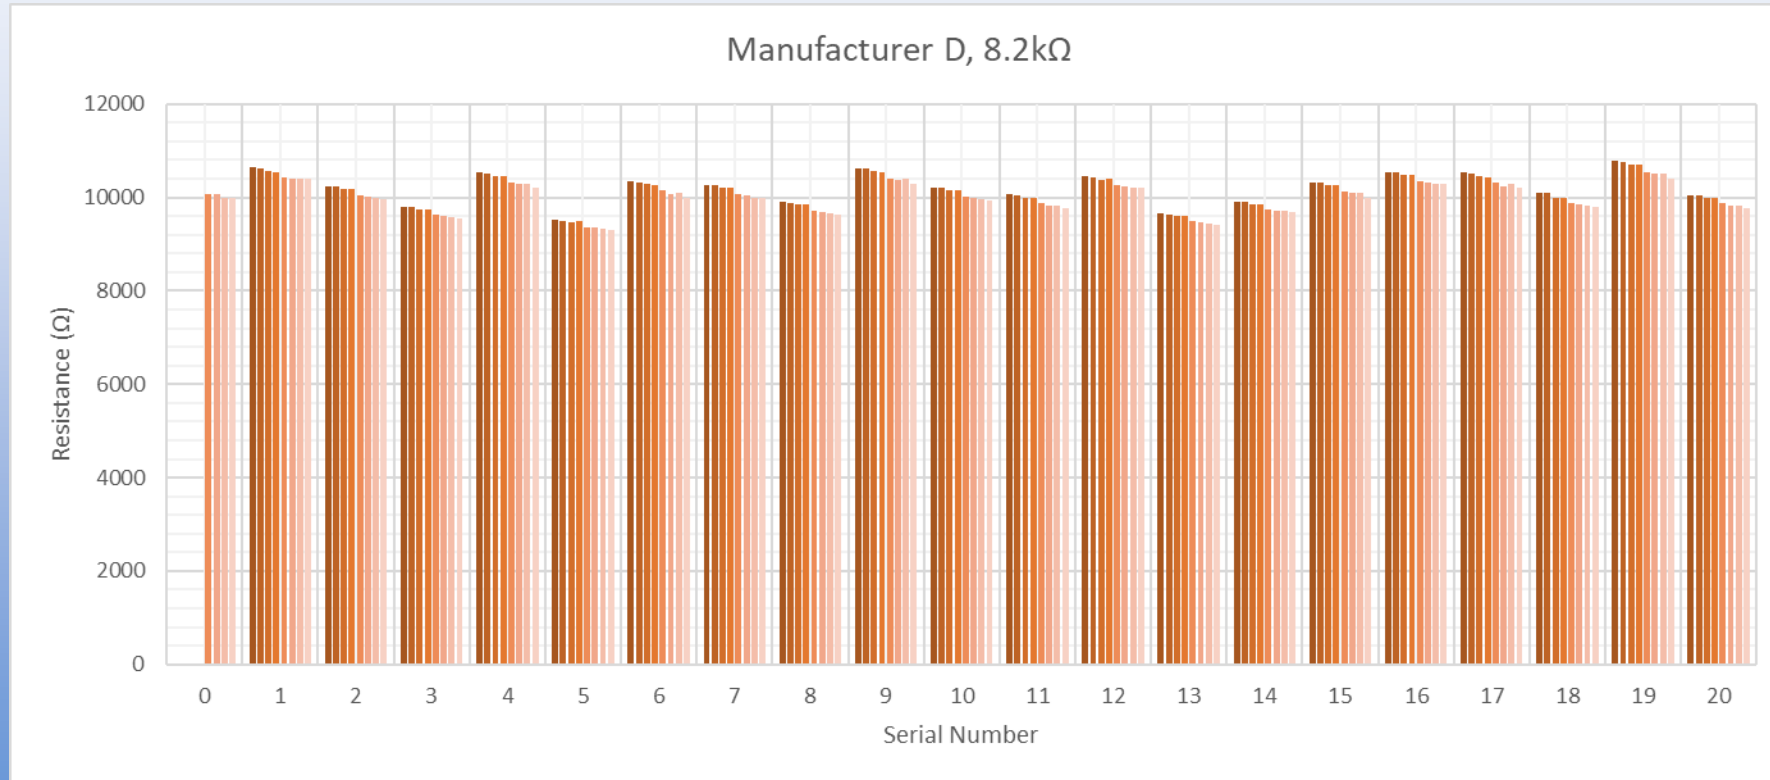
Sample Data - Color Code Not Matching Measurement

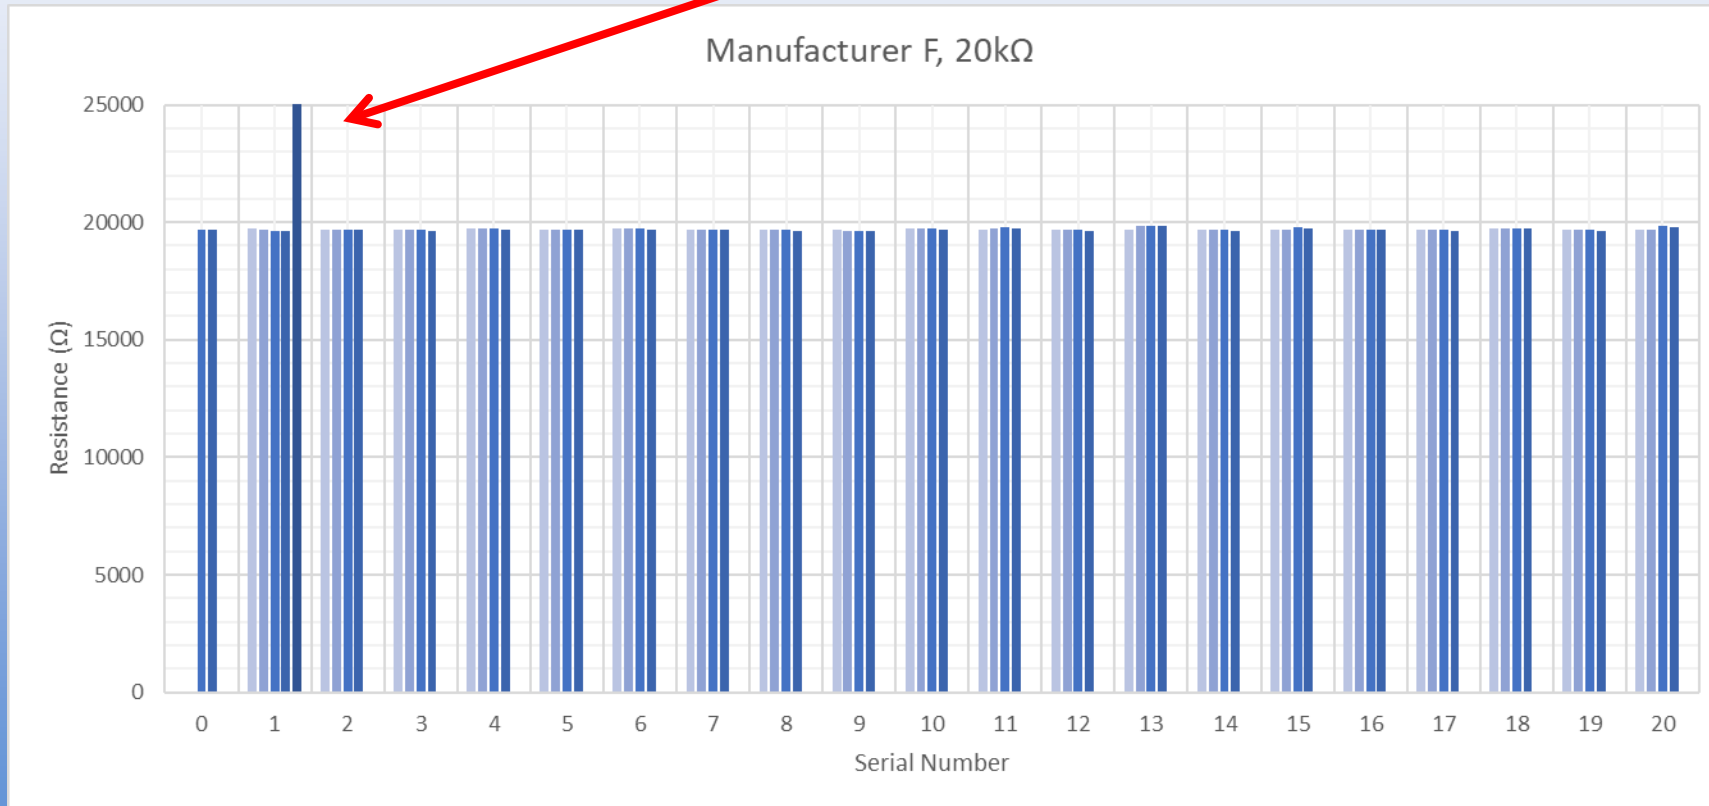
Sample Data – Open Circuit

Part failed open circuit due to electrical overstress at 10kV

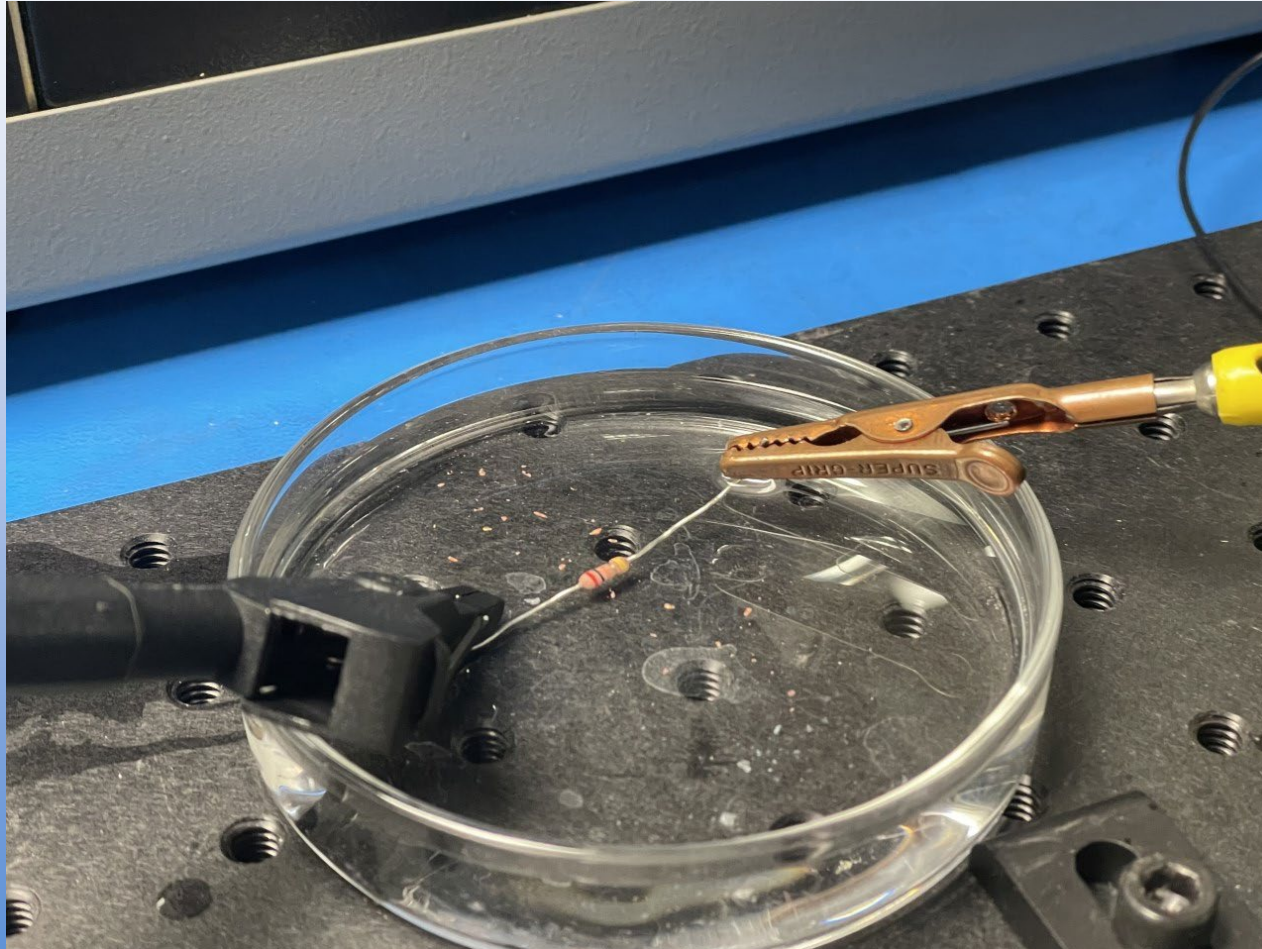
Fluoroinert Bath to Mitigate Arc Through Air

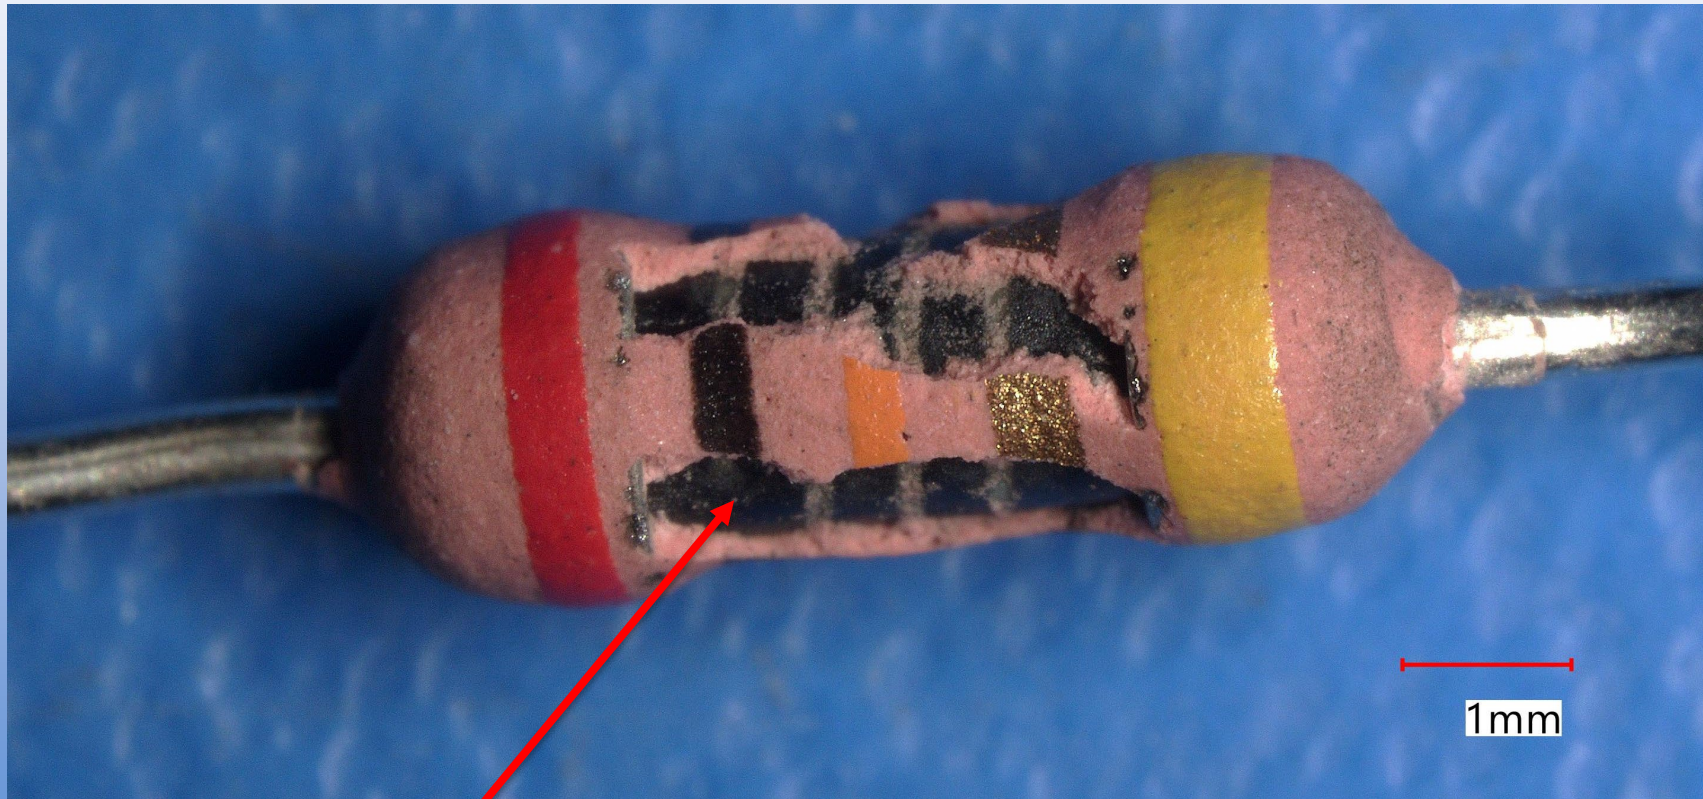
Severe Damage of Coating of Resistor when small part is submerged in Fluoroinert

Arcing damage is in the resistive element
