# SERFE PLSS Component Lessons Learned from ISS

ICES Paper 2023-267

52nd International Conference on Environmental Systems July 2023, Calgary, Alberta, CA

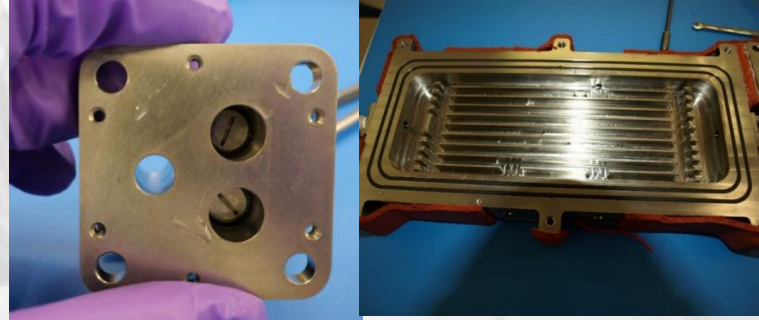
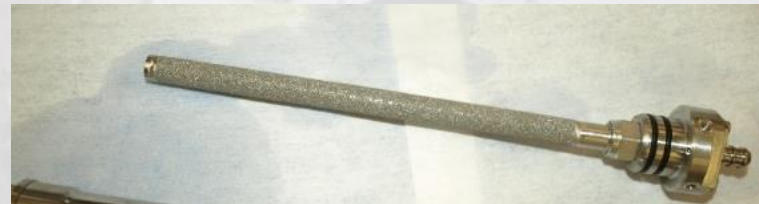
**Various SERFE components following removal, including RV-424A/B (top-left), heater assembly (top-right), TCV-421 shuttle (middle), and F-2048 (bottom).**

- Titanium: excellent strength/density/corrosion resistance properties but poses a challenge with machining titanium parts
- Primary issue during fabrication/assembly: unexpected rust spots on parts using traditional cutting operations to 3-D printed titanium manifolds
  - Titanium doesn't rust => process control issues left iron deposits
    - Dull tool on mill or poor cleanup between runs on laser sintering machine?
- Led to better control of manufacturing processes when xEMU thermal loop components were made

- Most of SERFE Flight unit titanium parts looked pristine during posttest inspections
  - Thermal control valve (TCV-421)
  - Relief Valves (RV-424A/B)
  - Heater (HTR-2060)
  - Filter (F-2048)
- Titanium as primary wetted metal in xEMU thermal control loop was a good choice once team learned to overcome machining challenges

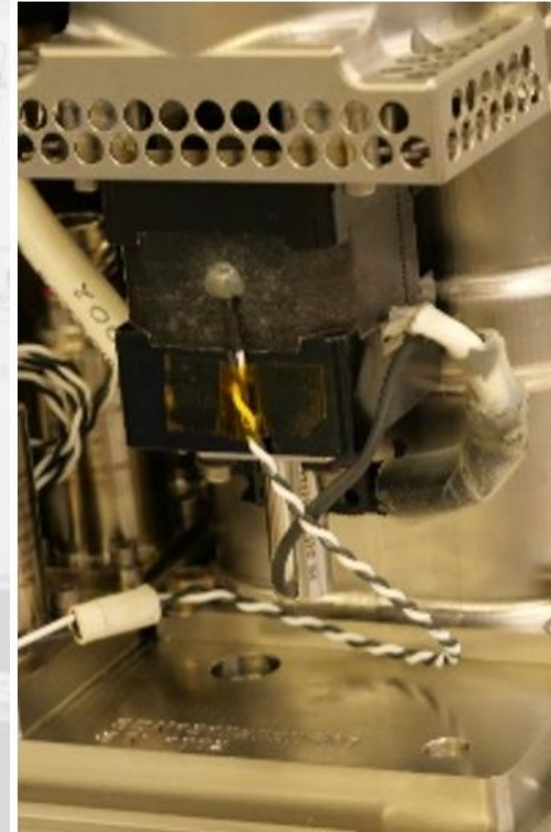
**Body rust on linear actuators of SWME BPV (left) and TCV-421 (right).**

- **Linear actuators (same as current xEMU PLSS hardware):**
  - SWME backpressure valve (BPV)
  - TCV-421
- SERFE Flight Unit in operation for over 2 years & never jammed due to cautious procedural controls
- SERFE TCV actuator tested for force output/evaluated for jamming: compared to linear actuators from xEMU with sticking history
  - Body rust observed on both SERFE actuators
    - Steel parts painted but exposed to humid environment inside of SERFE vacuum chamber
    - It is possible condensation formed on hardware after test points were completed

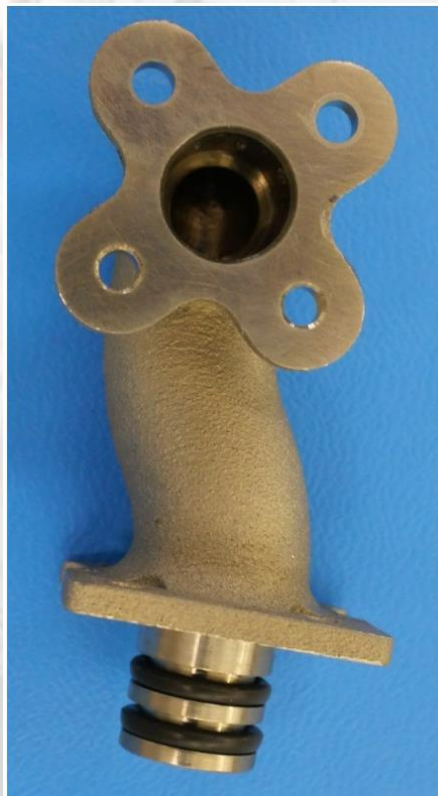
**Presumed rust spots on secondary pump manifold.**

- Pump inlet filter (422C)
- Pump check valve (CKV-427) at pump outlet
- Pump worked well on ISS
- Disassembly: rust spots on 3-D printed titanium manifolds/“tarnishing” of nitrided (gold colored) titanium pump body parts (M&P issues during assembly of pumps)
  - 422C: no FOD
  - CKV-427: looked good
- No component level testing performed at this time

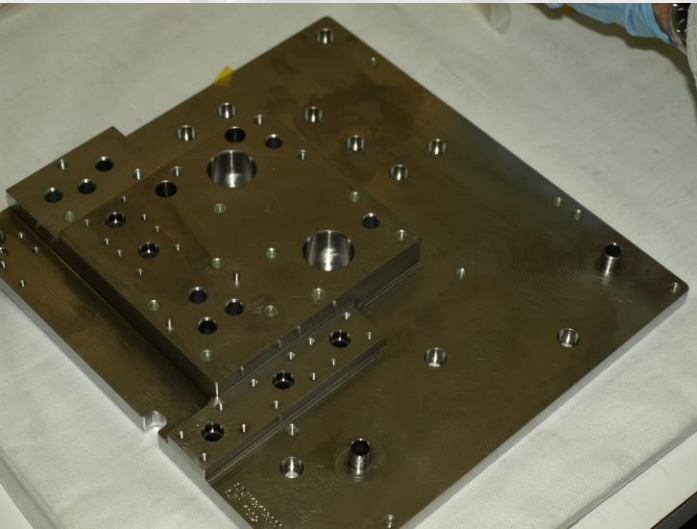
SERFE Backplate with Integrated Fluid Passages.<sup>1</sup>

- **Backplate/fluid ports inspection:**
  - Borescope used for visual inspection
  - Sectioned backplate to inspect weld joints of fluid passages
    - “Areas of interest” cut to locate anomalies (surface finish/mineral deposits in inlet ports)/create samples for further sectioning
  - Residual markings from electron beam welding close out plates to make water channels, reactions between backplate and water, left over water droplets reflecting off light
- M&P results/lessons learned from backplate
  - Reference 2023 ICES paper: “xPLSS Structural Backplate Design, Manufacture, and Test Overview.”<sup>4</sup>
