# High-Cycle Fatigue Behavior of SiC-based Ceramic Matrix Composites (CMCs) at High Temperatures

**11<sup>th</sup> International Conference on High Temperature Ceramic Matrix Composites (HTCMC'11)**  
**Symposium 10: Testing and Evaluation of Composites (Thermomechanical Behavior and Performance of Composites / Standard and DB)**

**Funded by NASA Hybrid Thermally Efficient Core (HyTEC) Project**

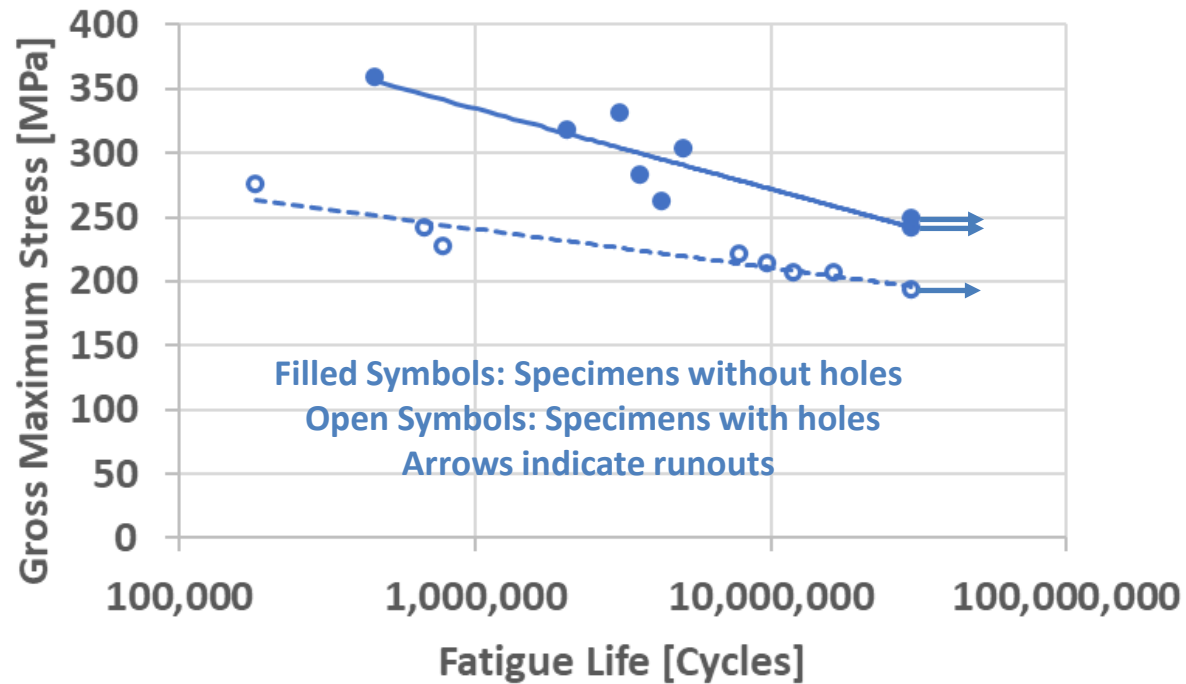
## High-Cycle Fatigue (HCF) Behavior without & with Simulated Cooling Holes at 816 °C (1500 °F)

**As expected, based on gross stress simulated cooling holes reduced HCF durability at 816 °C (1500 °F). However, only a small effect is observed with net section stress**

- ✓ **HCF lives of specimens with holes are somewhat lower than that of specimens without holes; more so at 1315 °C than at 816 °C. This might be due to cyclic creep and oxidation within cracks formed during HCF at the higher temperature.**

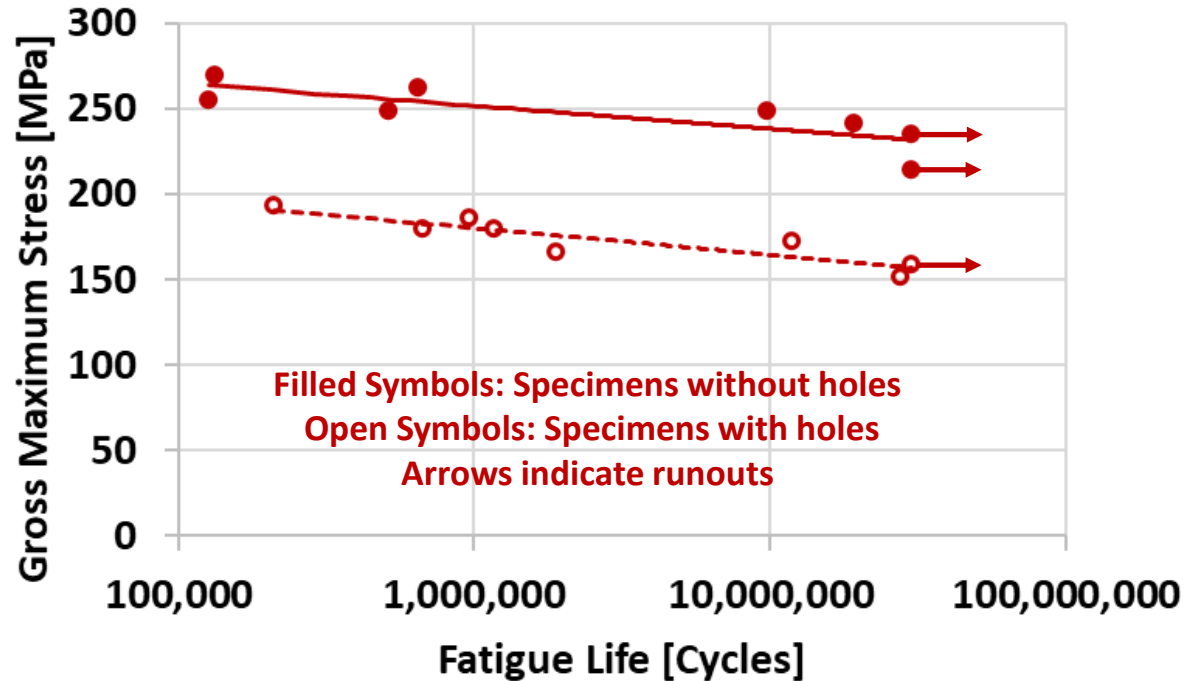
## High-Cycle Fatigue (HCF) Behavior without & with Simulated Cooling Holes at 1315 °C (2400 °F)

**Based on gross stress simulated cooling holes reduced HCF durability at 1315 °C (2400 °F). Reduction in fatigue life is evident even when accounting for net section stress**

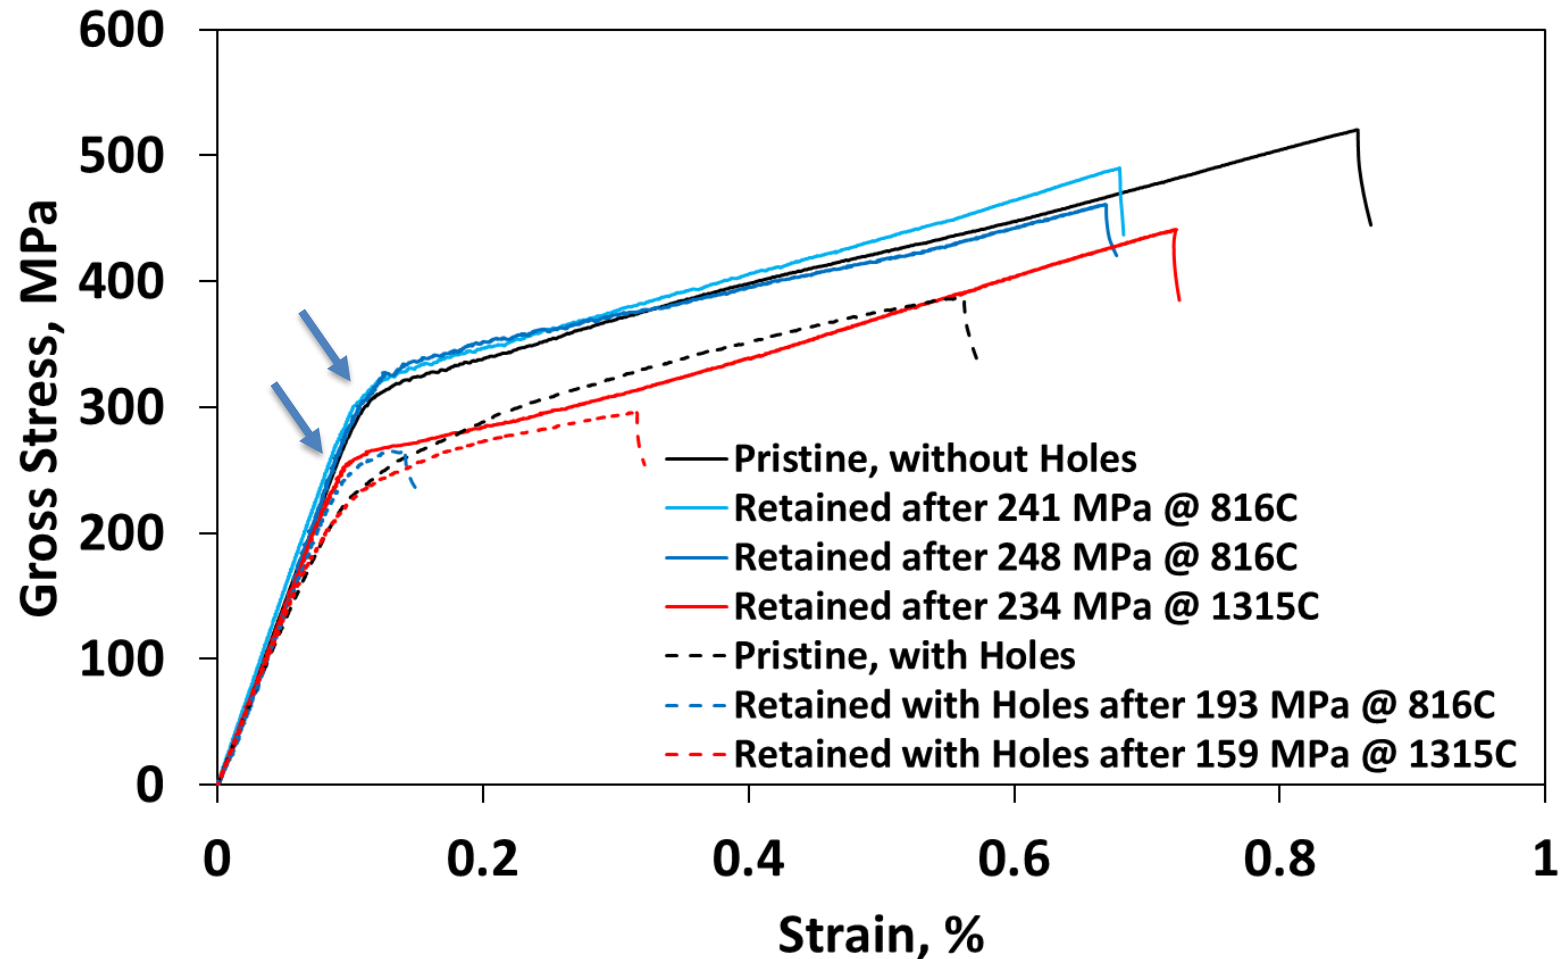
# Room Temperature Baseline (Pristine) & Residual Tensile Strength Tests on Specimens without and with Holes

- As expected, on a gross stress basis, proportional limit strength (PLS) values of specimens with simulated cooling holes (baseline and retained strength) are lower

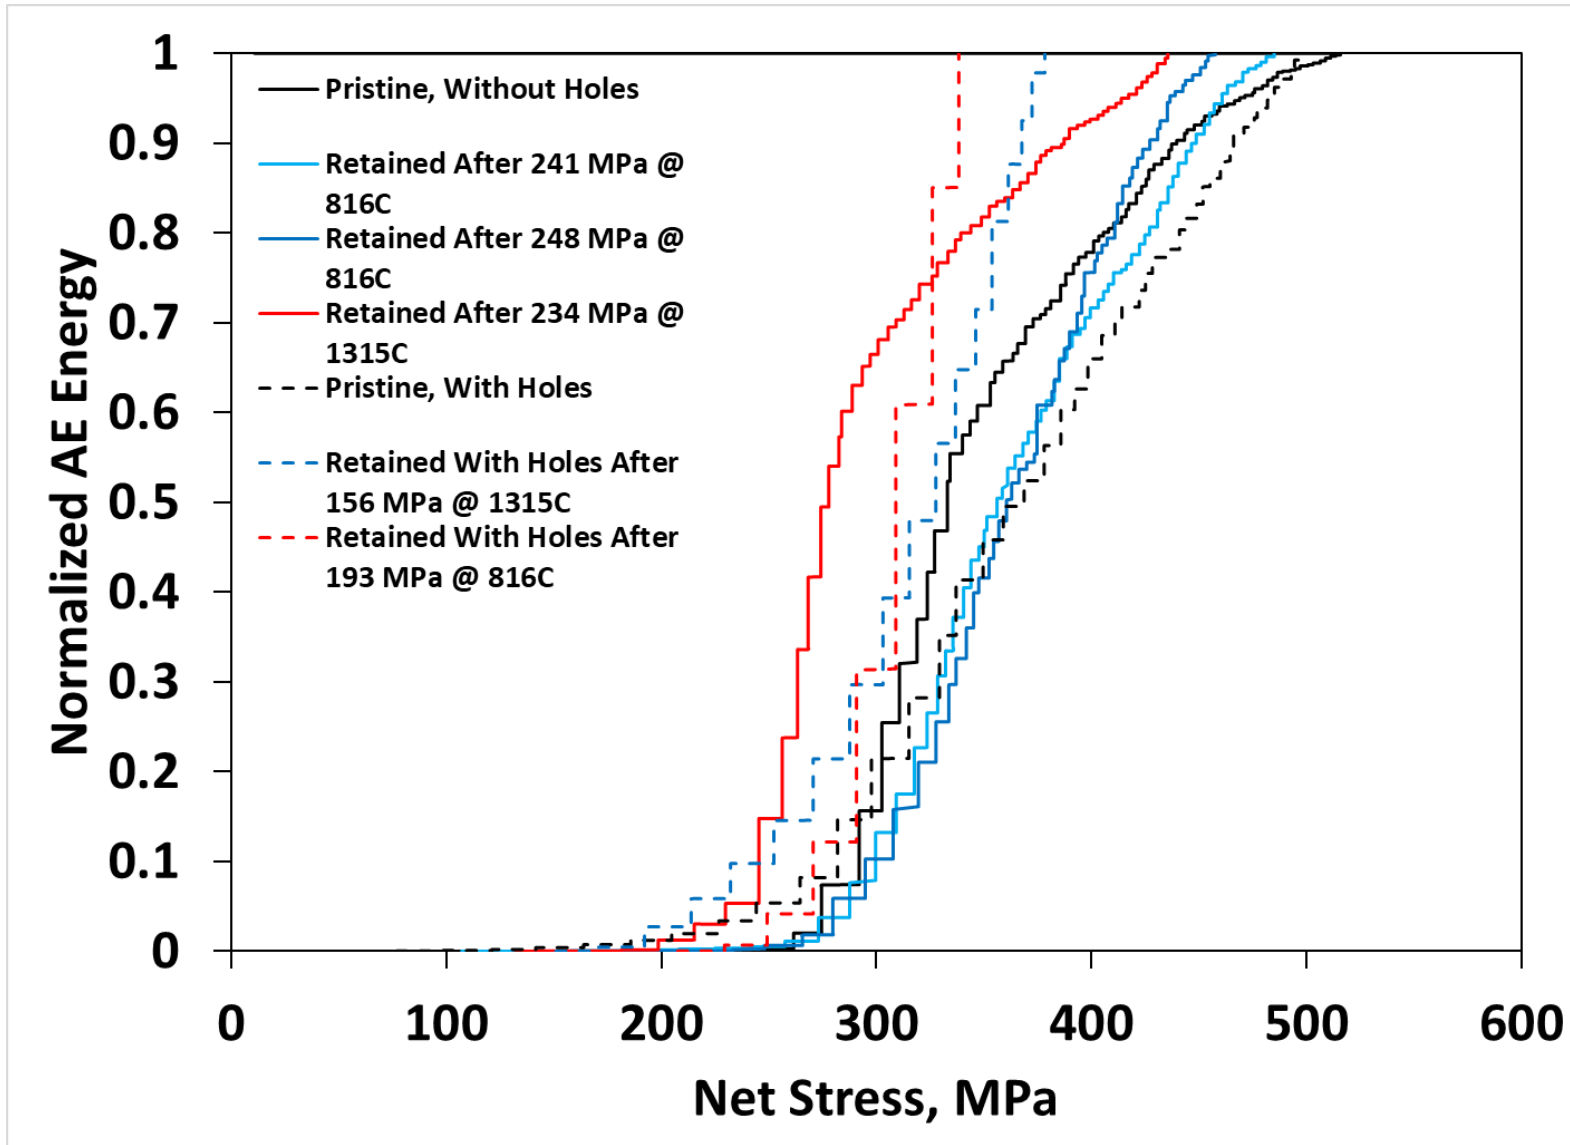
# Room Temperature Baseline & Residual Tensile Strength Tests on Specimens without and with Holes

□ When compared on a net section stress basis, differences in the stress levels triggering onset of acoustic events diminishes between specimens without and with simulated cooling holes

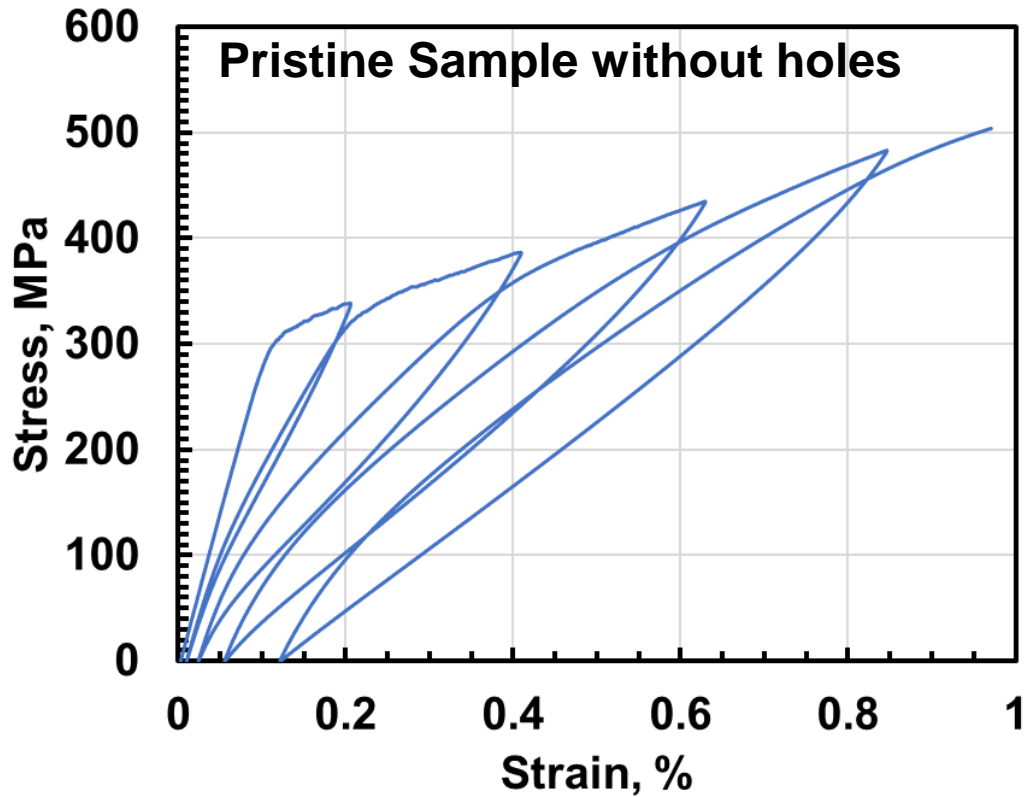
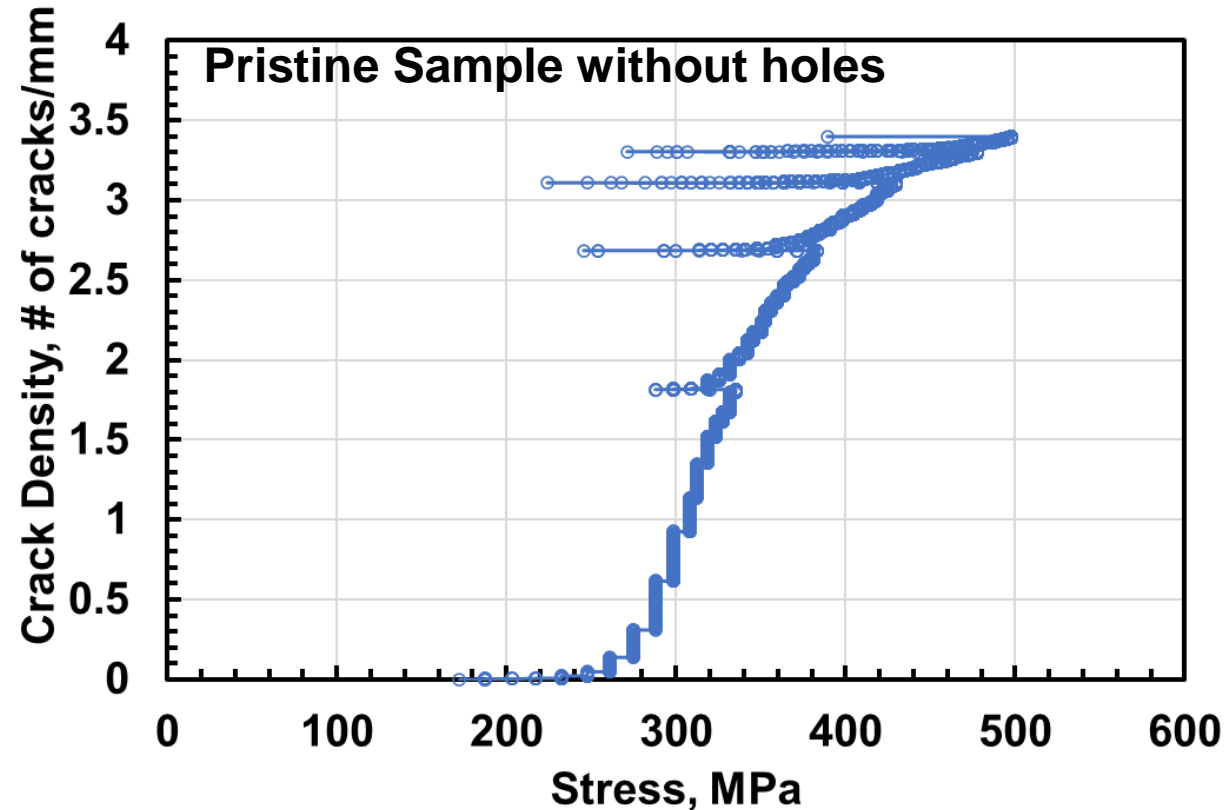
# Stress-Dependent Crack Density Evolution Derived from AE

- The normalized cumulative AE energy curve for a pristine sample without holes tested at RT in hysteresis loading to failure was multiplied by the measured crack density at failure to obtain the stress-dependent crack density evolution.

Sample Condition	# of AE Events
Pristine Tensile	11134
HCF Runout at 816 °C, 241 MPa then Tensile at RT	8868
HCF Runout at 1316 °C, 234 MPa then Tensile at RT	9516

- Crack formation and propagation at room and high temperature were discussed and crack densities were measured.**
- AE was used to estimate the stress dependent crack density evolution at RT.**
