Results from InSight Robotic Arm Activities

Abstract

The InSight lander carried an Instrument Deployment System (IDS) that included an Instrument Deployment Arm (IDA), scoop, five finger “claw” grapple, forearm-mounted Instrument Deployment Camera (IDC) requiring arm motion to image a target, and lander-mounted Instrument Context Camera (ICC), designed to image the workspace, and to place the instruments onto the surface. As originally proposed, the IDS included a previously built arm and flight spare black and white cameras and had no science objectives or requirements, or expectation to be used after instrument deployment (90 sols). During project development the detectors were upgraded to color, and it was recognized that the arm could be used to carry out a wide variety of activities that would enable both geology and physical properties investigations. During surface operations for two martian years, the IDA was used during major campaigns to image the surface around the lander, to deploy the instruments, to assist the mole in penetrating beneath the surface, to bury a portion of the seismometer tether, to clean dust from the solar arrays to increase power, and to conduct a

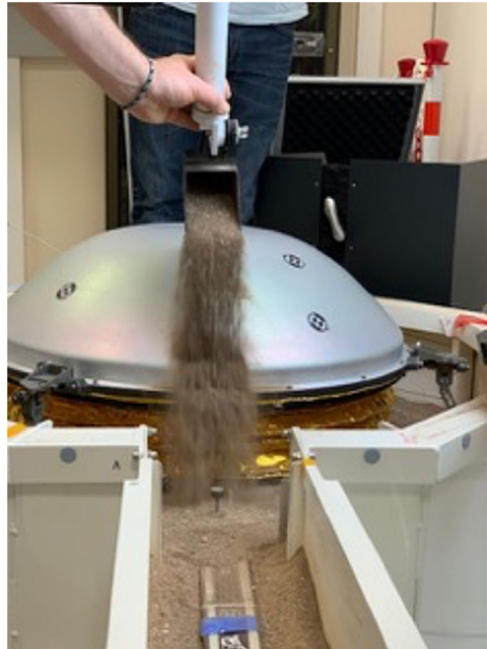
Fig. 9 Dump test on the WTS and SEIS tether in CNES testbed, using a hand-held three dimensional model scoop. Note the ball on the post of the pinning mass of the tether upon which soil is being dumped

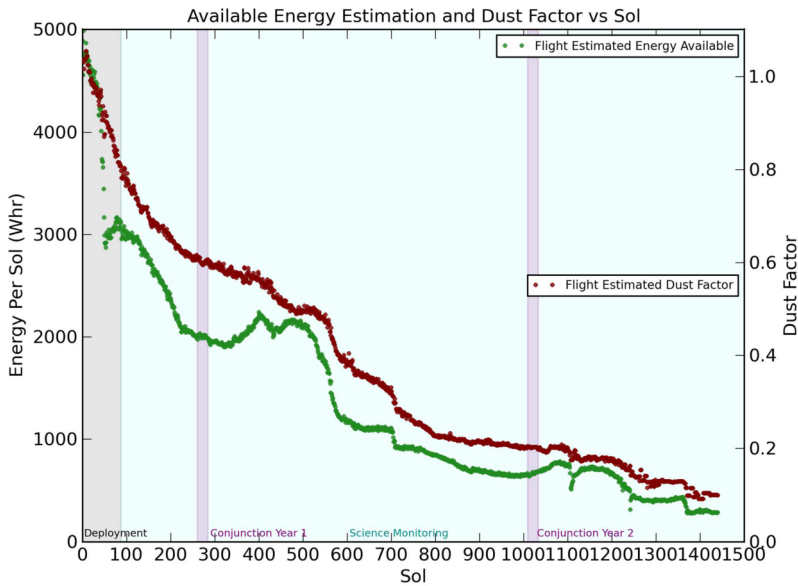
Fig. 16 Plot of energy generated per sol (green) and the dust factor (red) versus time (sol) of the InSight lander. Power decreased exponentially and the dust factor worsened by $\sim 90\%$ in the roughly 2 Mars years of the mission (1442 sols). Increased rates of change in dust factor (and power production) correlate with periods of higher atmospheric opacity associated with dust storms

irradiance reaching the cells by a loss factor, a value generally between 0 and 1 that limits the amount of that remaining direct and diffuse irradiance the cells receive. The dust factor is derived from a model of the power system based on ground testing data that includes different amounts of dust on the panels and illuminations from various angles. The dust factor is plotted in Fig. 16 and also follows a generally exponential decay from 1 immediately after landing to around 0.13 (13%) on sol 1337 after nearly 2 Mars years.

The dust accumulation on the InSight arrays was essentially unremitting (Lorenz et al. 2021a), with only one or two detectable cleanings of the order of 1% (e.g., Figs. 16). This is in stark contrast to the quasi-regular 30% cleaning events seen on Spirit and Opportunity’s solar panels (Stella and Herman 2010), and on optical sensors on Curiosity (Vicente-Retortillo et al. 2018; Lorenz et al. 2021b). One speculation has been that stronger background winds cause shear that suppresses the formation of the largest, most intense vortices which are responsible for the majority of dust lifting. This is supported by the increase in power law slope of the vortex pressure drop (a measure of intensity) in the InSight population measured by the meteorology instruments compared with other missions (e.g., Banfield et al. 2020), and in the character of the dust devil tracks at InSight compared with Gusev. These are both narrower (suggesting an absence of large vortices) and straighter (suggesting advection dominated by background winds) (e.g., Spiga et al. 2021; Chatain et al. 2021) in contrast with the cycloidal, meandering tracks often seen at Gusev.

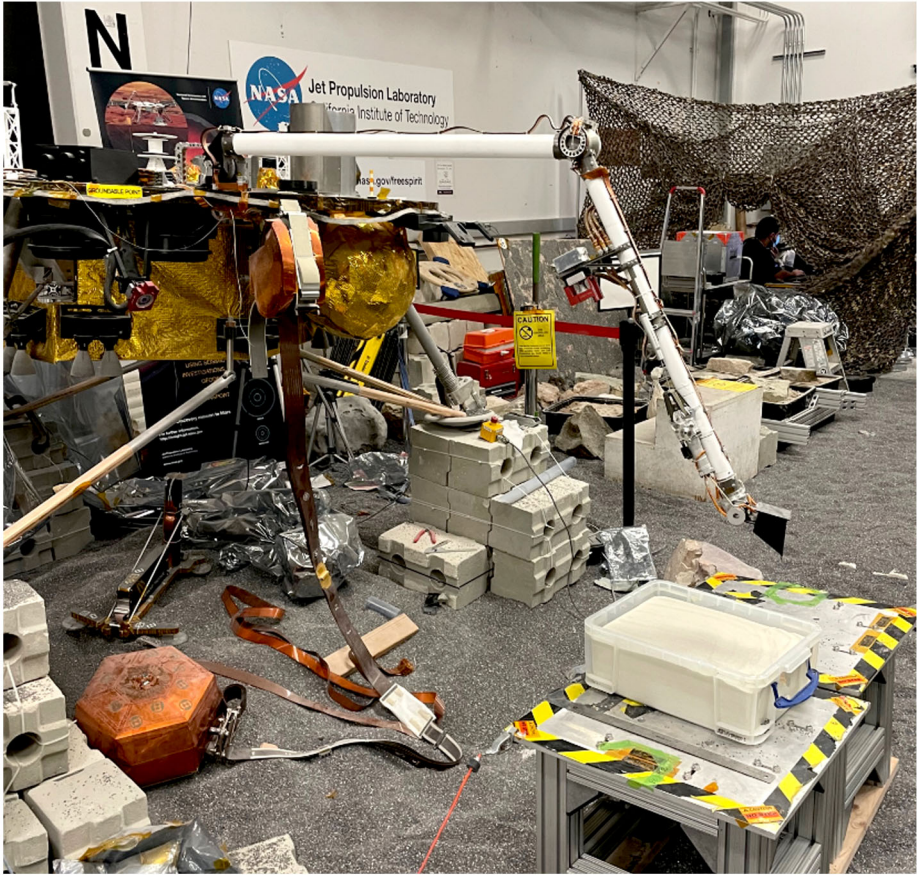
Fig. 27 Picture of the engineering model lander, robotic arm, and scoop in the JPL testbed. Note the container of simulant below the arm as well as the SEIS and HP³ models on the surface to the left. The IDC is on the forearm of the IDA and the ICC is mounted beneath the deck to the left (with red around the lens). Note the lander feet were placed on cinder blocks to enable end to end testing of arm activities that assisted the HP³ mole and interacted with the surface
