# Characterization of Low-Velocity Impact Damage in Thermoplastic Laminated Composites

Wade Jackson, Cheryl Rose, and Frank Leone

NASA Langley Research Center

38<sup>th</sup> American Society for Composites Technical Conference  
Greater Boston, Massachusetts, September 18–20, 2023

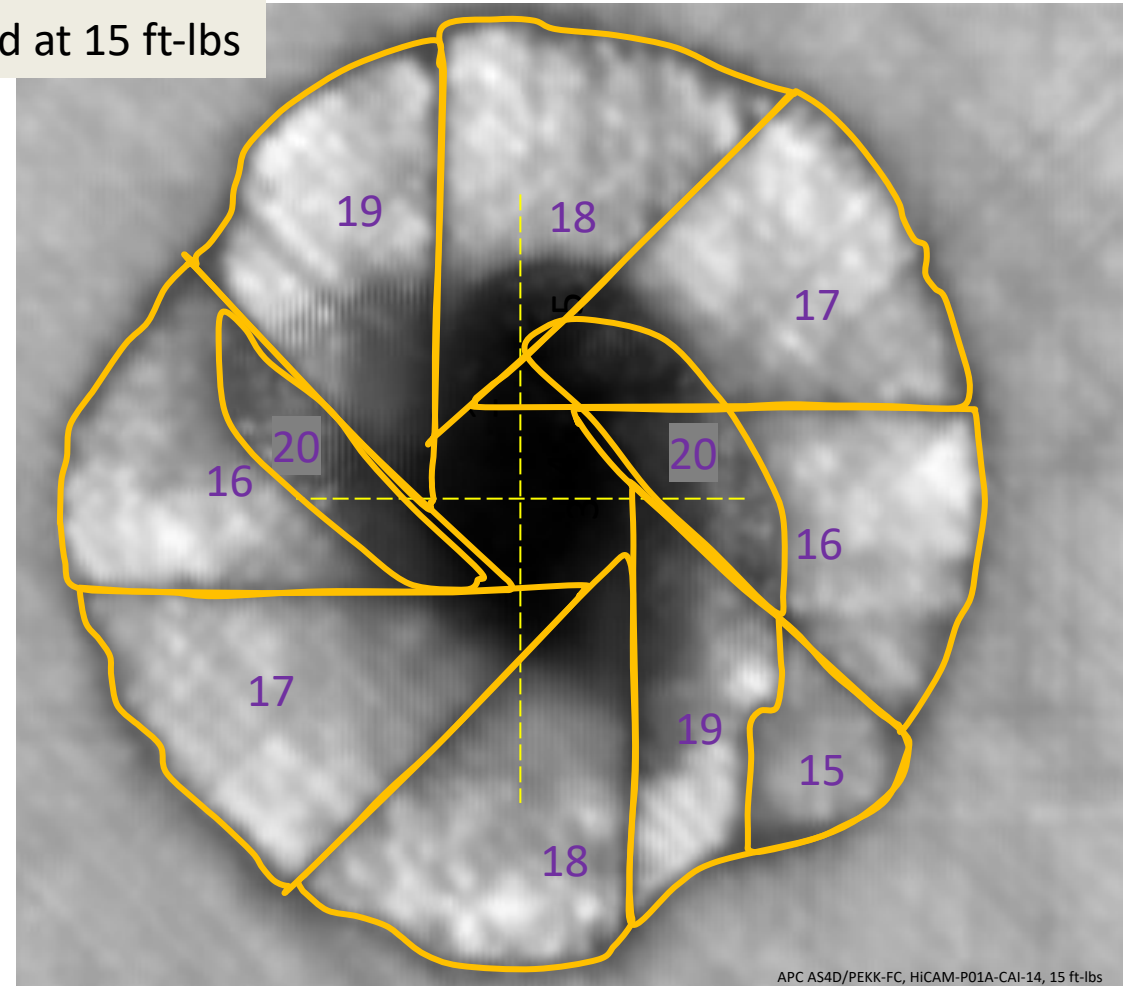
# Delaminated Interfaces Determined Using UT Time-of-Flight and X-Ray CT data

Impact Surface [-45/0/+45/90/-45/0/+45/90 /-45/0/+45/90/90/+45/0/-45/ 90/+45/0/-45/ 90/+45/0/-45] Back Surface

Interface #: 1 2 3 4 5 6 7 8 9 10 11 12 13 14 15 16 17 18 19 20 21 22 23 **Delamination**

Impact Side

Back Side (flipped left/right to match impact side UT)

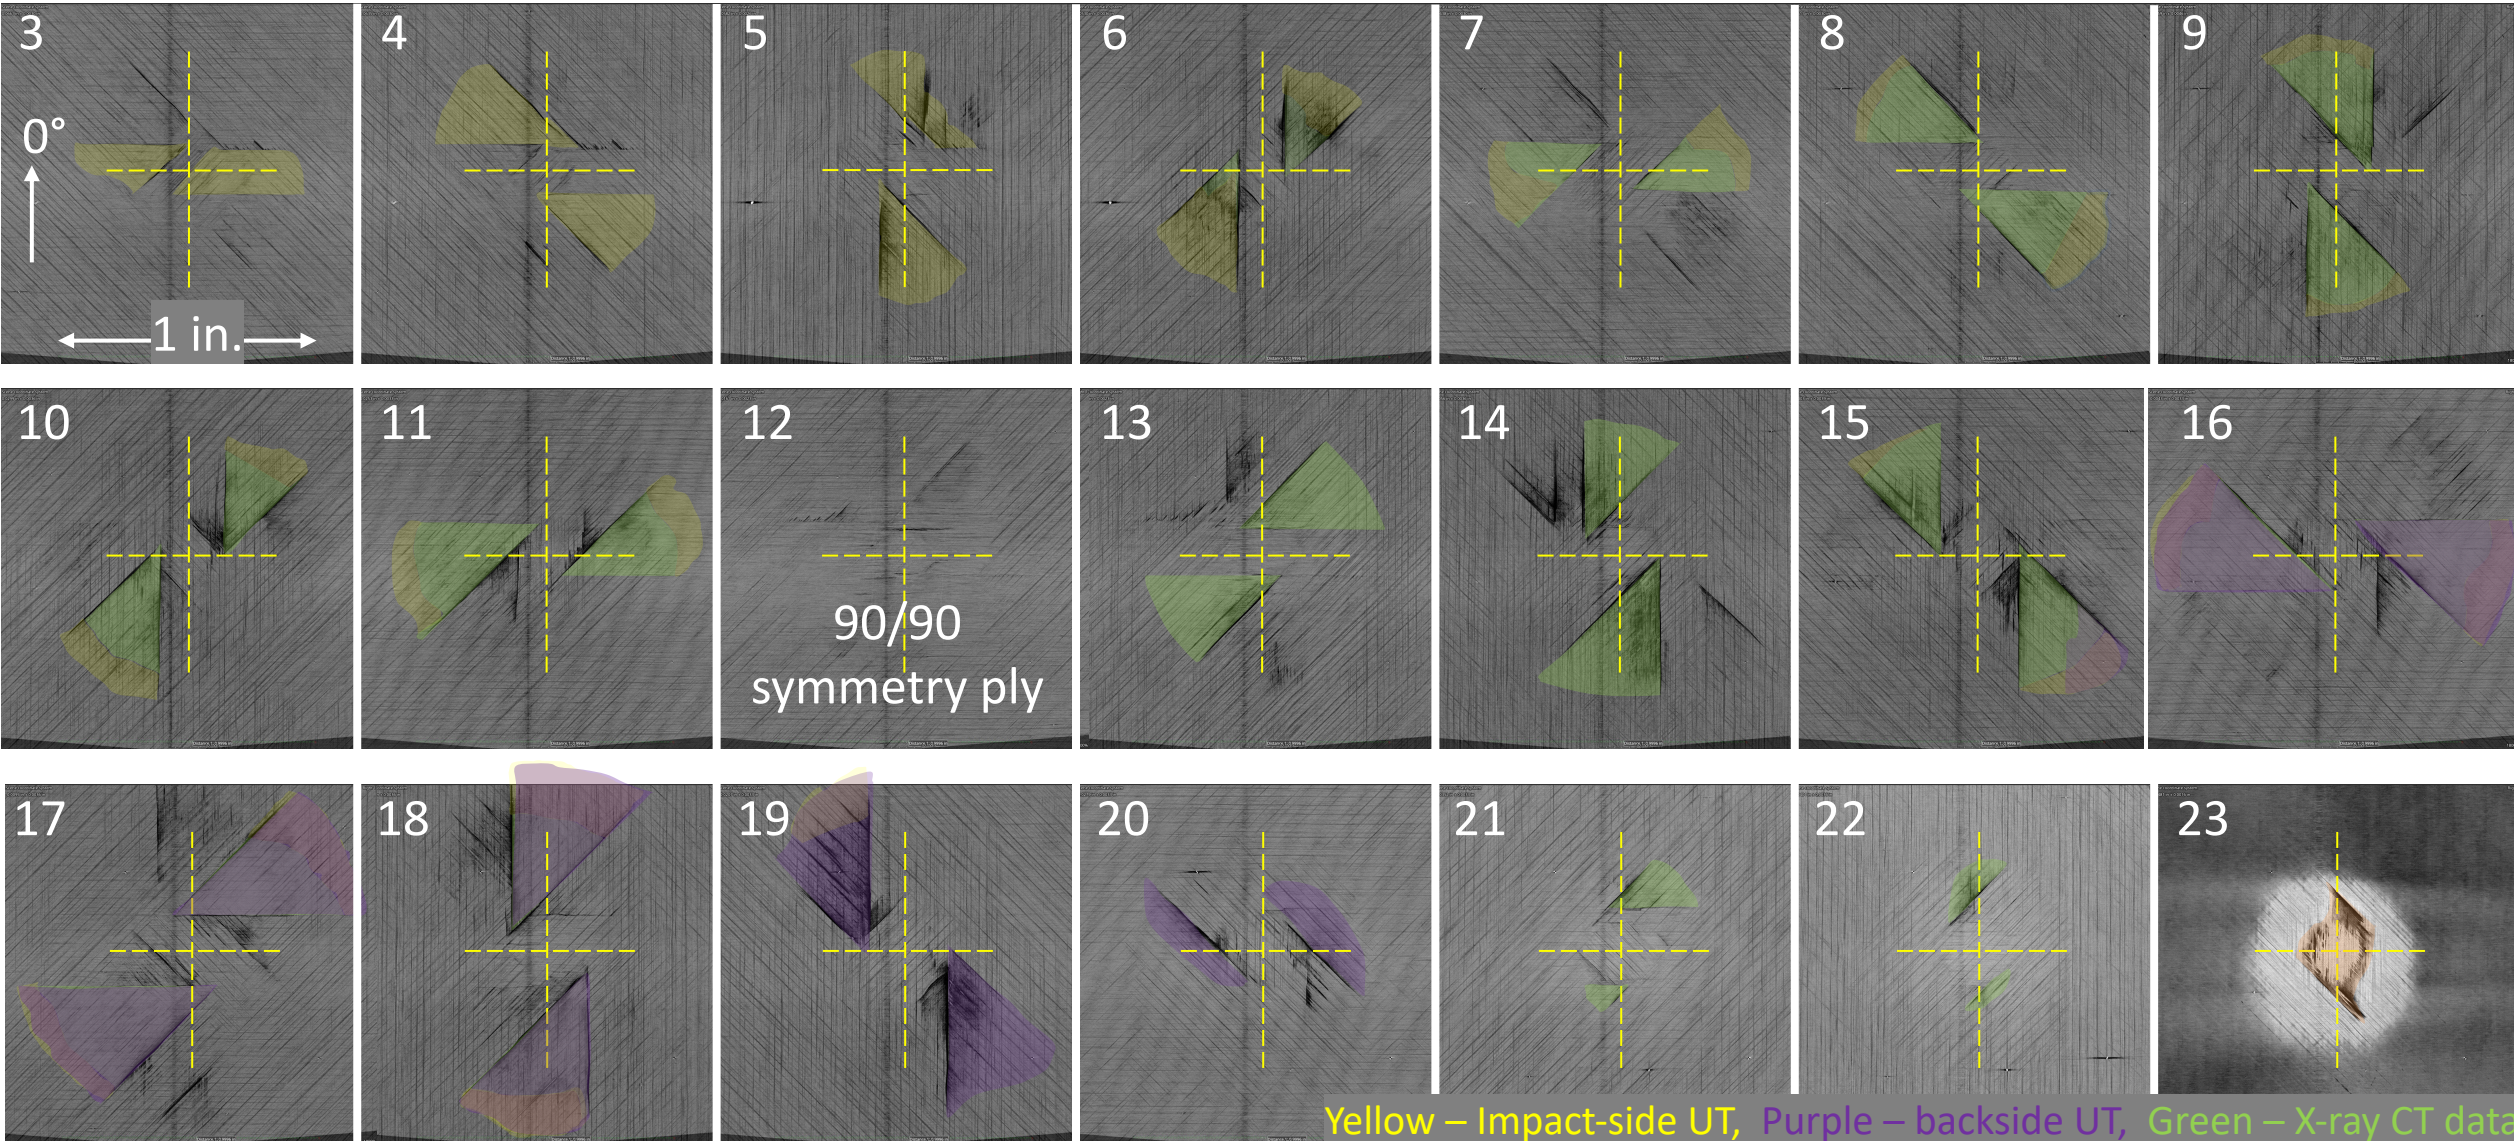
# Full Delamination Analysis of PEKK Impacted at 15 ft-lbs

Impact Surface [-45/0/+45/90/-45/0/+45/90 /-45/0/+45/90/90/+45/0/-45/ 90/+45/0/-45/ 90/+45/0/-45]

1 2 3 4 5 6 7 8 9 10 11 12 13 14 15 16 17 18 19 20 21 22 23

Delaminations

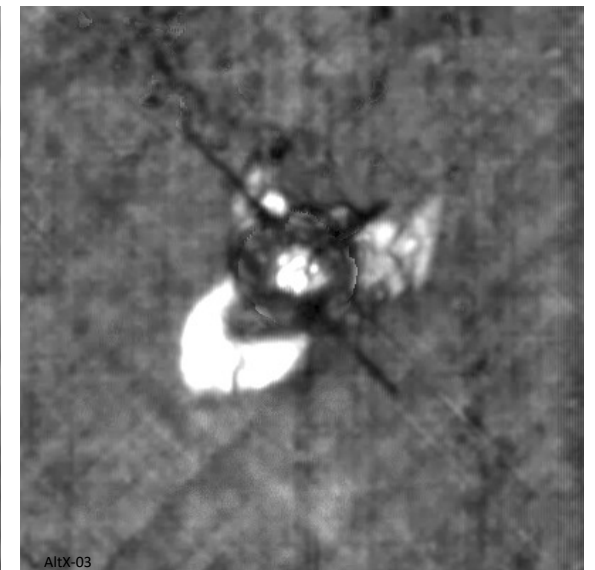
# Near-Surface Fiber Fractures

Impacts caused near-surface lines of fiber fracture in some specimens

- Observed only in PAEK specimens: ~50% of the baseline and all but one of the low-crystallinity specimens
- Fractures were generally perpendicular to the fiber directions
- Restricted to the top four plies near the impact surface

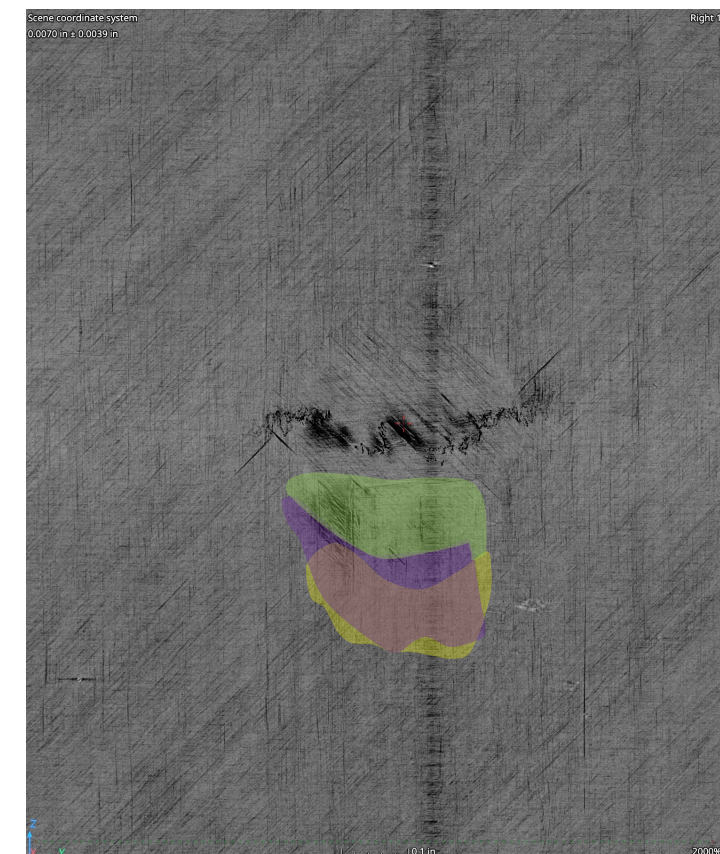
## Low-Crystallinity PAEK

One or two delaminations, irregular shapes - not bounded by matrix cracks

- **Low-Crystallinity Specimens:** Discontinuous between adjacent interfaces. Single unbounded delaminations with irregular shapes. Damage distributed through the thickness.
